Hopton Castle, Shropshire

Archaeological Evaluation Report

Archaeological Evaluation

Scheduled Ancient Monument No. 106648
Report reference: 71504.01
Path: X/projects/71504/post ex/report/TT Hopton Castle report (ed LNM)

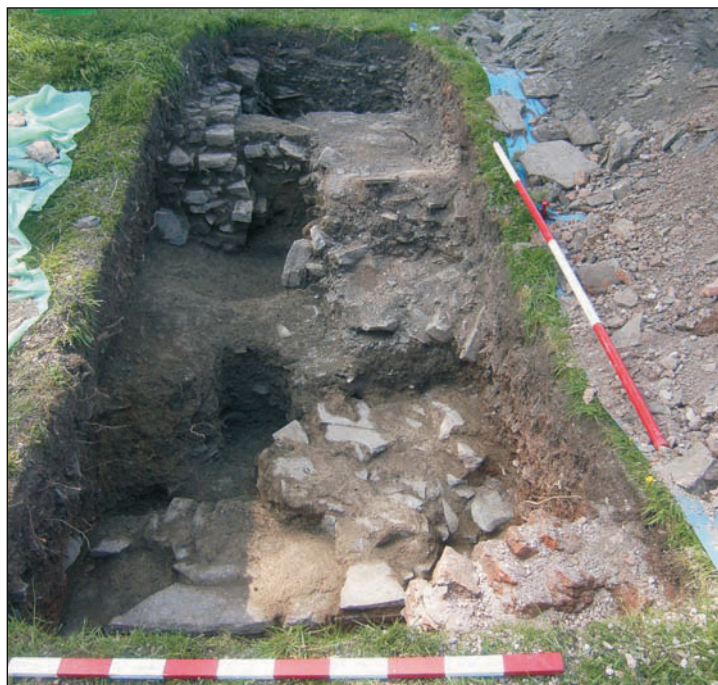
Plate 7: Post-excavation view Trench 2, view from north

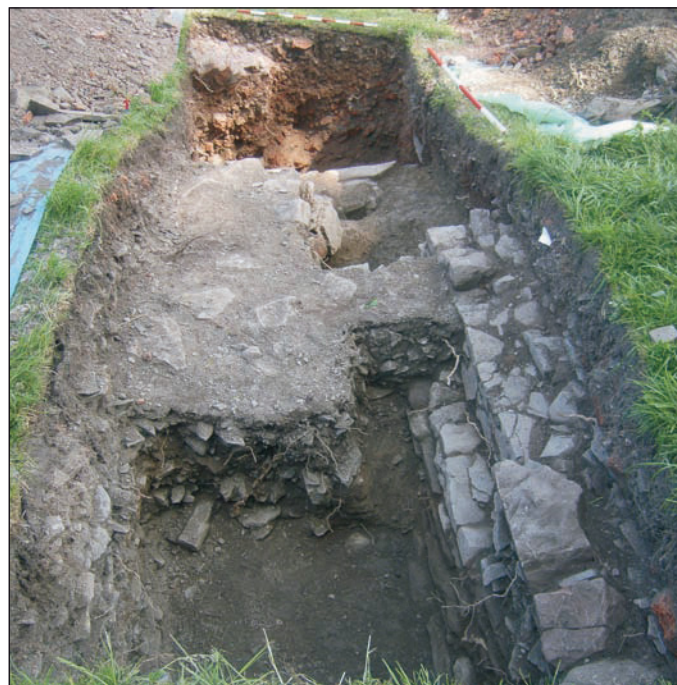
Plate 8: Post-excavation view Trench 2, view from south

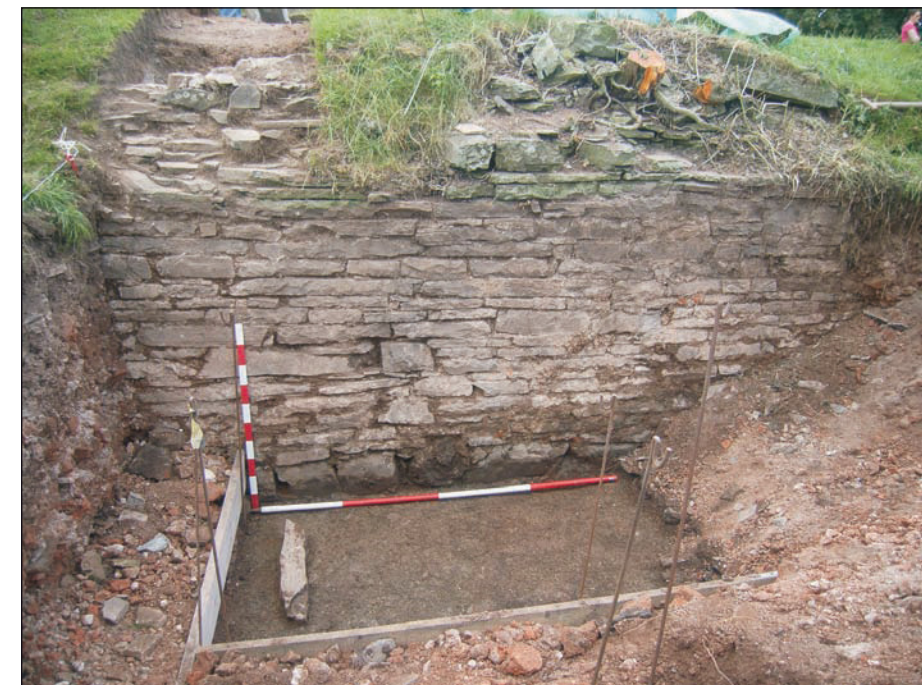
Plate 9: South-facing elevation wall 303

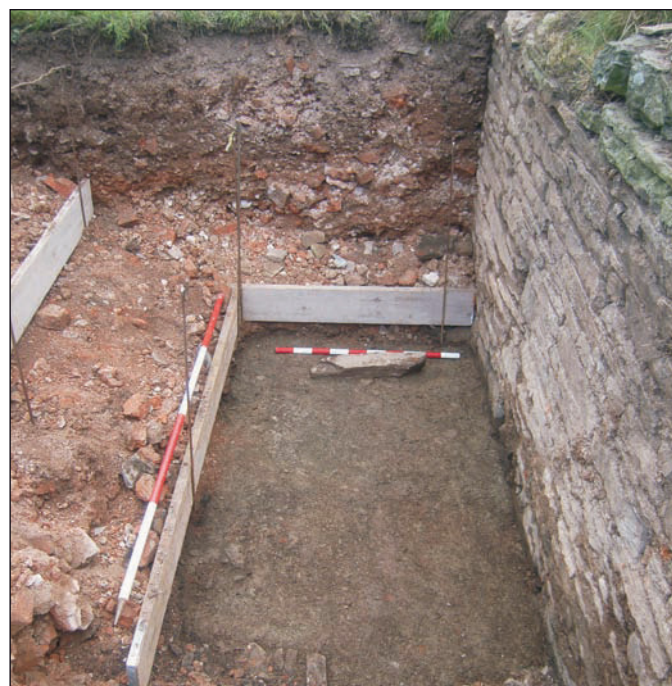
Plate 10: Demolition deposits Trench 3, view from east

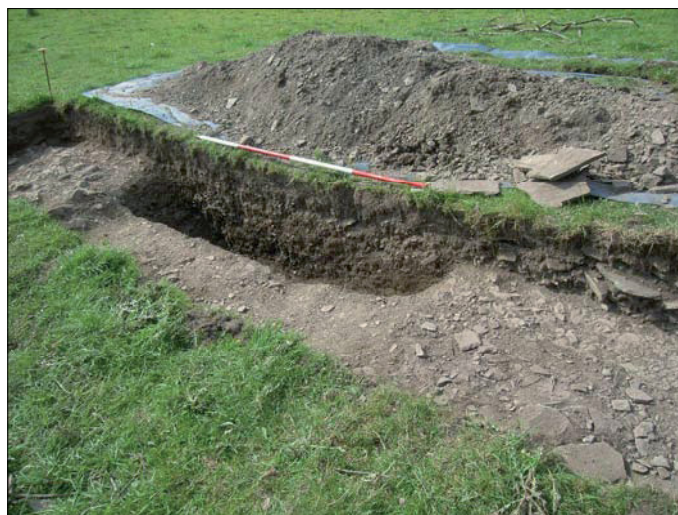
Plate 16: Oblique view, north-east facing section Trench 7
