**HEANOR HAULAGE,
LANGLEY MILL, DERBYSHIRE**

Archaeological Investigations

Report reference: 73612.01v_5

September 2010

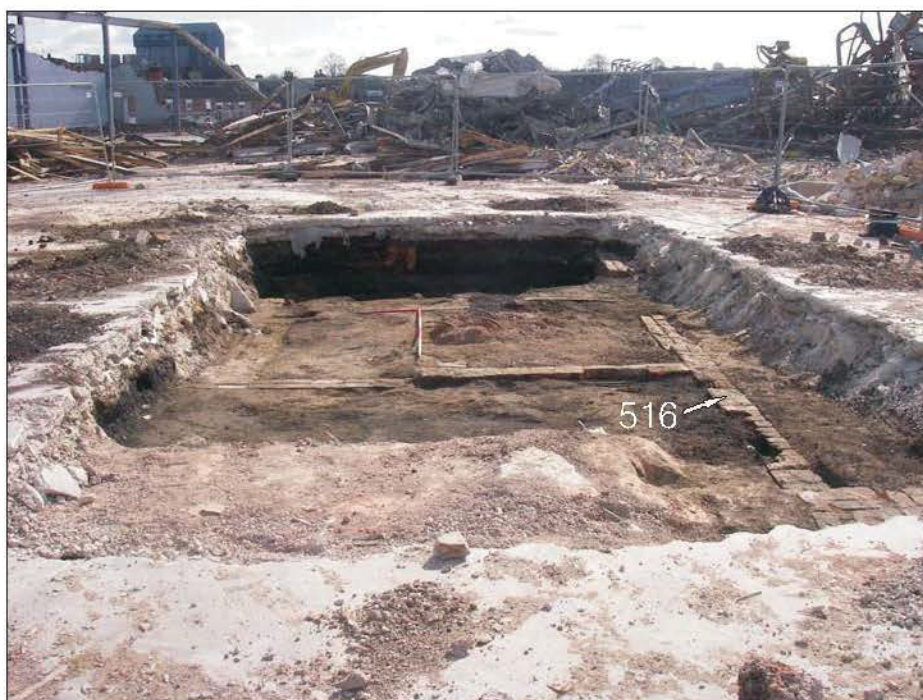
Plate 4: Trench 9, facing east. Showing the 1881 factory extension and the small room appended to the north.

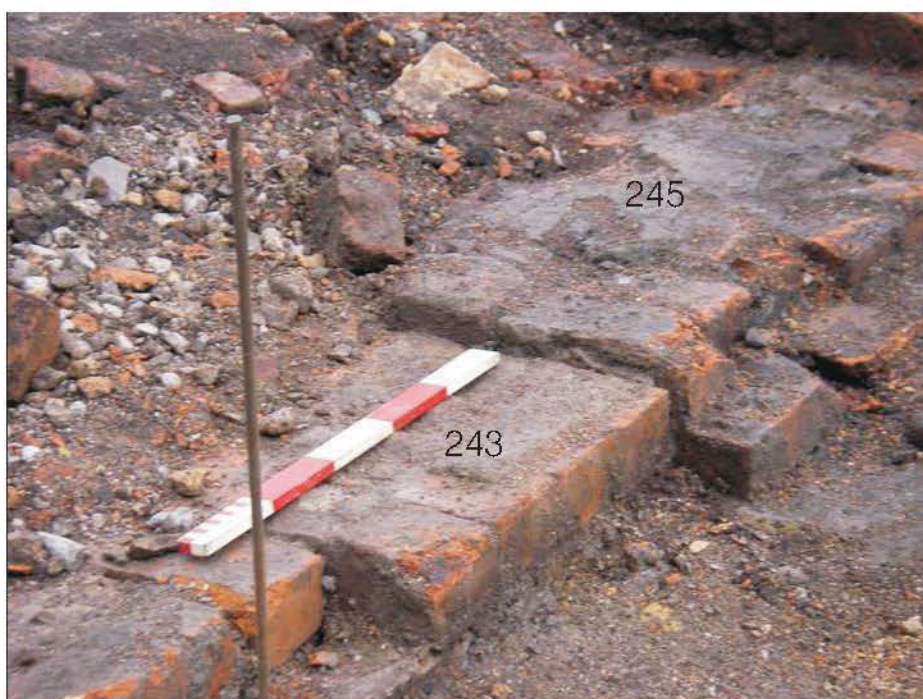
Plate 5: Trench 14, facing south-east. Showing the off line coursing between [245] & [243].

- 5.15.7 As discussed above, the initial factory appears to have seen two major phases of construction. The 1881 OS map (**Figure 2**) of the area suggests that this extension had taken place by that date. The second phase consisted of northern extensions to the east and west factory walls. The original western wall **244** was abutted by wall **232** and the original eastern wall **245** by **243** (**Figure 15**). The new walling was constructed from handmade, unfrosted bricks which were marginally smaller than those used in the first phase. The new walls were constructed in the same pier and panel method, but were narrower than the original walling. The panels measured 0.36m and the piers are 0.6m wide. Another indication of the differing phasing was the slight difference in coursing levels between the two walls (**Plate 5**).
