# Former Coach House Trenython Manor, Cornwall

Historic Building Record

Report reference: **74760.03**

**July 2010**

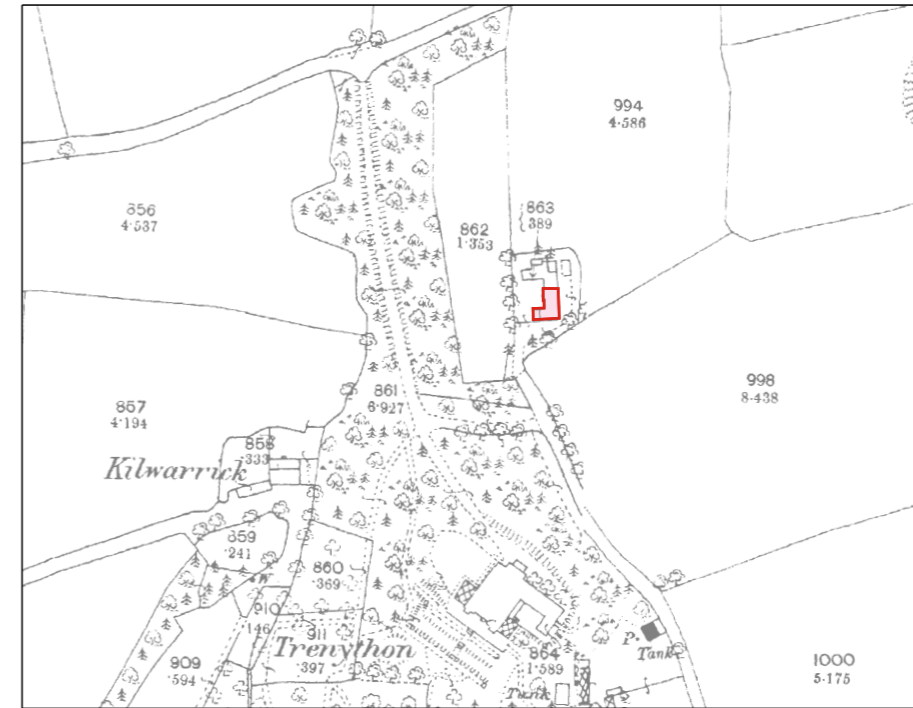
OS map of 1880

- 4.2.2 By the time of the 1880 Ordnance Survey plan Trenyhton Manor is shown to be fully developed (**Figure 2**). The large Manor house stands at the north-east end of a wooded valley and is surrounded by various structures including greenhouses. The site is called 'Trenyhton' on the map. The immediate area around the house had been landscaped with garden

terraces to the south-west and the wooded enclosures, shown on the Tithe map, extending to the south-west had been adapted with various paths and rides created through them. What appears to be a small stream is now shown running north-south from just south of Kilwarrick, which is still shown, but appears to have been divided into two separate rectangular buildings. To the north, a long carriage way had been created, leading from the north side of the manor house to Castledore Road.

- 4.2.3 The coach house is shown, built to its full size to the north of the main house. It stands on the east side of the north carriage way and is shown set in a rectangular enclosure surrounded by trees. It has a roughly 'E' plan with the front facing west comprising a central range and north and south wings. The south wing of the 'E' plan is shorter than the north wing and there are two small ancillary buildings attached to the north-east corner and north side of the north wing respectively. A third ancillary building is attached to the west end of the south wing. There is a short central projection looking onto an open yard to the west and a small yard on the east side with a single, probably, open fronted shed in the north-east corner. The main access to the coach house is shown to be on the east side with a curving track following around from the south

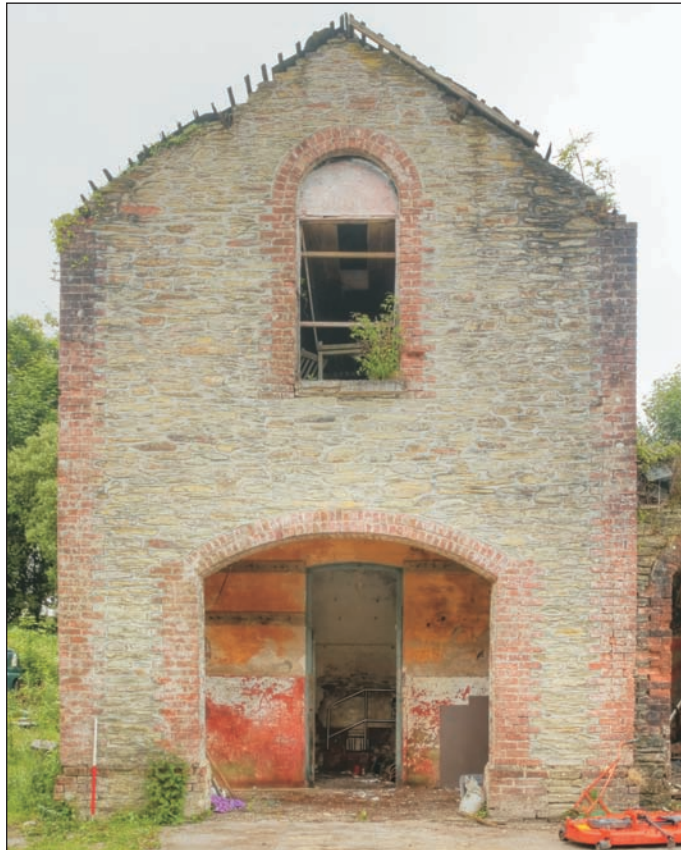
- 4.3.2 The central two storey element (**A**) is constructed from rag-work walls of local stone with red brick dressings around window and door openings and as quoins (**Plate 1**). The west facing elevation has a wide central arched opening on the ground floor with granite threshold and a tall window opening on the first floor, the arch of which pierces the stone gable. The wall has been re-pointed with cementitious mortar. Opposing doorways at the north and south ends of the porch originally gave access into the north and south halves of the central range, the south door is now blocked and the north door is still open and leads to the yard behind the 1930's houses.

Plate 1: Two storey element A west facing elevation

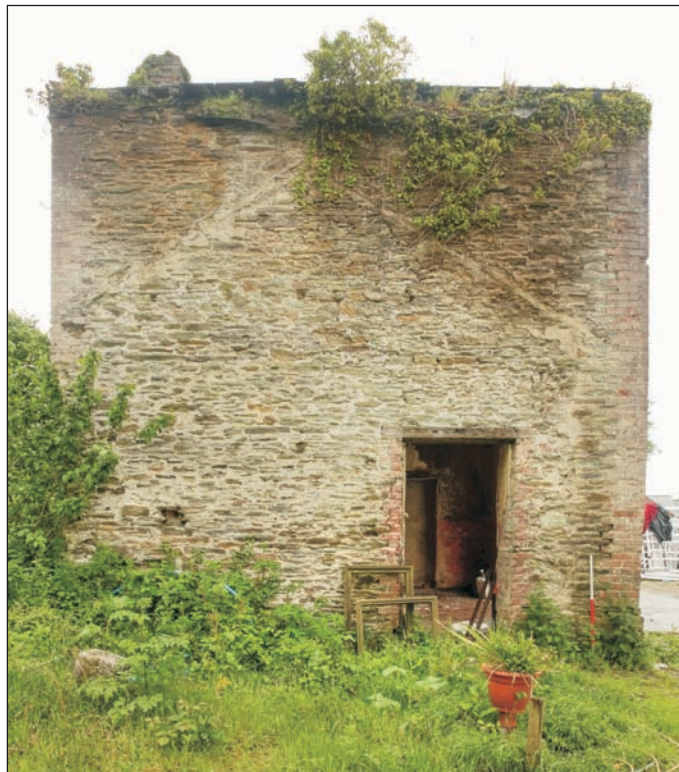
- 4.3.3 The north facing elevation of element **A** is also constructed in rag-work local stone (**Plate 2**). There is a single door opening with brick dressings and re-used timber lintel at ground floor level and to the west side. Quoins are, again, red brick but were not visible at low level at the north-east corner where it is of stone (**Plate 3**). There is evidence of the demolished north half of the central range visible as a pitched roof scar together with the scars of the east and west walls.

Plate 2: Two storey element A north elevation showing evidence of demolished north range

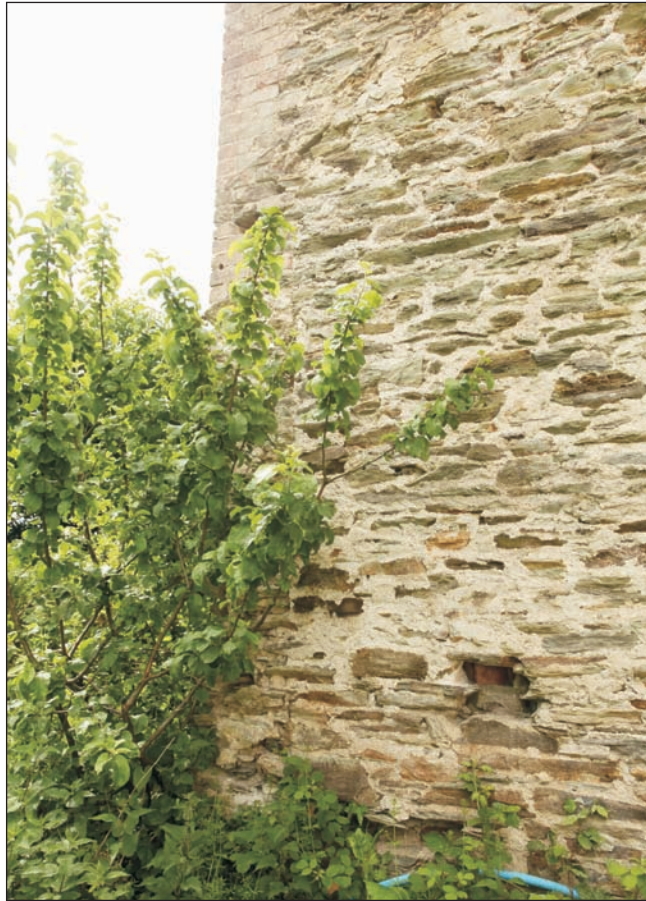
Plate 3: Evidence of original stone wall and brick quoins at north-east corner of central element A

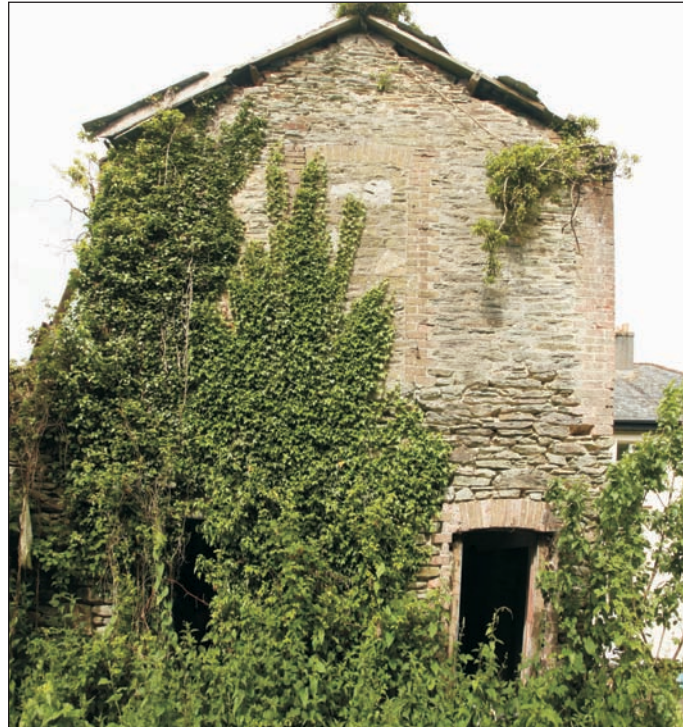
- 4.3.4 The east facing elevation of element **A** continues with rag-work walling although much of this elevation was covered with ivy and other vegetation (**Plate 4**). There are two window openings with cambered brick soldier arches and brick dressings on the ground floor and a blocked opening in the first floor. This opening appears to have originally been a door but is now blocked with a mixture of granite blocks and stone set in cementitious mortar.

Plate 4: Two storey element A east facing elevation showing windows and blocked first floor door opening

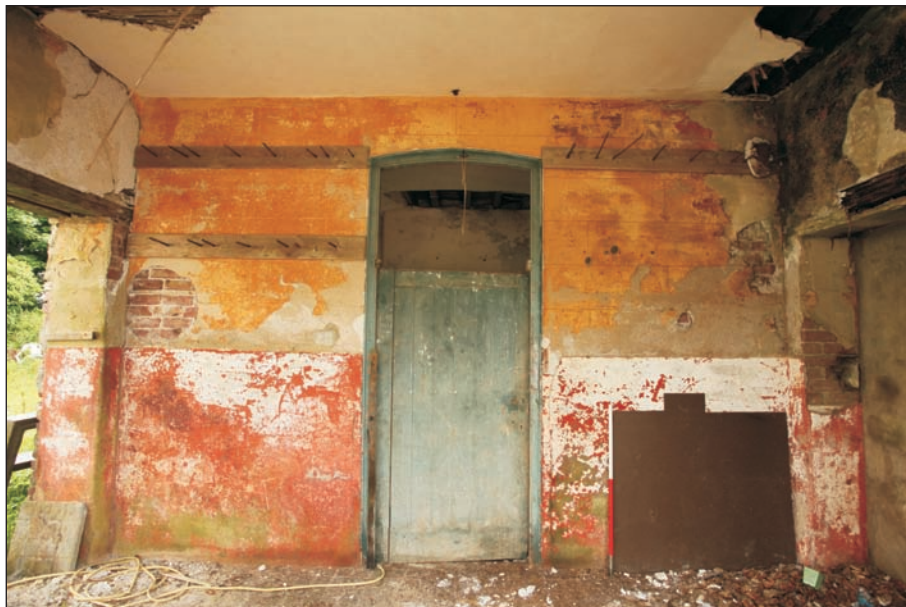
Plate 5: Central porch area showing door access into east room office/bothy

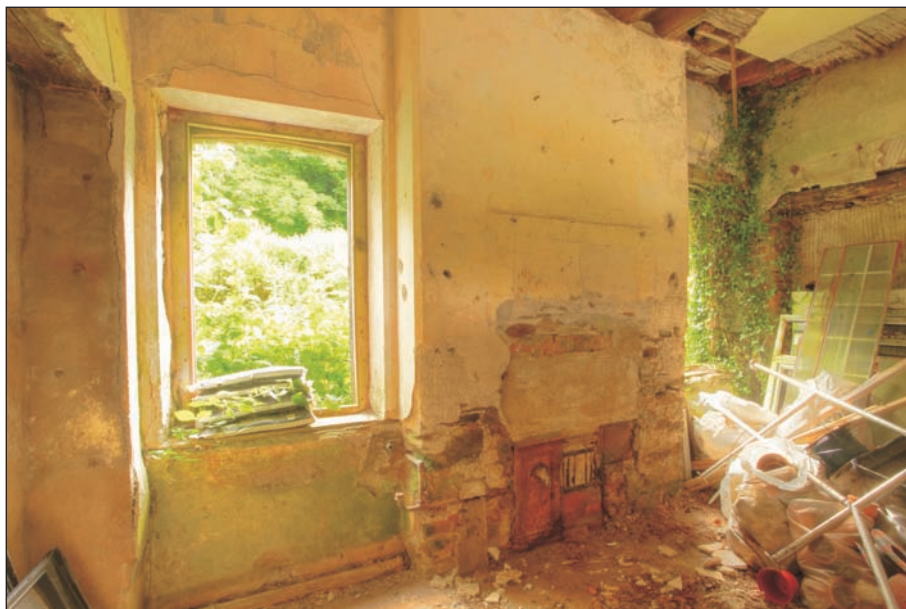
- 4.3.5 Internally, the ground floor space of the two storey element has been divided into a west porch area and a ground floor east room or office /bothy. The floor surface of the porch area is laid with blue Staffordshire squared paviors and the floor surface of the east room is concrete screed. Wall surfaces are plastered and painted with block lines scored into the surface. The room is accessed via a centrally placed original wide softwood door with the remains of a borrowed light frame above (**Plate 5**). The room measures 4.8m north-south and 3.1m east-west and, although largely empty of original features, still retains its original layout with light provided by the two windows set either side of a central chimney in the east wall (**Plate 6**). The windows are missing but the surviving frames suggest that they were originally of sash design. Along the north and south walls of the east room are pairs of cupboard or shelving recesses (**Plate 7**). These have been formed in the body of the stone walls but are finished with red brick

Plate 6: Ground floor east room showing original window openings either side of chimney

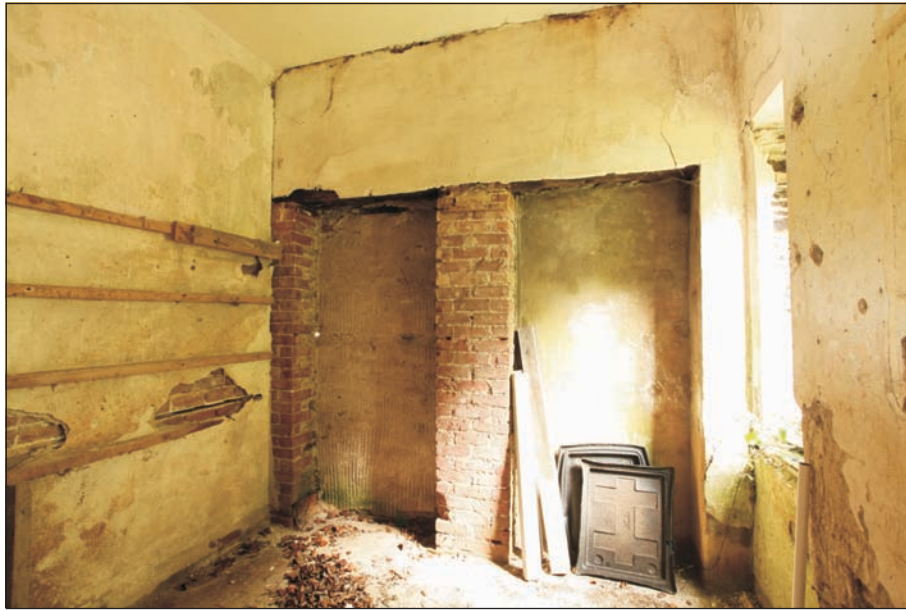
edging and a central pier. Timber lintels support the walls above the recesses and appear to be re-used railway sleepers. The fireplace still contains the original iron fire grate which incorporates a water tank on the north side. The space above the fire grate has been blocked but there are fixing marks above the fire grate on the chimney breast suggesting that there was once a fire surround and over mantle here (**Plate 8**). The ceiling is lathe and plaster fixed to first floor joists.

Plate 7: Cupboard recesses in north wall of east ground floor room

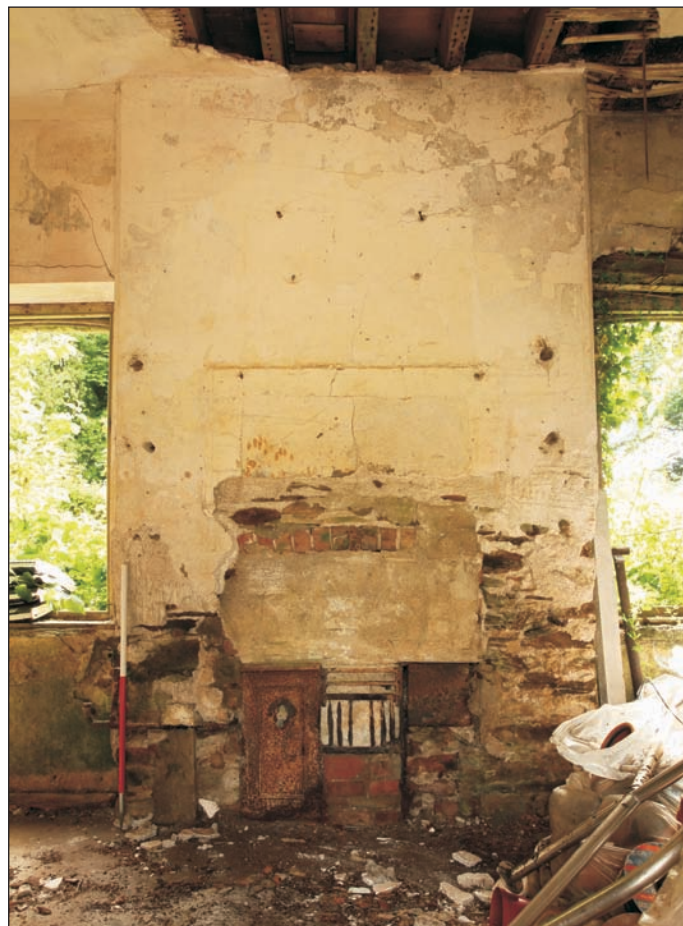
Plate 8: Detail of original Victorian fire grate, water tank and evidence of fire surround east room ground floor A

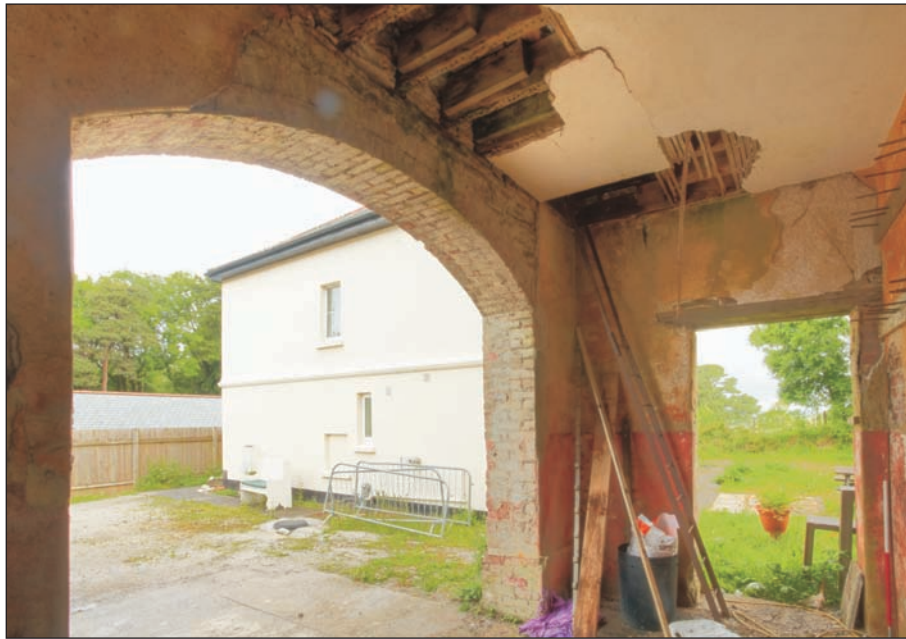
- 4.3.6 It was not possible to access the first floor as the floor surface was deemed unsafe. But a visual inspection from the arched opening provided some opportunity to assess this space. Access to the first floor was via an iron pole ladder in the north-west corner of the porch area (**Plate 9**). At the top of this ladder was a short vertical wooden ladder fixed to the north wall. The room itself was boarded out with what appeared to be dark coloured pine tongue and groove to the walls and ceiling. At the time of the survey it housed wooden racking and stacks of old chairs. The chairs appear to be the same as those shown in an undated image produced for an article produced in the magazine journal 'Back Track' railway magazine September–October 1994 edition (not shown in this report). In this publication, there is an article on the history of railway convalescent homes and an image in the article shows the stately dining room at Trenyhton when it was occupied by the Railway Convalescent Home. The dining room is shown with a formal layout of dining tables set with the same straight back chairs found in the first floor room. The surviving roof trusses were viewed from a narrow gap in the ceiling boards and appeared to be simple 'A' frames of softwood comprising principal rafters with halved apexes and collars at present ceiling level. The pitched roof itself is in a partial state of decay but is still covered with slates.

Plate 9: Covered porch area showing iron pole ladder access to first floor

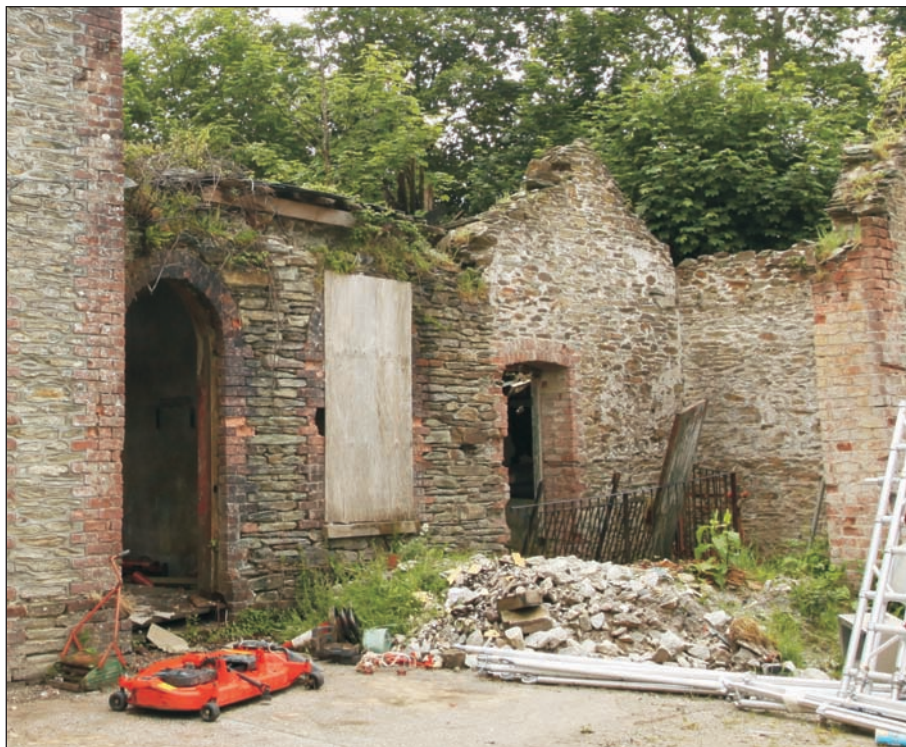
- 4.3.8 The single storey south element **B** and single storey south wing **C** were built as two conjoined elements (**Plate 10**). Element **B** was enclosed but the north side of the south wing **C** was probably open as there is no evidence of a north wall enclosing this side. The roof of element **B** is in a state of dangerous collapse and the roof of element **C** is completely missing. The original function of element **B** is unclear. No access for horses is provided and there is no clear evidence of internal division, so it probably served a more utilitarian function such as a work shop.

Plate 10: Elements B and C viewed from north-west

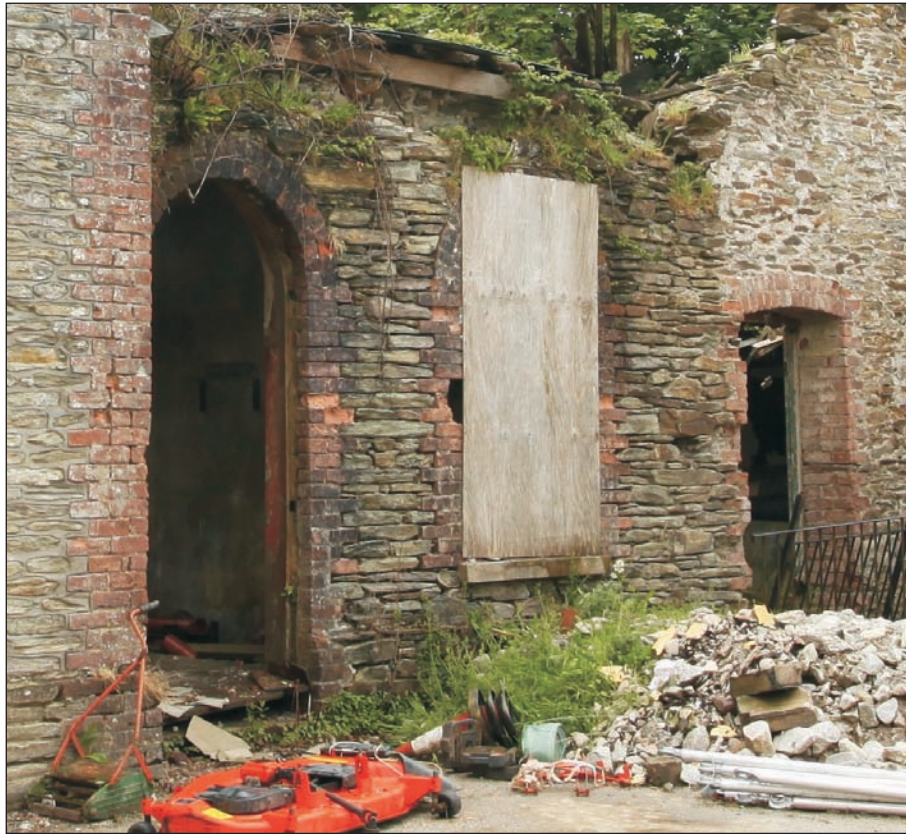
- 4.3.10 There are three openings in the west wall of element **B**. Originally there were two arched windows set in the decorative rag-work stone wall and a doorway at the south end set into the rubble section of walling. The northern-most window opening has been altered to form a doorway leading into the west yard (**Plate 11**). This was probably carried out at the same time as the doorway on the south side of the arched porch was blocked. The southern most window opening is presently boarded over.

Plate 11: Detail showing conversion of window opening into doorway

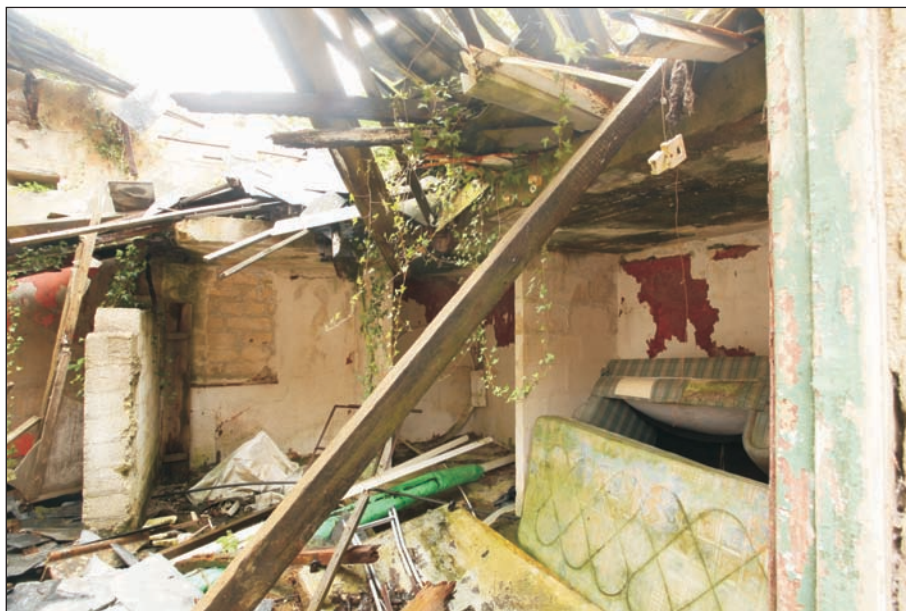
- 4.3.11 The original internal space of element **B** measured 9.2m north-south and 4.8m east-west. The east wall had a single blocked window opening toward the south end leaving a wide area of wall with no openings. The original internal space has been subdivided by a narrow wall creating a small rectangular room measuring 2.6m north-south and 4.8m east-west on the south side of the central element **A**. The remaining space forms a room 6.4m north-south and 4.8m east-west. This room has been further divided by a series of low bays along the south and east walls (**Plate 12**). The bays are formed by concrete block walls supporting a thick cast concrete flat roof which appears to have been built under the, once extant, now collapsed, original slated roof.

Plate 12: Series of low bays with concrete roof at south end of element B

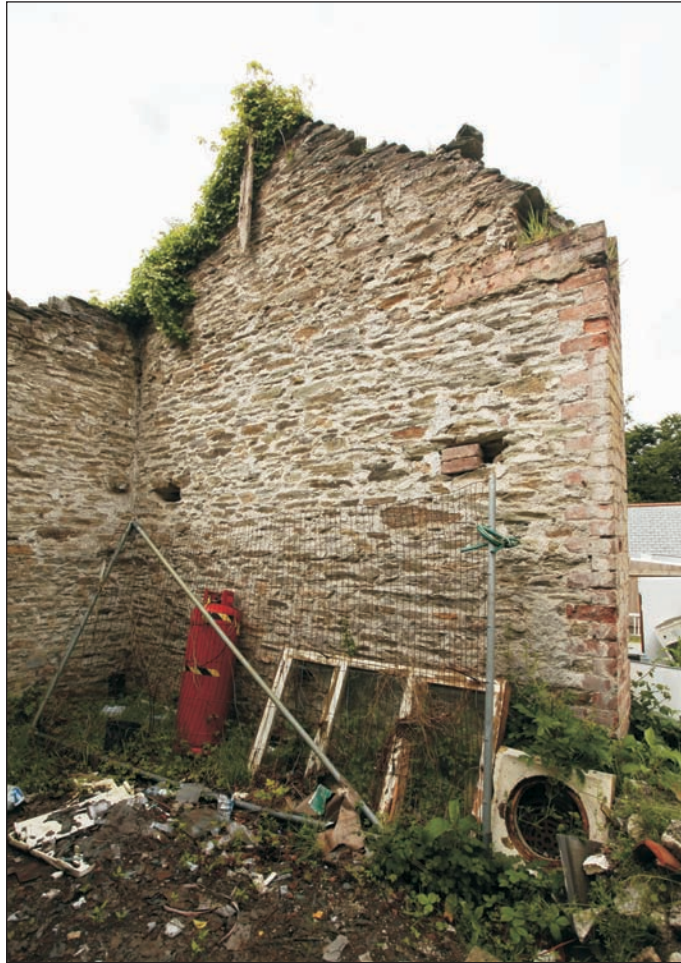
- 4.3.12 Element **C** appears to have always been open-ended. There are no obvious signs of blocked openings or fixings that would suggest wall coverings or fittings (**Plate 13**).

Plate 13: Internal remains of element C

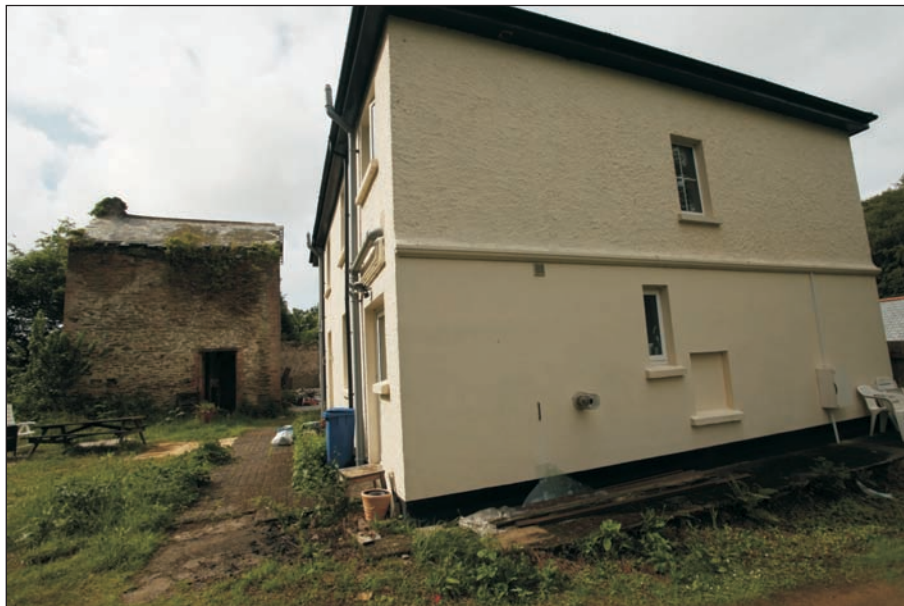
- 4.3.14 Of the demolished north wing of the coach house there is no surviving evidence above ground level. This area is now occupied by the footprint of the two 1930's houses (**E**) and their rear, east yard (**plate 14**).

Plate 14: 1930's houses built on the site of the original coach house north wing
