## Moat Hall, Braithwell, Doncaster, Scheduled Monument No.13234

Archaeological Watching Brief Report

Report reference: 75820.03

**December 2010**

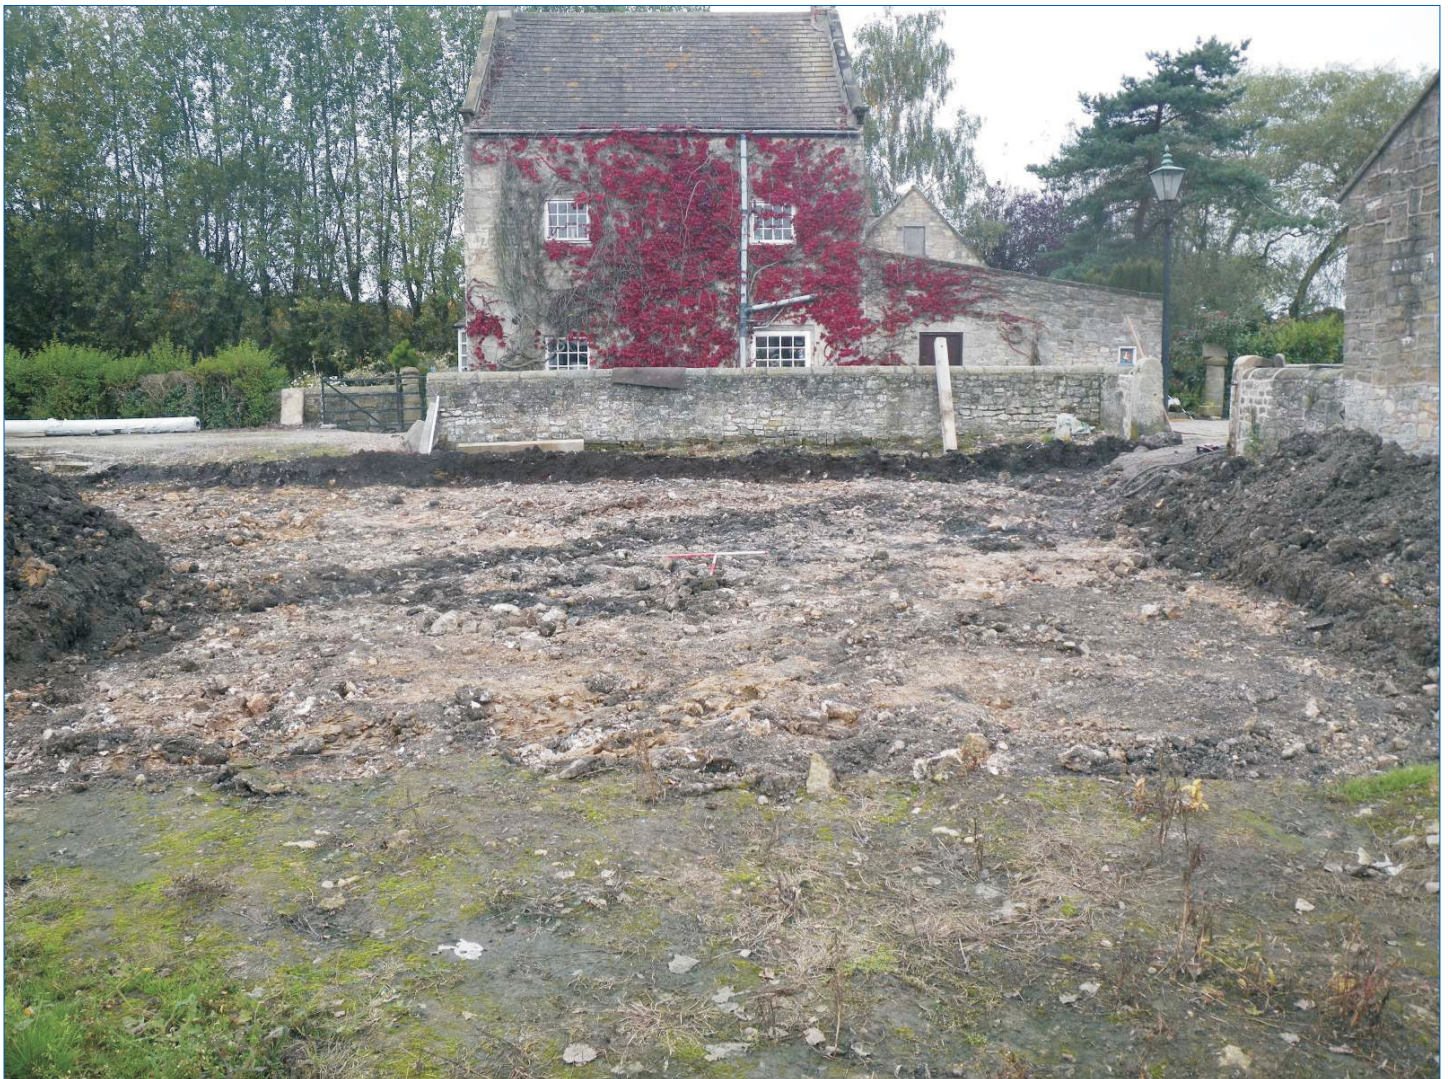
- 5.2.2 In the north of the area a spread of limestone cobbles **102** had been deposited near to the buildings (**Figure - front cover**). This layer formed either a rough yard surface or a simple dump of stone in a corner of the field. The southern part of the Watching Brief area was situated on the boundary between the drive and a former field boundary. Within this area was a mid greyish brown deposit of silty clay **117** with a very high concentration of limestone cobbles. This deposit is presumably a by-product of sorting stone to the edge of the field during the use of the land as farmland.

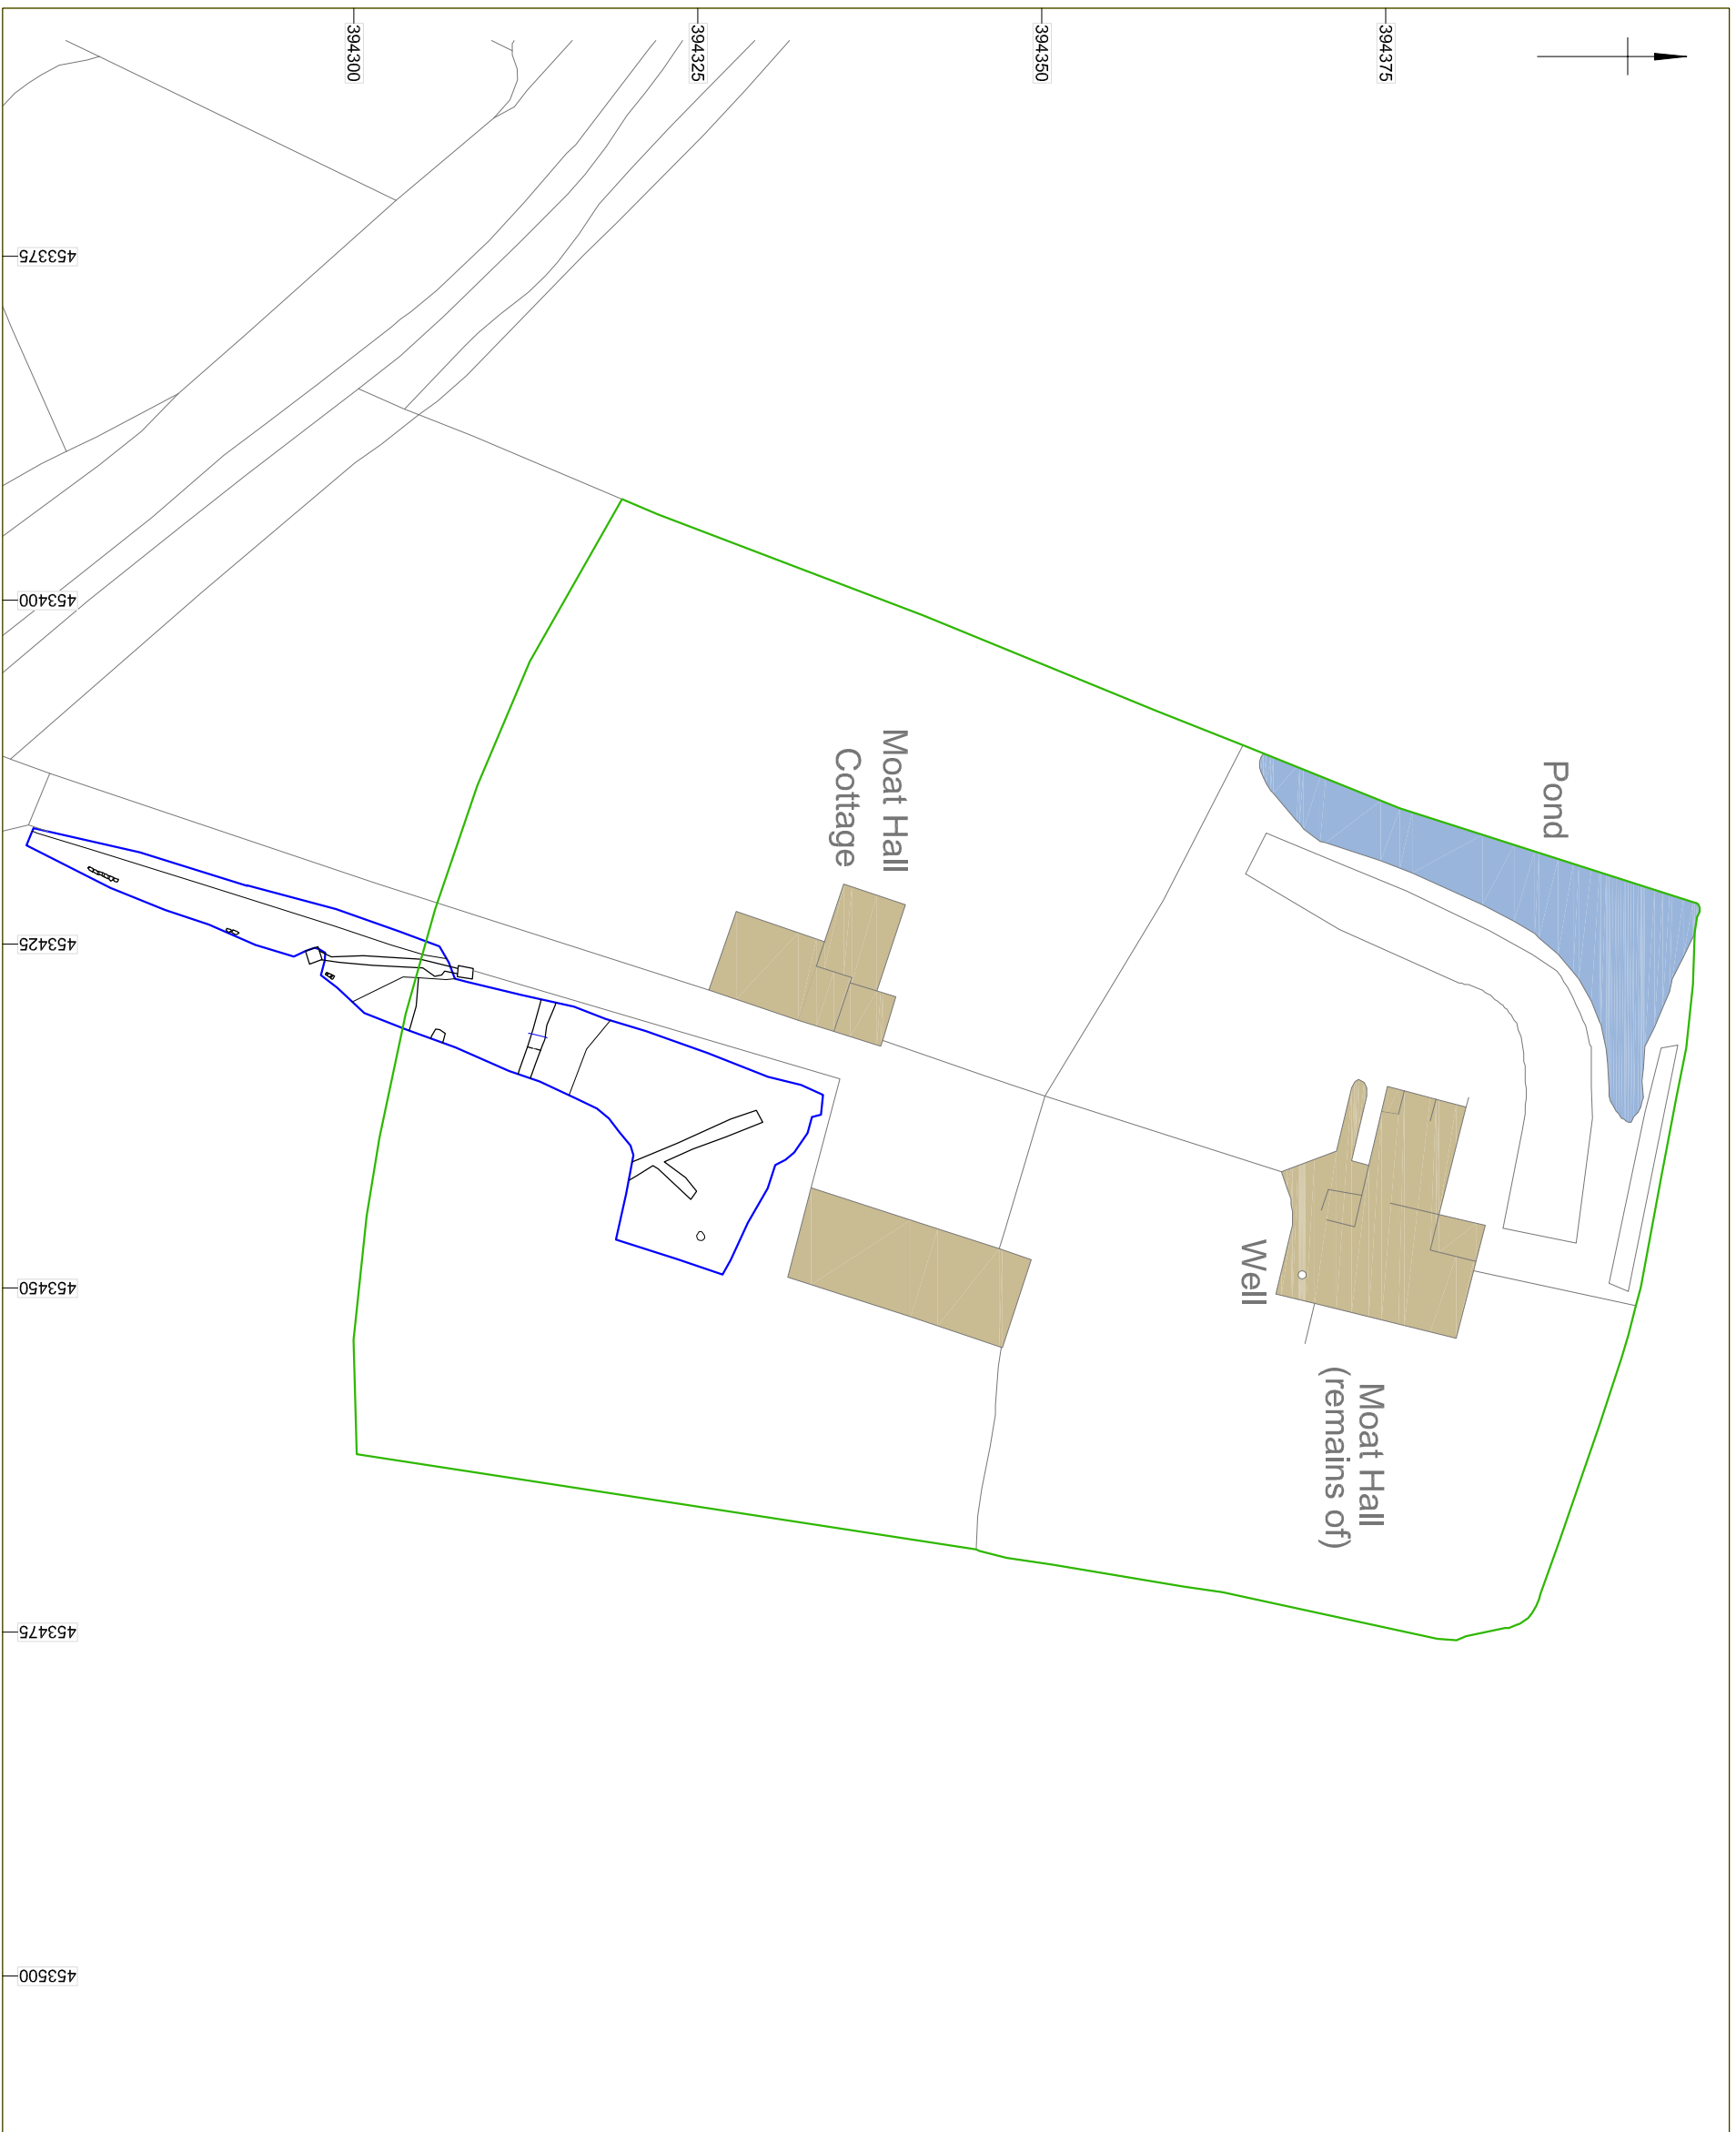
Figure 2

- 2.1.6 The development area is located to the south of the standing remains of the hall and runs south from Moat Hall Cottage across the line of the former moat (**Figure 2**).

Location of Scheduled Ancient Monument and area of Watching Brief

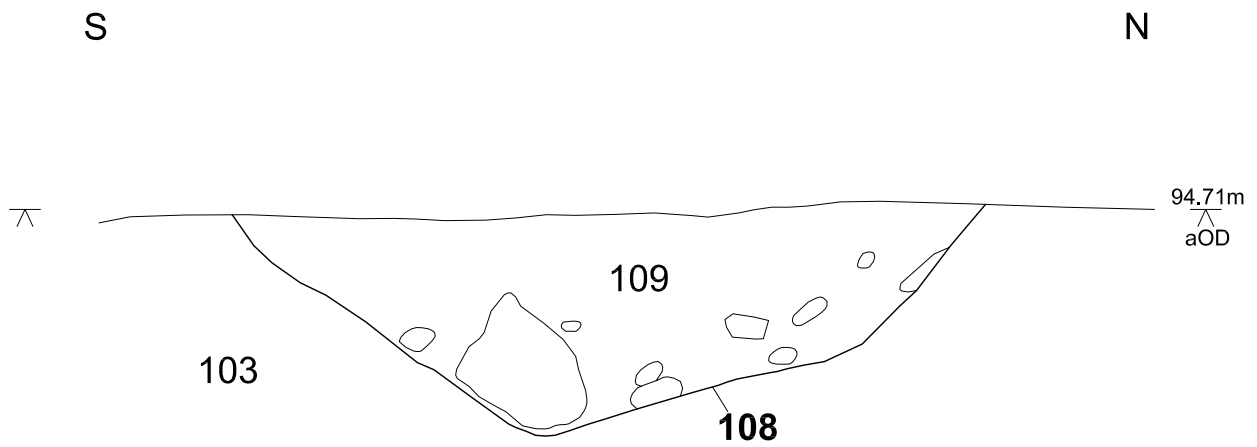
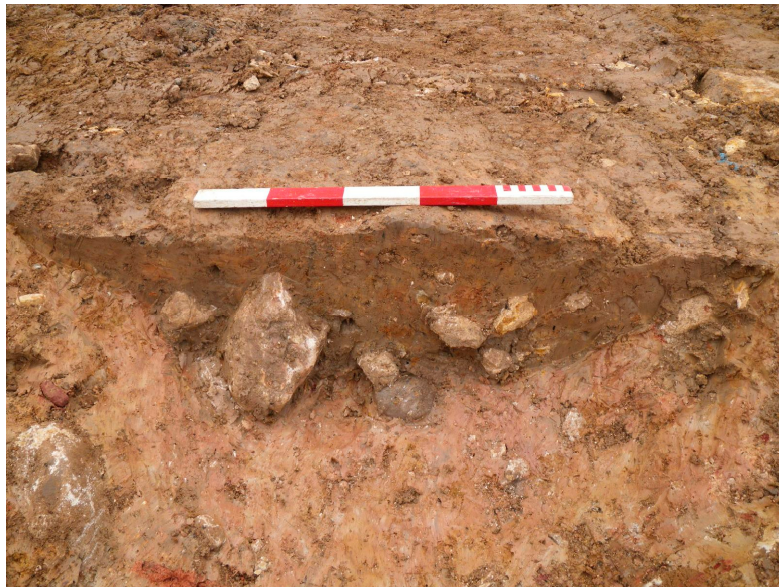
Figure 5

- 5.3.2 Running east-west through the exposed section of natural within the centre of the Watching Brief area was a 0.9m wide ditch, **108**. A 1m section was excavated, showing that the ditch had a depth of 0.29m and contained a mid greyish brown silty clay fill **109** with moderate charcoal flecking and limestone pebbles (**Figure 5**) and could possibly be the remains of a robbed-out wall foundation. A 20 litre sample of **109** was taken for post-excavation processing. Due to its shallow depth and the extent of recent root action environmental processing was deemed inappropriate and instead the sample was sieved through a 2mm mesh for the recovery of artefacts; however none was found. To the south of ditch **108** was a small rectangular pad of stones **110** that extended under the baulk to the east (**Plate 3**). This appeared to rest in a shallow cut **105** but as works did not threaten this feature it was left *in situ*. Observation in plan indicated that **110** possibly represented a foundation pad for a post or similar structure.

Section through ditch 108

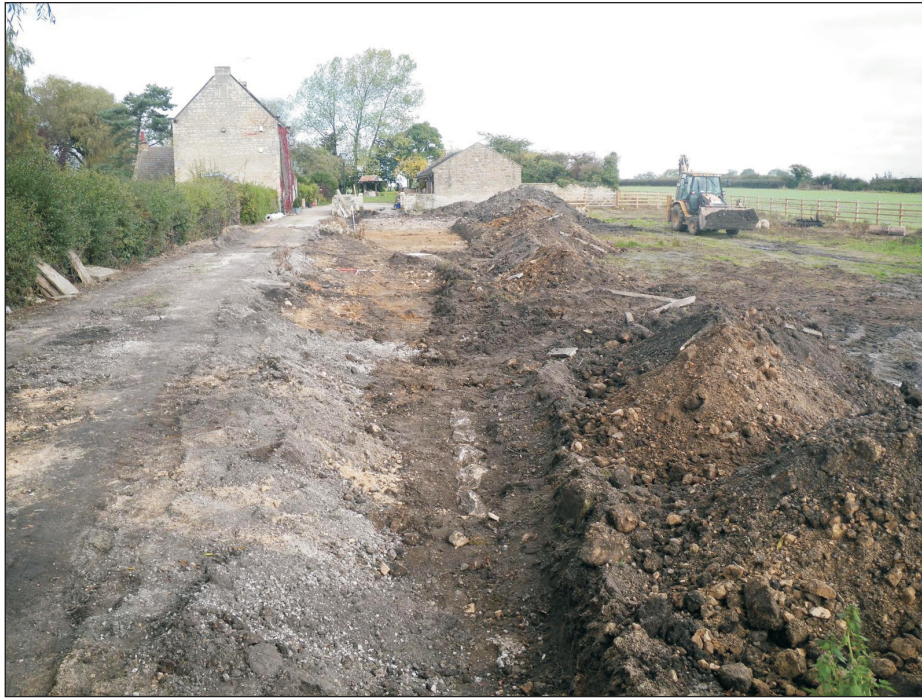
Plate 1: Site fully excavated, looking north.

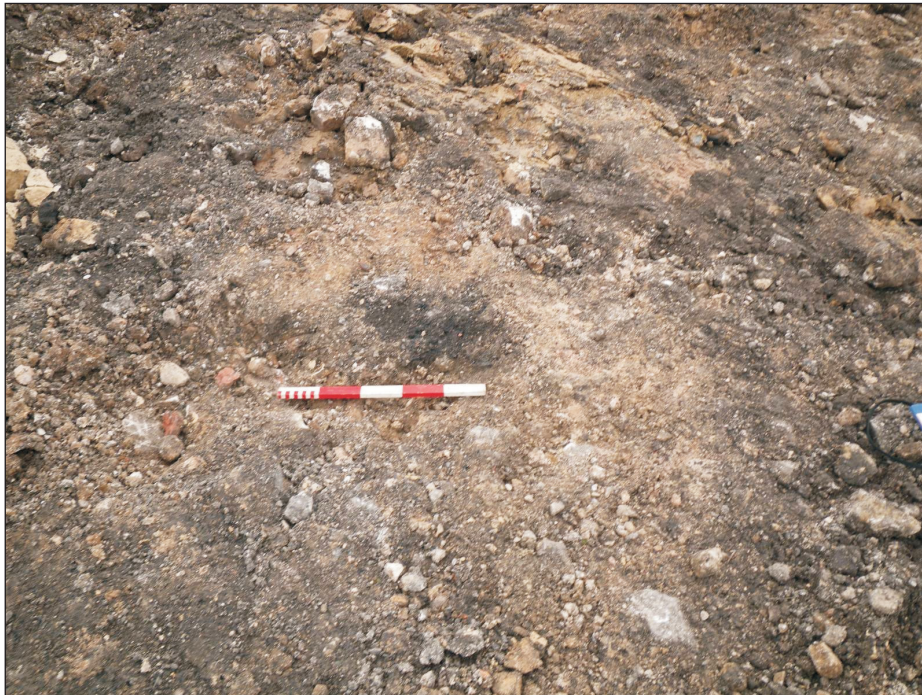
- 5.3.1 To the northeast of **102** was a spread of ash **104** containing post-medieval pottery, clay tobacco pipe and CBM (**Plate 2, Figure 3**). **104** appeared to lie directly on top of stone layer **102** at a depth of c. 0.05m BGL. The ash deposit likely to derive from the raking-out of one of the fireplaces in the cottages to the west.

Plate 2: Ash spread 104, looking south.

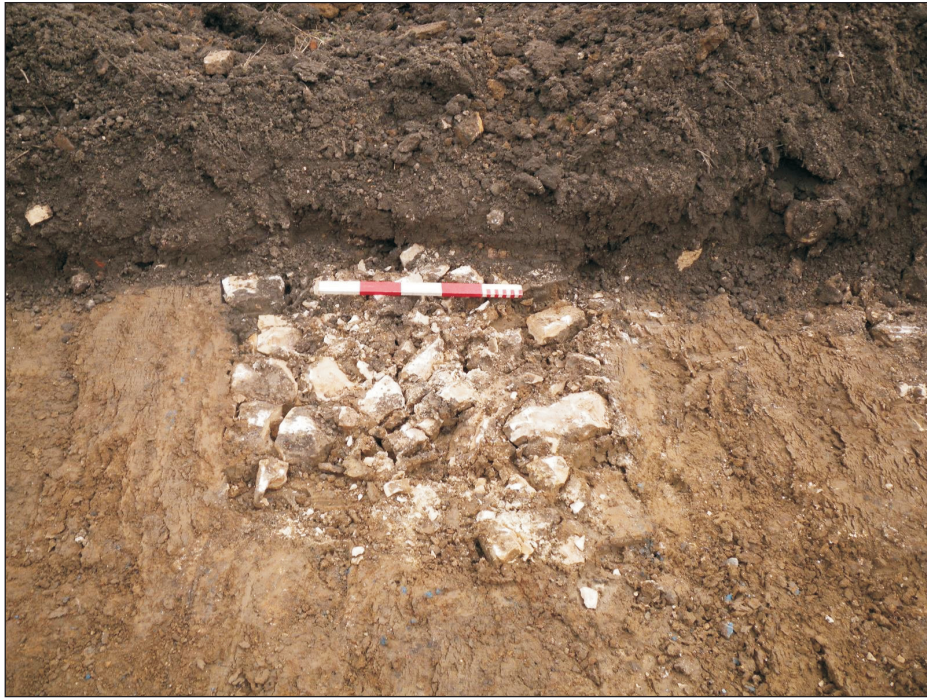
Plate 3: Stone pad **110**, looking east.

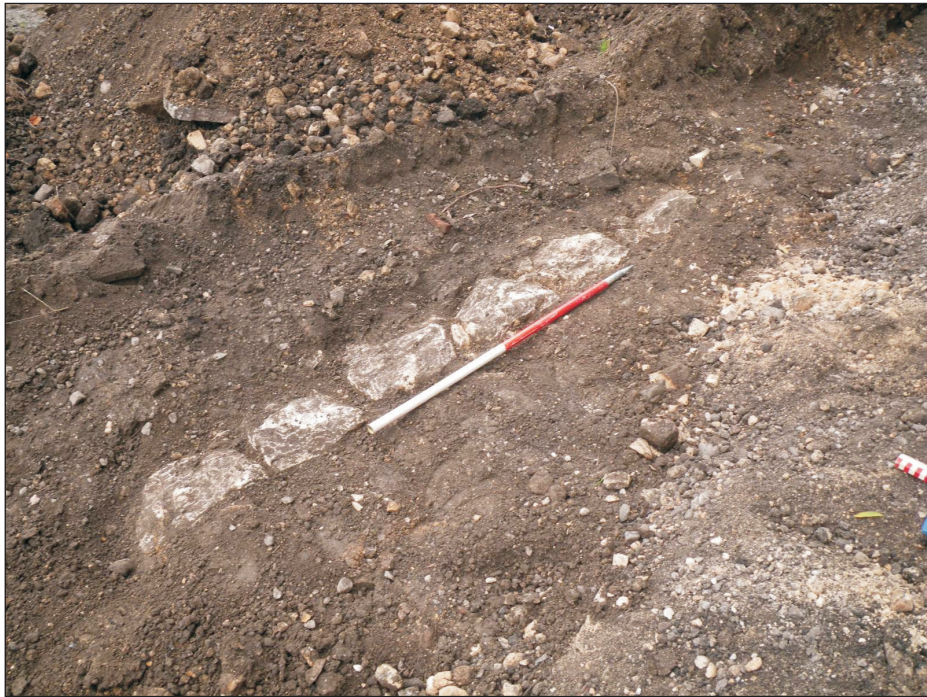
- 5.3.3 Although the southern portion of the site was not excavated beneath **117**, the top of a possible linear feature was partially exposed. This feature consisted of three discrete areas of roughly rectangular stone blocks placed in line and together they appear to be the remains of one wall running north-south. The northern section, **114**, shows some truncation with two or three of the blocks being cracked into several pieces - possibly due to the shallow depth at which they were found. The central part of the structure, **115**, consisted of two stone blocks and the southern section, **116**, consisted of six blocks aligned north to south (**Plate 4**). These features all ran under **117** and only the areas exposed during groundworks were cleaned and recorded. There is a strong possibility that these structures continue underneath the overlying deposit and possibly even meet to form one continuous structure. Due to the lack of detailed investigation and the simple construction method

- 6.1.2 The only feature that could potentially relate to the pre-19<sup>th</sup> century occupation of the Site was the stone wall represented by **114**, **115** and **116**. These remains were fragmented and were only partially revealed during the groundworks. However, the stone-built wall roughly follows the line of the existing driveway and could represent the boundary of an earlier access track. The wall appeared to be of traditional dry-stone construction with (at least) one neatly faced elevation, and it is not datable. It could be contemporary with the Moat Hall Cottages (thought to be early 19<sup>th</sup> century) but an earlier date and an association with the scheduled remains cannot be precluded.

Plate 4: Walling section **116**, viewed from northwest.
