WA0605 Officers & Senior Ranks Garrison Mess, Aldershot, Hampshire

Archaeological Watching Brief Report

Ref: 74404.02 January 2011

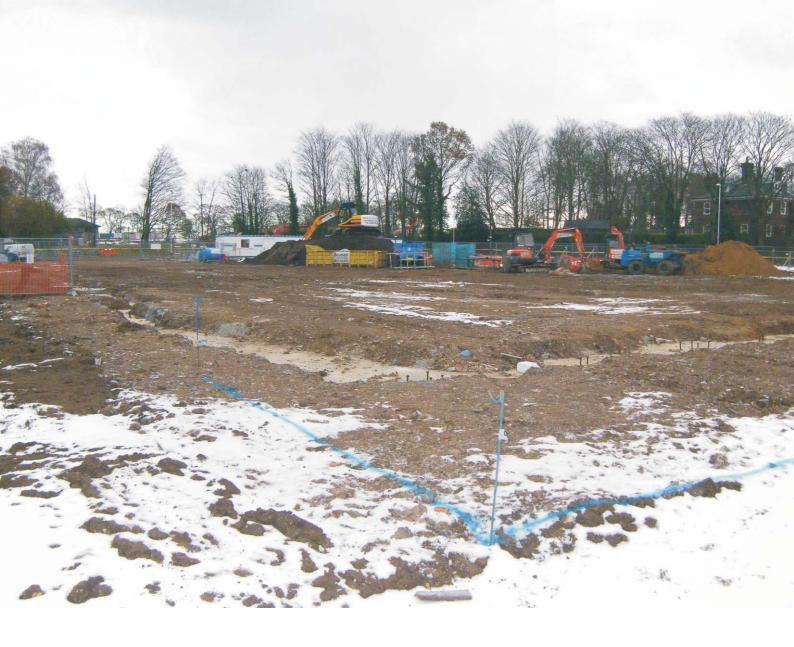
Figure 1 Site location plans showing area of Watching Brief
Cover General Site (WA0605) photograph viewed from the north-west

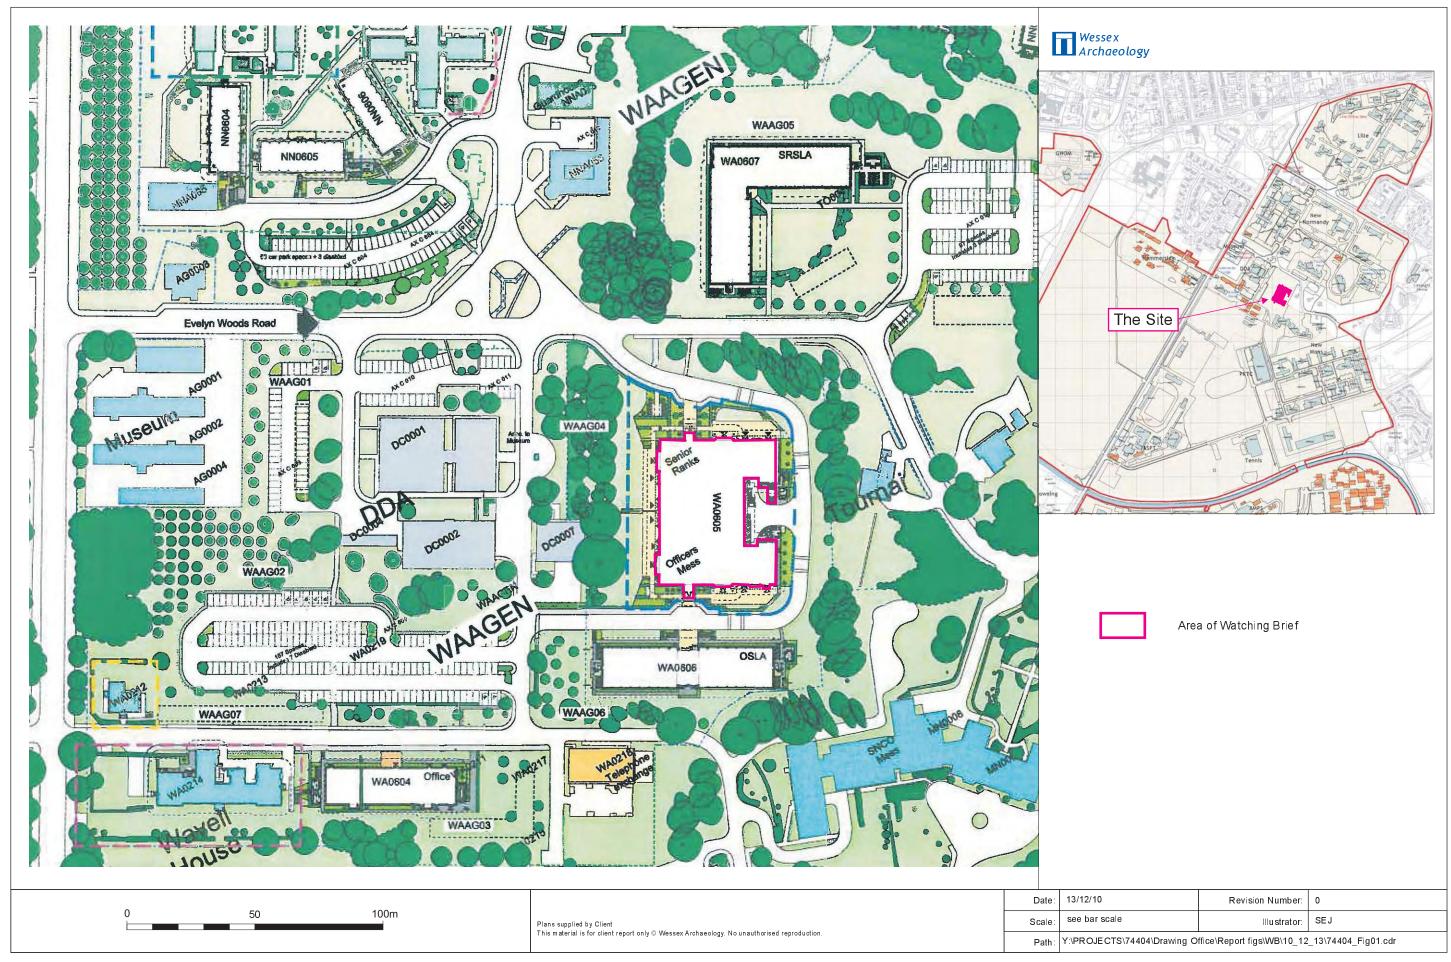
Site location plans showing area of Watching Brief
