**TOTTENHAM HOUSE AND ESTATE SUB-STATION,
MARLBOROUGH,
WILTSHIRE**

ARCHAEOLOGICAL EVALUATION

December 2020
Report No. 1391

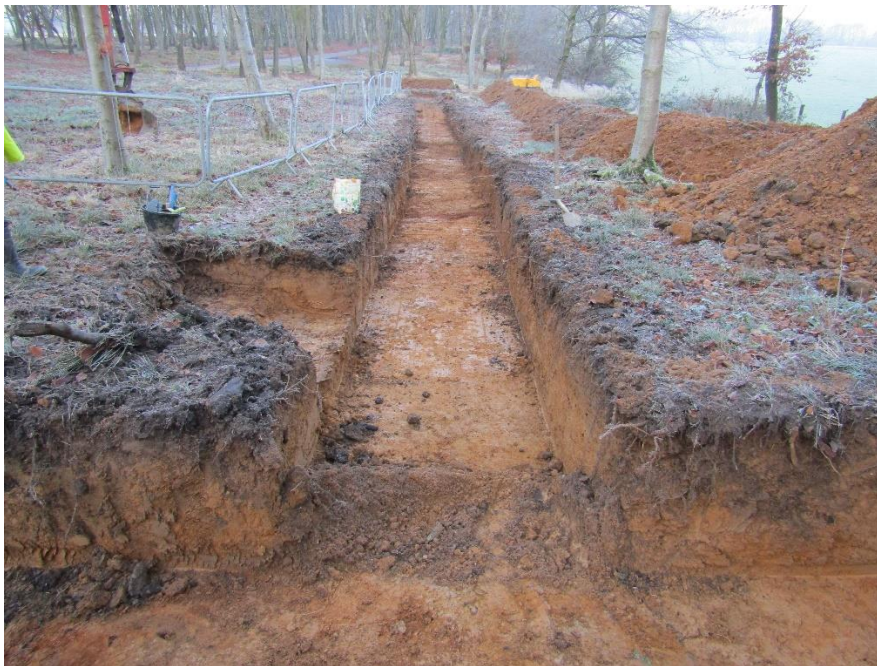
Trench 1 Looking West

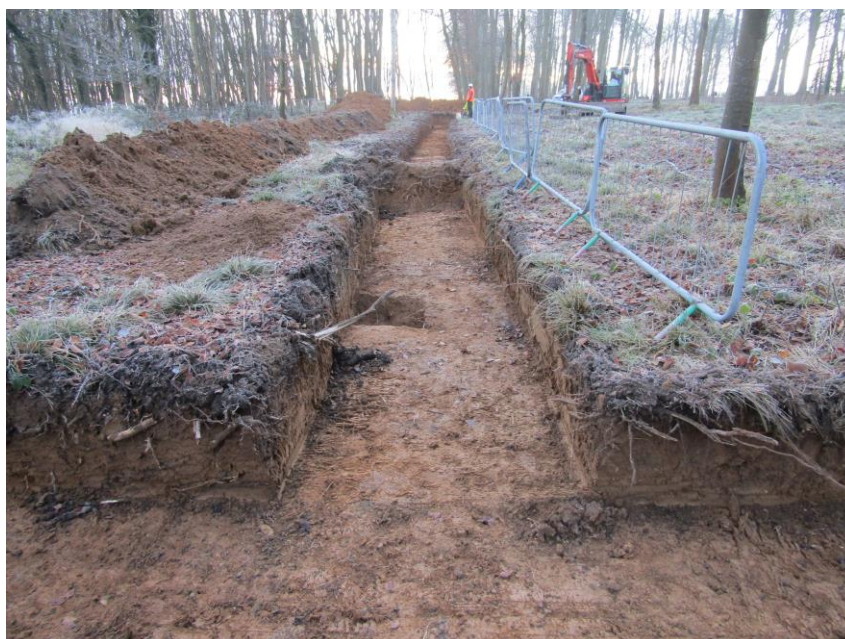
Trench 1 Looking East

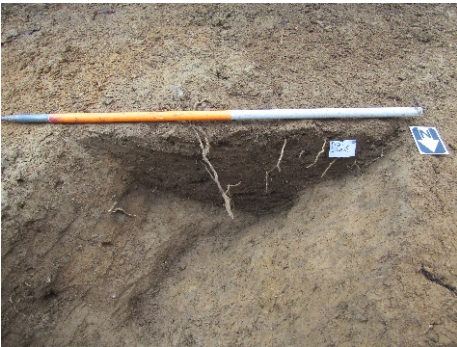
FIGURE 3: Trench 1 Plan and Section

- 5.1 Natural deposits of orange brown clay, with gravel bands were present at an average of 0.78m (163.96m AOD) below the Modern ground surface. These were sealed by an orange brown clay/silt clay subsoil (1002), between 0.54 and 0.7m thick, which contained occasional patches of flint pebbles and gravel, but was entirely devoid of artefacts. The subsoil was overlaid by a dark brown loose clay silt topsoil (1001), between 0.14 and 0.25m thick. This deposit was heavily root disturbed and was also devoid of artefacts. An isolated deposit of modern dumped material was present between the top and subsoil horizons approximately 10m from the southwestern end of the trench. Due to the presence of plastic within this deposit, the material was noted but not retained.

- 5.2 Present near the northwestern end of the trench was linear feature [1003] (Figure 3). This feature was roughly aligned northeast-southwest and contained (1004), a pale brown clay silt fill. This deposit was heavily root disturbed and contained no obvious charcoal or artefactual evidence. Due to the proximity of the trench to the purported Roman road, it was decided that the feature should be excavated to 100% in order to aid artefact retrieval. However, during this additional excavation, no artefacts were recovered. The edges of the feature were shown to be uneven in both plan and section and upon this further excavation, it was decided that the feature was probably not archaeological but natural in origin.

001: NORTHEAST FACING SECTION [1003]
