**BROADWATER, MANOR ROAD,
WANTAGE,
OXFORDSHIRE.**

ARCHAEOLOGICAL WATCHING BRIEF

September 2019
Report No. 1328

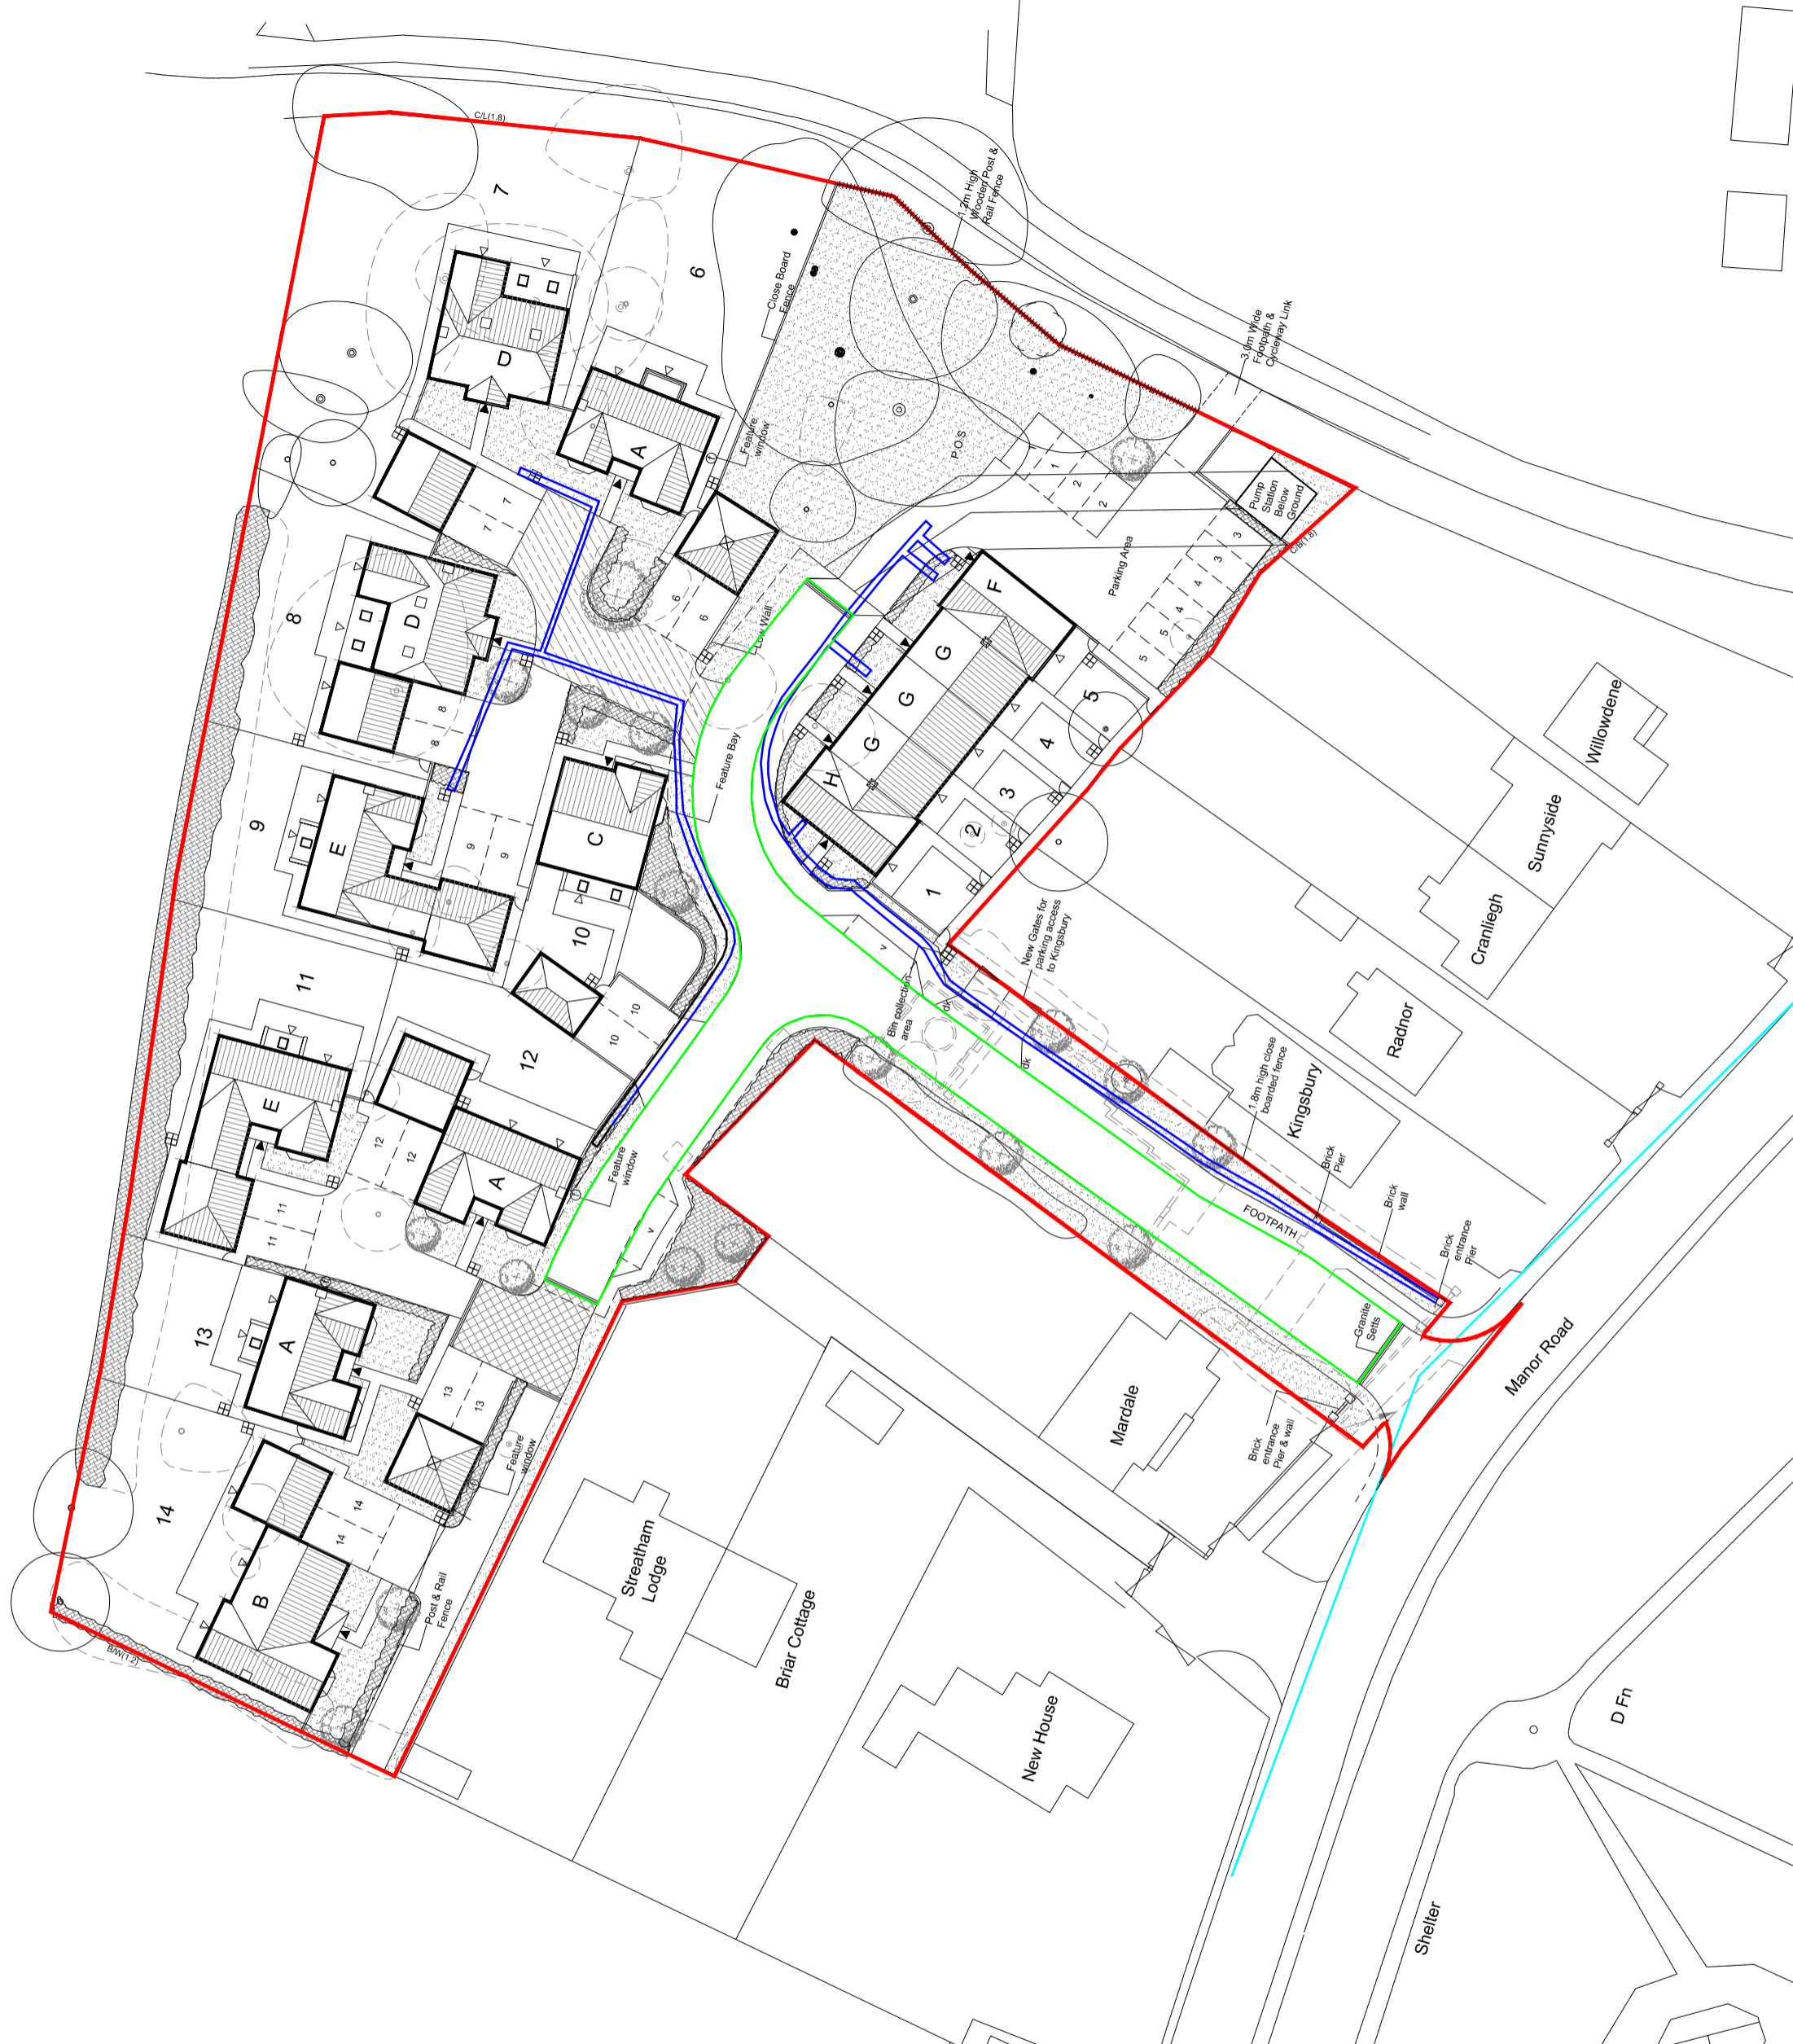
FIGURE 2: Watching Brief Areas

— Approximate Location of Road Strip 2016
— Location of Monitored Service Cuts 2019

- 5.1 The first phase of watching brief in 2016 consisted of a road strip and subsequent excavation for roadside drainage (see Figure 2).
 - 5.1.1 The road strip was approximately 6 metres wide and penetrated to a depth of 0.6m below the Modern ground level. The roadside drainage cut was 0.9m wide and was excavated to a further 1m in depth. The trench followed the southeast edge of the road between Plot 12 and 10 and then turned southeast to follow the access road down to the junction with Manor Road.

- 5.1.4 No archaeological finds, features or deposits were present within any of the areas monitored in 2016.
- 5.2 In 2019 the excavation of the remaining service trenches were monitored; the location of these trenches are marked on Figure 2.
