**LAND AT GREYFRIARS CHURCH,  
FRIAR STREET,  
READING,  
BERKSHIRE.**

**ARCHAEOLOGICAL EVALUATION**

September 2012  
Report No. 828

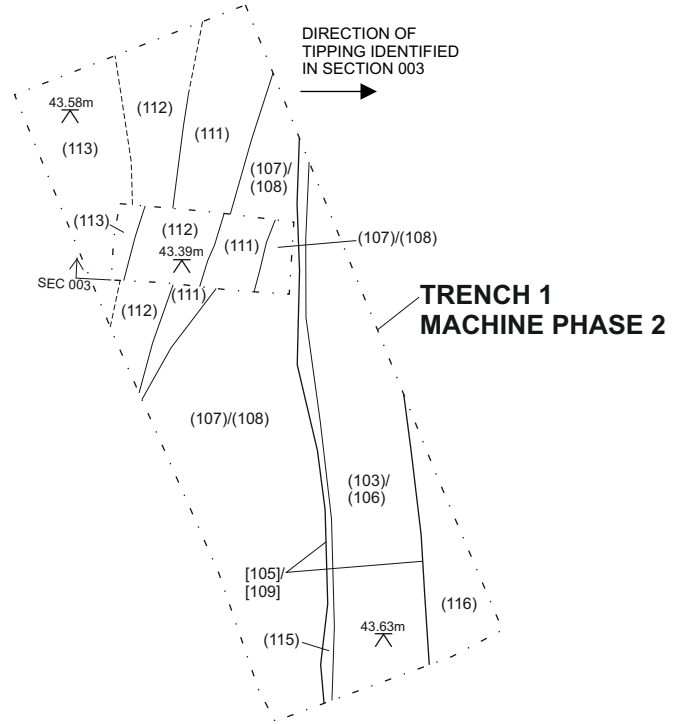
**FIGURE 3: Trench 1 Plans and Sections**

5.2.1 The trench was excavated, through Modern overburden layers (101) and (102), to an average depth of 0.30m (44.32m OD) below Modern ground.

5.3.1 The trench was excavated to an average depth of 1.01m (43.61m OD) below Modern ground, which represented the proposed development formation level, including a minimum buffer zone of 0.15m, as requested by Fiona Macdonald of Berkshire Archaeology.

5.3.2 The earliest deposits within the trench consisted of soil layers (111), (112) and (113), which appeared to represent a sequence of tipped/dumped layers. A total of four sherds of Medieval pottery were present within fills (112) and (113). Layer (111) was overlaid by deposit (107)/(108).

- 6.3 Layers (112) and (113), present within Trench 1, were associated with Medieval pottery and possibly represented the top of the archaeologically significant deposits in this area. These were located at a depth of 1.04m (43.58m OD) below Modern ground.

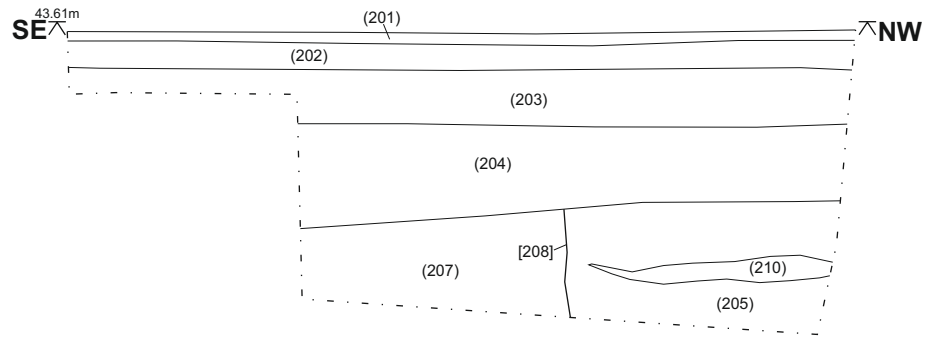
**SEC 004: NORTHEAST FACING SECTION TRENCH 2**

5.4.1 The trench was excavated into the top of natural gravels, which were present at an average depth of 1.92m (41.62m OD) below Modern ground. The natural deposits were overlaid by fill (207), which contained a single sherd of Medieval pottery, as well as a fragment of ceramic tile.

5.4.2 Feature [208] extended across the northern half of the trench and was a fairly substantial cut, with near vertical sides and a flat base. The feature was not directly associated with any artefactual evidence, however; it was stratigraphically later than fill (207) and can, therefore, be assigned a Medieval or later date.

5.4.3 Feature [209] cut through layer (204), was directly overlaid by Modern rubble layer (203) and, as such, was most likely to represent Post-medieval or Modern activity.

- 6.4 All of the features and deposits within Trench 2 were recorded from outside the trench and, consequently, they were poorly dated. Feature [208]/(205) was sealed by soil layer (204) and, therefore, possibly represented archaeological activity. This feature was present at a depth of 0.90m (42.65m OD) below Modern ground.

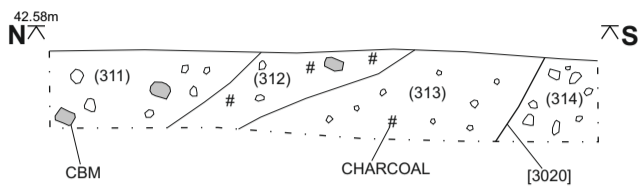
**SEC 006: WEST FACING SECTION [3020]**

5.5.3 Fill (314) was the earliest deposit at the north end of the trench, but did not yield any dating evidence. Deposits (311), (312) and (313) most likely represented tipped/dumped layers, which were associated with possible cut feature [3020]. A total of two sherds of Medieval pottery, recovered from fill (313), were the only dating evidence associated with possible cut [3020] and, as such, the feature remained poorly dated.

- 6.5 Feature [3020] and associated fills (313), (312) and (311) were poorly dated, however; the occurrence of Medieval pottery sherds within fill (313) suggested the possibility that these features represented the top of archaeologically significant deposits, which were located at a depth of approximately 0.86m (42.51m OD) below Modern ground, moreover; the occurrence of natural gravels in Trench 3, at height of 42.40m OD, indicated the potential for the presence of areas of preservation, at approximately 1m below Modern ground.

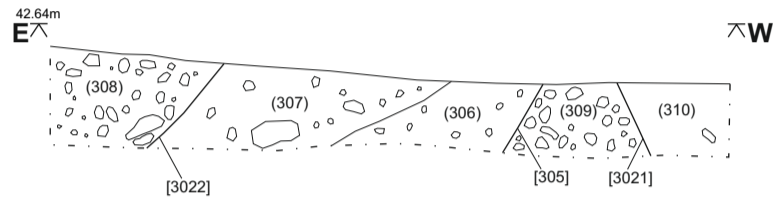
**SEC 007: NORTH FACING SECTION [305], [3021] and [3022]**

5.5.4 The south end of the trench contained multiple, steeply interleaved deposits (306), (307), (308), (309) and (310). Due to the limited nature of the investigation, it was not possible to confidently demonstrate if these represented multiple cut features or a series tipped/dumped deposits and, due to a paucity of associated artefactual evidence, these features remained undated.

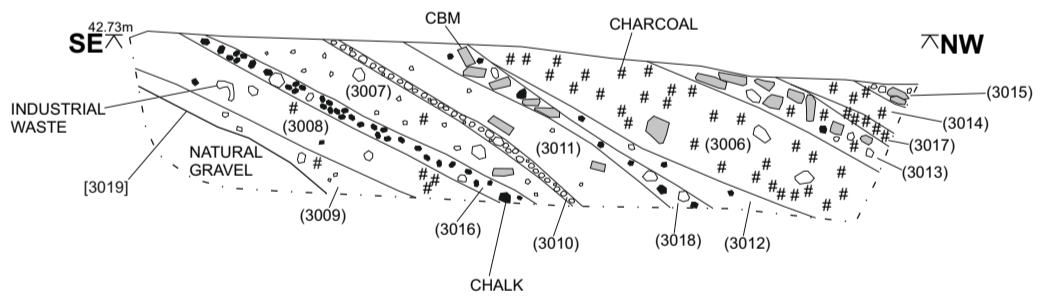
**SEC 008: NORTHEAST FACING SECTION TRENCH 3 SHOWING [3019]**

5.6.2 Feature [3019] cut into the top of the natural deposits to a depth greater than 1.5m and appeared to represent a large cut, which sloped downwards from south to north. The feature contained 13 fills; (3009), (3008), (3016), (3007), (3010), (3011), (3018), (3012), (3006), (3013), (3017), (3014) and (3015), which formed a series tip layers. These most likely represented episodic dumping within feature [3019]. A total of 10 sherds of Medieval pottery were recovered from fills (3006), (3007) and (3016). Other artefacts associated with Feature [3019] included CBM/tile, industrial waste, animal bone, oyster shell fragments and fragments of degraded metal implements/nails. At least three charcoal-rich layers, (3006), (3014) and (3017) were also present. Layer (3006) had been partially vitrified and may have been related to an industrial process.

- 5.6.3 No demonstrably Post-medieval or later material was associated with Feature [3019] and, therefore, it was most likely to have been at least partly in-filled no later than the Medieval period. It was possible that Feature [3020] (Machine Phase 1) represented the upper part of Feature [3019], although it was not possible to demonstrate this.
