**LYDIARD PARK CULVERT,
LUDIARD PARK, LUDUARD TREGOZE,
SWINDON
WILTSHIRE.**

ARCHAEOLOGICAL WATCHING BRIEF

Report No. 924
December 2013

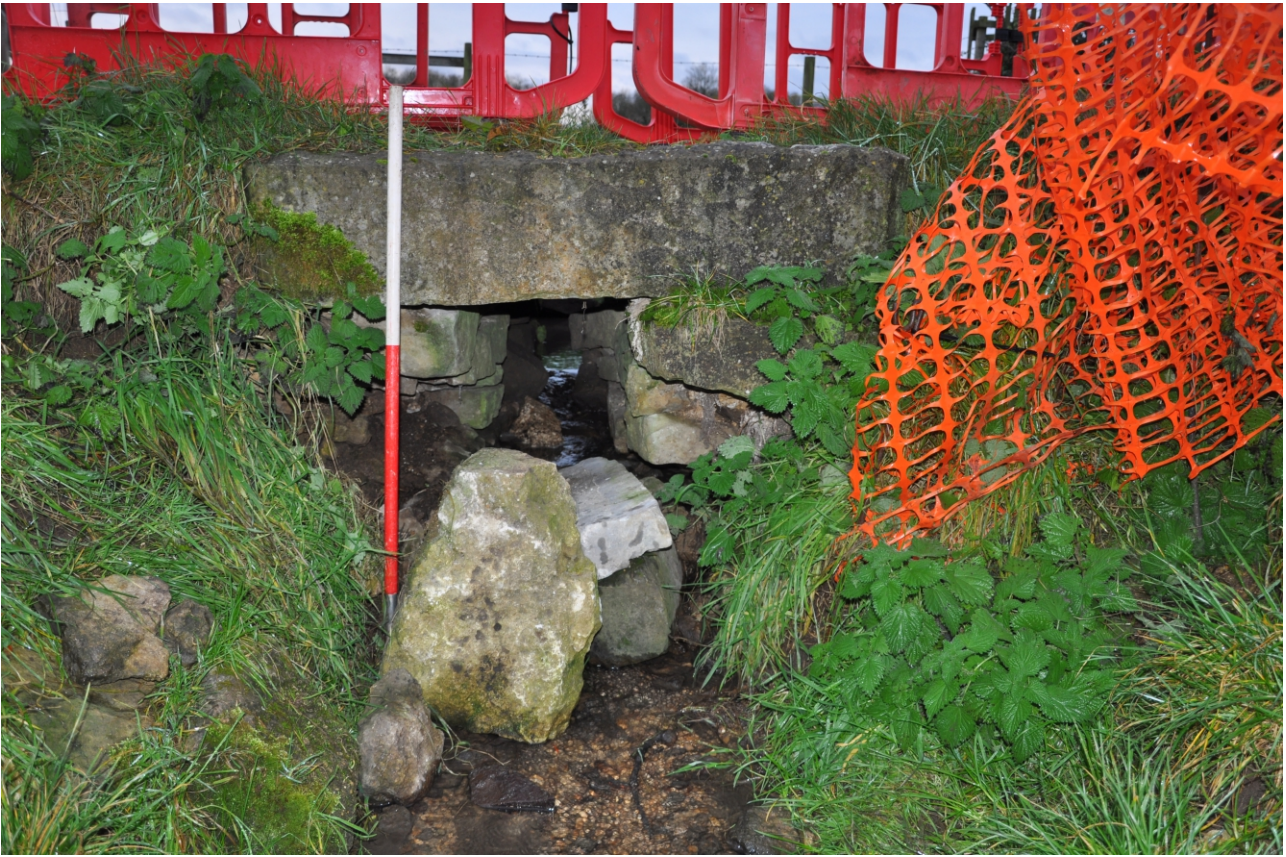
CULVERT NORTH ELEVATION

- 5.1 A series of 20 scaled colour photographs were taken with a high resolution digital camera in order to record the culvert and to set it into context prior to the groundworks. Photographs were taken at both the culvert's north and south entrances (Figure 3) along with details of its interior. General views of the track over the culvert were also taken to set the culvert in context. A measured sketch of the culvert's south elevation is shown in Figure 4.

- 2.2 The project involved the replacement of a collapsing stone clapper culvert and abutments with a precast concrete pipe and headwalls constructed from stone reclaimed from the existing structure.
