**ALL SAINTS CHURCH,
LYDIARD MILLICENT,
WILTSHIRE.**

ARCHAEOLOGICAL WATCHING BRIEF

March 2015
Report No. 1043

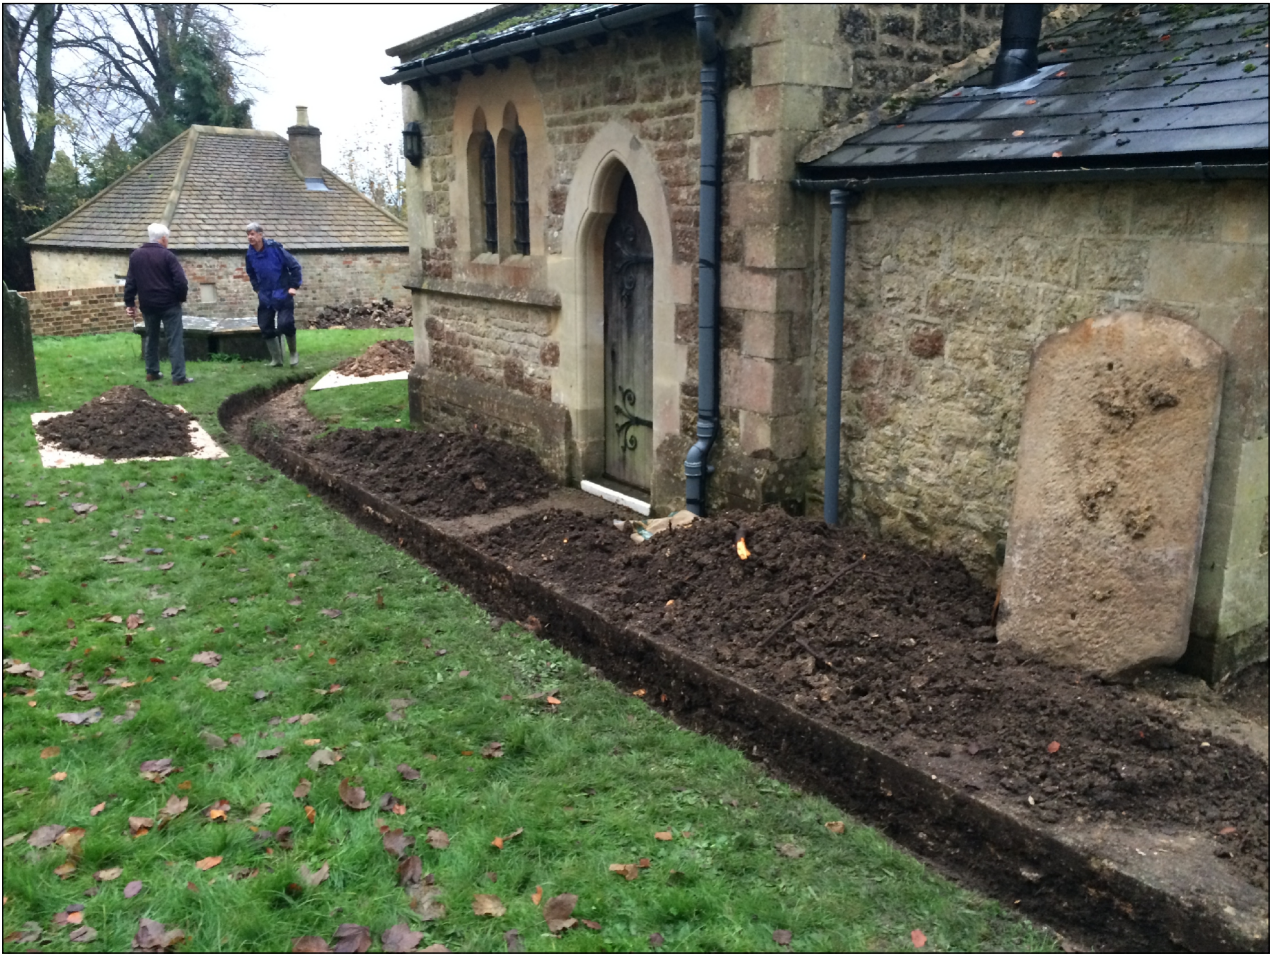
**FIGURE 3: Pipe Trench After Excavation Looking
East From The North of All Saints Church**

- 5.1 The turfline (**101**) was very thin (0.05m) and lay over variable interleaved deposits of made-ground (**102**)/(**103**)/(**104**) at least 0.25m deep. Immediately to the north of the church and adjacent to concrete hard-standing this deposit consisted of a mid-dark brown plastic clay silt (**102**) with occasional small stone fragments.

- 5.2 As the pipe-trench curved around the north-east of the church the deposit changed to a beige-yellow friable fine sandy silt (**103**) with occasional fragments of CBM and medium undressed stone. To the south the deposit became more mixed, a beige-yellow friable sandy silt with lenses of mid-brown plastic clay silt (**104**). This contained frequent fragments of CBM, medium undressed stone and occasional large fragments of undressed stone – with a particular concentration of these stone to the east of the nave.

- 5.3 To the east of the nave was a concentration of disarticulated human bone. No grave cut was observed and the area showed signs of disturbance. Finds from this area consisted of occasional sherds of Post-medieval/Modern pottery which included one fragment of willow pattern.
