**GOLDEN VALLEY MILL,
BITTON,
SOUTH GLOUCESTERSHIRE.**

ARCHAEOLOGICAL EVALUATION

July 2016
Report No. 1139

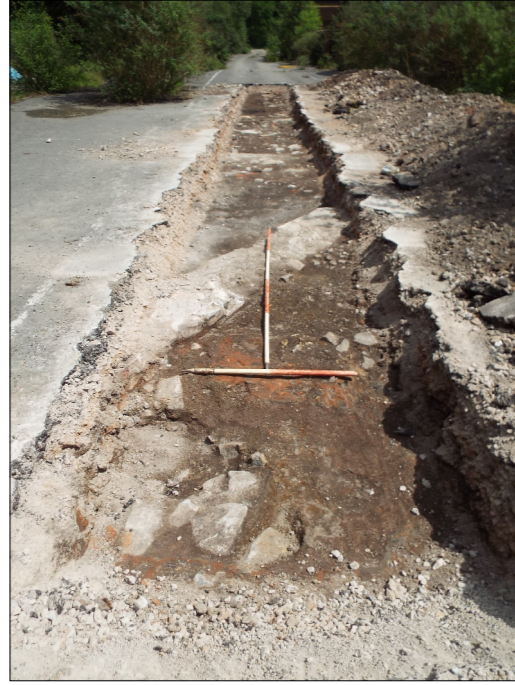
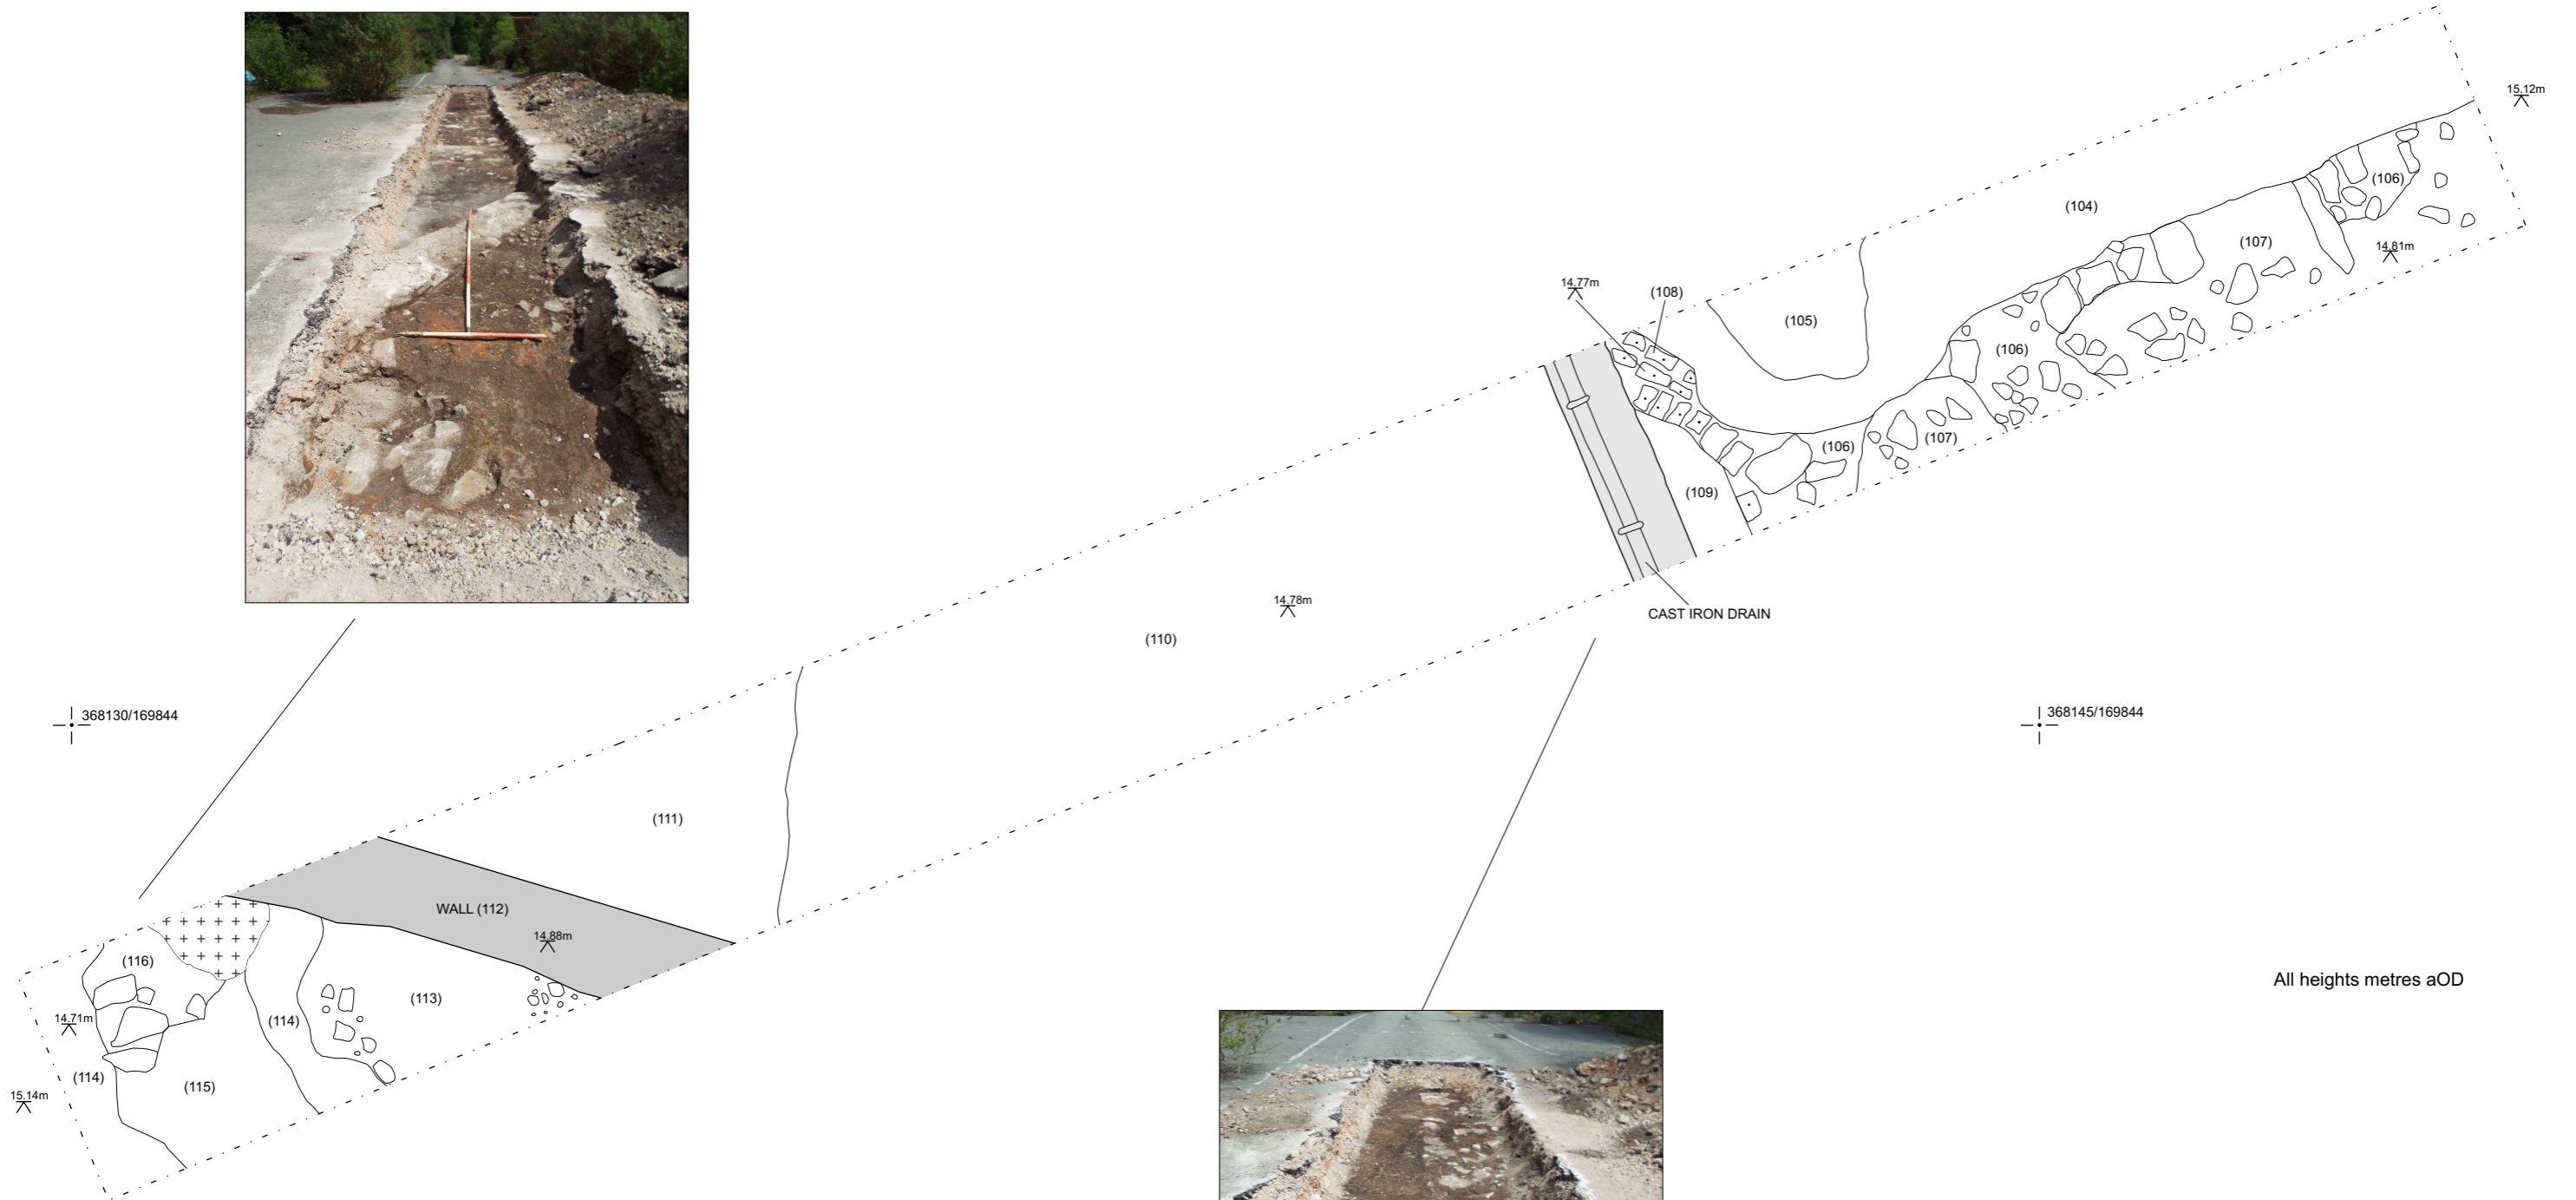
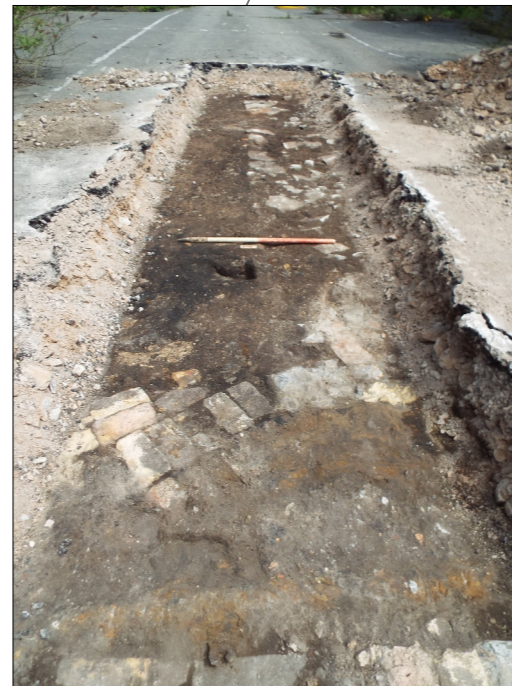
- 6.3.1 The entire length of Trench 1 contained significant archaeological deposits, which were directly sealed by a 0.25m thick layer of stone chippings/hardcore **(101)**, **(102)** and **(103)** which were in turn sealed by a 0.10m thick layer of tarmac **(100)**.

- 6.3.2 At the northeastern end of the trench a beige mottled brown rammed surface **(104)**, 6.5m+ by 1.25m+ in plan, was positioned against a northeast-southwest aligned wall **(106)**, 7m+ long by 1m+ wide, which comprised unmortared irregular small to large stone blocks, which were faced on their northwestern side. Possibly partly sealing the wall were patches of surface **(107)**, which was similar in make up to **(104)**. An ashy deposit **(105)**, 1m+ by 1m+ across, was present near the southwestern end of **(104)**. In plan it was not possible to ascertain its relationship with **(104)**.

- 6.3.3 Curving northwestwards in an arc from the southwestern end of wall **(106)** was a brick-built wall base **(108)**, which comprised headers and stretchers bonding, 1m+ long and 0.5m wide. It is likely that **(108)** is part of the same structure as **(106)** but may represent a different phase. Located against the southwestern face of walls **(108)** and **(106)** was a pale brown compact silty clay surface **(109)**, 1.25m+ by 0.5m+ across, this layer and wall **(106)** were then truncated by a cast iron drain pipe cut to the southwest.

- 6.3.4 This same drain pipe cut also truncated the northeastern edge of **(110)**, a greyish brown very compact silty clay, 7m long by 1.8m+ wide, which contained very frequent small to large sub-angular and angular stone fragments, many of which had clearly been dressed. Layer **(110)** was most likely the fill of a cut (see paragraphs 7.2 to 7.4 below).

- 6.3.5 To the southwest of surface **(110)** was surface **(111)**, a black compact deposit 3.5m long by 1.8+m wide. This surface abutted wall **(112)**, which was aligned northwest-southeast, 2m+ long and 0.70m wide and comprised of small to large sub-rounded, sub-angular and angular stone fragments bonded by concrete mortar and appeared to have been faced on both sides.

- 6.3.6 To the southwest of wall **(112)** abutted a thin (0.05m thick) surface of a dark greyish brown compact silty clay **(113)**, 2m long by 1.40m+ wide. This in turn at least partly sealed a 0.06m thick reddish orange firm clay surface **(114)**, 2.5m+ by 1.25m+ across.

6.3.7 To the southwest and possibly sealed by **(114)** was a pale greyish brown firm mortary surface **(115)**, 1.25m+ by 1.25m+ across, which in turn appeared to seal a deposit of rough cut small to large sub-angular and angular stone rubble **(116)**, 1m+ by 1m+, which was associated with a patch of very compact lime mortar.

**SOUTHWEST END OF TRENCH 1
LOOKING NORTHEAST**

**NORTHEAST END OF TRENCH 1
LOOKING NORTHEAST**

7.1 The significant deposits in Trench 1, although undated, almost certainly relate to early industrial activity on the site and are perhaps associated with the 1760s 'battery' mills. They consist of a series of rammed earth/industrial residue surfaces and associated walls, with brick wall base **(108)** perhaps representing the curved lining of a furnace.

7.2 The large compact deposit **(110)** in the centre of the trench contained a quantity of dumped dressed masonry and it would seem likely that it is the fill of a cut that truncated the extant surfaces to the northeast **(109)** and southwest **(111)**. Other deposits at the extreme southwest end of the trench, while of uncertain nature, are certainly related to the earlier phase of industrial activity.

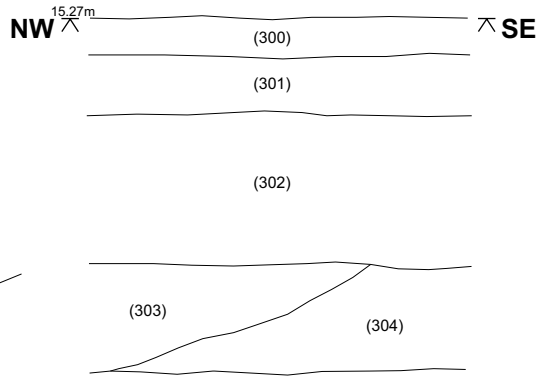
FIGURE 5: Trench 3, Plan and Section

6.5.1 The natural substrates of orange brown/yellow brown clay silts were encountered at an average depth of 0.96m (14.31m aOD) below the Modern ground surface and showed signs of contamination. These were sealed by a 0.30m thick dark brown silty clay **(304)** which may represent a buried soil horizon. Located only in the northwestern 1.5m of the trench was deposit **(303)**, a brown silty clay 0.30m thick, which contained frequent small to medium stone inclusions and possibly represented the fill of a service trench. This and **(304)** were then sealed by a 0.40m deep layer of made-ground **(302)**, which comprised a dark greyish brown sticky clay silt with frequent small to large stone inclusions. Deposit **(302)** was then in turn sealed by a 0.15m thick layer of stone chippings/hardcore **(301)** and then a 0.10m thick tarmac layer **(300)**.

6.5.2 No structural features, archaeological finds or deposits were present within this trench.

**SOUTHWEST FACING SECTION
TRENCH 3**

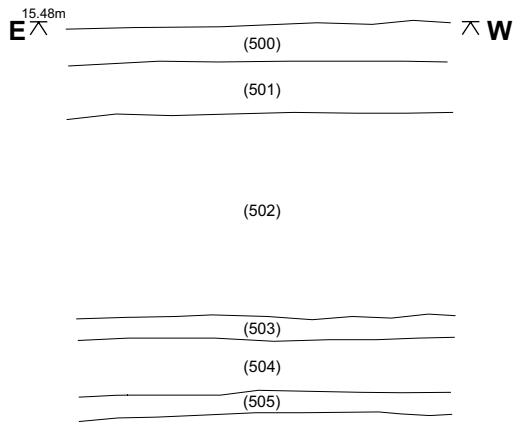
FIGURE 7: Trench 5, Plan and Section

6.7.1 The natural substrates of orange brown clay silt were encountered at an average depth of 1.1m (14.38m aOD) below the Modern ground surface. The trench was initially machine excavated down to intact structural deposits. These were sealed by a 0.60m thick layer of brick rubble **(502)**. Deposit **(502)** was then in turn sealed by a 0.13m thick layer of stone chippings/hardcore **(501)** and then by a 0.10m thick tarmac layer **(500)**.

6.7.2 The entire length of Trench 5 contained two perpendicular walls **(507)/(508)** and an associated floor surface **(503)**. Brick rubble deposit **(503)** infilled walls **(507)** and **(508)** and sealed surface **(503)**. The walls were identical in makeup and comprised small to large sub-rounded, sub-angular and angular stone bonded by concrete mortar and faced on both sides. Each was 0.90m wide and 0.50m+ deep, with wall **(507)** aligned northeast-southwest and wall **(508)** aligned northwest-southeast. Butting these walls was a thin (0.05m thick) concrete surface **(503)**, which was covered with blue paint in places.

6.7.3 To examine the extent of any truncation by this structure a sondage was excavated through surface **(503)** at the western end of the trench. Immediately below the surface was a 0.16m thick deposit of black silty clay **(504)**, which contained very frequent charcoal fragments. Below this was a thin (0.06m deep) grey mottled yellow silty clay **(505)**, which lay directly on the natural deposits **(506)**.

**NORTH FACING SECTION
TRENCH 5**

- 7.7 The walls (**(507)** and **(508)**) and floor **(503)** in Trench 5 roughly conform in alignment to buildings shown in both the 1843 (Figure 9) and 1912 (Figure 10) maps. The extant floor **(503)** may be more recent, though, as it exhibited traces of blue paint. Nevertheless, it is likely that the extant walls preserve the same property boundaries as were in existence in the mid-19th century.

- 7.8 Interestingly, directly below floor **(503)** was a thin, charcoal rich deposit **(504)**. This highly distinctive layer was not found elsewhere during the evaluation and it is possible that this is physical evidence of one of the many conflagrations that affected the Mill site throughout its history (see Paragraph 2.3 above).
