**MANOR FARM HOUSE,  
BENHAM PARK, MARSH BENHAM  
WEST BERKSHIRE**

**ARCHAEOLOGICAL ASSESSMENT  
AND WATCHING BRIEF**

**October 2008**

**Report No. 590**

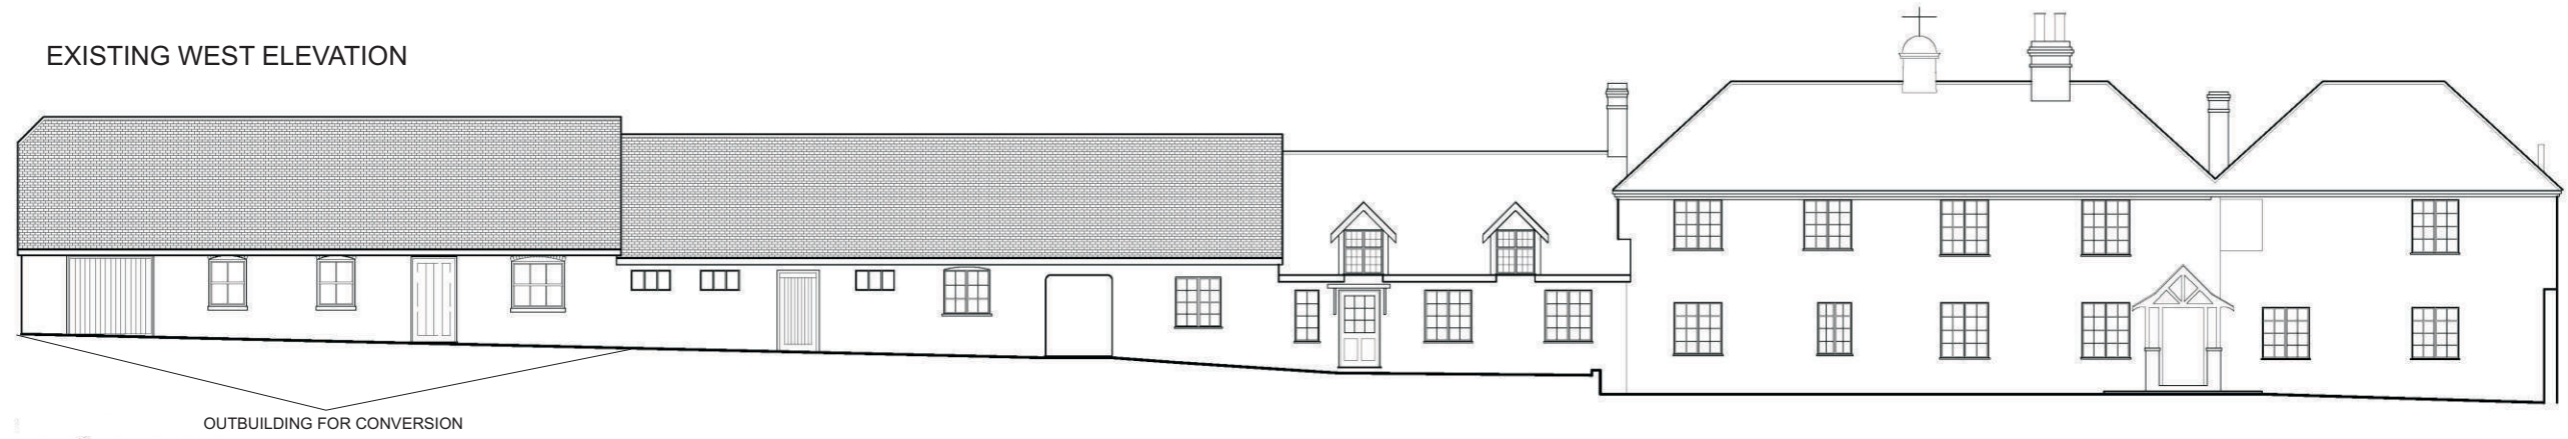
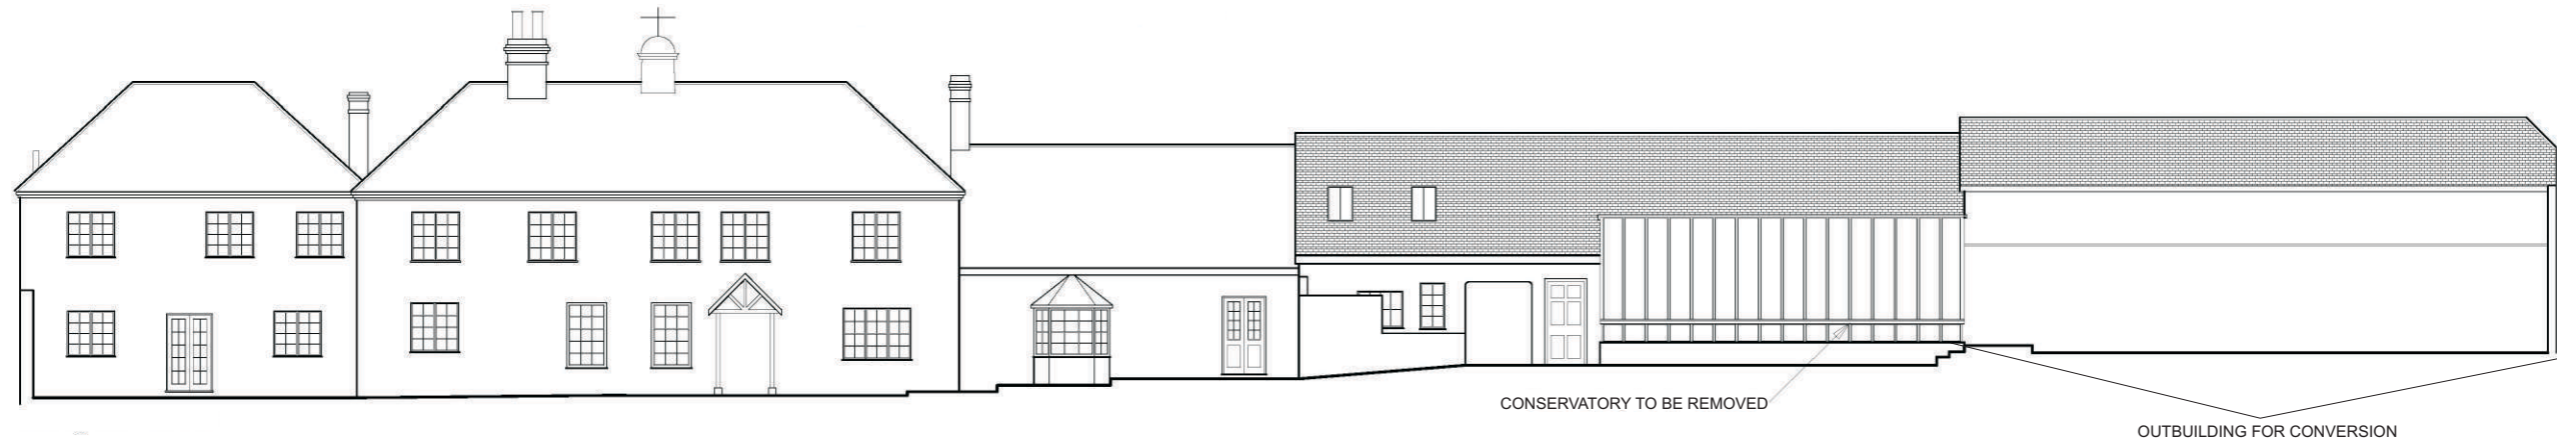
<p>Site Code: MFH07          Accession Code:</p>
<p>0m <span style="float: right;">10m</span></p> <p>1:200@A3</p>
<p><b>FIGURE 3: Plan and Elevations Before Commencement of Works</b></p>

EXISTING WEST ELEVATION

EXISTING EAST ELEVATION

SECTION A-A THROUGH OUTBUILDING FOR CONVERSION

PLAN OF OUTBUILDING FOR CONVERSION

- 3.1 The study area comprises what was an extant brick-built building which formed the northern end of the existing Manor Farm House, which is currently in domestic use (Figure 3). The area of the proposed new build measured approximately 15m by 6.5m and was rectangular in shape (Figure 20). To the north the building was bounded by an existing brick wall which was to be retained, to the west it was bounded by gardens and to the east was a modern gravelled driveway.

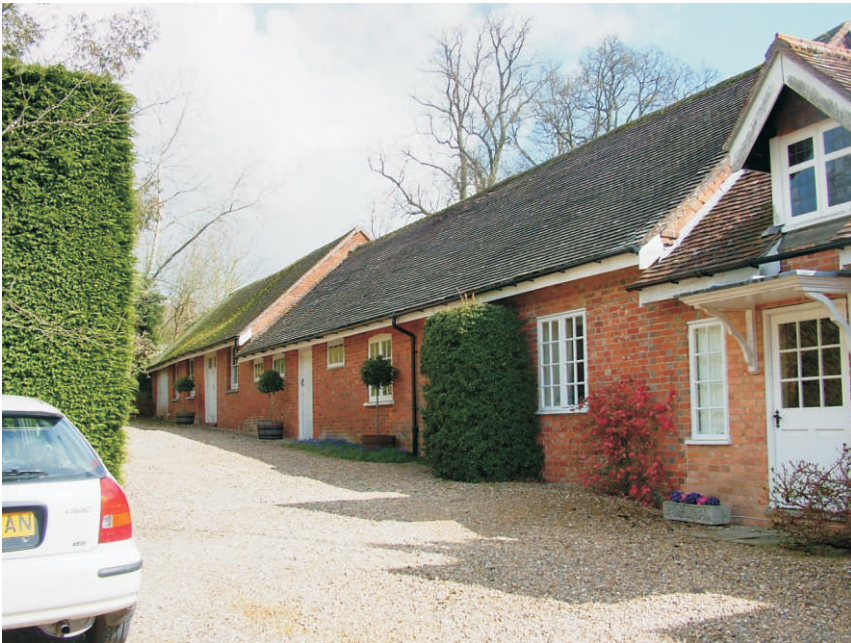
Site Code: MFH07 Accession Code:
<b>FIGURE 21: Photographs</b>

NORTHEAST FACING SHOT OF FRONT (WEST FACING ELEVATION) OF MANOR FARM HOUSE BEFORE COMMENCEMENT OF WORKS. THE SITE IS SITUATED AT THE 'BACK' OF THE PHOTOGRAPH

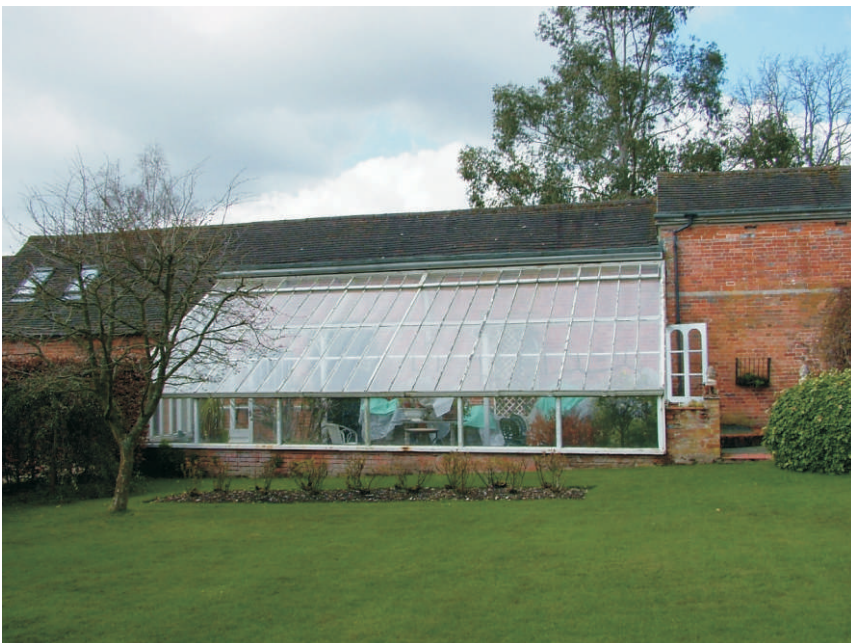
WEST FACING SHOT OF THE REAR (EAST FACING ELEVATION) OF THE NORTHERN END OF MANOR FARM HOUSE BEFORE COMMENCEMENT OF WORKS. THE SITE IS SITUATED ON THE RIGHT OF THE PHOTOGRAPH. THE GLASS BUILT BUILDING (CONSERVATORY) WAS ALSO SUBSEQUENTLY DEMOLISHED.

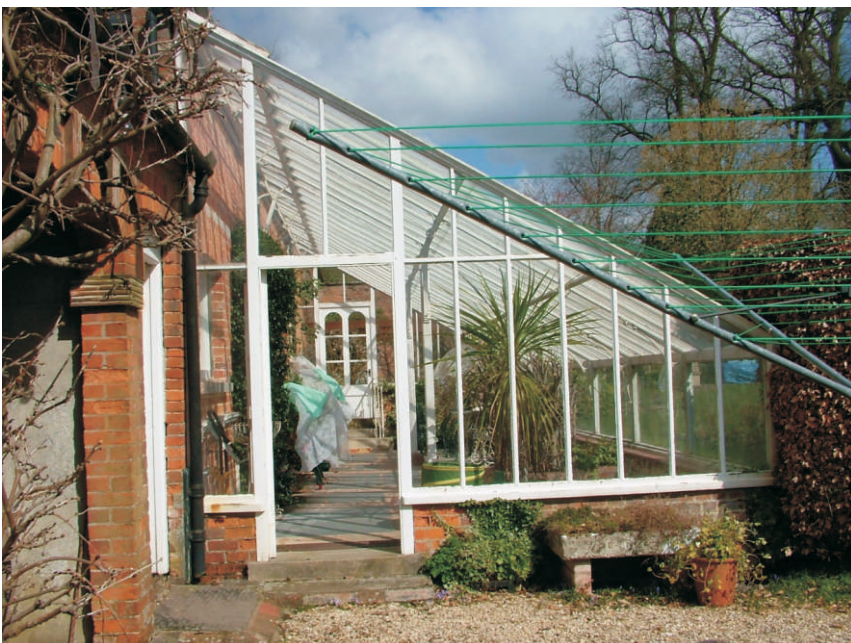
NORTH FACING SHOT OF THE CONSERVATORY BEFORE COMMENCEMENT OF WORKS.

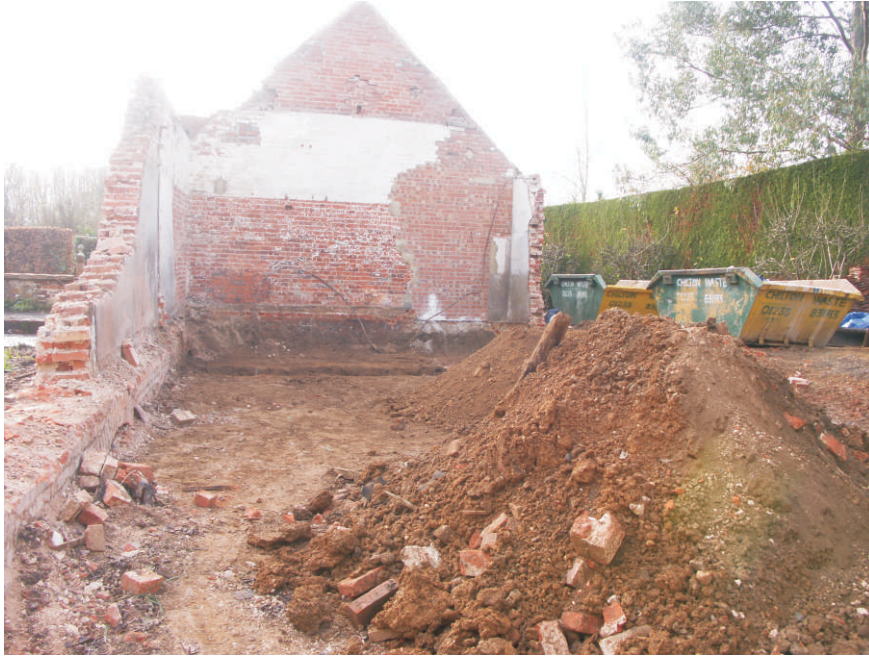
**SOUTH FACING SHOT OF EXCAVATED AREA**

- 10.1 The northern and eastern walls of the outbuilding had been reduced to ground level and were to be reutilised as footings for the new build. Evidence for a western wall, where the new footings were to be excavated, was present only at the southern end of the outbuilding between the western end of Trench A and the existing dwelling. The complete absence of footings in the remainder of the area suggests that the outbuilding was open to the west, or had been constructed on above ground foundations or post pads. During the watching brief, two below ground level arches were seen on the western side of the eastern wall foundation (Figure 22). They comprised open, rough brick arches.

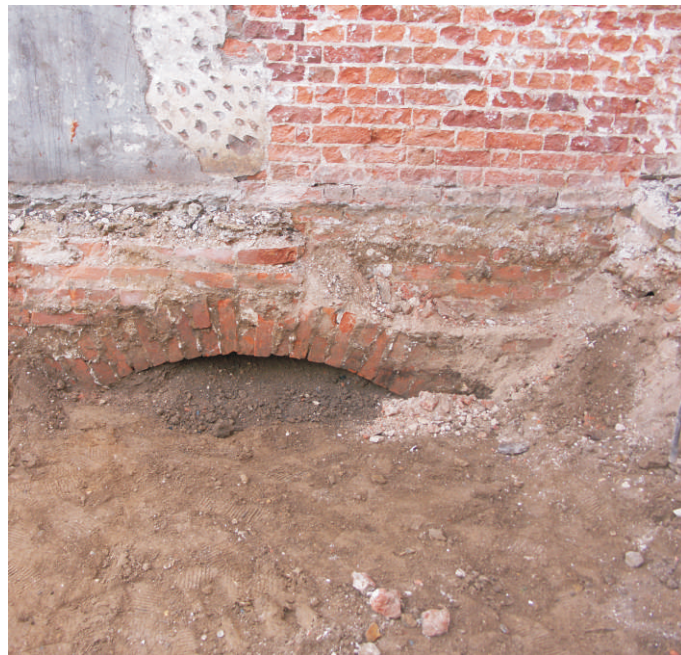
**EAST FACING SHOT OF BRICK ARCH IN NORTHERN WALL,  
TRENCH A TO THE NORTH**

- 11.6 Evidence which could have suggested function of the outbuilding were restricted to the levelling layer of brick rubble under the floor of the outbuilding, the brick arches in the eastern wall and the absence of a foundation wall on the western side of the building. The levelling layer tells us little, except how the structure was constructed. The arches are a feature often associated with structures such as granaries and suggests they could have been for ventilation. As mentioned above, the absence of a foundation wall on the west side of the building could suggest that the original structure was open on this side, however, there is no further evidence for this. As a result, there was no clear evidence pertaining to the function of the structure observed during the watching brief.
