# **1EW03 – Enabling Works Central AWHh Fieldwork Report for Trial Trench Evaluation at Station 53C, Portway Farm, Buckinghamshire (AC250/43)**

**Site Code: 1C19PWFTT**

Document no.: 1EW03-FUS\_IFA-EV-REP-CS06\_CL09-000003

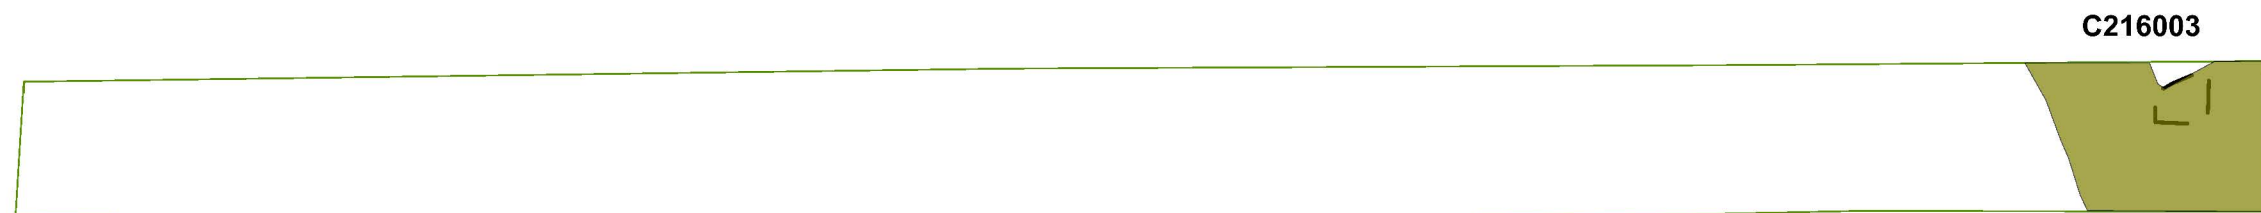
High Speed Two,  
Portway  
Figure 7. Details of trenches 12, 13 and 16

| Figure 7 | Details of trenches 12, 13 and 16 |

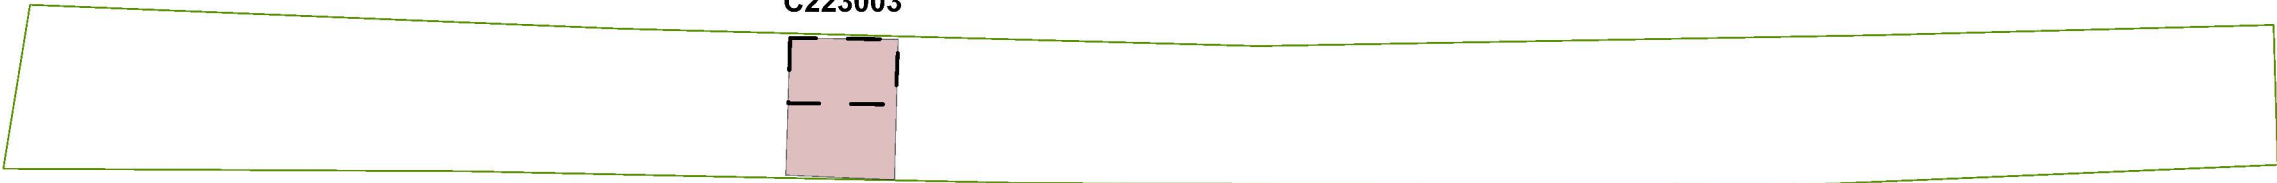
High Speed Two,  
Portway  
Figure 8. Details of trenches 21, 22 and 23

| Figure 8 | Details of trenches 21, 22 and 23 |

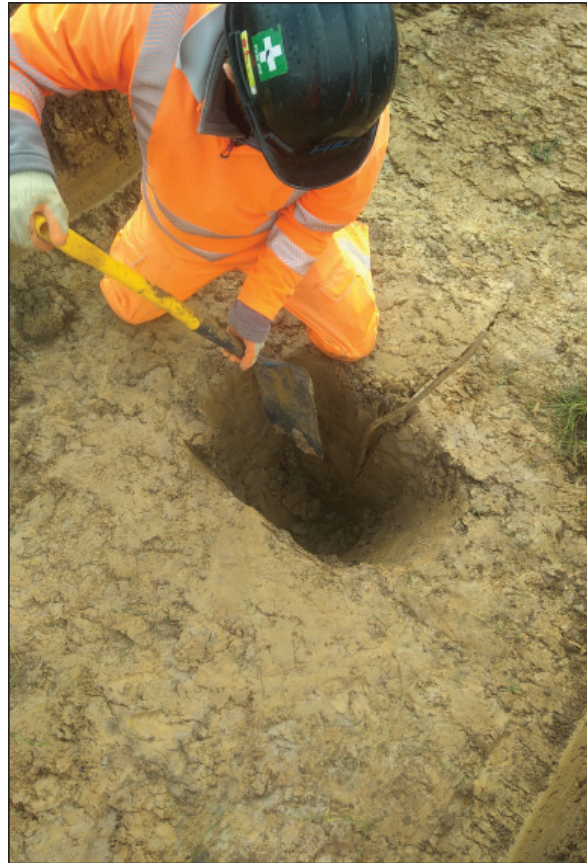
Plate 1 - Second World War aerial array anchor point under investigation

- 10.1.3 The only evidence identified that is likely to be associated with Station 53CA were a series of possible metal anchor points. These were found within a number of the trenches and were contained within imperceptible construction cuts of varying depths, that cut into the geological substrate. The anchor points themselves consisted of lengths of metal rod/rebar, some of which, where investigated, were found to be attached to large blocks of wood, with the wood acting as a foundation sleeper to hold the rebar in place. At their original extent the simple lengths of iron rod may have been a single piece bent over into a V-shape, attached to the aerial superstructure by means of a fixing bracket (Plate 2). It was this V-shaped rod that likely had each end attached to the wooden foundation block. A possible aerial fixing bracket was recovered and had metal fittings at either end, suggesting it was part of a larger structure (Plate 2). The anchoring metal rod would have passed through the loop of this bracket, held in place by the circular 'pulley wheel' type fitting while under tension. Each end of the metal rod would then be secured below ground within the wooden block. The use of wooden foundations to hold the structure in place is likely reflective of the very rapid construction that was needed for such an installation. The lack of more substantial foundations is perhaps evidence that the need for concrete was greater elsewhere for the construction of anti-invasion defences or that wooden blocks were simply deemed fit for purpose due to the relatively lightweight aerial structure that required support.

- 10.1.4 It is likely these anchor points formed part of the wider supporting structure for the wireless transmitter array that occupied the Site. The aerial layout is known to have consisted of '35 dipole aerials and four 3-wire rhombics' (Gregory, 2015) which suggests a dense array of antennae over a relatively large area. Transmitter Station 53C survived the Cold War as it was turned into a Secret Intelligence Service (SIS) communications facility and it is possible that over time, the wartime aerial arrays were deliberately removed and replaced with more up to date technology. Gregory attributes the general survival of SOE wartime structures due to their continued post-war use. During this time the Second World War period transmitter array might be modified or removed but could be rapidly re-installed if necessary (Gregory, 2015). It therefore cannot be certain if the identified anchor points definitely relate to the Second World War installation or the later Cold War installation.

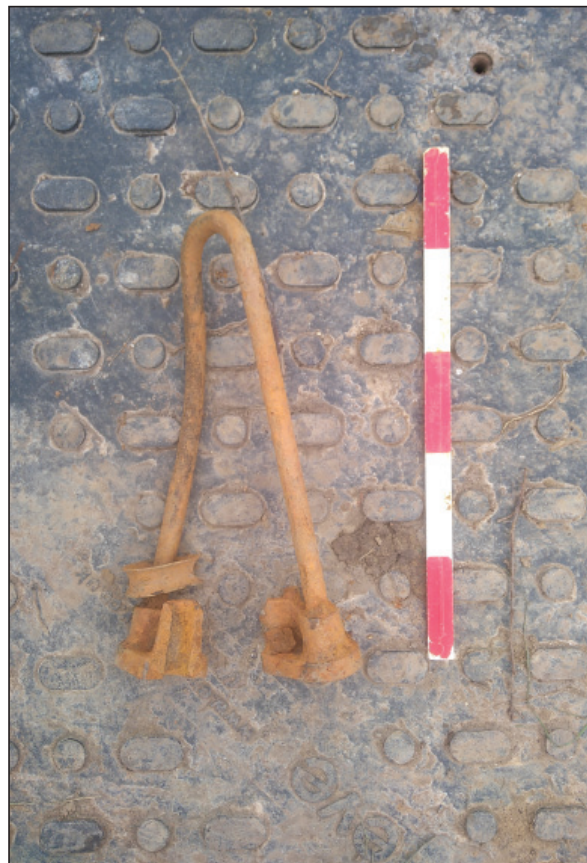
Plate 2 - Recovered example of metal anchor point

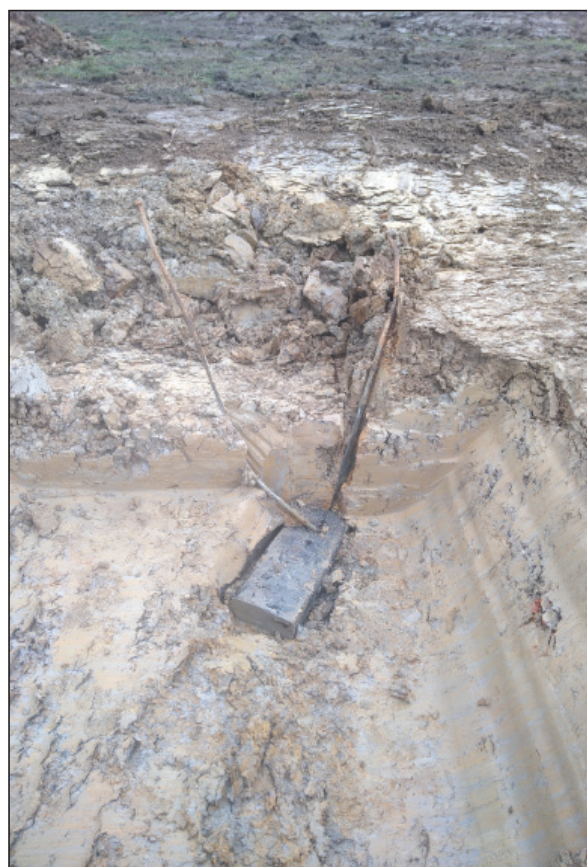
Plate 4 - Second World War anchor point *in situ*, Trench 5
