Trial trench log

1C20WRBTT / 43 / 55 / Archaeology present / 14 Jan 2021

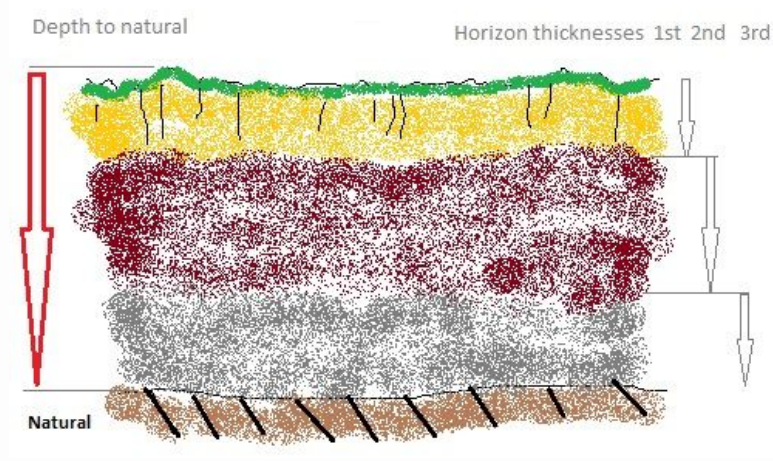
Trench sketch

1st MP depth to natural	0.20
1st MP Horizon thicknesses	
1st MP Horizon thicknesses 1	
Horizon type	Top soil
Thickness of this horizon in meters.	0.20
Context number	5501
2nd MP depth to natural	0.50
2nd MP Horizon thicknesses	
2nd MP Horizon thicknesses 1	
Horizon type	Top soil
Thickness of this horizon in meters.	0.20
Context number	5501
2nd MP Horizon thicknesses 2	
Horizon type	Subsoil
Thickness of this horizon in meters.	0.20
Context number	5502
2nd MP Horizon thicknesses 3	
Horizon type	Other
Natural overcut	
Thickness of this horizon in meters.	0.10
Context number	5503
3rd MP depth to natural	0.30
3rd MP Horizon thicknesses	
3rd MP Horizon thicknesses 1	
Horizon type	Top soil
Thickness of this horizon in meters.	0.20
Context number	5501
3rd MP Horizon thicknesses 2	
Horizon type	Subsoil
