## Trial trench log

1C20WRBTT / 43 / 70 / Archaeology present / 03 Feb 2021

| Site | 1C20WRBTT, HS2-C,<br>Northamptonshire | | | | |

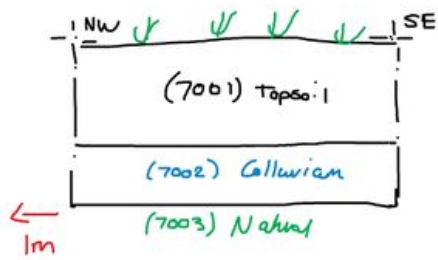
Photo 7

30m

0.52

| Horizon type | Top soil |
| Thickness of this horizon in meters. | 0.32 |

| Horizon type | Colluvium |
| Thickness of this horizon in meters. | 0.20 |
