1EWo2 Enabling Works – Area South

Interim Report for trial trenching at 18 inch pipe – spur, 450NB Pipeline Diversion (007) Fulmer to Haste Hill

Document number: 1EWo2-CSJ-EV-REP-Soo2-
000018

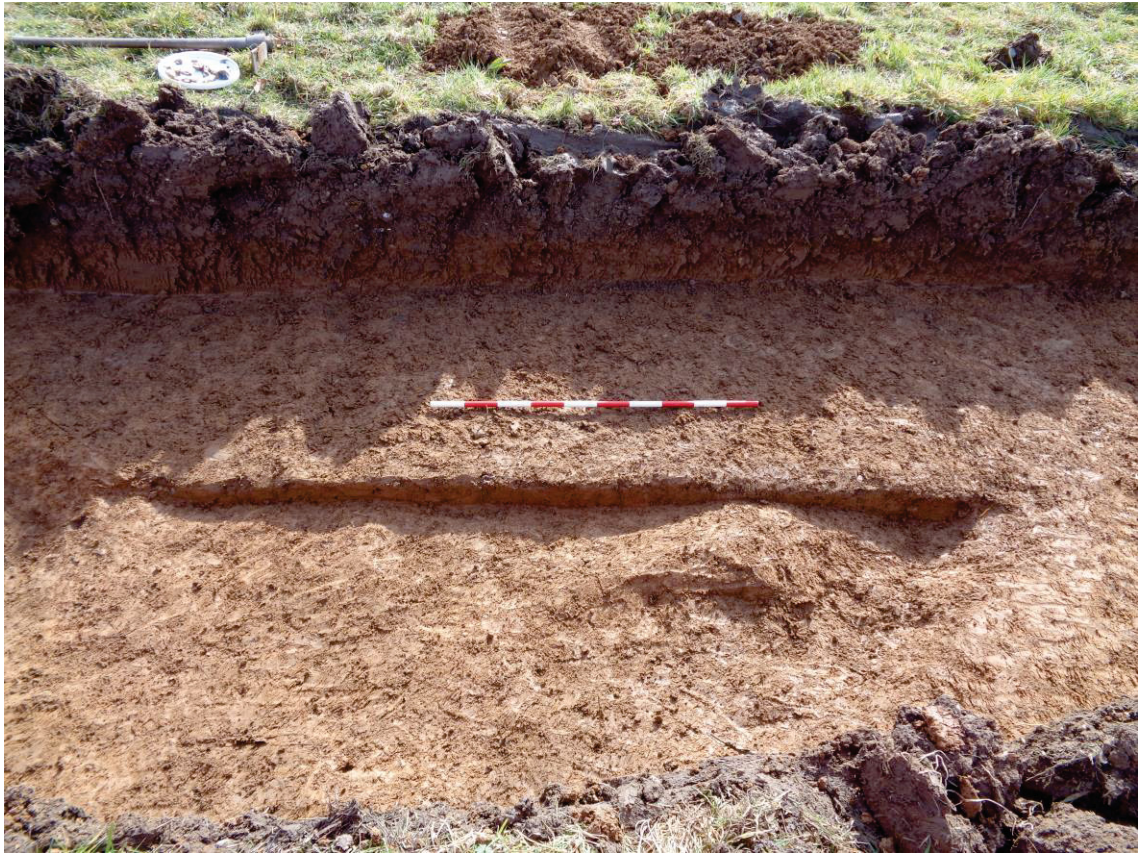
- 2.3.2 Trench 7 was located in the west of site, orientated northeast-southwest. The northern half of the trench was on the southern slope heading towards the stream. The southern half of the trench was on a plateau of land.
- 2.3.3 The natural soil horizon was a mottled grey yellow clay, interpreted on site as sterile alluvium.
- 2.3.4 In the northern end of the trench, cut into the natural horizon, was a large irregular feature interpreted as a tree throw (context [19]). This was up to 3m north-south and extended beyond the edges of the trench. It was up to 0.10m deep and filled within orange sandy silt. A series of flint flakes were retrieved from the fill.

Image 1 Photograph of tree throw [19], facing west.

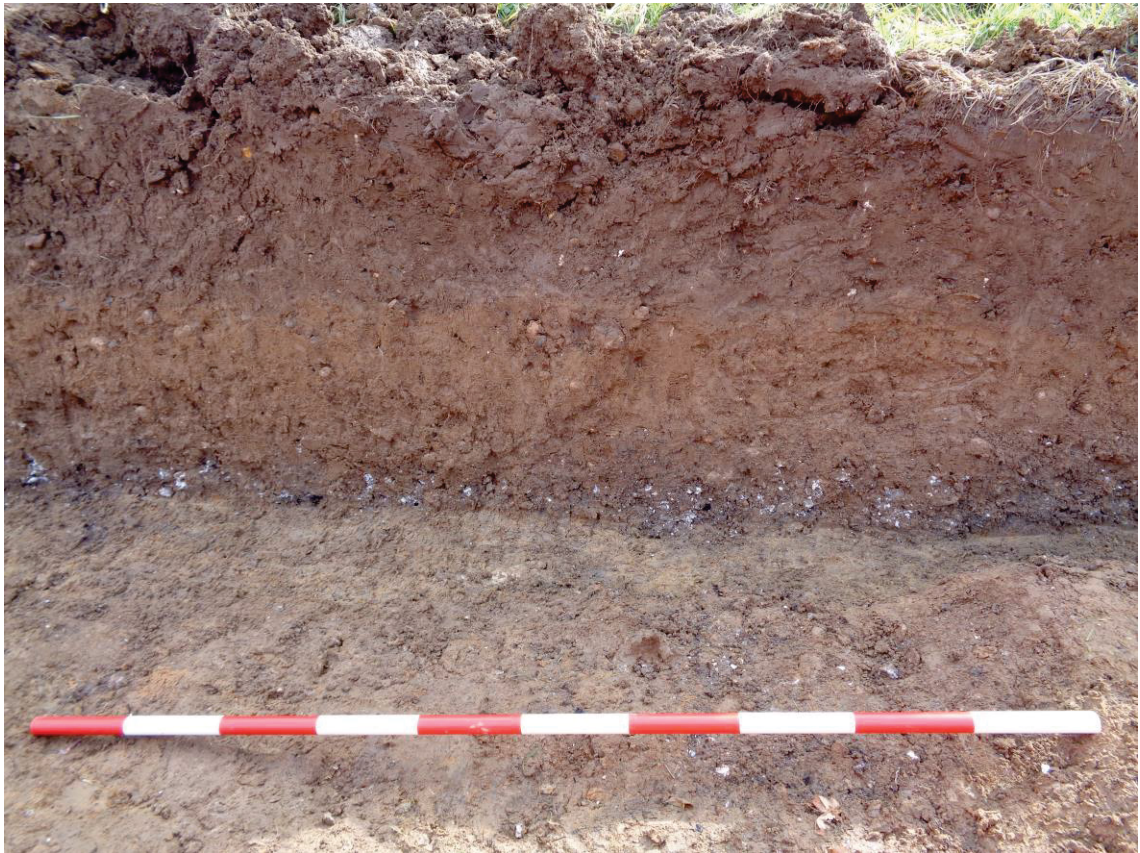
- 2.3.5 In the centre of the trench, at the break of slope in the topography, was two large spreads containing burnt flint and flakes, and six potential stake holes. The lower deposit (context [22]) was a layer of small to medium charcoal pieces and burnt 'fire cracked' flint. The spread was up to 6.50m north south and extended beyond the edges of the trench. This spread was up to 0.10m thick, the surface was at a maximum surface height of 38.70m OD, 0.70m below ground level.

- 2.3.6 Above this was a further deposit of material (context [21]) which contained some burnt 'fire cracked' flint in a brown silty clay matrix. Within this were identified a small collection of microliths. This deposit extended 8.60m north-south and beyond the edges of the trench. This was up to 0.20m thick and a maximum surface height of 38.75m OD, 0.60m below ground level.

Image 2 West facing section in Trench 7, showing the burnt flint horizon [22], the brown silt horizon [21], colluvium subsoil [18] and the topsoil.

- 2.3.7 Both of these deposits were sampled; a slot 0.20m wide was excavated against the eastern section and the deposits separated and placed into sample buckets.

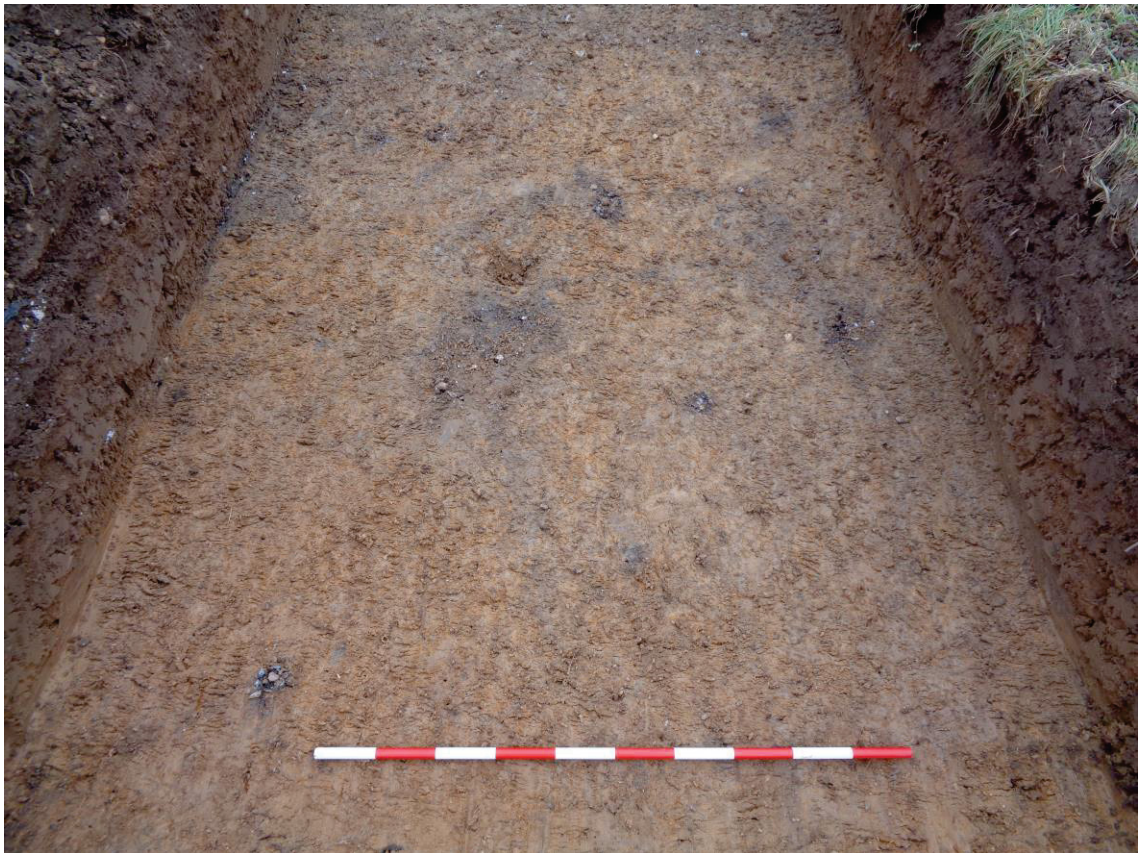
Below the deposits were six circular features filled with the burnt flint and charcoal of deposit [22] (context numbers fills: [23] to [28], cuts: [31] to [36]). They were up to 0.20m deep and were 0.10m to 0.20m in diameter. They had straight steep sides, and terminated at a rounded point. Whilst thought to possibly be the remains of tree roots, there is also the possibility these are stake holes. These features were recorded, and their fills 100% sampled so the interpretation can be considered further during the final report.

Image 3 Pre-excavation photo of potential stakes holes (contexts [31] to [36]), facing north

- 2.3.9 Initial interpretations of these deposits and holes could either be occupation debris with associated stakes holes, or hill wash with infilled tree root holes (based on the location of the accumulation at the base of the southern slope). If hill wash, the material is still significant as it indicates activity at the top of the hill just to the north of Trench 7.
- 2.3.10 Deposit [22] was sealed by a thick layer of colluvium (context [18]) which also contained a number of flint flakes. This was up to 0.30m thick, thinning to 0.10m thick towards the top of the slope at the north of the trench.
- 2.3.11 The whole trench was sealed by 0.30m of topsoil.

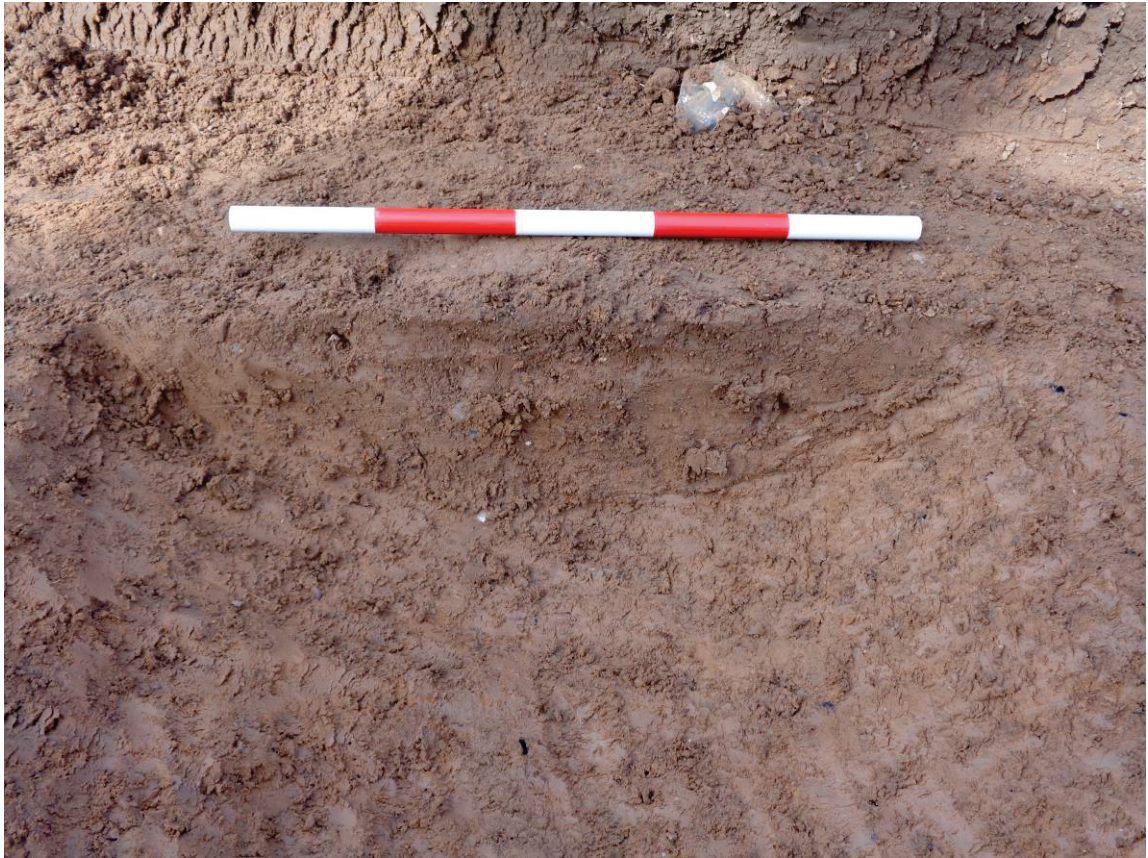
- 2.3.12 Trench 8 was located in the west of the site, orientated east-west. The trench was located mid-way down a south facing slope towards the stream.
- 2.3.13 The trench was machined to a sterile orange colluvium horizon as features a (date to be confirmed) Mesolithic flint flakes were found at this level. Cut into this horizon were two linear features orientated north-south and one small post hole. The linears (contexts cuts: [11] & [13] fills: [8] & [10]) were shallow with rounded bases, up to 0.80m across and 0.1m deep. They were filled with an orange brown sandy silt containing fragments of (date to be confirmed) Iron Age pottery.

Image 4 Photograph of the south facing section of linear [11]

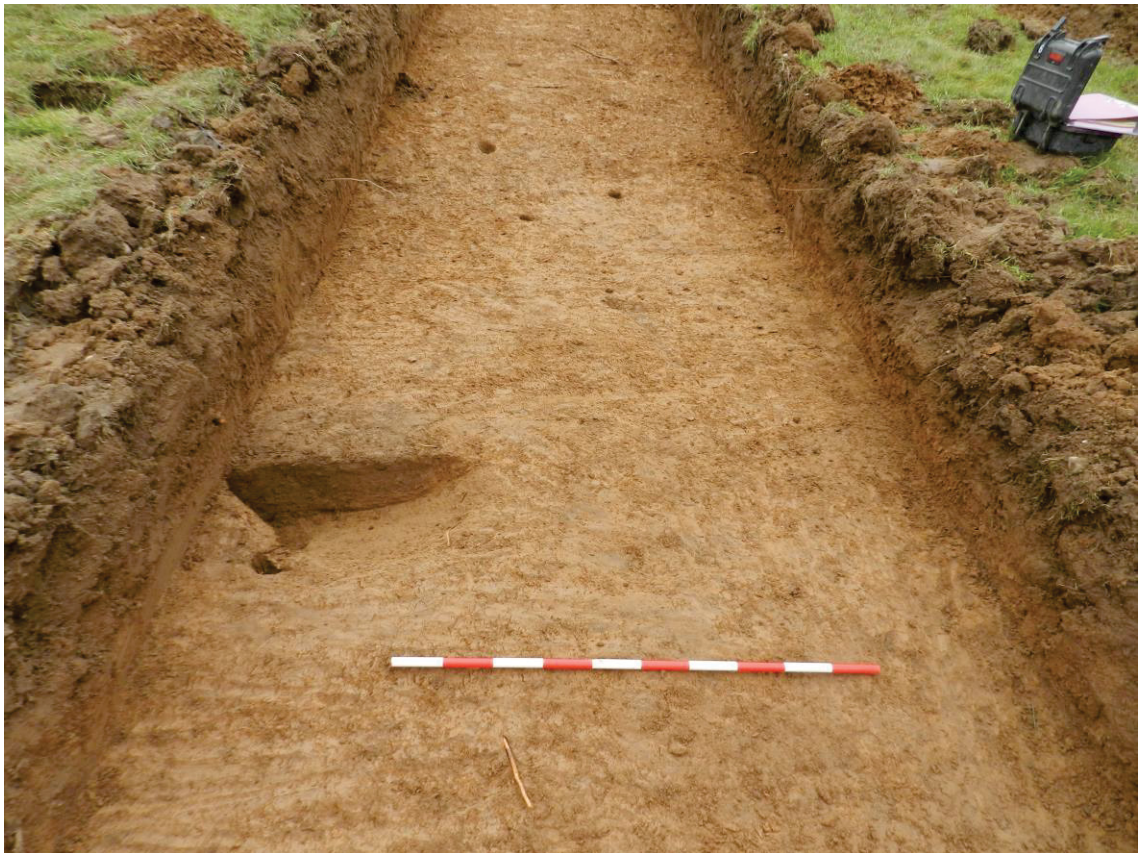
- 2.3.16 Trench 14 was located in the east of the site, running northwest-southeast. The natural horizon was an orange grey clay.
- 2.3.17 In the centre of the trench cut into the natural were a six possible stake holes and a circular pit. These were all filled with a similar material to the sub soil, and contained fragments of (date to be confirmed) Iron Age pottery. It is also possible these were the remains of a bush or small tree, but were recorded due to the finds contained within. These were overlain by 0.10m of orange silty clay subsoil and 0.30m of dark brown topsoil.

Image 5 Photograph of Trench 14 looking north, showing stake holes and circular pit.
