CAM ARC Report Number 927

The Post Office, 84-86 Fore Street, Hertford, Hertfordshire

Desktop Assessment

February 2007

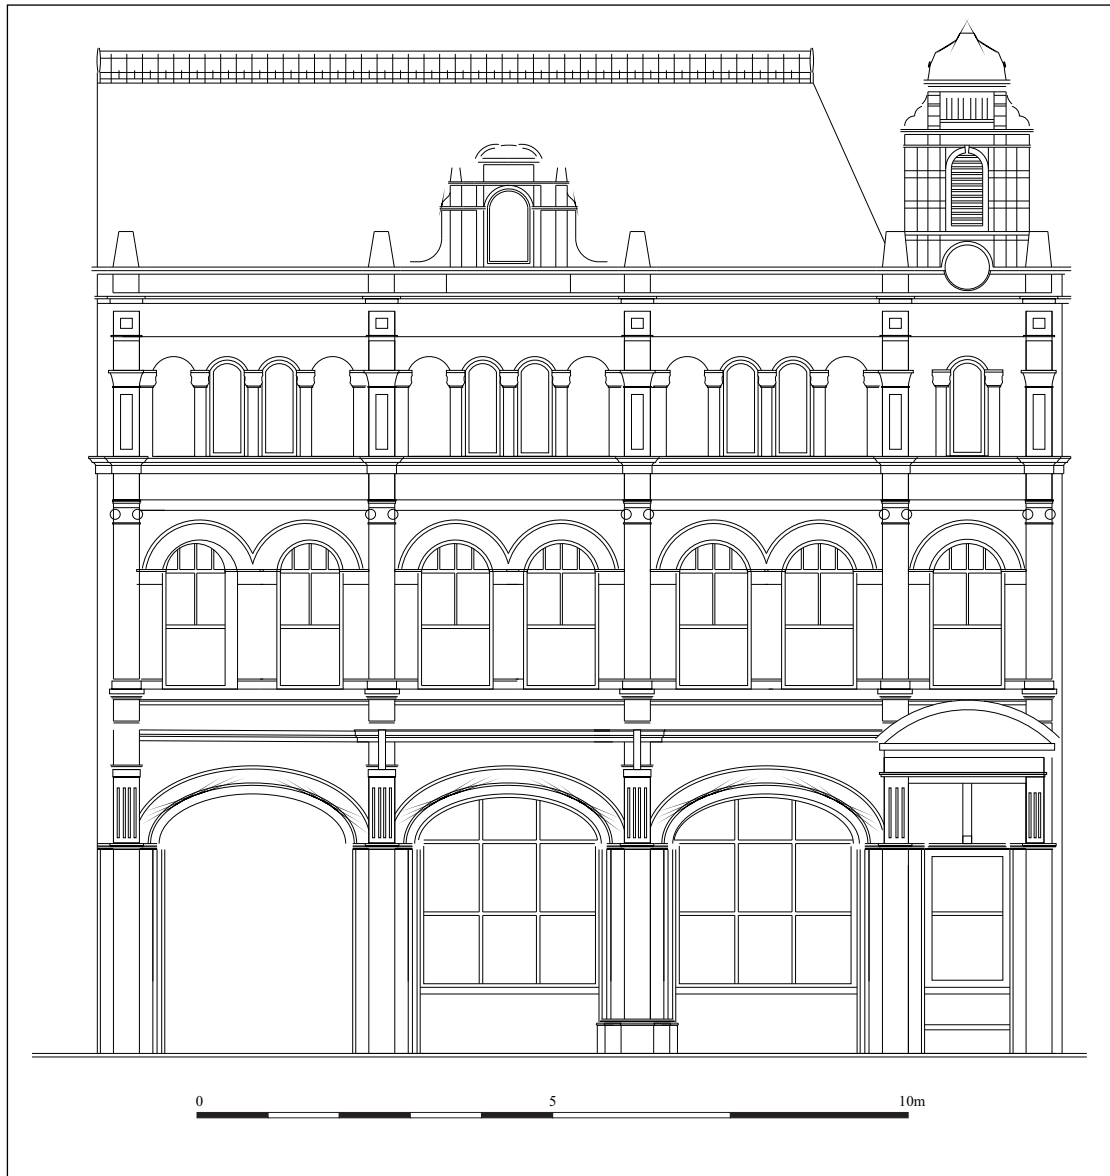
Figure 9: Post Office elevation drawing (from GSS Architecture)

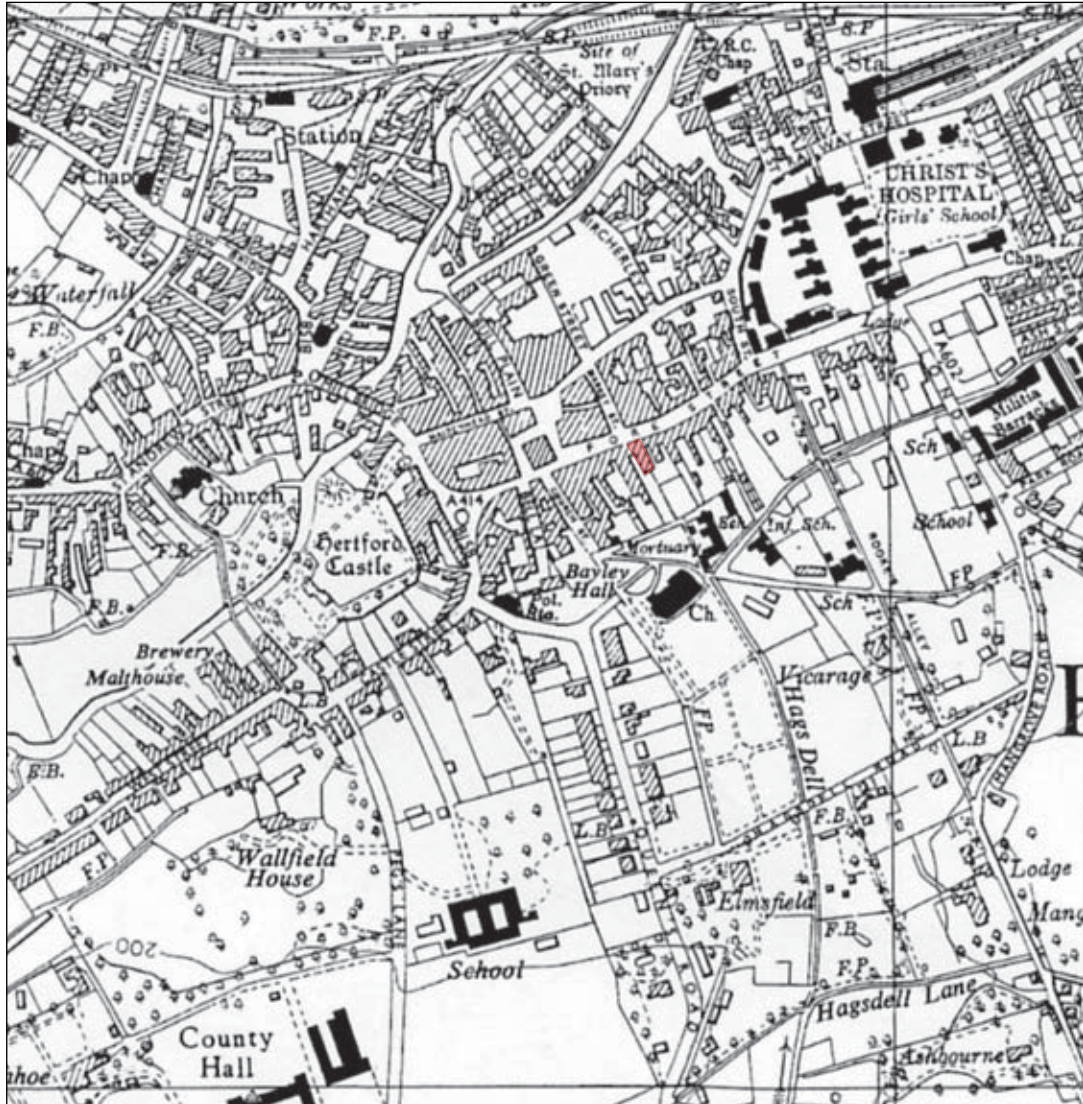
Figure 12: 1960 Ordnance Survey Map, with study site highlighted in red (with permission of Hertfordshire Archives and Local Studies)

By the 1960 Ordnance Survey map, an extension appears to have been built on the side of the building, incorporating the existing one to form a small courtyard or opening (figure 12). This could be due to the relocation of the staircase, now in this location, as part of the re-modelling when the entrance was moved. The three outbuildings have gone by this point, replaced by new ones which span the width of the plot. An addition has also been made at the rear of the building. This could be the light pinkish brick-built single-story extension with flat roof, still in use and visible from the rear today (plate po rear). The extension may have been to house the telephone exchange, mentioned, but without date as a later addition in a study by the Hertford Civic Society (Hertford Civic Society, 1966). The boundary at the rear is still present and the area behind is still undeveloped.

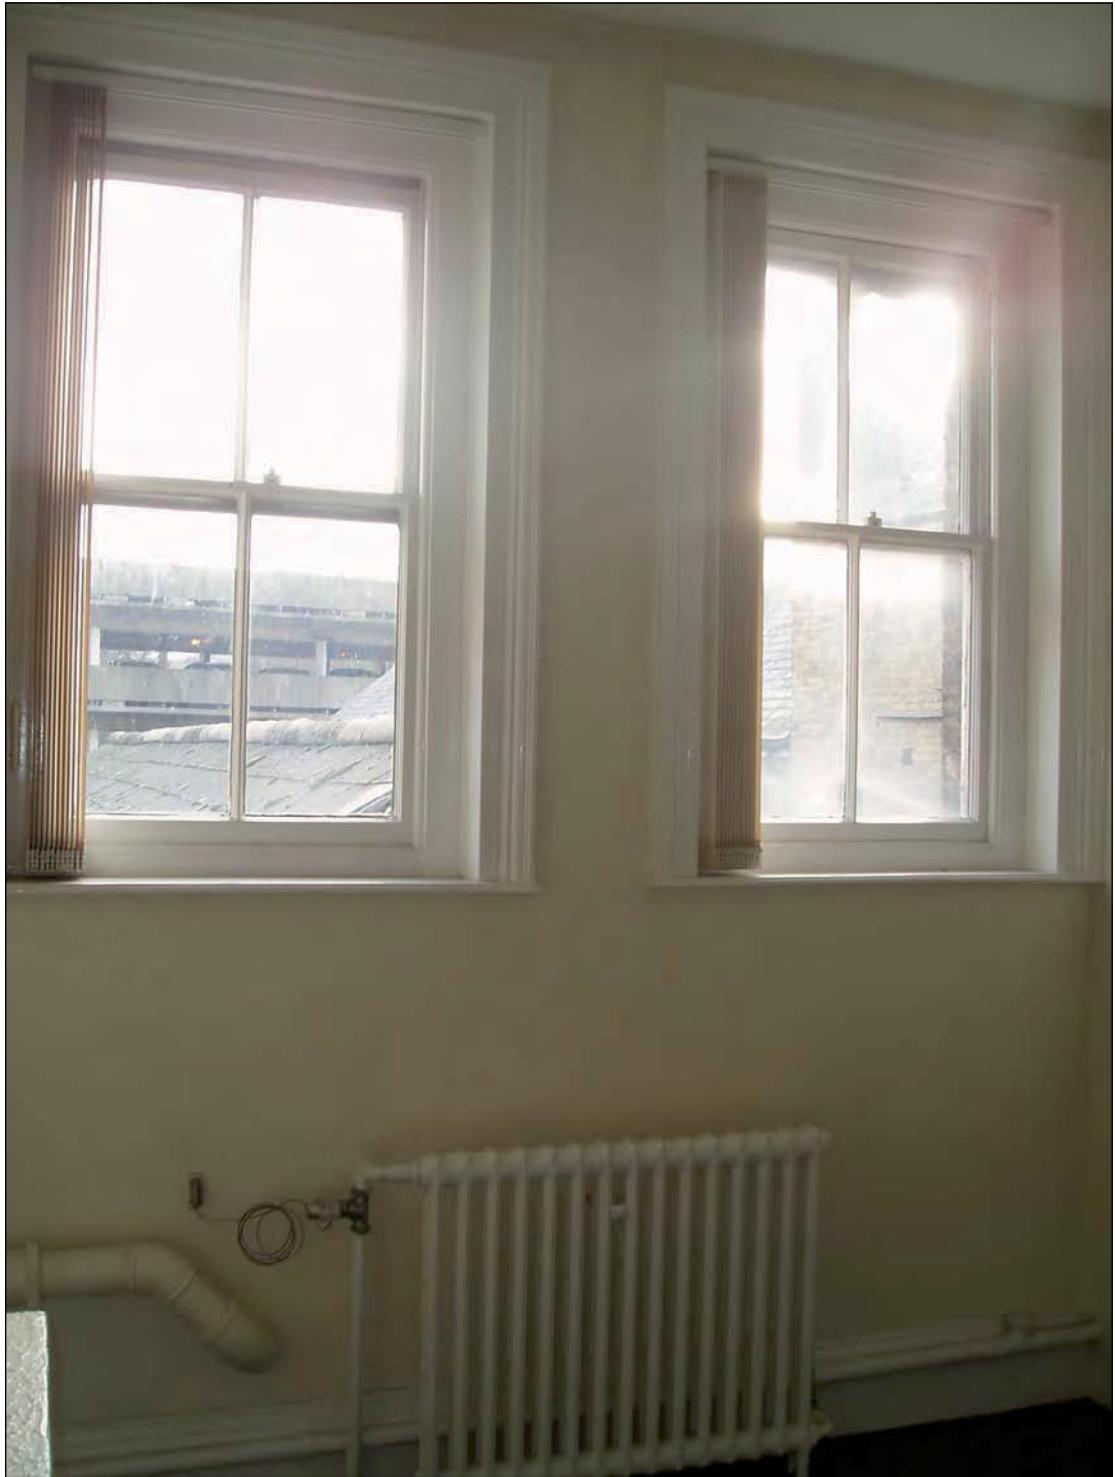
Plate 6: Original windows on first floor

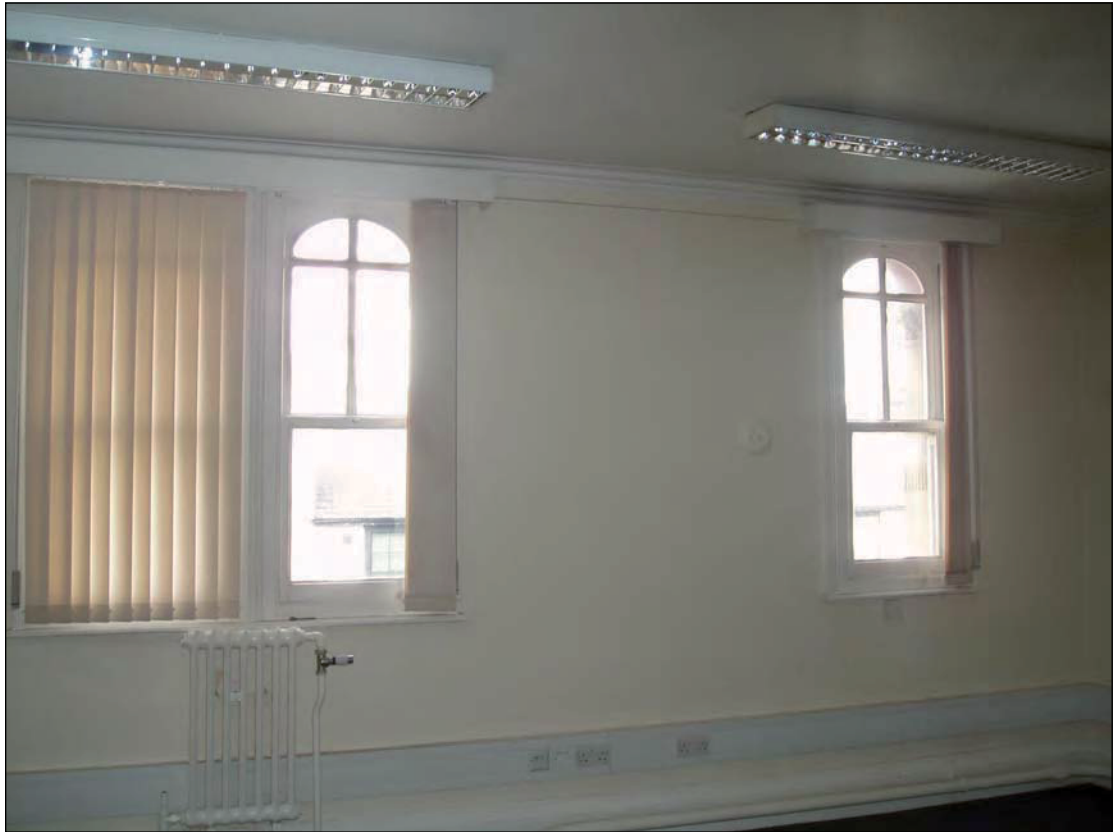
Plate 7: Original windows on second floor

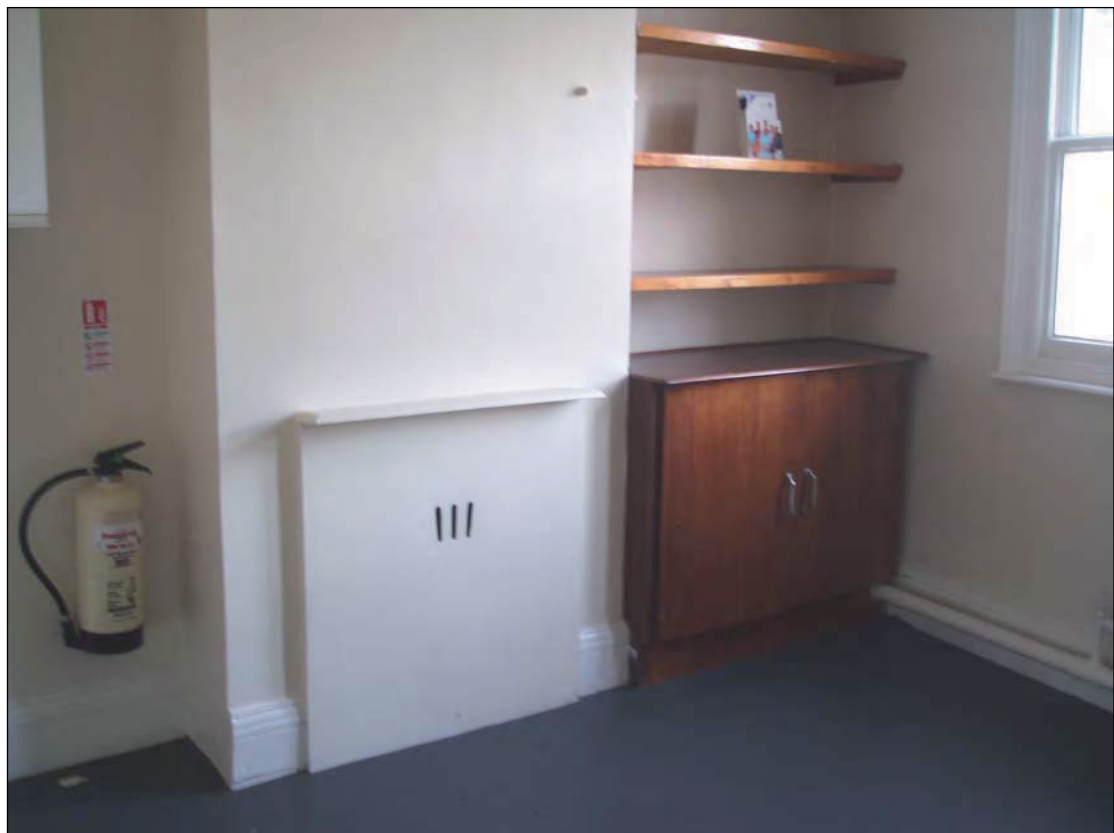
Plate 8: Original fireplace on second floor

breasts (plates 8 and 9). Other original features were also noted including a built-in cupboard on the second floor (plate 10).

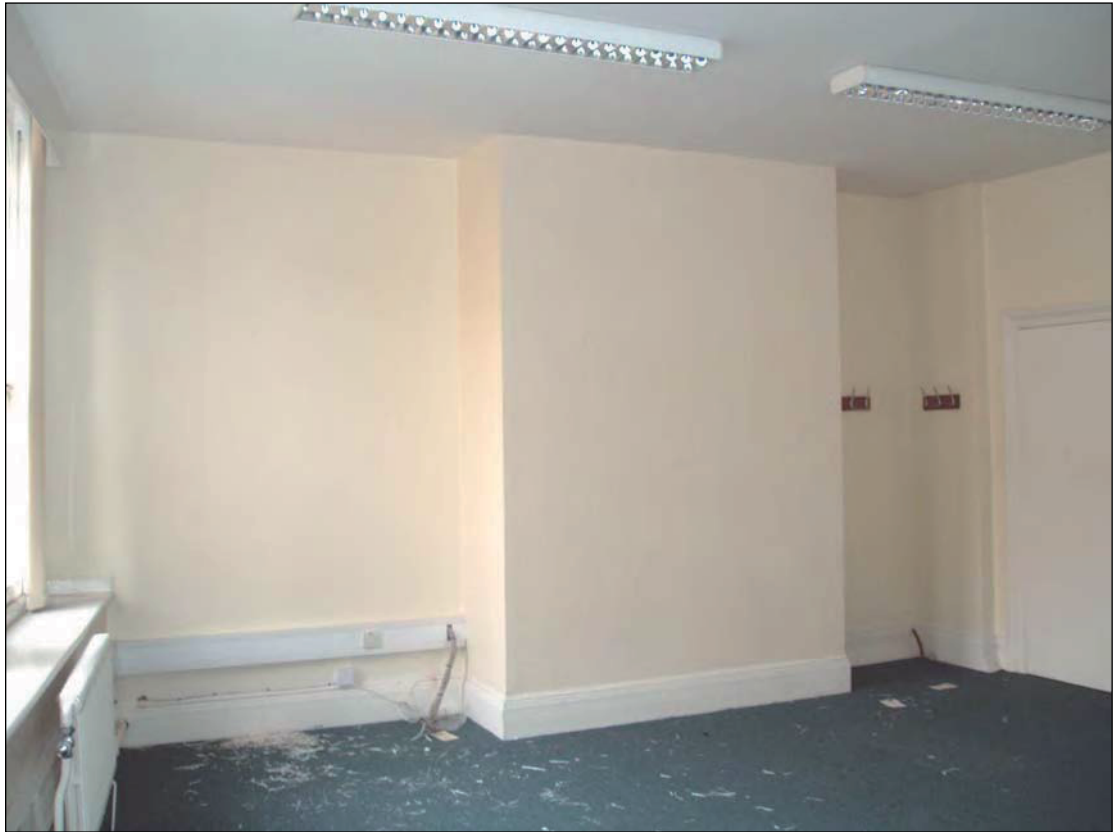
Plate 9: Possible concealed fireplace on first floor

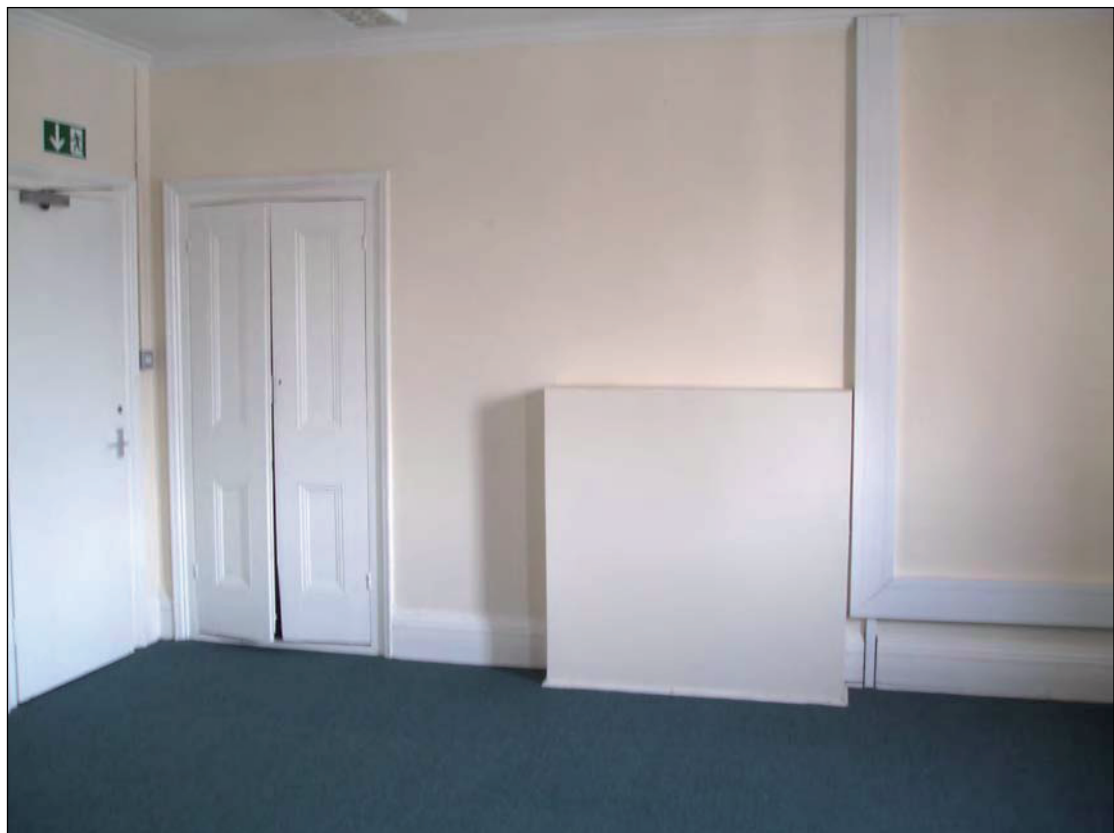
Plate 10: Original built in cupboard and possible concealed fire place on second floor
