CAM ARC Report Number 933

**Archaeological Investigations
and Historic Building
Recording Survey at the Church
of St Mary and St Andrew,
Whittlesford, Cambridgeshire**

Excavation and Historic Building Survey

Site Code: WHI SMC 06

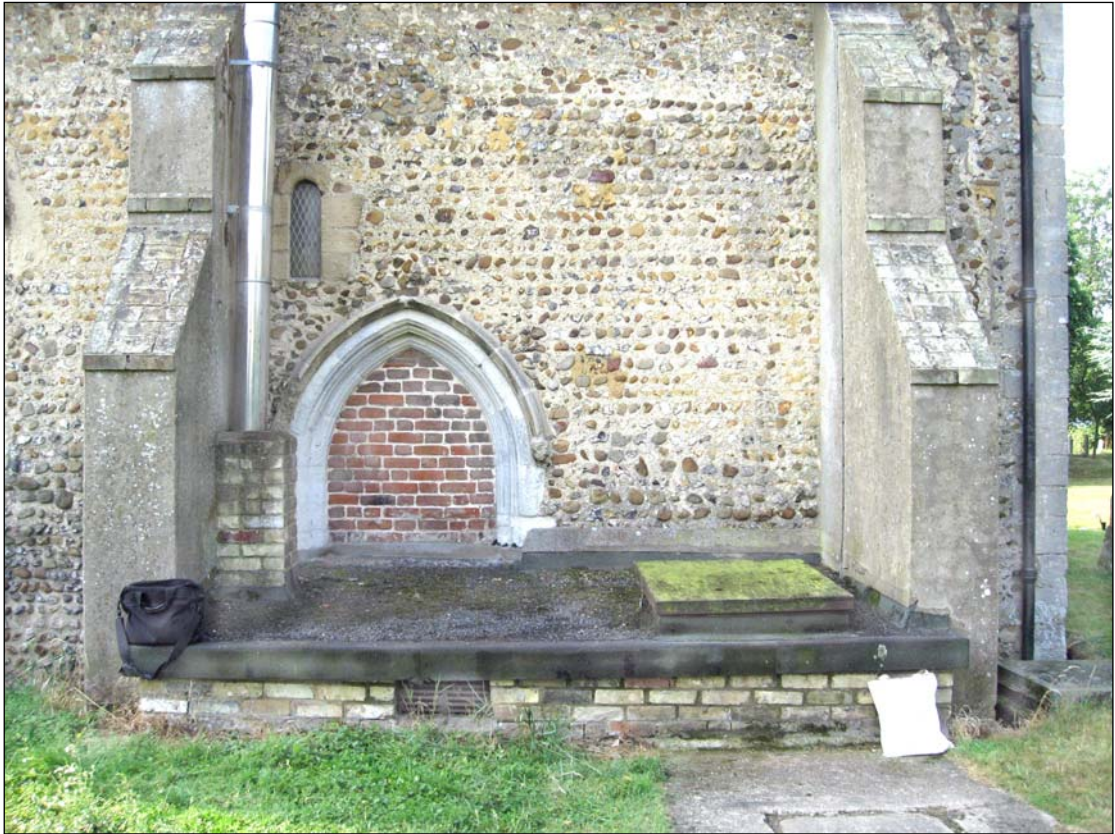
Plate 15: Sunken boiler room

The element of the church under investigation was on the north side. A sunken boiler room had been constructed in front of the doorway, the date of which was uncertain, but appeared to be post 19th century (Plate 15). The ground level had clearly been raised since the door was in use. As part of the development, in order to provide access to the extension, the ground level outside needed to be lowered and the boiler room removed. At the time of the boiler room's construction, several burials would have been disturbed. This may account for the large number of disarticulated remains found in Trench 5 immediately to the west.

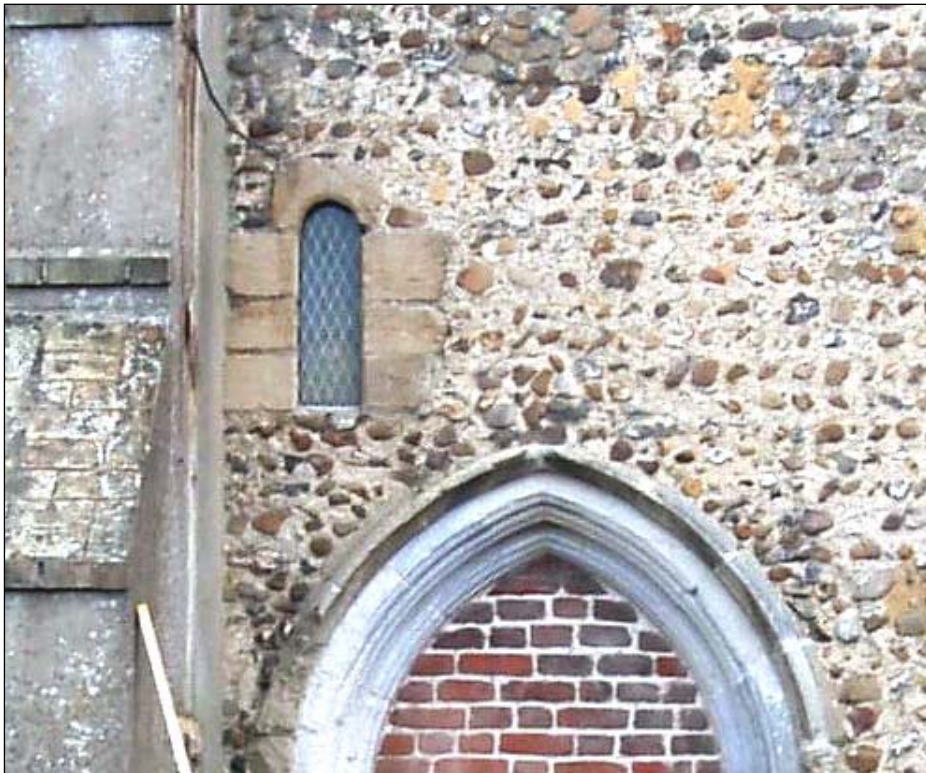
Plate 16: Norman window in north wall

The north wall retains one of the original Norman windows (Cotton 1989) (Plate 16). Due to the cost of glass at the time, windows were often very small, and splayed inside to admit more light. The style of the window matches other examples of the period, such as those found at Adel, Yorkshire and Itchingford, Sussex (Needham, A. 1944).

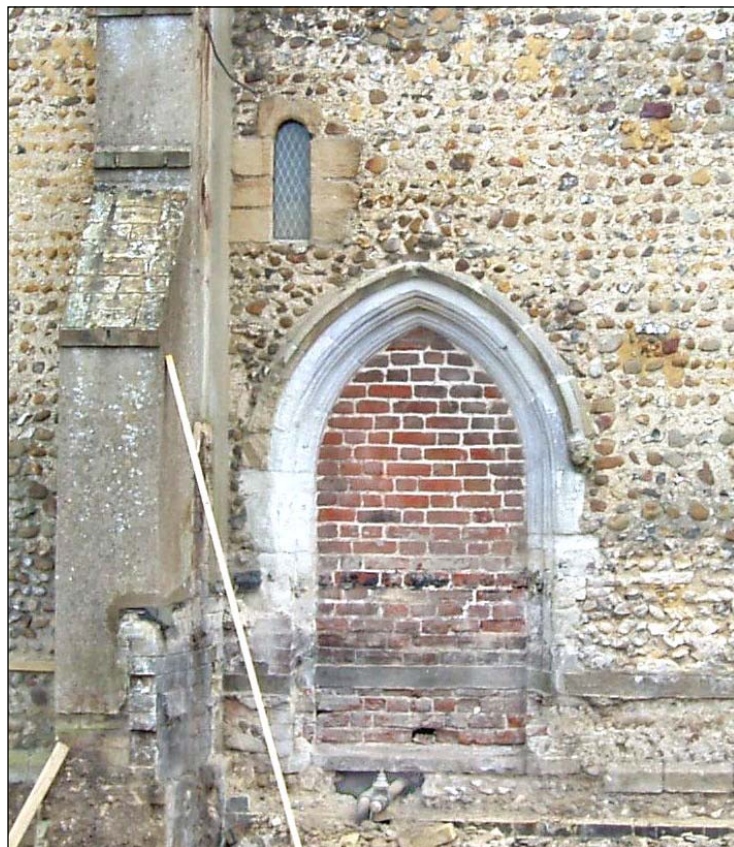
Plate 18: Blocked-up door

The doorway (Plate 18) was an equilateral arch with a decorative stone moulding, fitting the style of the 13th-14th century when a plain, strong defensive door was no longer needed. Around the decorative stone moulding was a dripstone arch made from limestone (?). At the end of the dripstone, on the right-hand side of the door, were the remains of a carved stone head. This is again a common feature of the 14th century and may have been a knight or lady, king or queen (Needham 1944), however, due to exposure to the elements, it is now too worn to tell.

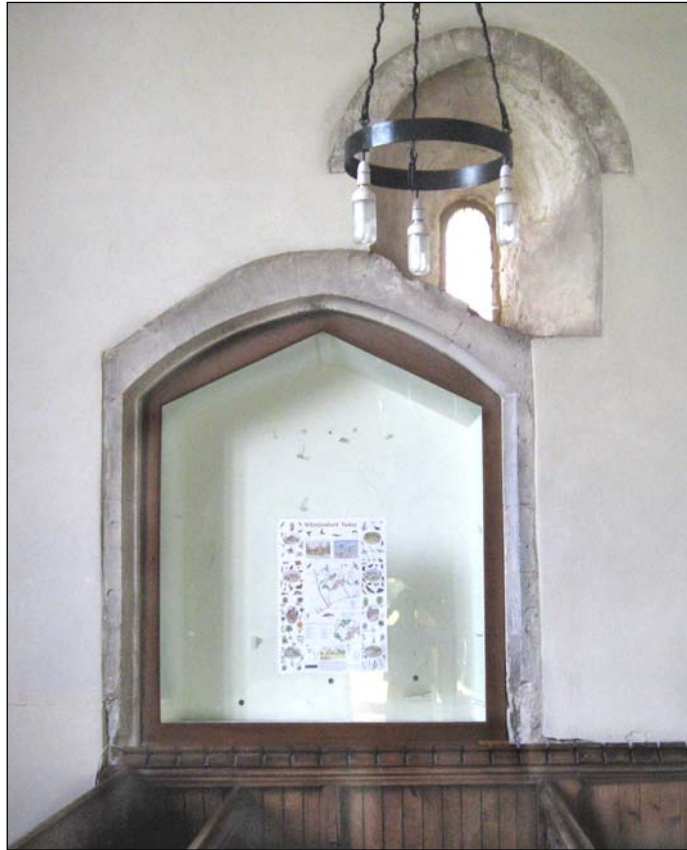
Plate 19: Doorway and Norman window from inside of church

From the inside of the church, it was possible to see that the doorway truncates the top of the door arch moulding of the Norman window, (Plate 19).

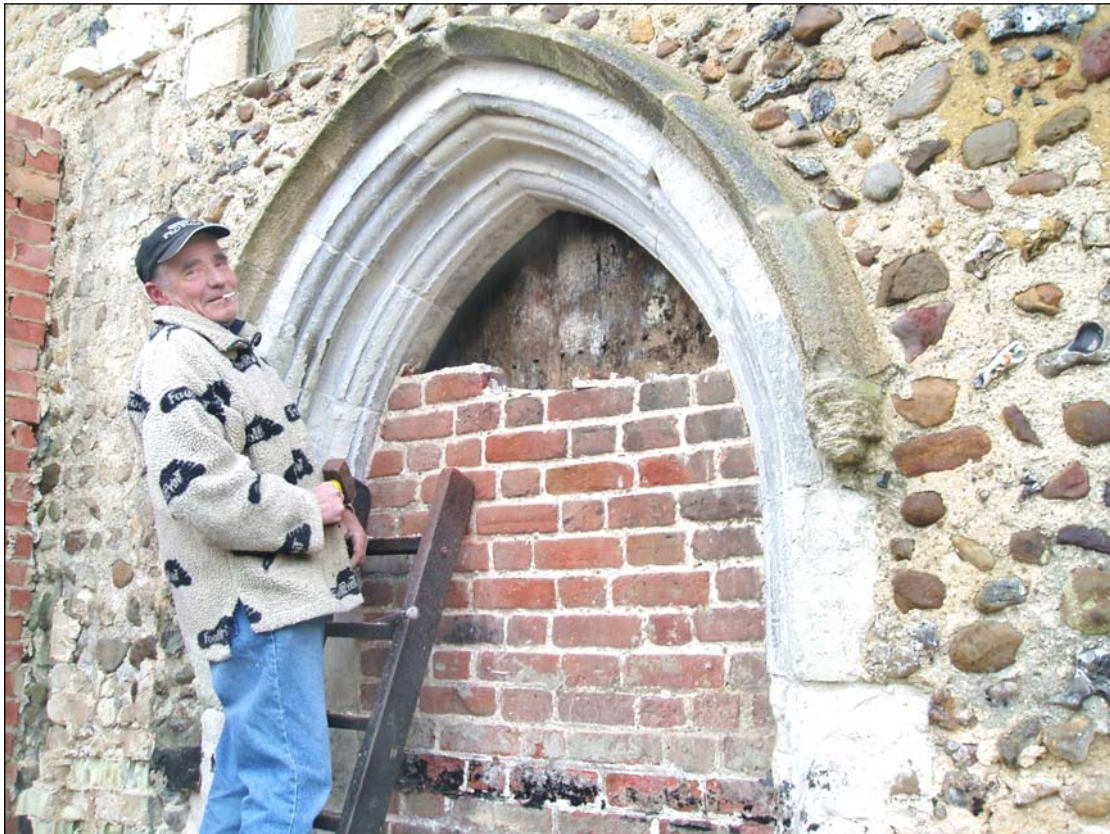
Plate 20: Door during exposure

Once the buttress and belowground store had been removed (figure 8), the blocked doorway was opened, revealing a wooden door behind the brickwork, hanging *insitu* (Plate 20).

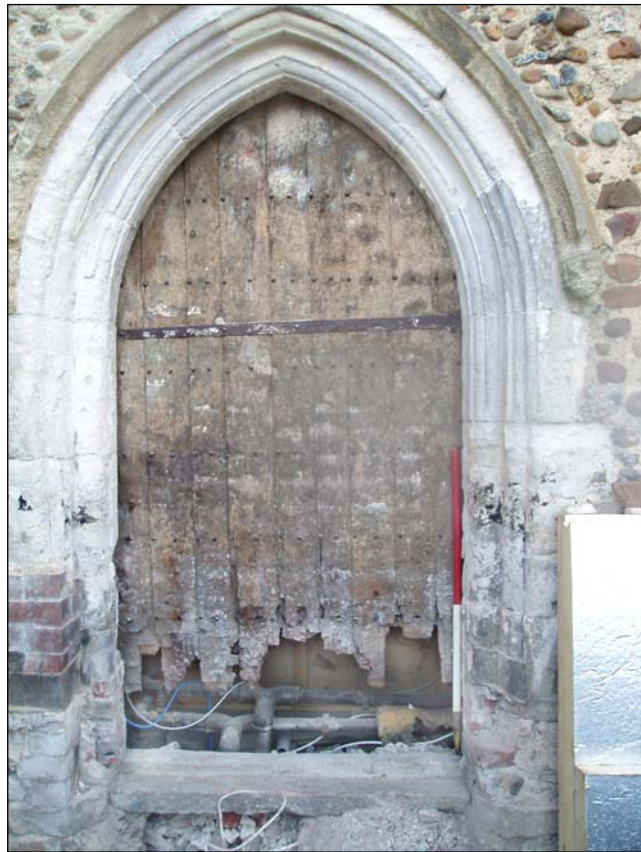
The door (Fig 8, Plate 21 and 22) was constructed of nine over-lapping oak panels, each of which was approximately 1.5cm thick. The panels were bound together using narrow oak strips secured horizontally on the back of the door (visible only from the inside) using square-head iron nails (Fig 8). The hinges (only the top hinge remained) were constructed of iron, and hung on two brackets mounted within the stone arch. The hinges were bound to the length of the door with iron studs and decorated with a cross pattern (Plate 23). The door was in relatively good condition, however approximately 30cm were missing from the bottom possibly as a result of damage caused by the water pipes for heating inserted below. There was no outer handle on the door, and locked only from the inside with a sliding bolt held in place with iron brackets. The door could be securely locked using an integral hasp and staple (Plate 24) with a padlock (not present).

Plate 21: Door from outside

Plate 22: Door from inside church
