Primrose Lane Hospital, Huntingdon, Cambridgeshire:

An Archaeological Evaluation

January 2008

Site Code: HUN PLH 06

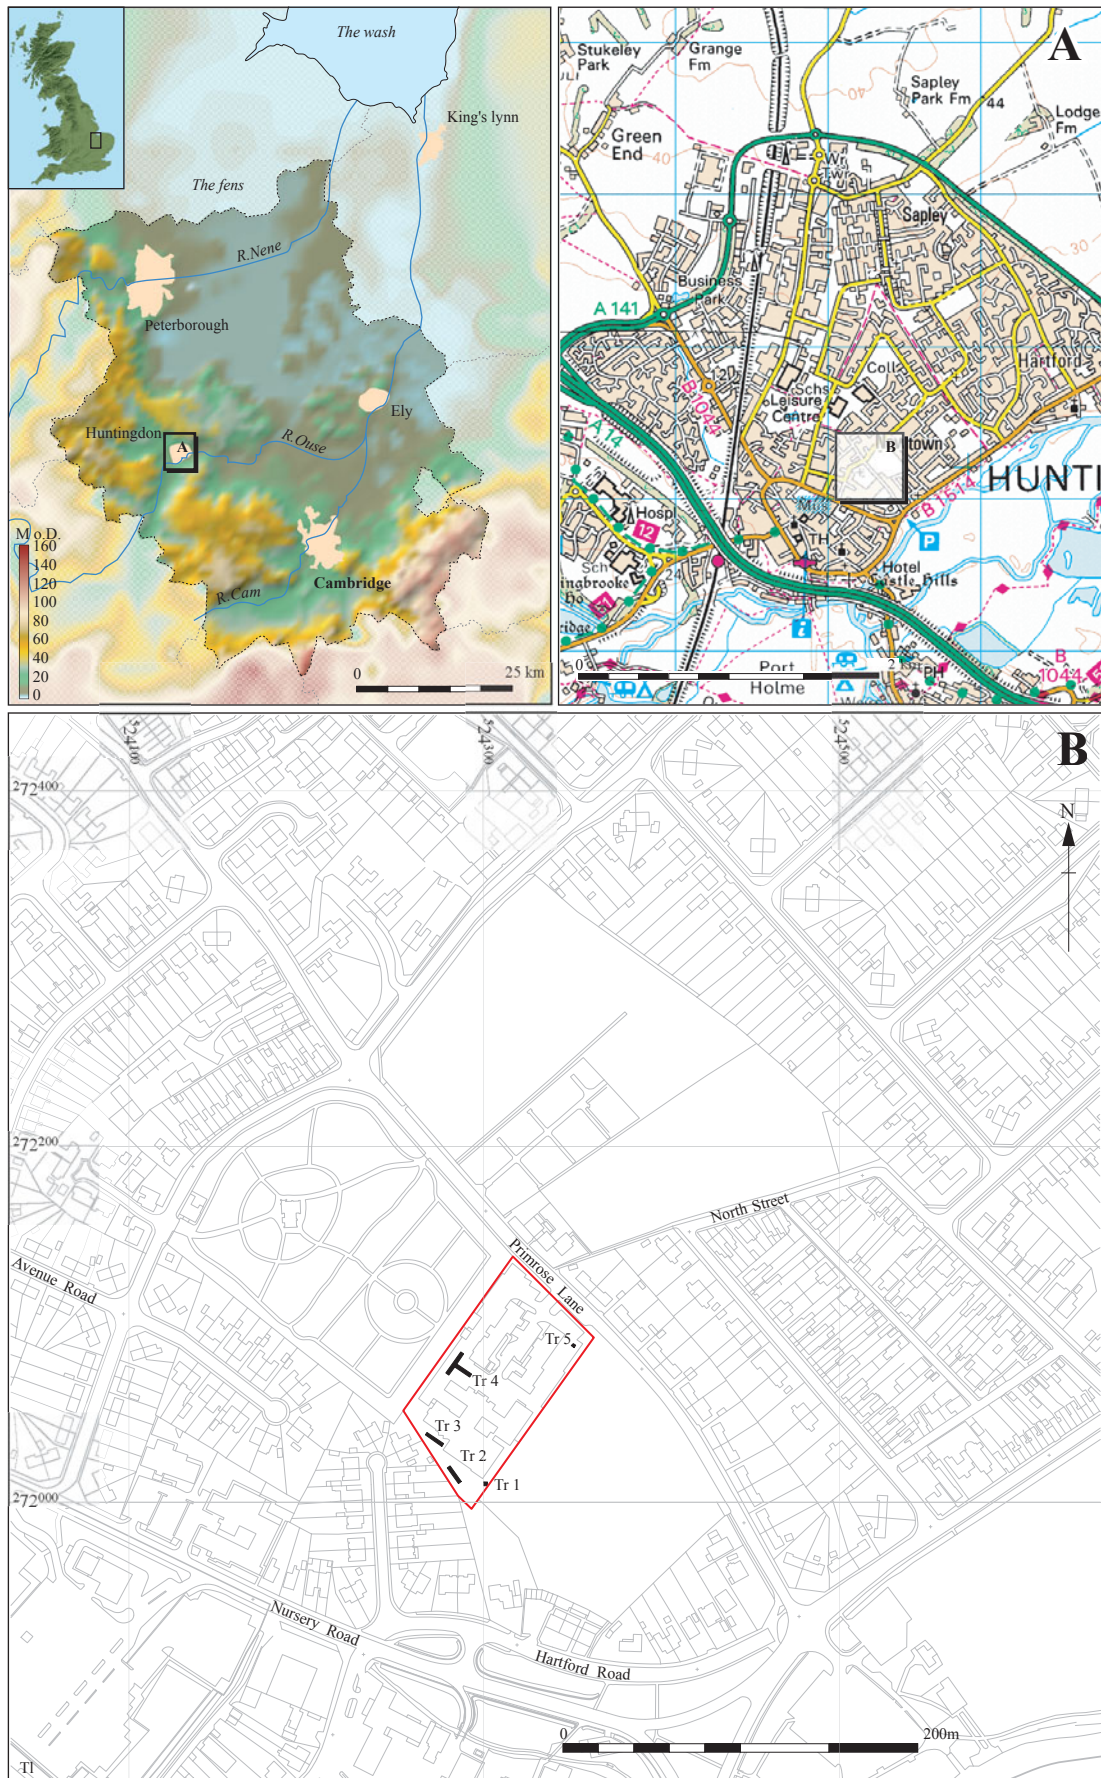
Figure 1 Location of trenches 1-5 with the development area outlined (red)

Five trenches were opened totalling approximately 50m and were located using GPS. The existing buildings on site and the service plan provided meant that the areas suitable for trenching were very small. Because of this the coverage of the evaluation across the site was much reduced.
