Historic Building Recording and Archaeological Investigations at 2 High Street, Barley, Hertfordshire

**Historic Building Recording and
Archaeological Excavation and Watching
Brief**

Site Code: XHT BAR 07
HER Event Number: N/A
Date of works: 10th September, and 23rd November
2007
Grid Ref: TL 3993 3857

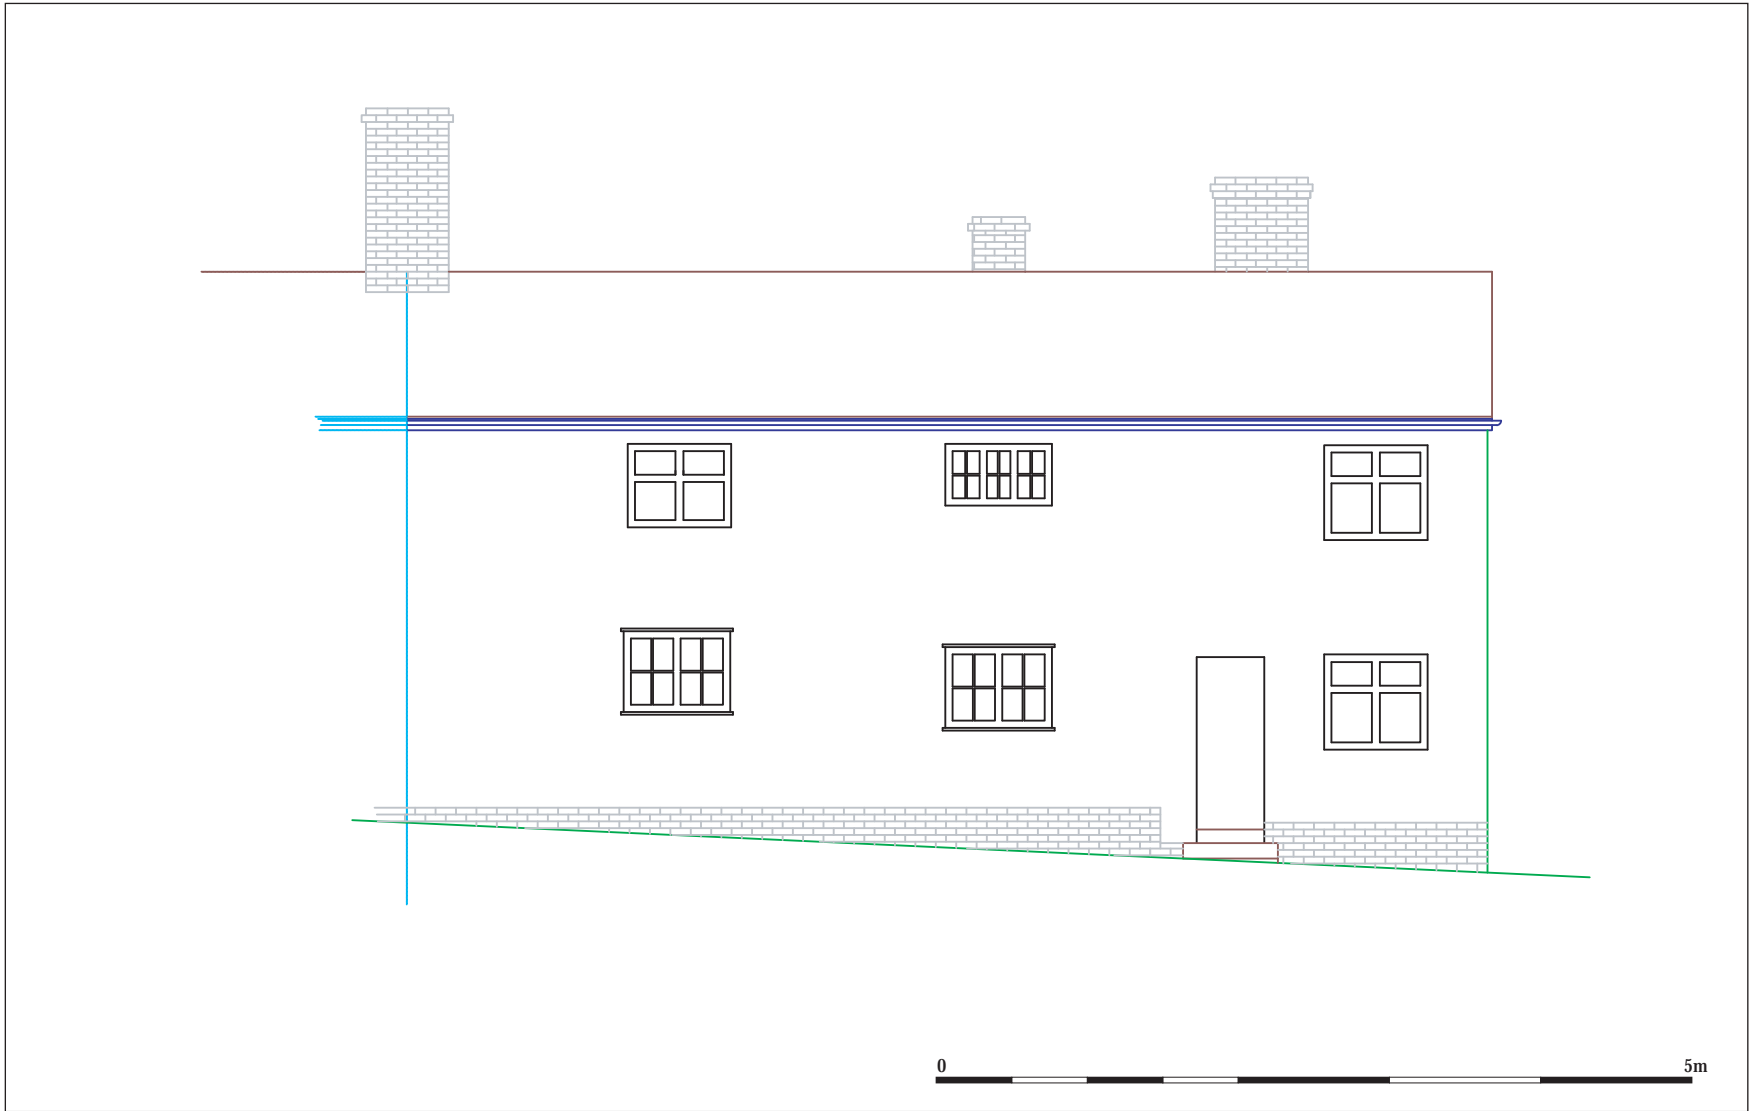
Figure : Front elevation of o 2 High treet Barley

At the time of inspection, the front of the number 2 High Street was rendered and painted pale green (plate 1). A brick plinth was visible at the base with up to seven courses of brick in an irregular bond comprising headers and stretchers (plate 2).

The house is a two-storey dwelling of timber-framed construction upon a brick plinth, resting beneath a moderately gently pitched slate-covered roof.

High Street is on a slight slope, and this is clearly visible in the brickwork of the of properties 2 and 3, as the number of courses of brick increases down-slope to maintain the building on one level.

There were six windows, three on each floor – set two to the right of the front door and four to the left.

From the front, a central chimney between no. 2 and 3 was visible. It was also possible to see evidence of timber framing behind the rendering.

From the front it is also possible to see a blocked doorway within the wall of number 3.

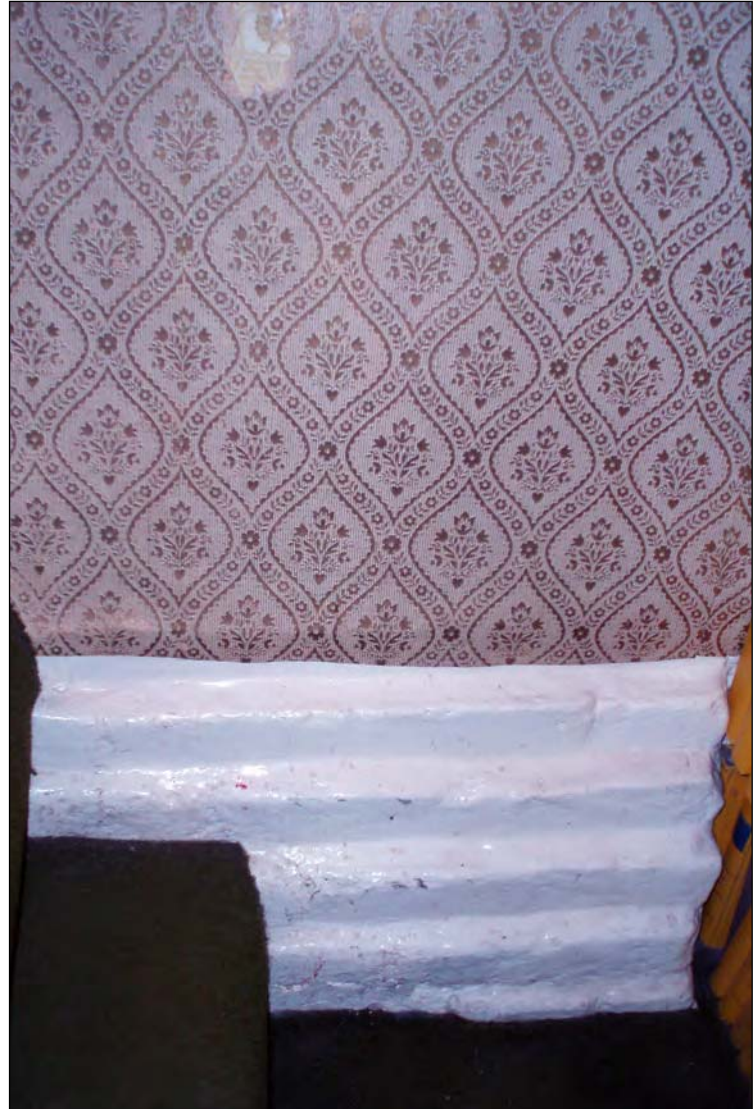
late : Side of hi ne reast ta en fro stairs

The first floor was accessed via a set of stairs at the rear of the house and within the wall it was possible to see the location of the outside of chimney noted in the office (plate 6).

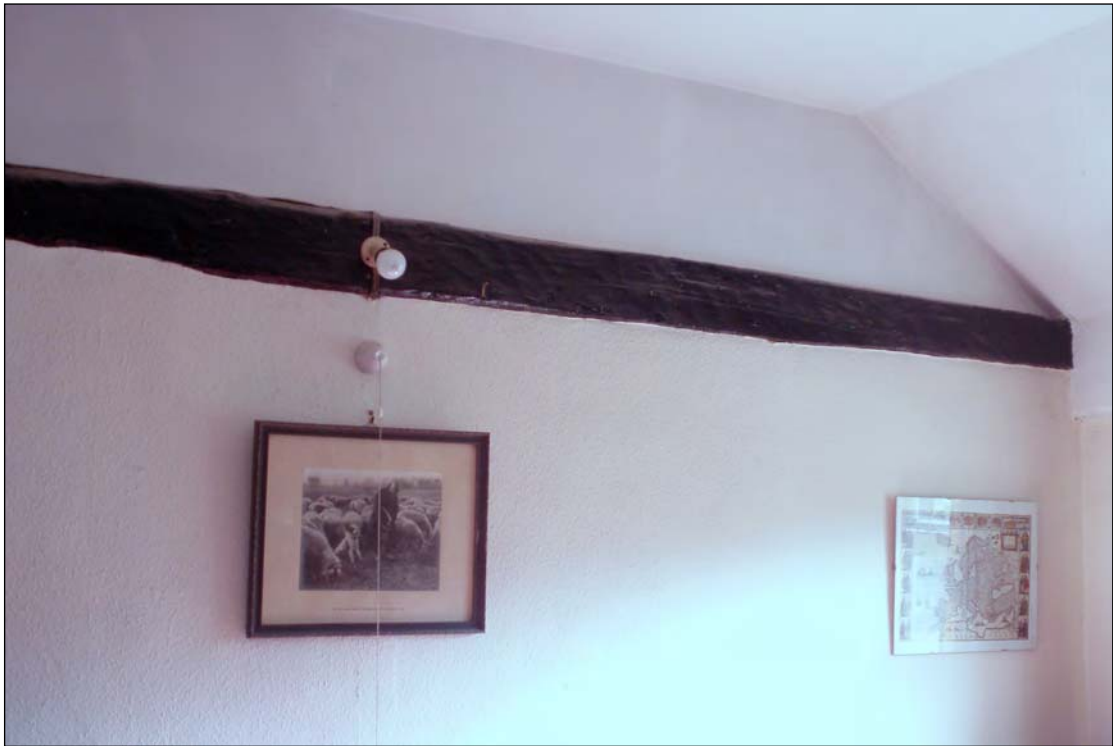
late : ie ea

At the top of the walls in the bedrooms and stretching across to the rear wall, the location of what appeared to be tie beams were visible (plate 7).

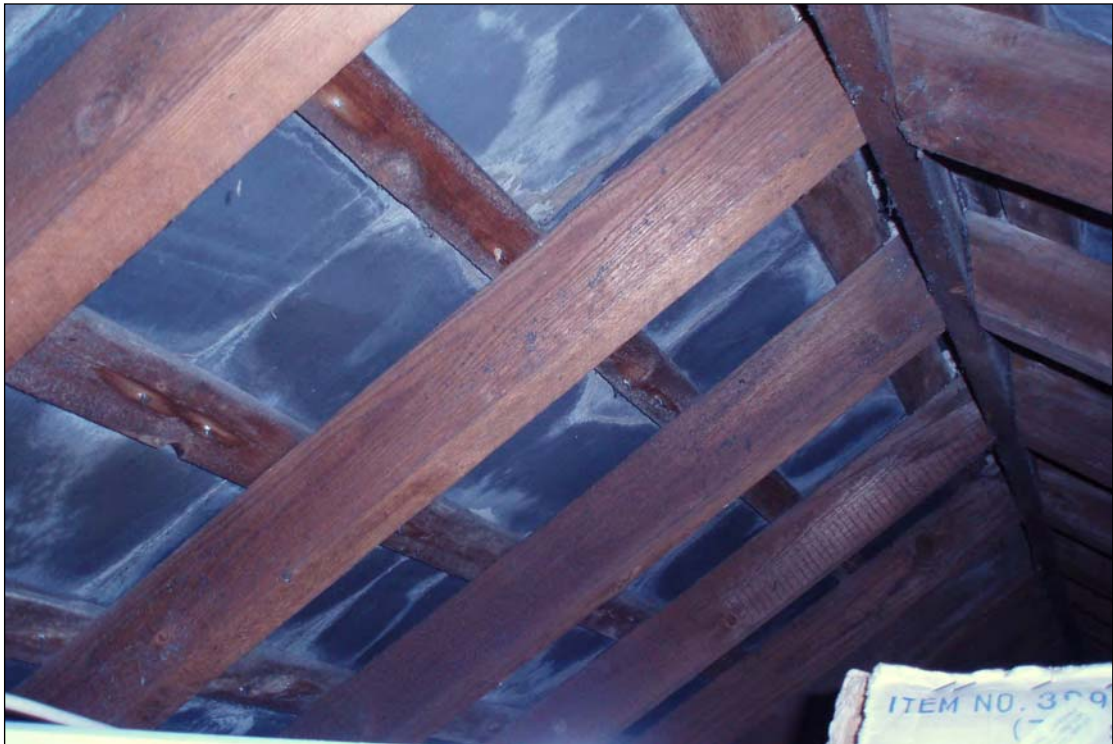
late : epla ed roof

The attic was accessed from the first floor via a small opening. From here it was possible to see that the original roof structure had been very recently replaced (plate 8). The upper part of the brick chimney was also visible (plate 9).

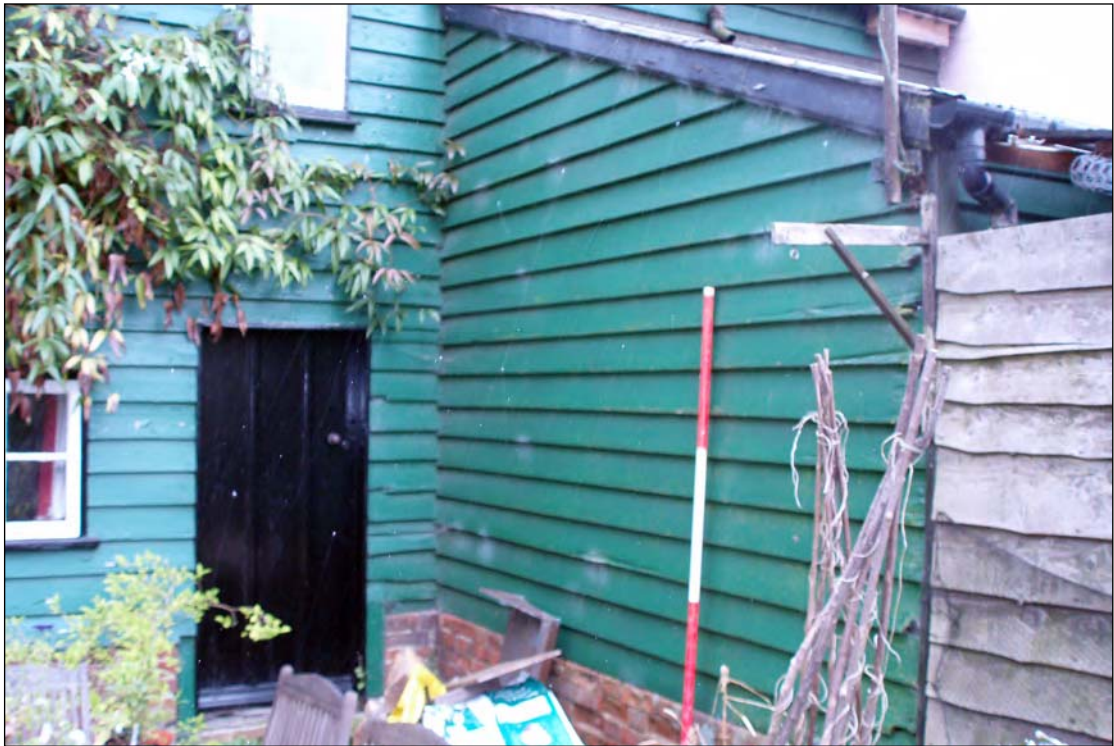
late : ean to prior to re o al

The element of the building under investigation was a lean-to at the rear of the main house, on the western side and at the time of inspection was being used as a shed/store housing motorbikes and various tools (plate 10).

The lean-to/shed was of timber-framed construction, built upon a brick plinth on two sides (north and south) and under a corrugated iron roof.

The timber frame was covered with weatherboarding, laid horizontally around the frame and painted green. The frame was presumably laid on top of the plinth to raise it from the ground and contact with the damp/wet ground.

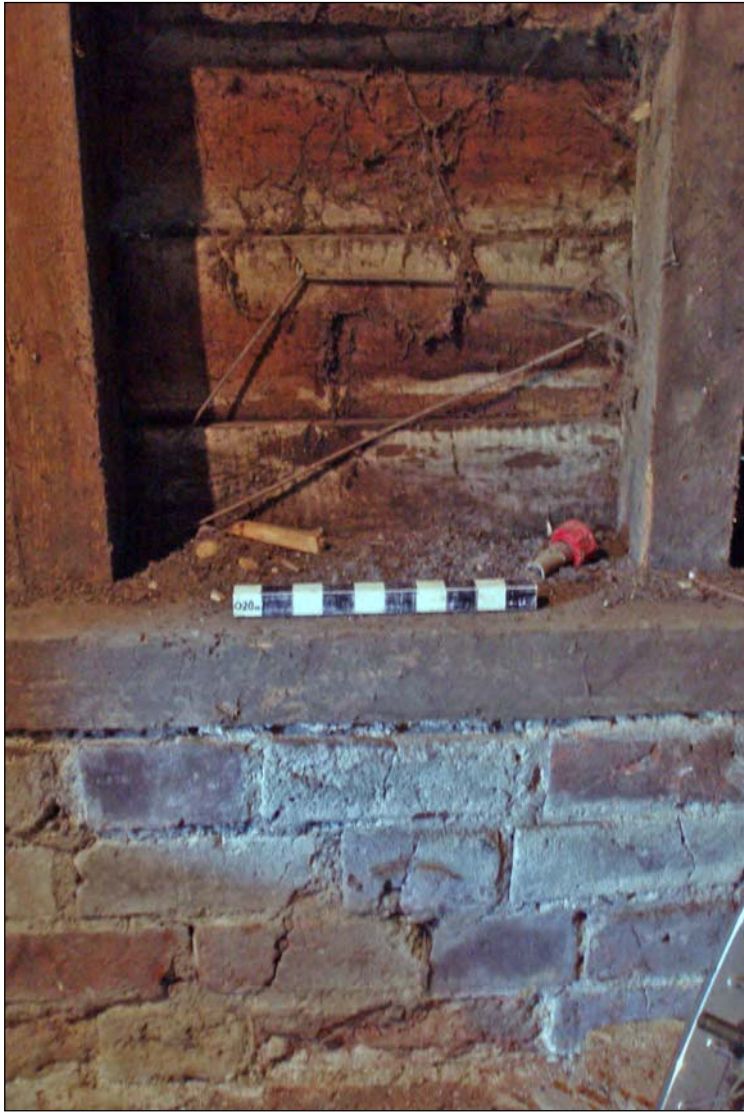
late 1: detail inside lean to

The brick plinth was constructed in Flemish bond, comprising seven courses (visible) of red brick with an average dimension of 22 x 7cm (plate 11). The mortar was a creamy beige cement with grit and small stone inclusions. The bricks appear to have horizontal pressure marks, indicating that they were hand made.

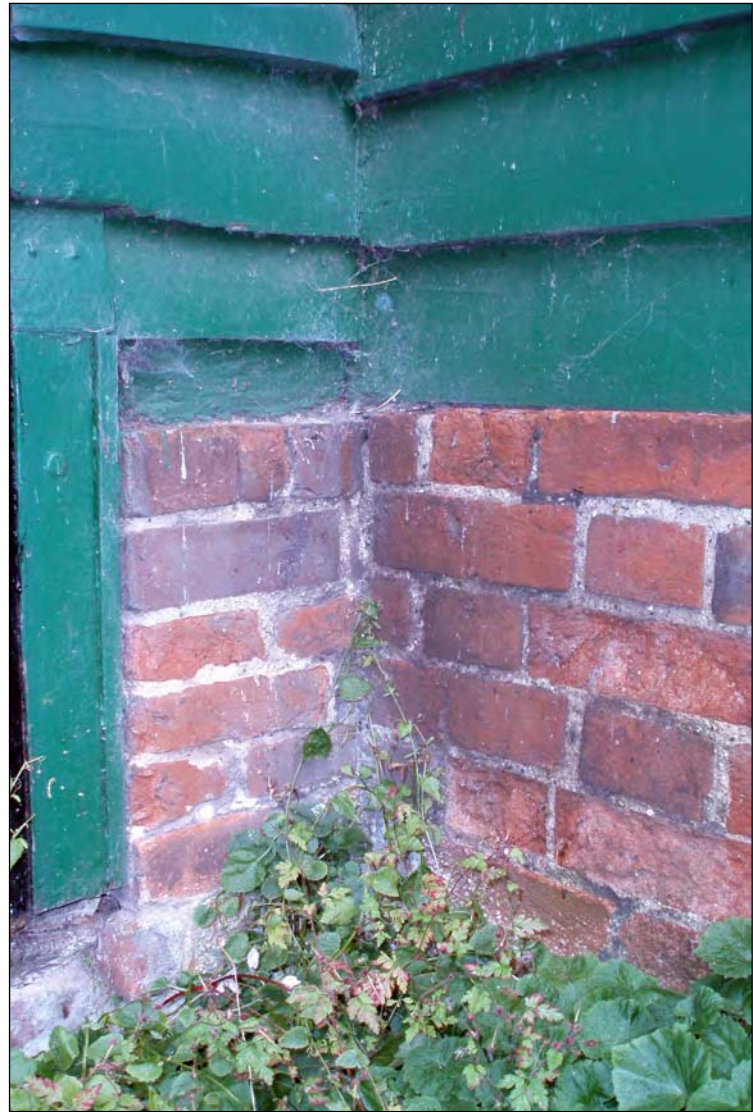
late 2: lean to against house

The lean-to appeared to be later, rather than contemporary with the main building. The type of brick used to construct the plinth was different to that of the main house, and in the corner where they meet, there was no evidence of it being keyed in (plate 12).

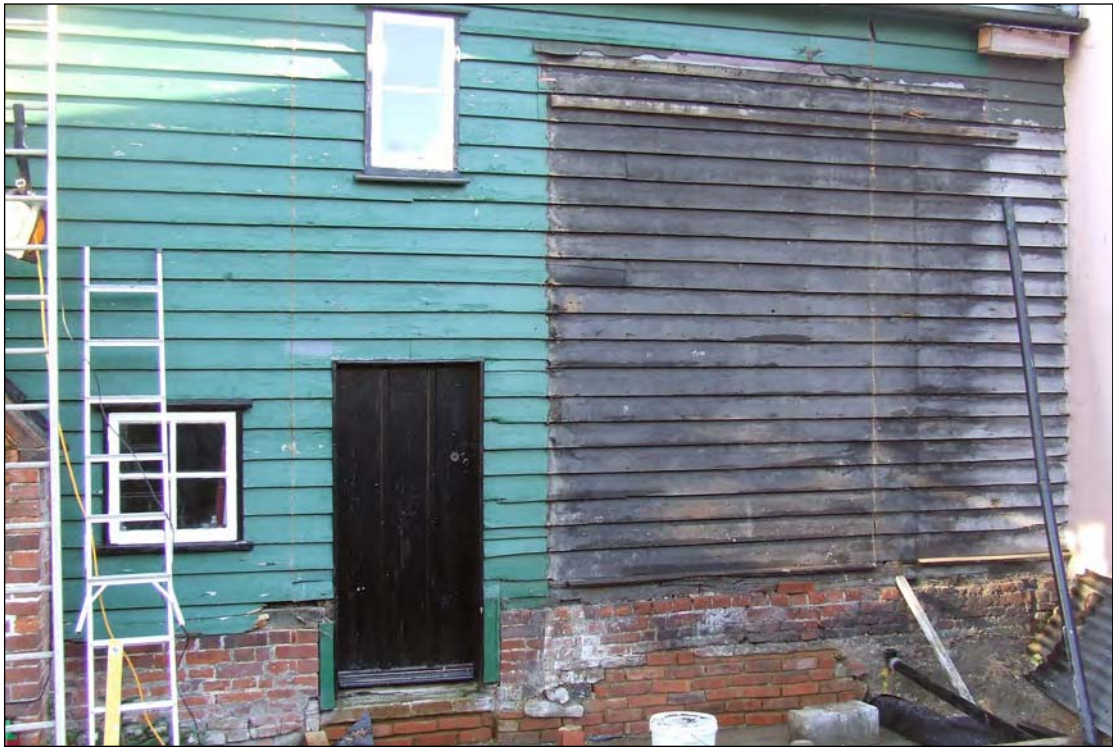
late 3: weather boarding following removal of lean to

The lean-to comprised opposing timber frames of which the internal elevation of one was drawn (figure 5). The weatherboarding/panelling used on the rest of the house was exposed at the rear of the lean-to

(opposite the door) (plate 13, when lean-to was removed). There were no obvious nails or fixtures used on the construction of the building.

The removal of the lean-to revealed the weatherboarding intact. This dates the construction of the lean-to after the addition of the weatherboards.

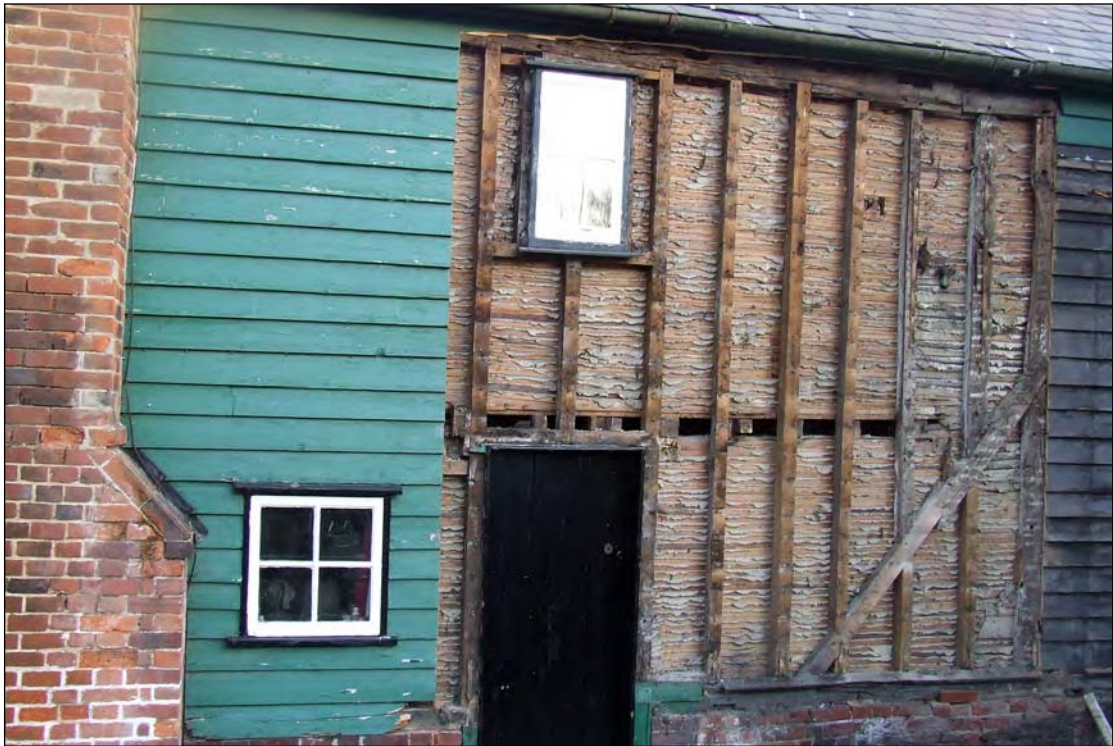
late 4: timber frame exposed following removal of weather boarding

The exposed wall revealed shows the survival of some early as well as replaced timbers which make up the stud wall, behind which lathe and plaster work was clearly visible (plate 14).

Most of the timbers appear to be 19th century or later replacements, other than some of the studs (far right on plate 14), the upper part of the wind brace (plate 16) and the top plate which all appear much earlier.

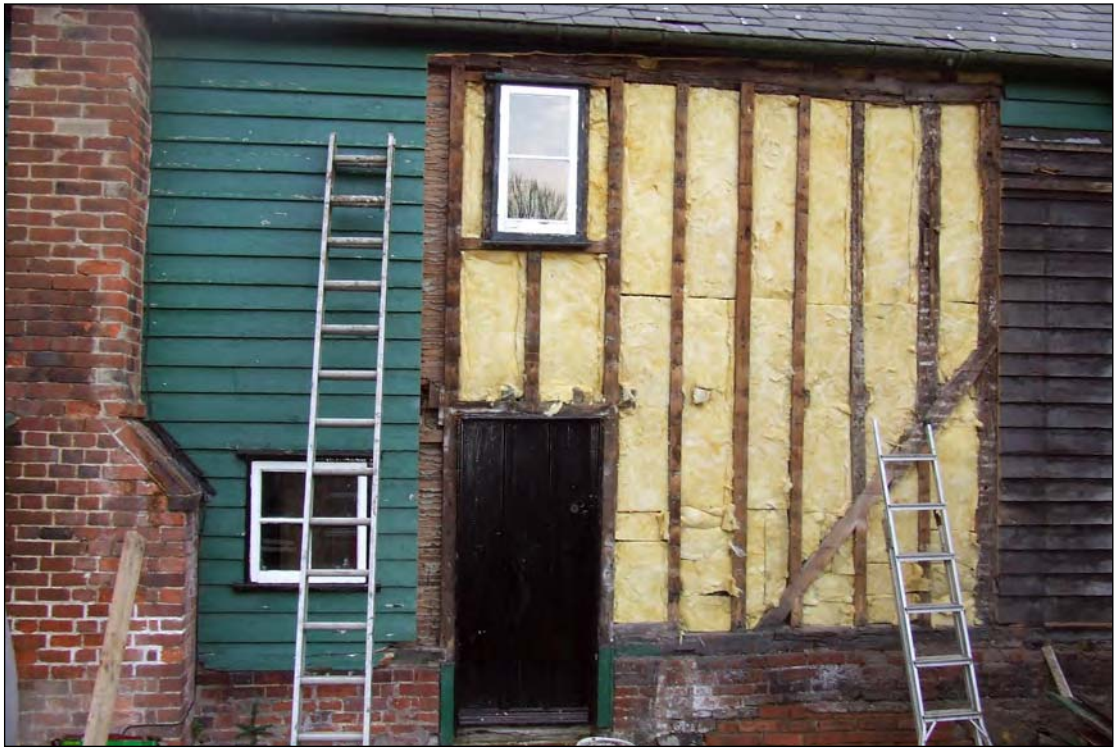
late : i er fra e in filled ith insulation

Although an archaeologist was not present during the removal of the boards, the client undertook a detailed photographic record of their removal and the exposed wall before and after the insulation wadding was inserted (plates 14 and 15).

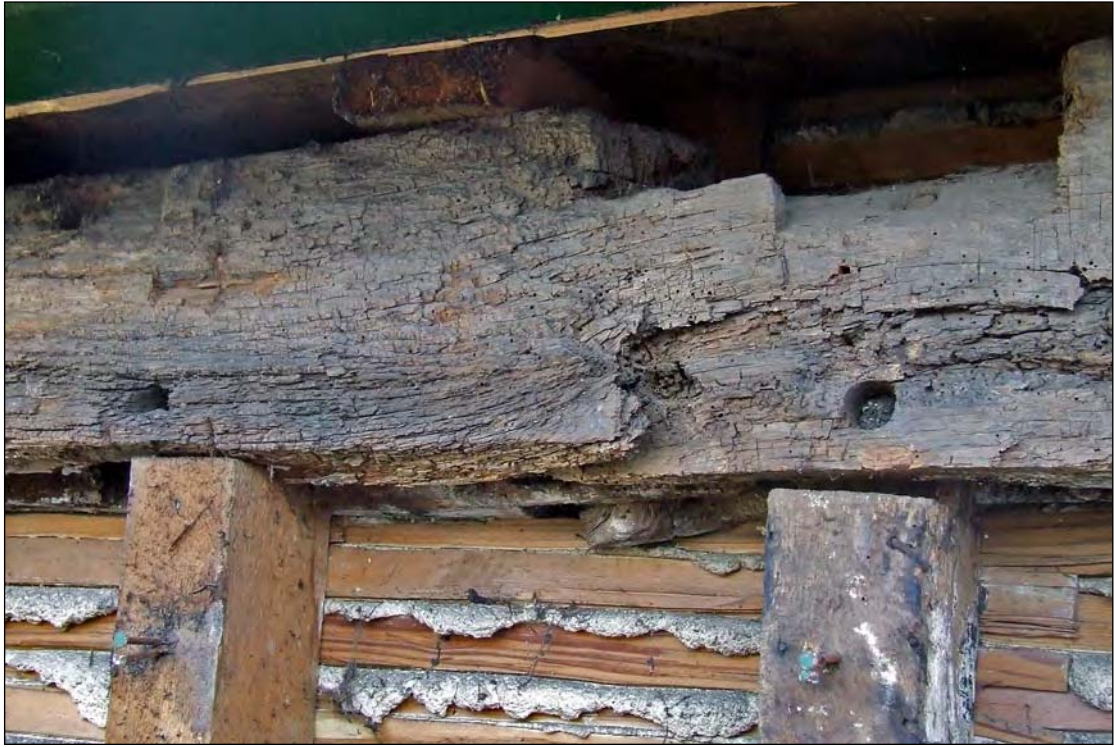
late : op plate ith orti es

Interestingly, within the wall plate, two mortices are visible (plate 17). This may suggest that the building originally extended further to the rear, however, as there was no evidence for this within the archaeological investigation or anywhere else within the rear elevation, it is more likely that this timber has been reused.
