# Historic Building Recording and Archaeological Survey at 35-39, Highfield Road, Berkhamsted, Hertfordshire

## February 2008

**CAM ARC Report Number 989**

## **Historic Building Recording and Archaeological Survey**

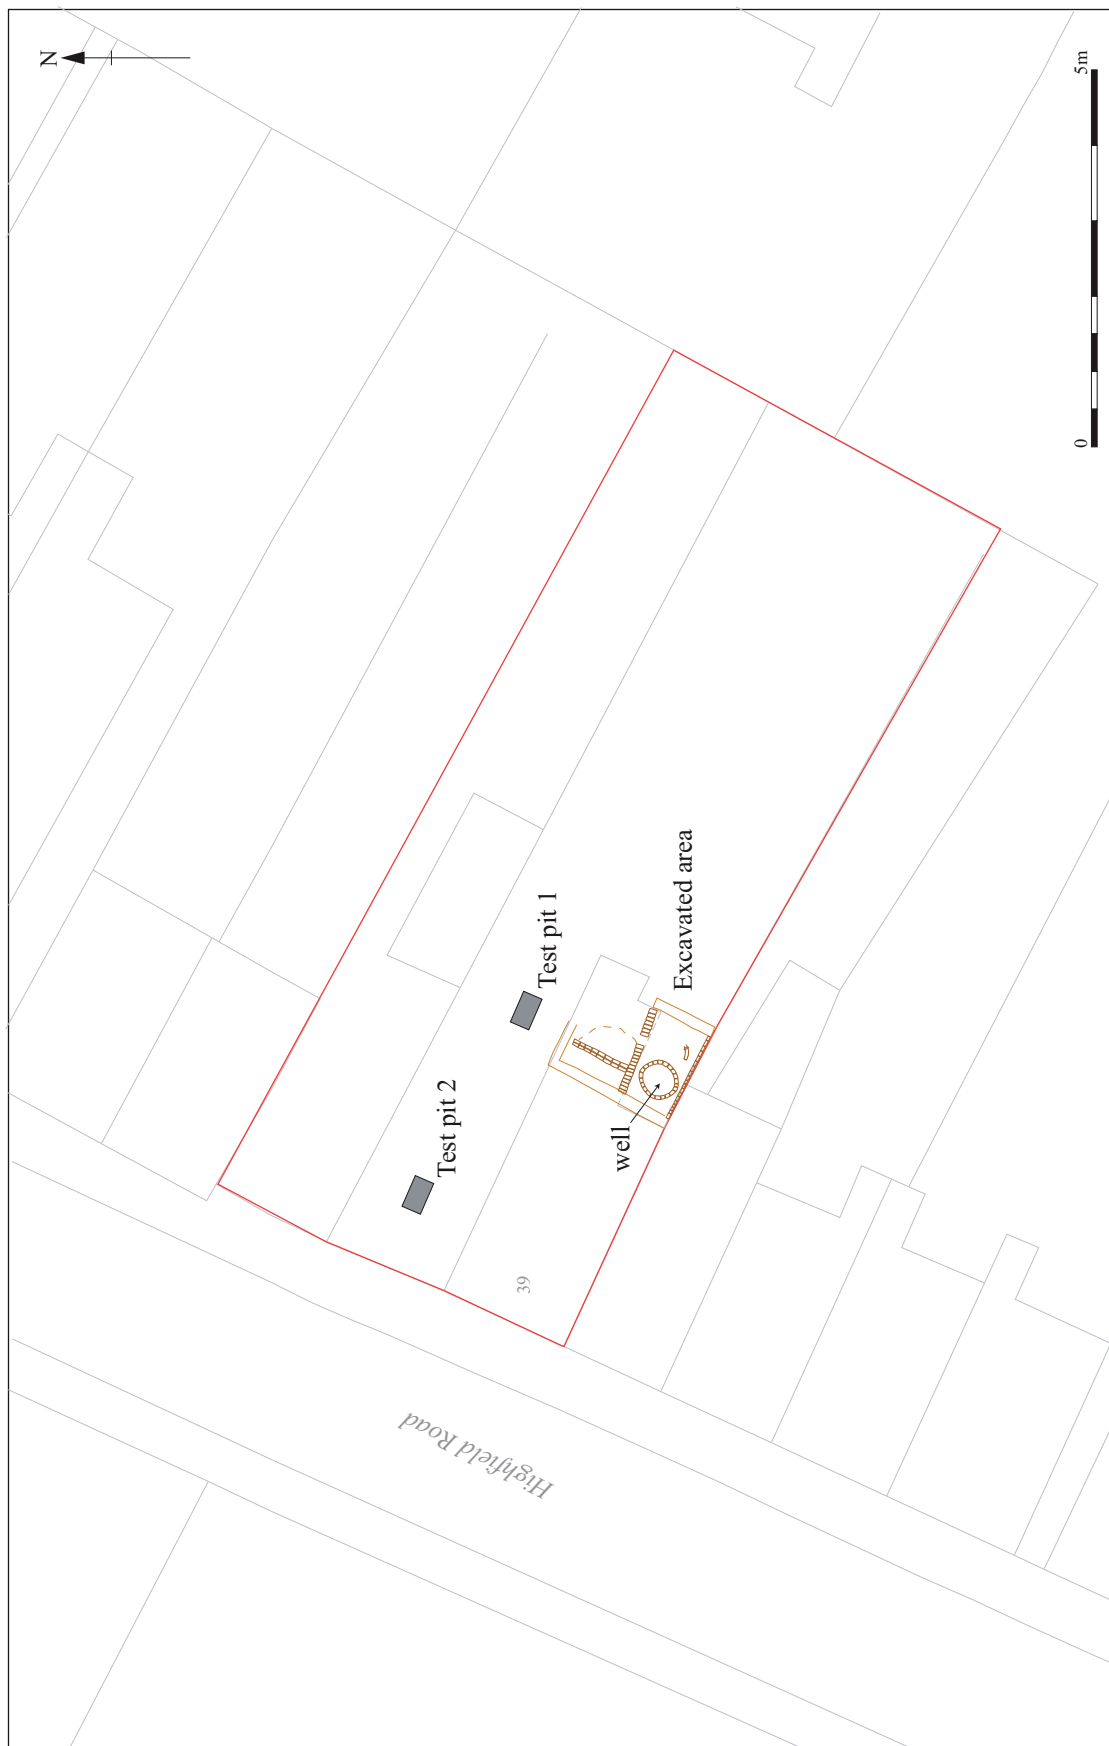
*Figure 2: Development area ,showing archaeological excavation and test pits*

Both test pits were located on the land between numbers 35 and 39 as requested in the brief. The additional area of excavation was located directly to the rear of the original property, beneath the modern extension (Figure 2).

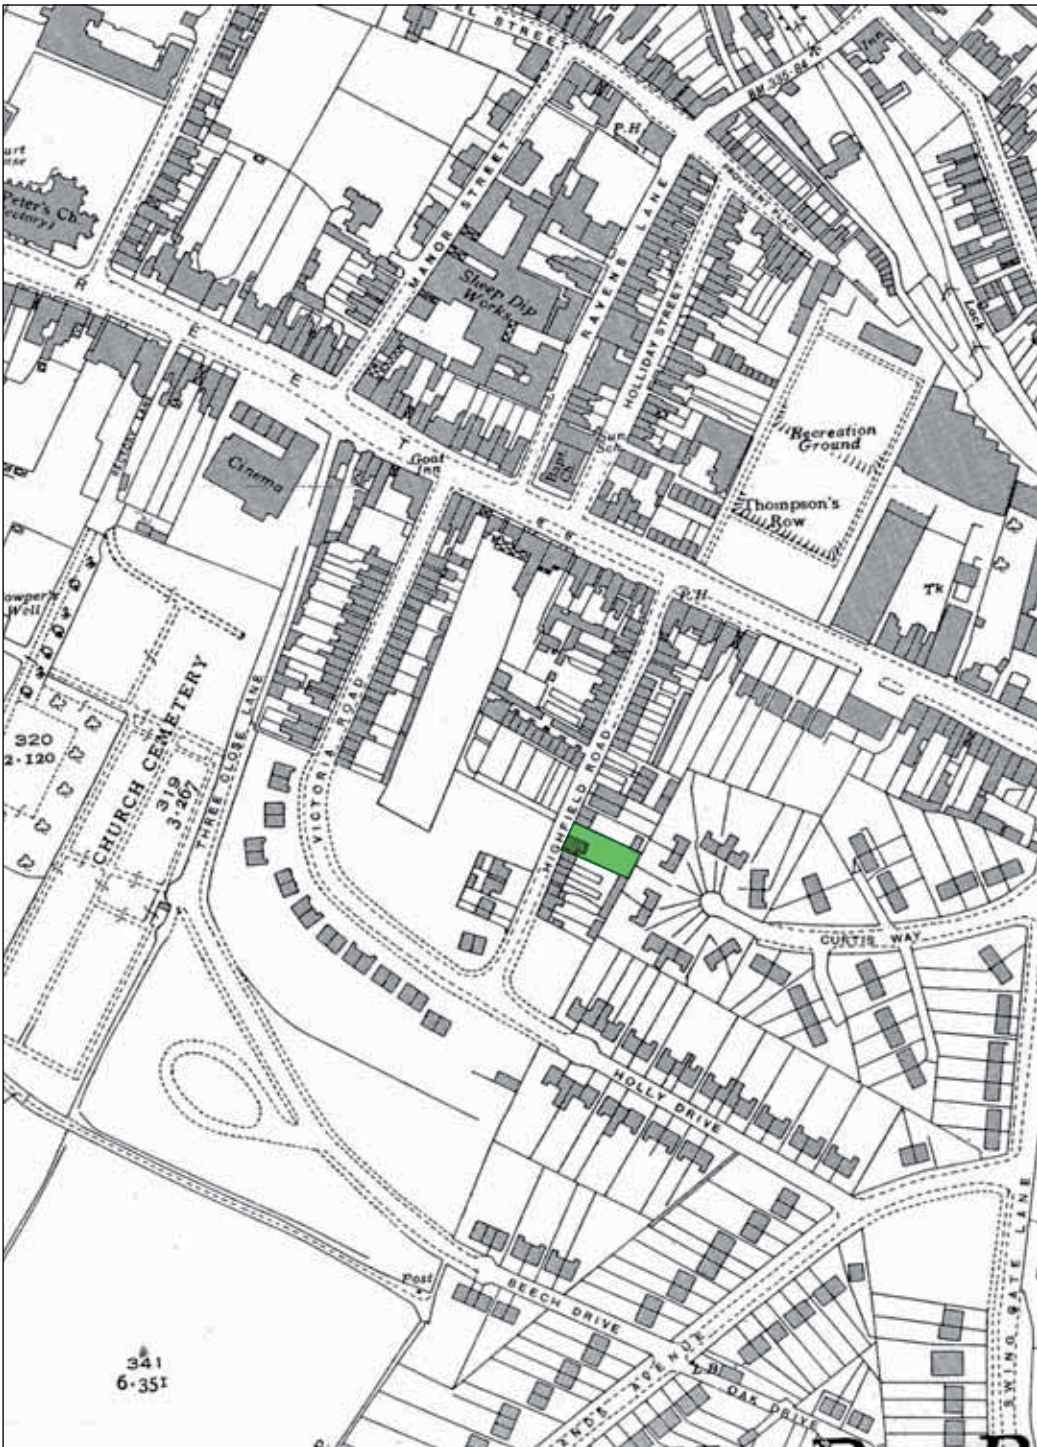
Figure 6: 3rd Edition Ordnance Survey Map, 1925

The 3rd Edition Ordnance Survey map of 1925 (figure 6) shows no change and by the 4th edition, 1938 (figure 7), all of the outbuildings at the rear have gone and the development area appears much as it does today.

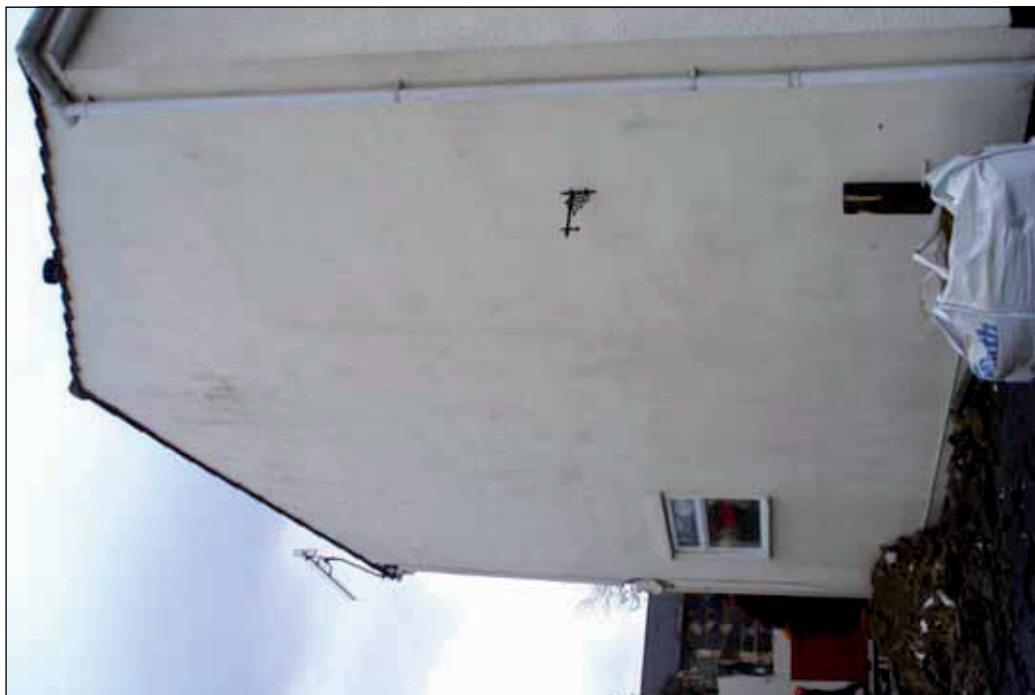
Plate 2: Side elevation

This north-east facing elevation was also completely rendered, and no original features were visible (plate 2). This elevation comprised the side of the original brick-built house and the breeze-block construction extension (being removed at time of visit).

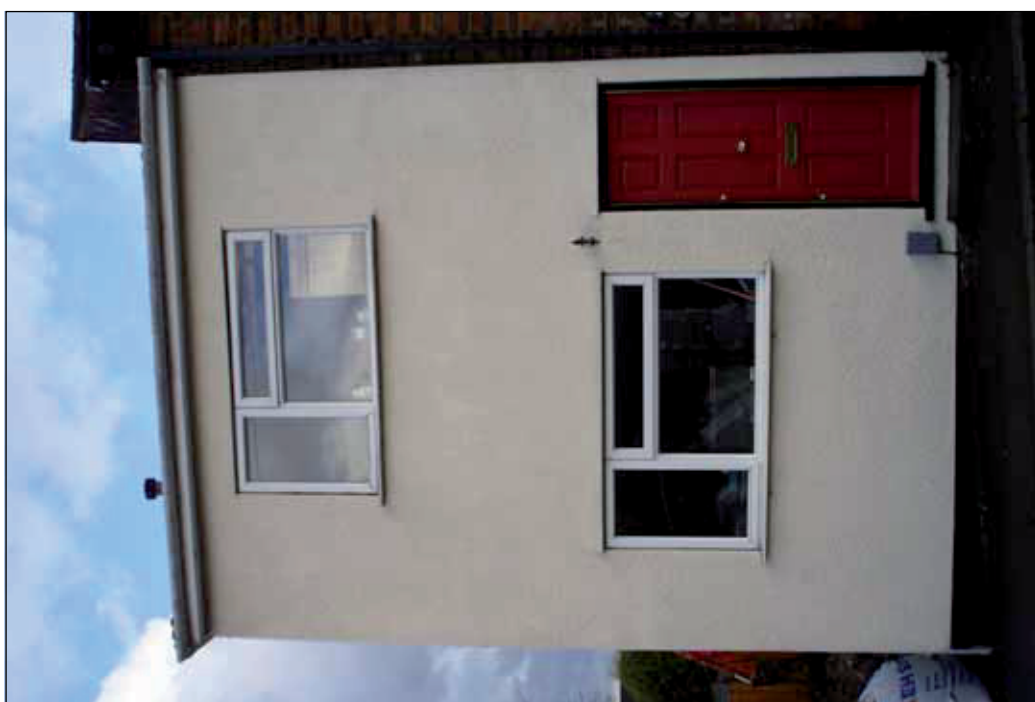
Plate 1: Number 39, Highfield Road

Number 39 Highfield Road was a two-storey building of brick construction under a gently pitched concrete tiled roof (plate 1). The exterior of the property had been completely covered with a creamy-beige, coarse sand render. The property was adjoining number 41 on one side and had a vehicular access/driveway on the other. At the time of the building recording taking place, the modern extension at the rear was being demolished. Within the rest of the property, all plaster had been removed from the walls, leaving the brickwork exposed and the first floor ceiling had been removed, exposing the roof space. The staircase had been re-sited and the ground floor floorboards had been replaced.

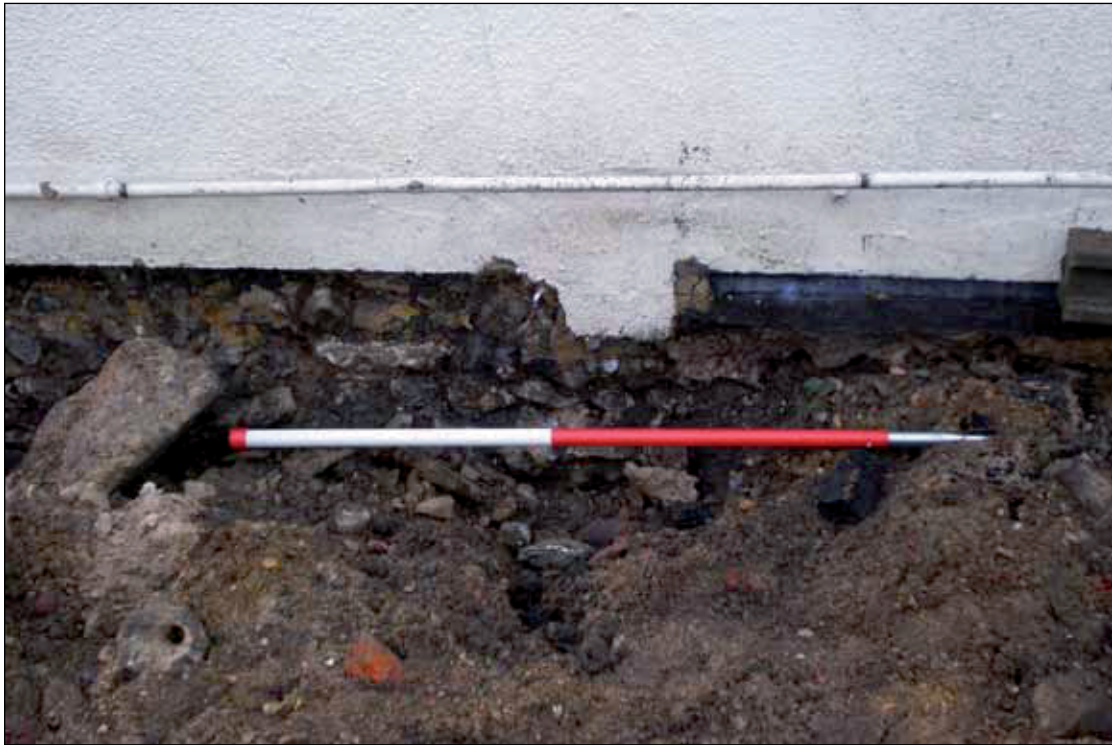
*Plate 3: Flint foundations*

Exploratory groundworks by the developers revealed that the house was constructed on flint foundations. (plate 3)

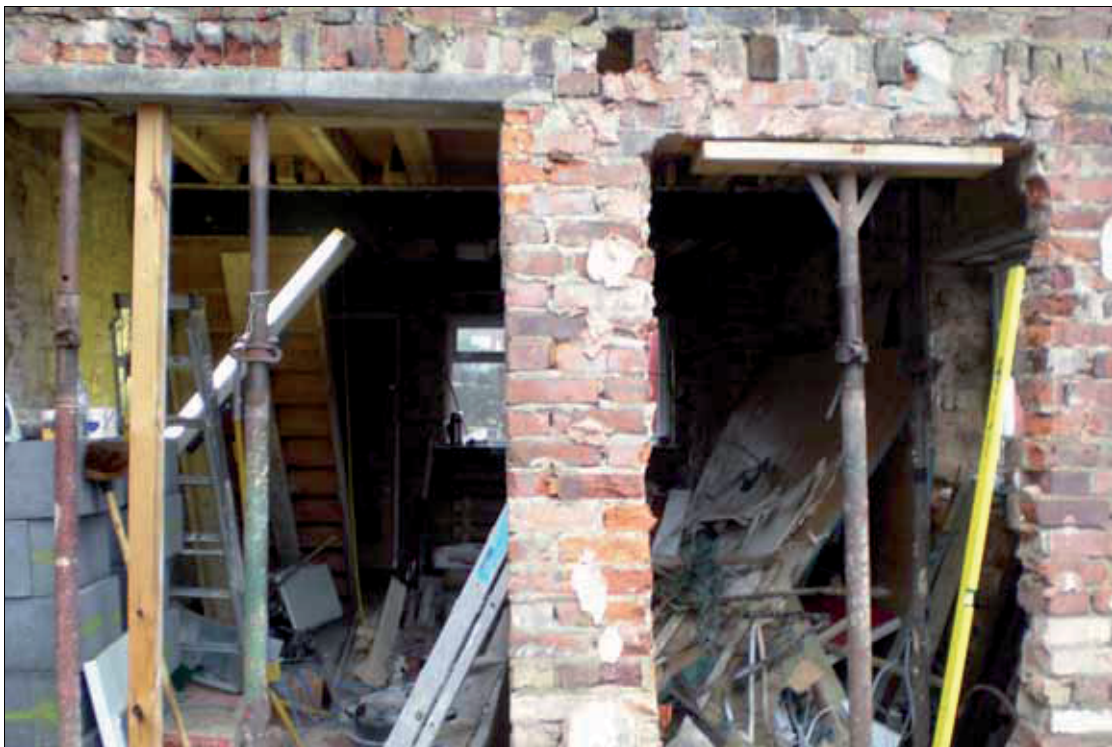
*Plate 4: Rear elevation*

As the breeze-block extension was removed, some of the original fabric of the rear ground floor of the house was revealed (plate 4). The first floor was completely rendered and the ground floor was best viewed and recorded from the inside.

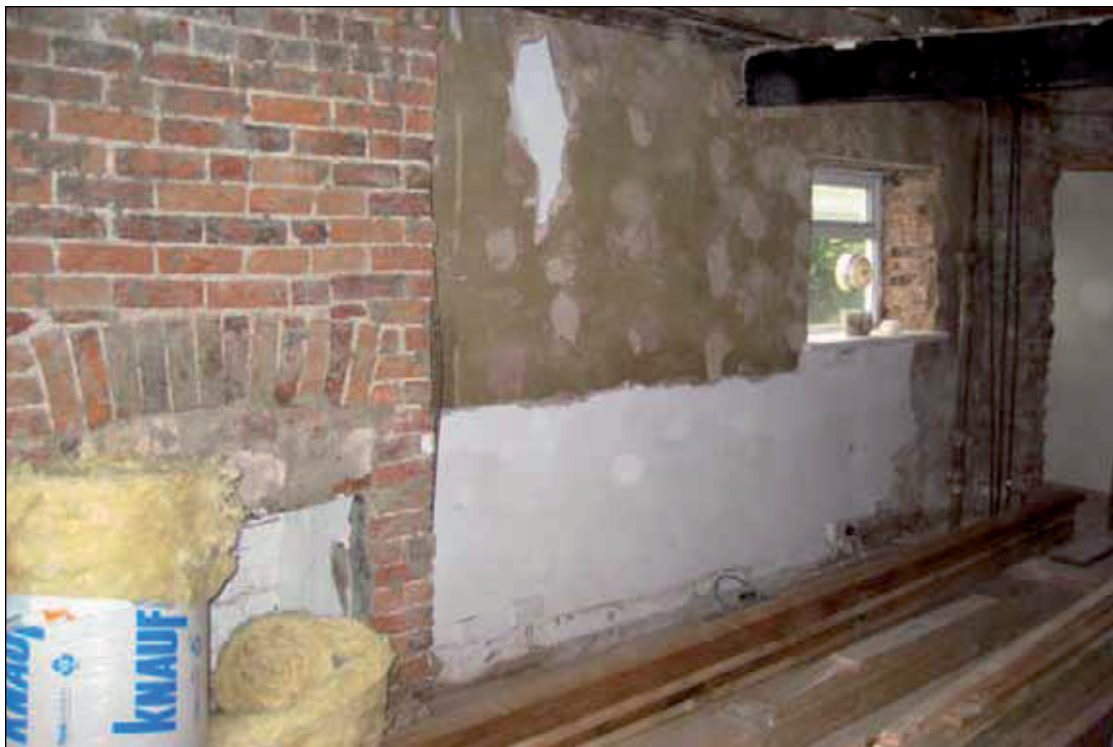
*Plate 8: Fireplace*

Within this wall a chimneybreast and fireplace was recorded (plate 8). This was of brick construction in a mostly stretcher bond with two courses of headers at the top. The brick arch over the opening has been in-filled at some stage, making the opening smaller. Sooting on the inside suggests it has been in use since this alteration occurred. There was no fire surround or grate. The opening measured 0.92m (width) by 0.50m (depth) by 0.60m (height).

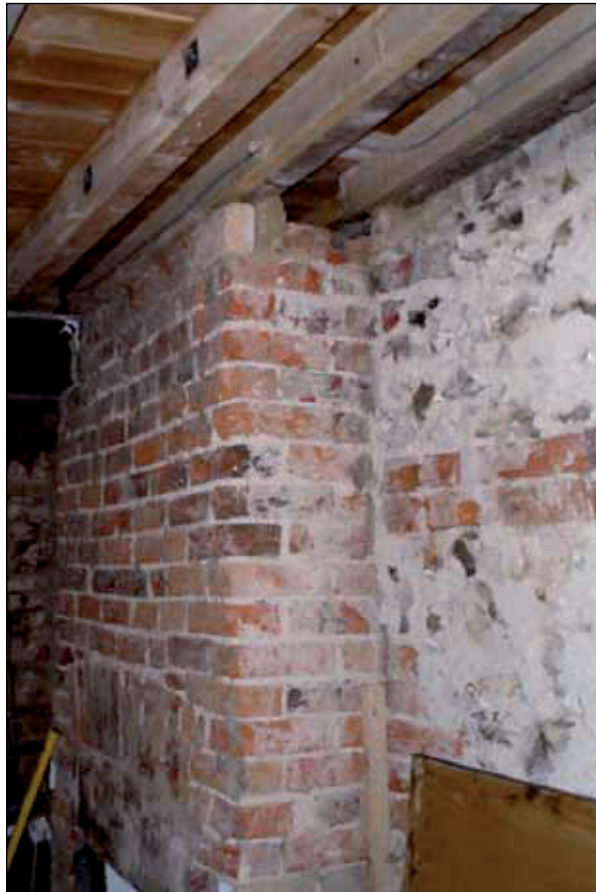
*Plate 9: First floor cutting through chimneybreast*

As part of the recent development, the top of the chimneybreast has been cut through by the replacement of the first floor (plate 9).

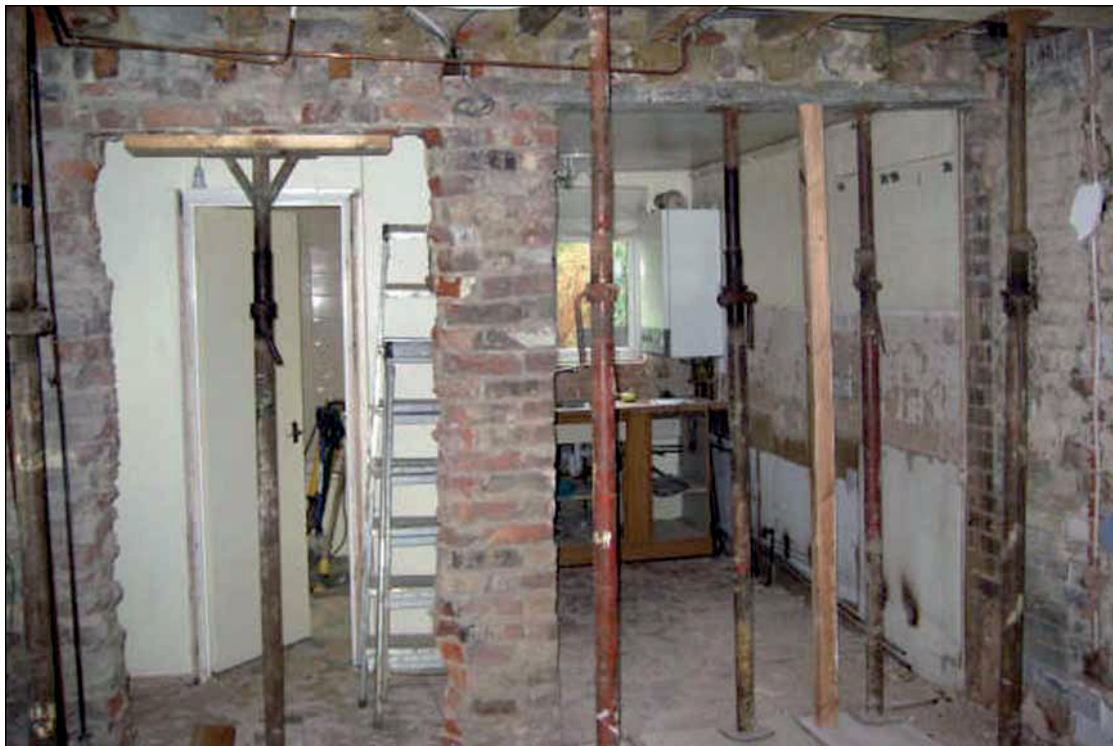
*Plate 10: Rear wall (from inside)*

The downstairs rear wall of the property has undergone substantial alterations during its lifetime. Within this wall two openings were recorded (plate 10). One opening (on the left as viewed from inside) does not appear to be original and was probably created to give access to the bathroom and lobby in the modern extension. The opening on the right however does appear to be original. The brickwork on one side of the opening appears to have been finished to respect an opening. It does appear however, that the opening was widened to the wall to allow access to the modern extension kitchen area and the long lintel was likely to have been inserted at this point.

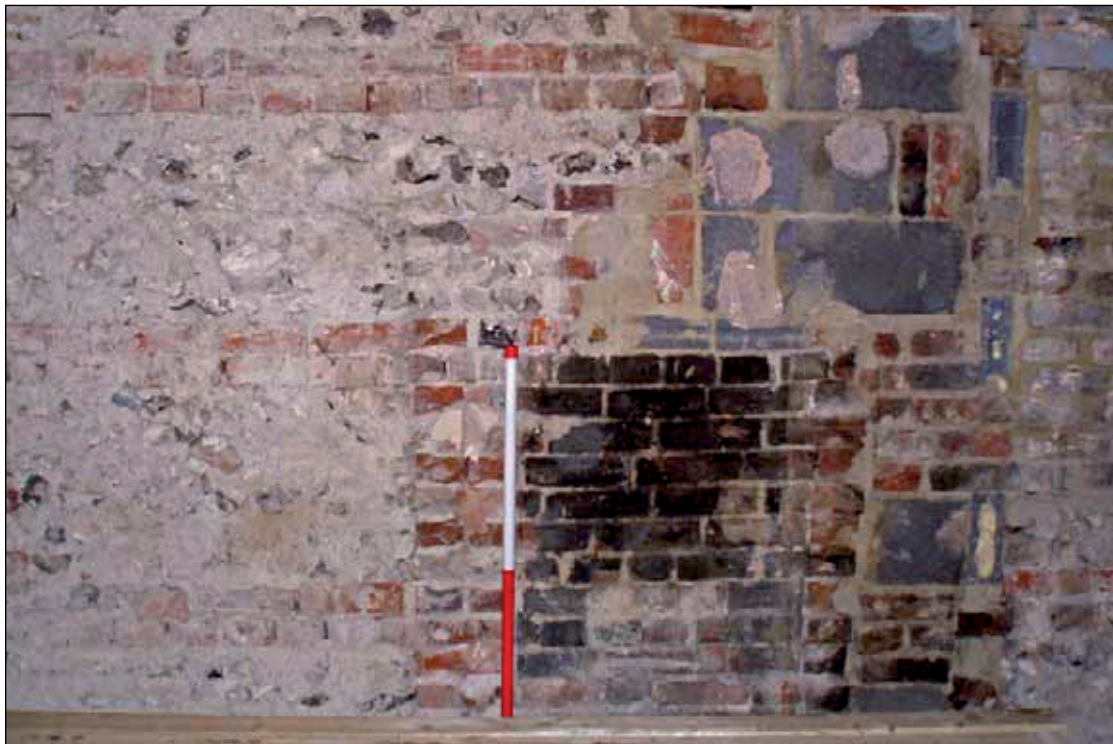
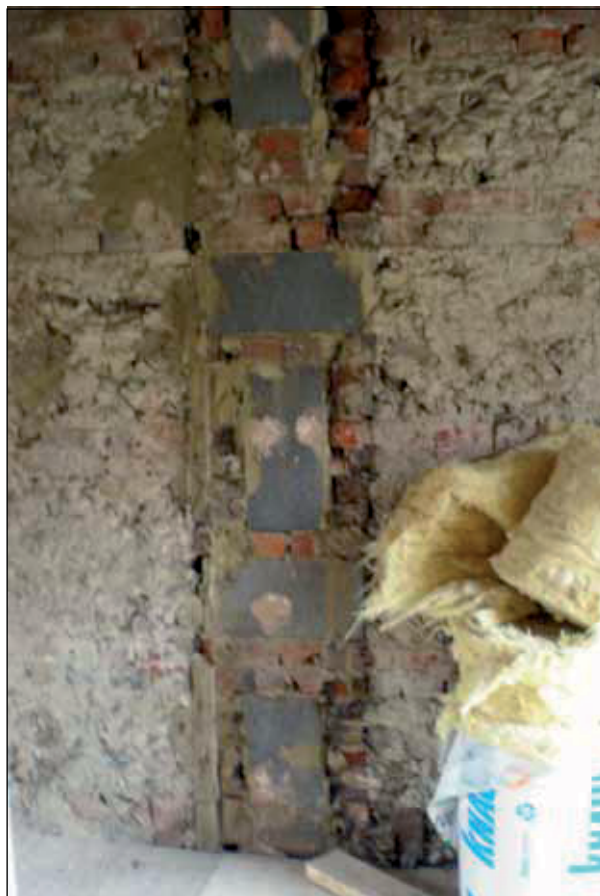
The first floor had been completely gutted and stripped of any partitioning walls fixtures and fittings. It was however possible to record evidence of the location of the original chimney breasts which had been noted on the floor below (plate 11 and Plate 12). Both chimneybreasts had been in-filled with grey breezeblock and reused brick. Sooting on the wall suggests that there was a fireplace on this floor, above the existing one recorded downstairs. The rear one however, shows no evidence of having an upstairs opening.

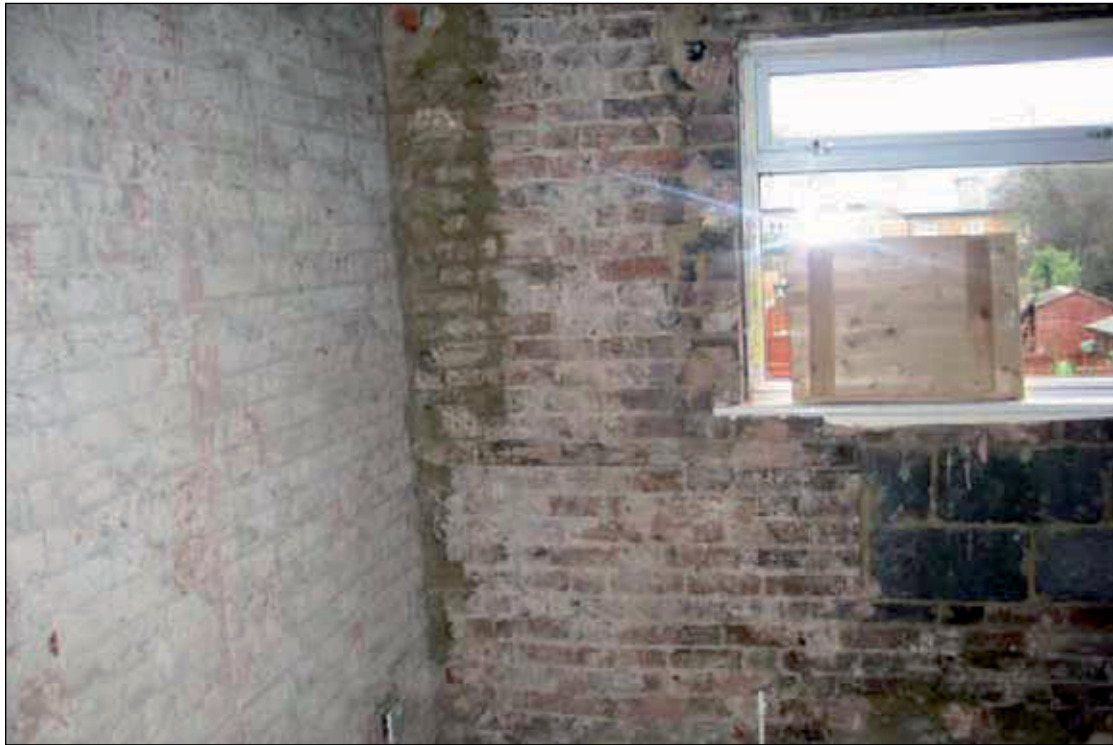
*Plate 13: First floor window, showing location of earlier window below*

Similarly to the ground floor, beneath the window at the front of the house, there is evidence of an opening for an earlier window. (Plate 13) It appears that modern grey breezeblocks and brick have been used to infill the void and repair the area from which the original window was removed; presumably when the current double-glazed window was inserted. The breezeblock and brick repair is evident up to approximately 0.53m below the level of the modern replacement and 0.93cm in width.

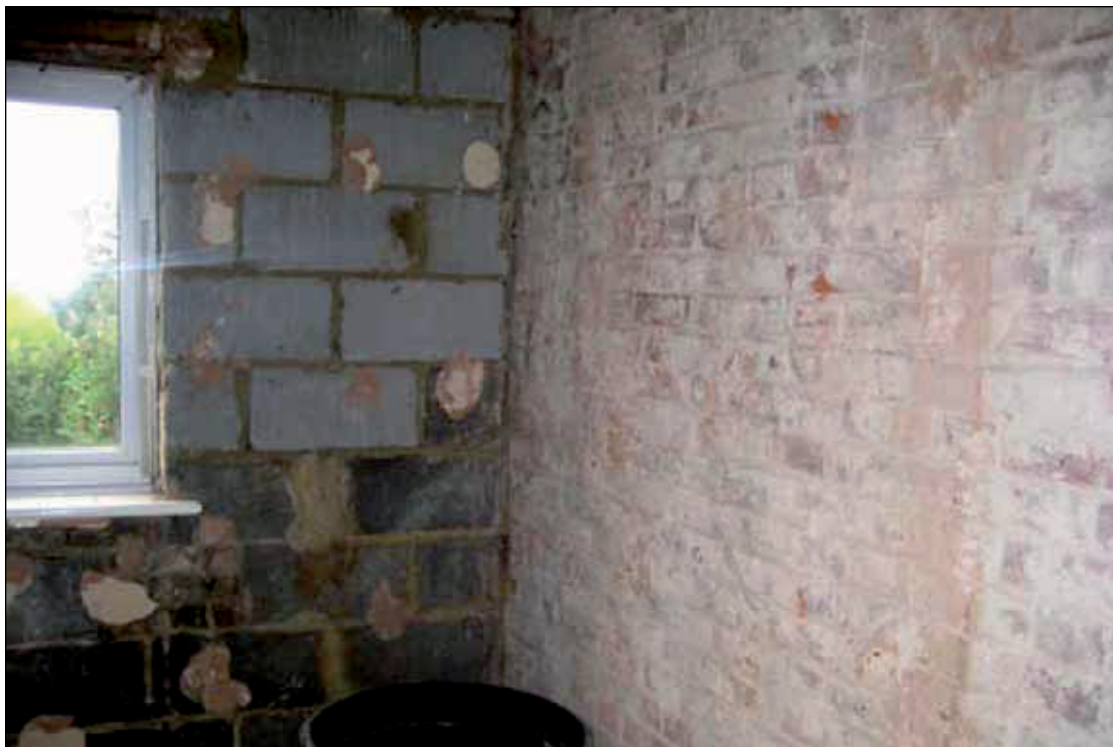
*Plate 14: First floor rear wall from inside*

The rear wall on this floor has been completely replaced and no evidence of the original wall exists. Some early bricks appear to have been reused in the construction of the wall in places (plate 14).

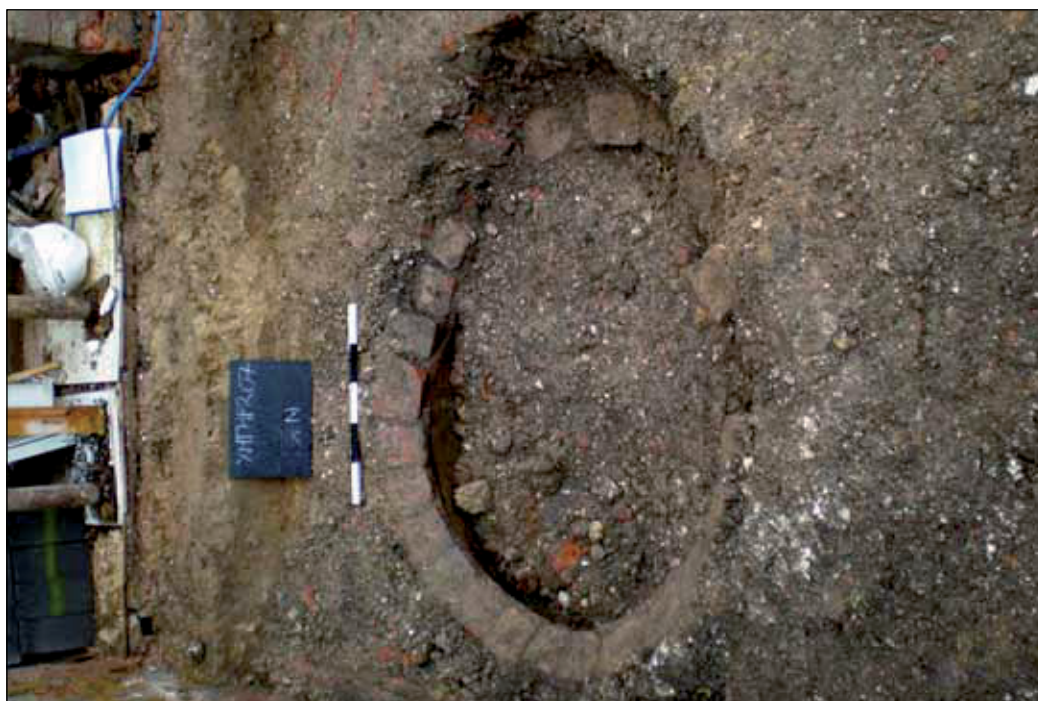
Plate 16: Well

A brick lined well was recorded, located close to the garden wall dividing numbers 39 and 41 (plate 16). This well measured approximately 0.90m in diameter and was lined with a creamy yellow mortar which had been stained black due to the dark deposits within the well. The well was excavated using a mechanical excavator to a depth of over 2.6m, however the base was not found. All material removed from the well was visually scanned; however much of the material which came out was grey roof slate.

in fact a soak-away or associated with the outside building, and not intended to be seen or regularly accessed from above-ground level.

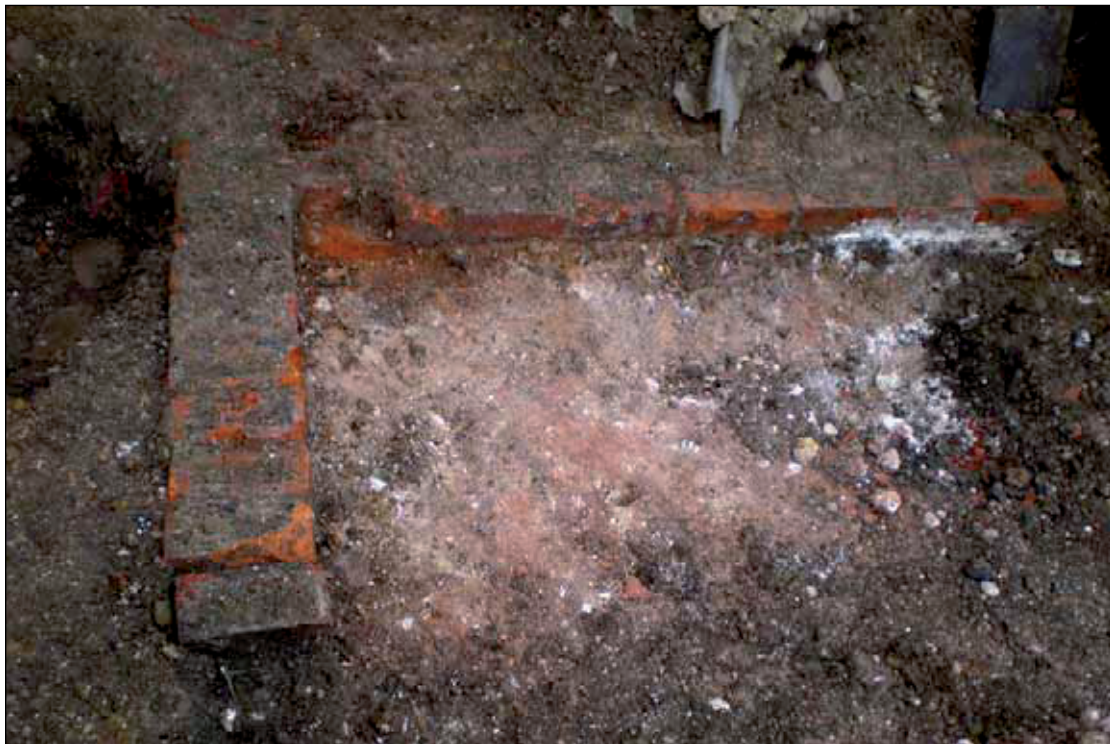
*Plate 17: Brick foundations and mortar*

Two alignments of brick wall foundations were recorded, likely to be contemporary and were at right angles to each other (plate 17). The foundations were at least two courses and the brick used was a bright orange, frogged brick, measuring approximately 22cm x 10.5cm x 6.5cm. The bricks were bonded using a white, creamy sandy mortar with small crushed flint and gravel inclusions. The alignments of the walls respected the alignments of the existing building and may represent a part, which has been demolished.

There was evidence of a possible floor surface within the area enclosed by the brick walls (plate 17). A light pink and white mortar was recorded within part of the enclosed area and may have extended further had excavation been possible. This layer is likely to represent a mortar to support a floor surface, possibly made of tile. A number of broken red quarry floor tiles were observed during machining, but not retained and may have come from an earlier tiled floor of this outbuilding.

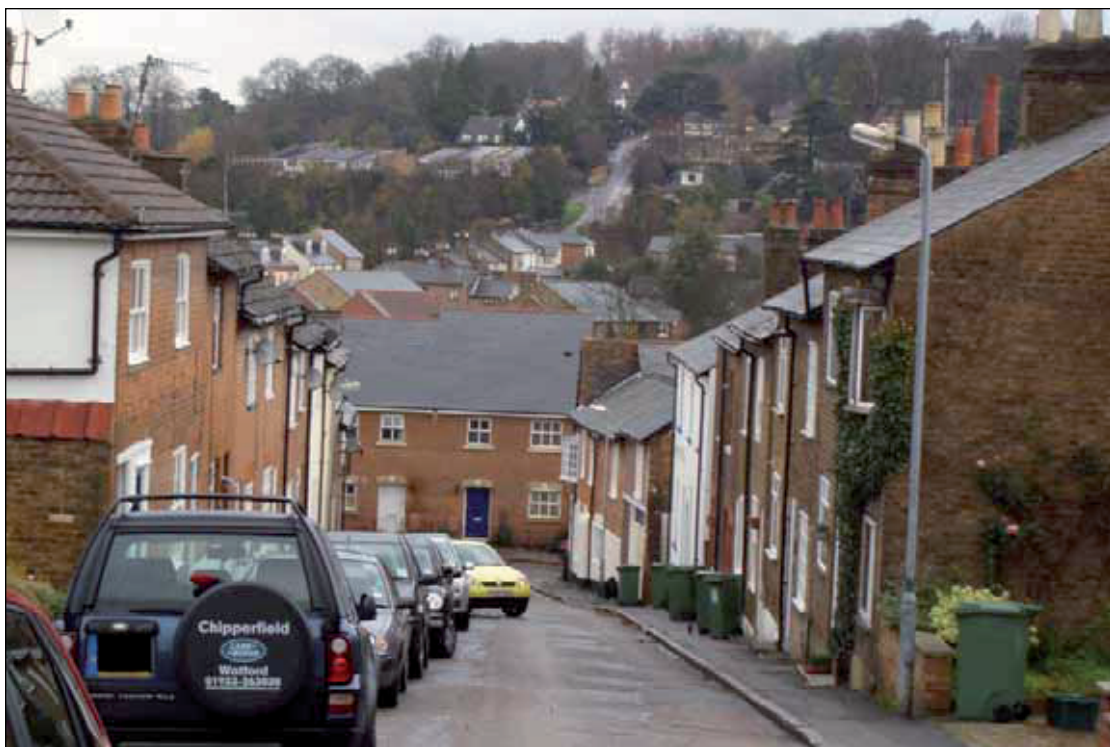
*Plate 18: Highfield Road, looking downhill*

Despite the complete replacement of the roof and original timbers, it is likely that the original property had a slate roof. Most of the houses within Highfield Road still retain the original grey slate roofs and this would have been a commonly used material for properties of the mid-late 19th century (plate 18). Excavation of the well at the rear of the house produced a significant quantity of grey slate and it could be suggested that when the roof was replaced, much of the original material was discarded into the well.

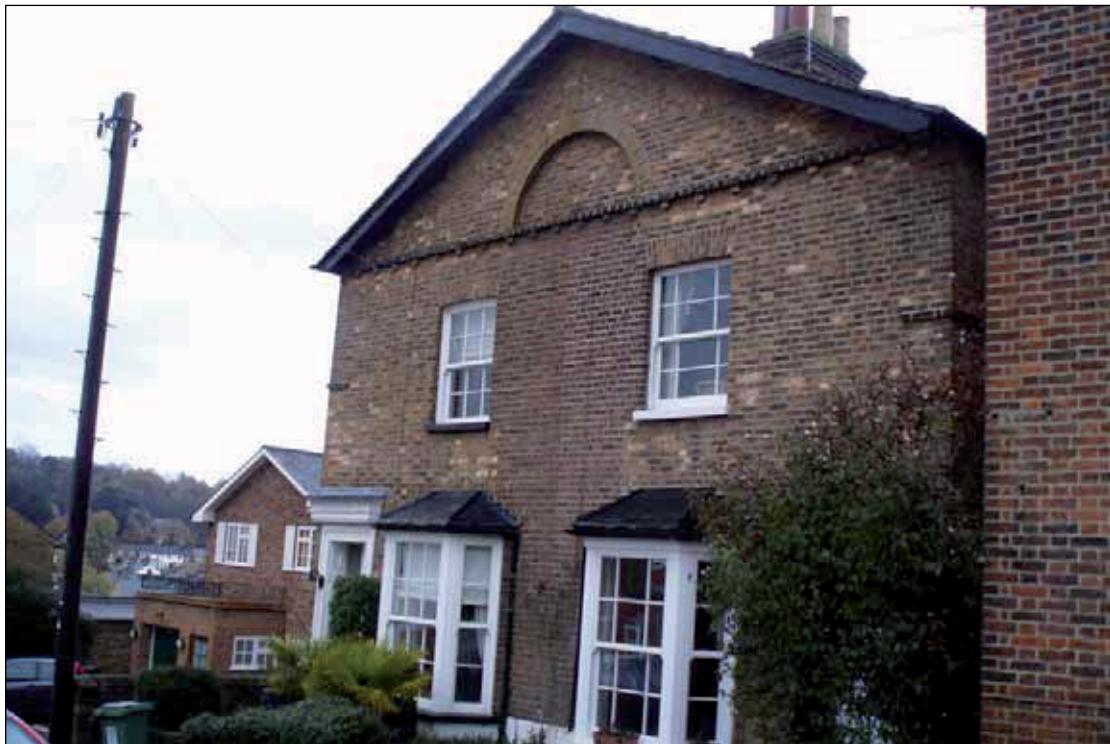
*Plate 19: Former Wesleyan Chapel*

The architectural styles of properties in Highfield Road vary greatly, most appear to date to the early-mid 19th century and post second world war. The Wesleyan Chapel (plate 19) (see historical background) dates to 1854 and may be one of the earliest surviving buildings on the road. Numbers 33 and 35 (plate 20) also appear to be earlier in date than most of the other terraced properties on the road. The double-hung sash windows at number 33 are original and are found in many houses built during the 19th and early 20th century. The row of terraces to the right of the study area appears to be contemporary in date (plate 21 and 22). They are all built using the same brick type and all in a Flemish bond. The detail recorded within number 39 suggests that it is later than the others on the row, however, probably only by a few years.
