**CAM ARC Report Number 1002**

# Hampden House, Temple Place, Huntingdon

### **Desk Based Assessment**

Site Code: HUN HAH 08 Date of works: 21<sup>ST</sup> Jan 2008 Grid Ref: TL 2436 7172

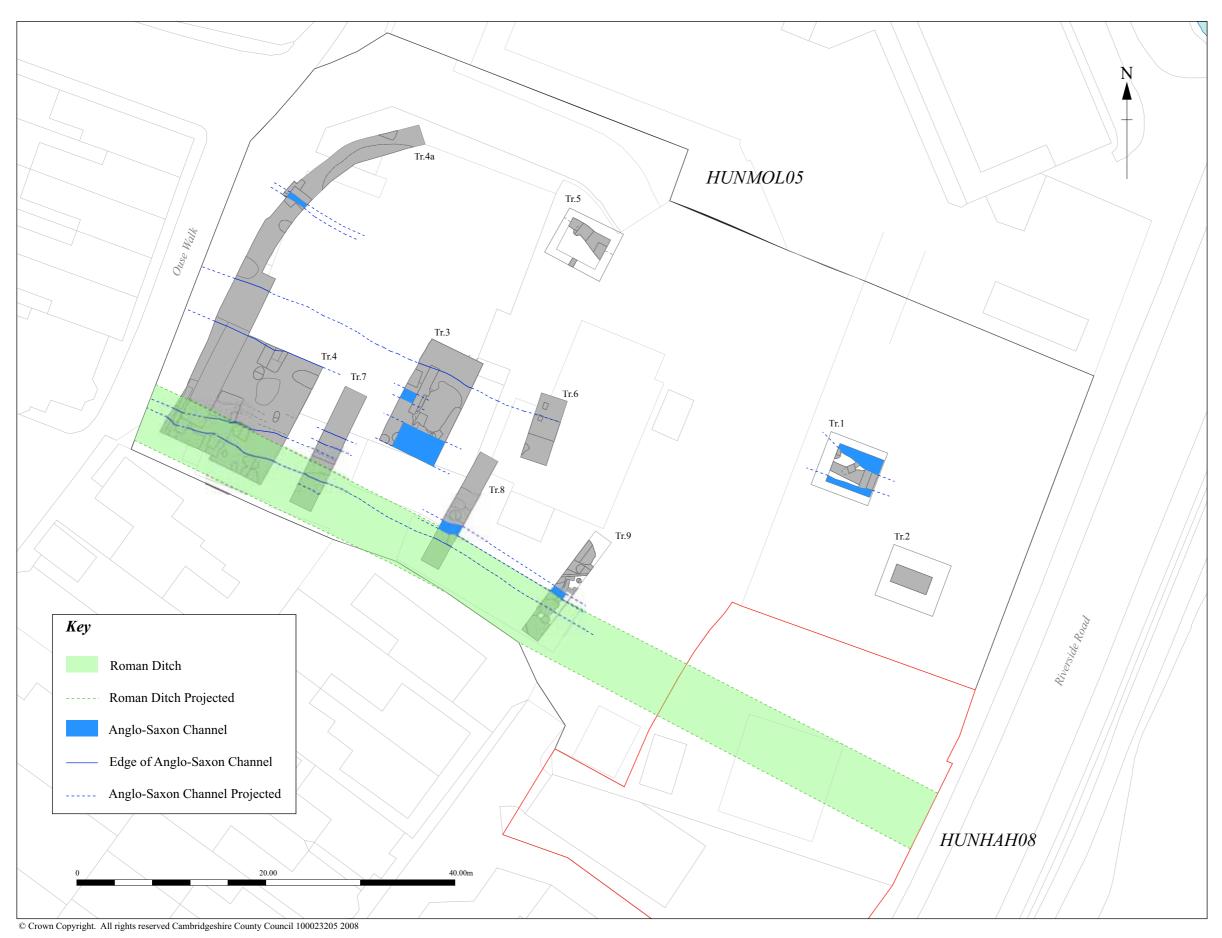
Figure 4: Continuation of ditch and channels from previous excavation HUNMOL05

The adjacent site at the former model laundry (CHER MCB 17084) revealed little in the way of early Saxon occupation, just a few sherds of pottery, however it did reveal a significant amount of late Saxon activity. A series of ditches or channels were identified across the site. The channels appeared to have been partially deliberately in-filled and partly filled through natural processes i.e. flooding and silting. When a channel was in-filled a new channel was cut in a progressively northerly direction. The main channels ran roughly northwest to southeast for at least 40m from the western edge of the site and a probable terminal or entrance was seen at the western edge of the site in trench 9. The eastern trench, trench 2, revealed no continuation of the channels suggesting they may be located further to the southeast beneath the gardens of the adjacent house (Fig 4).

The channels possibly represent a significant boundary between habitable land on the higher ground to the south and more marginal floodplain to the north. The deliberate infilling and movement northwards of the channels could be to increase the area of dry land in this marginal location, as pressure on the land increased, perhaps due to population growth in the Danish settlement to the south and west (Clarke 2005).
