CAM ARC Report Number 1028

An Historic Building Survey at The Old Railway Station, Stoke Ferry, Norfolk

Building Survey

June 2008

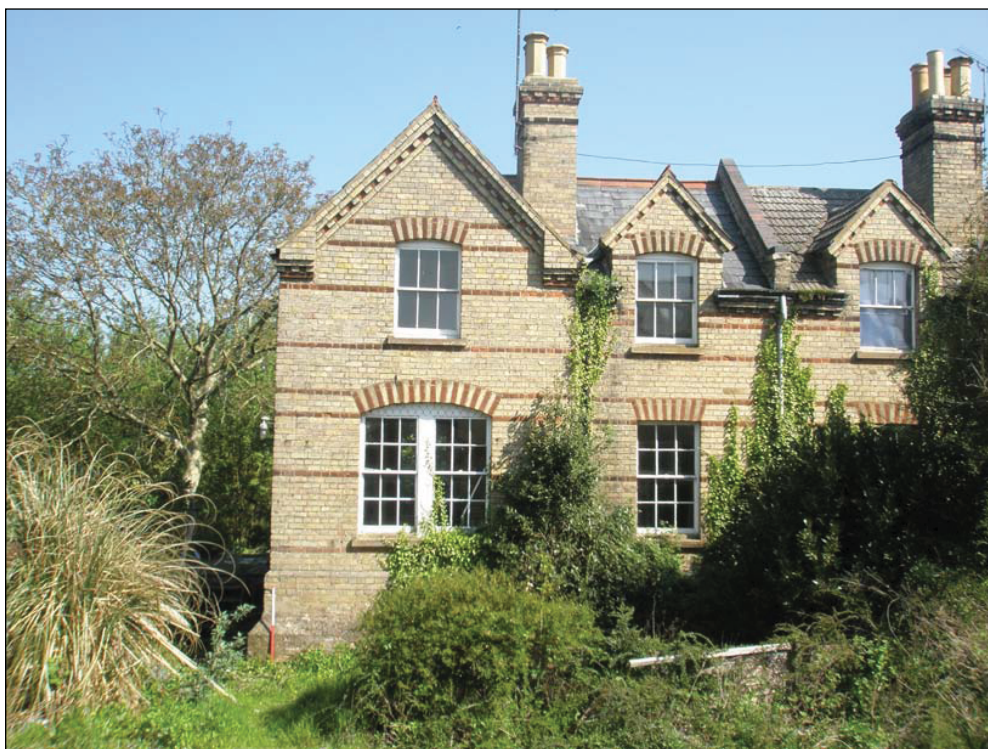
Buildings A (*Plate 1*) and B (*Plate 2*) are semi-detached cottages to the north of the station building. The cottages are two storeys high, with the second storey occupying the roof space, the roof taking the form of two gabled roofs joined by a central intersection (forming an “H” shape) in which are constructed two gabled dormer windows – one for each cottage. The wall between the cottages extends up and is topped by a course of black/red bricks, traversing the roofs of each cottage. Unlike the other buildings on the site, Building B has been tiled with grey (possibly ceramic) tiles and ridge tiles.

Plate 1: South facing elevation of Building A

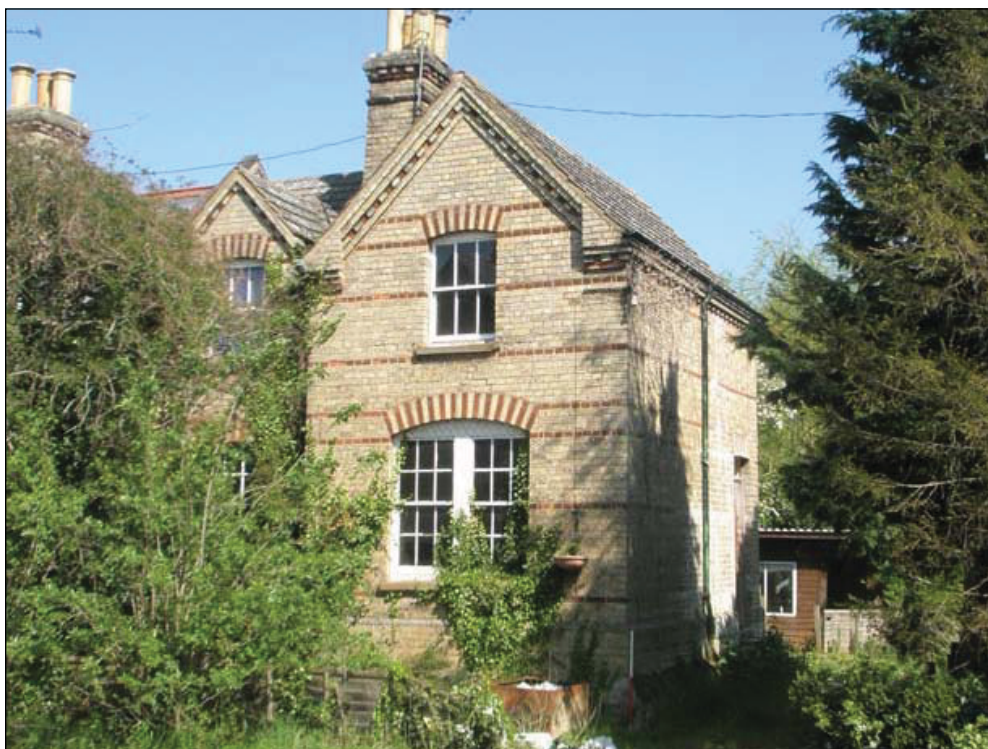
Unlike the other buildings, Building B has been roofed with grey tiles (possibly ceramic) and plain ridge tiles. Another point of decorative interest is the “fish scale” woodwork occupying the segmental arch above the largest lower floor south facing window of both building A and B (*Plate 5*). The buildings also retain most of their Queen Anne Revival style double-hung sash windows (Hall, 2005, 81).

Plate 2: South and east facing elevations of Building B

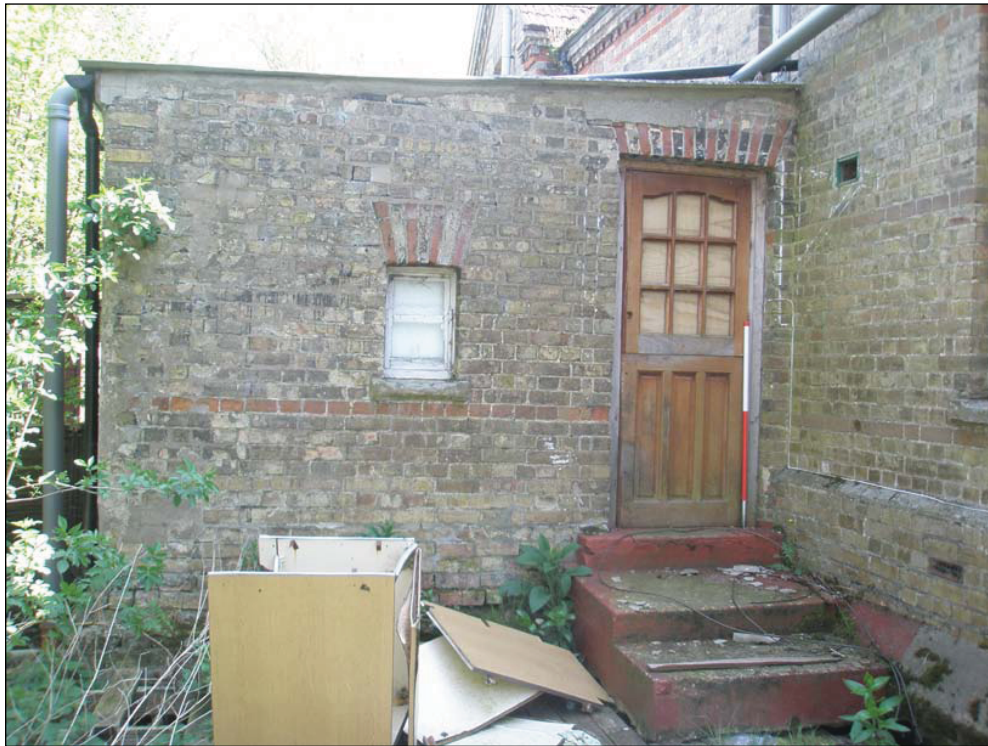
Both cottages have single storey extensions to the rear that look roughly contemporary with the building of the cottages. The extension to Building A has a flat roof that inclines towards the house and displays some of the architectural features as the other buildings (*Plate 3*). The extension to Building B is slightly bigger than that to Building A, it has a flat roof and again displays some of the architectural features seen on the other buildings, although the window is modern, having either been inserted or enlarged in recent times (*Plate 4*).

Plate 3: Extension (west facing elevation) to Building A

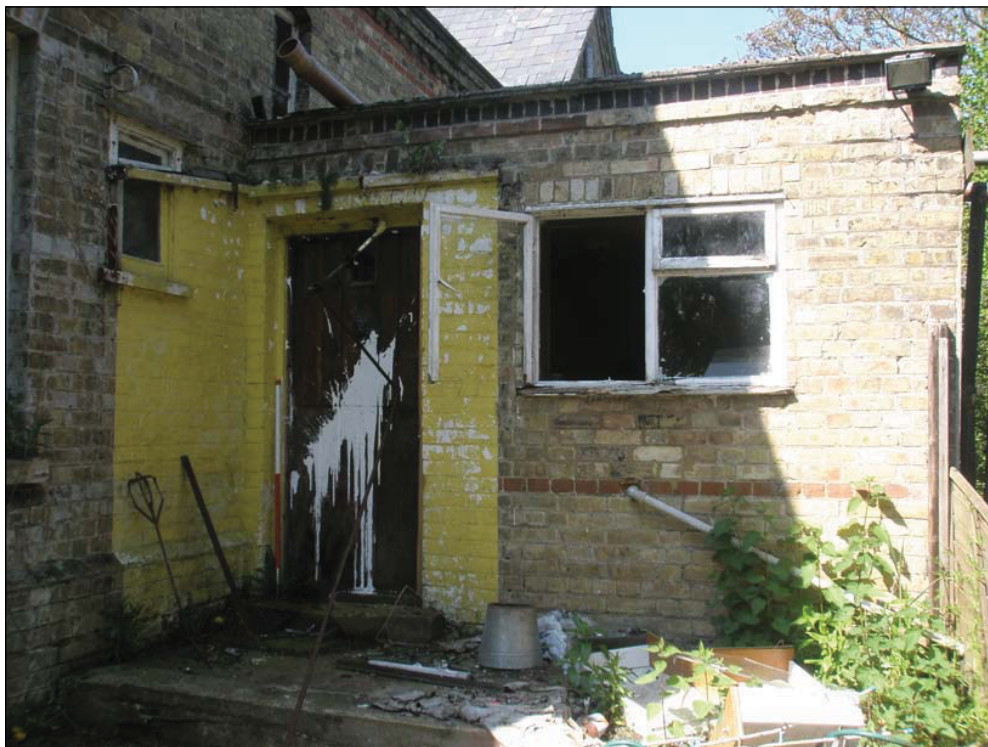
Plate 4: Extension (east facing elevation) to Building B

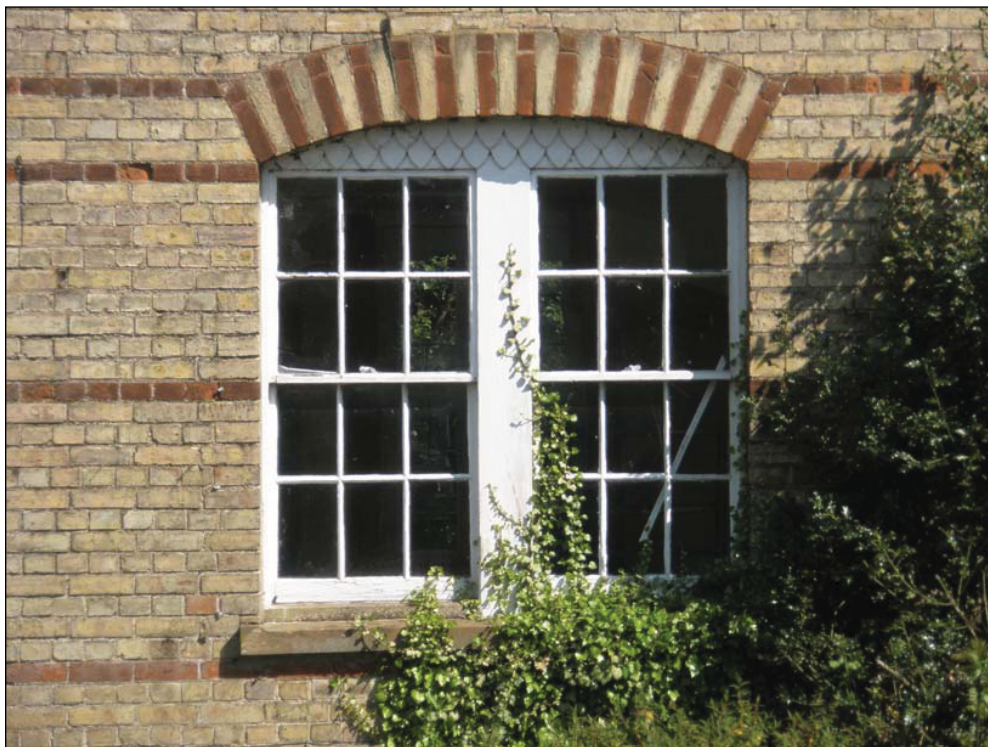
Plate 5: Detail of Large lower floor window, Building A

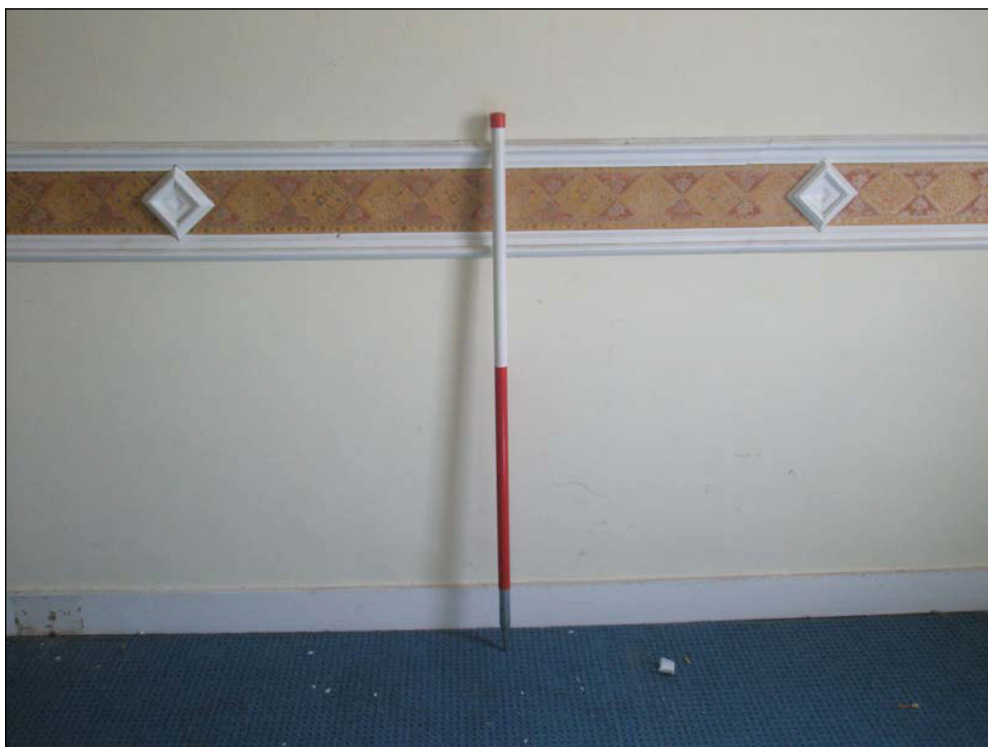
Entrance to Building A was possible, revealing several original features, including a decorative dado rail in one (*Plate 6*) and Victorian fireplaces (*Plate 7*) in both upstairs rooms. Damage to the floor enabled the lower construction of the cottage to be viewed – the arches used to give stability to the structure mentioned above (*Plate 8*). Entrance to Building B was not possible due to vandalism. It is likely from inspection that both buildings have only ever been used for accommodation.

Plate 6: Dado rail in upper floor room of Building A

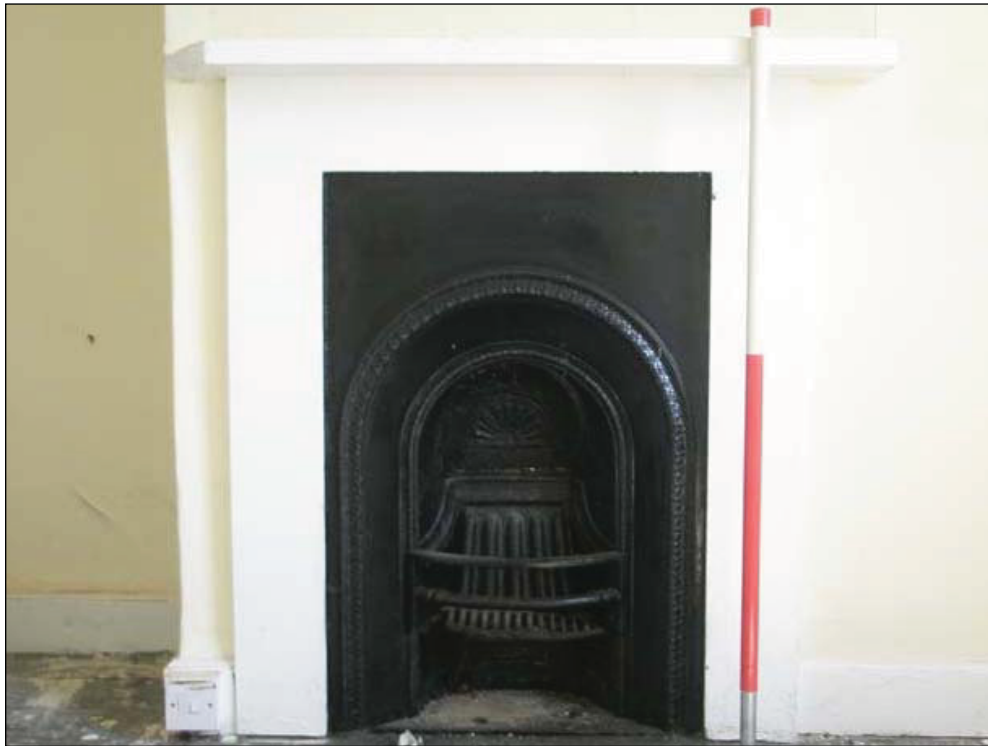
Plate 7: Fireplace in upper room of Building A

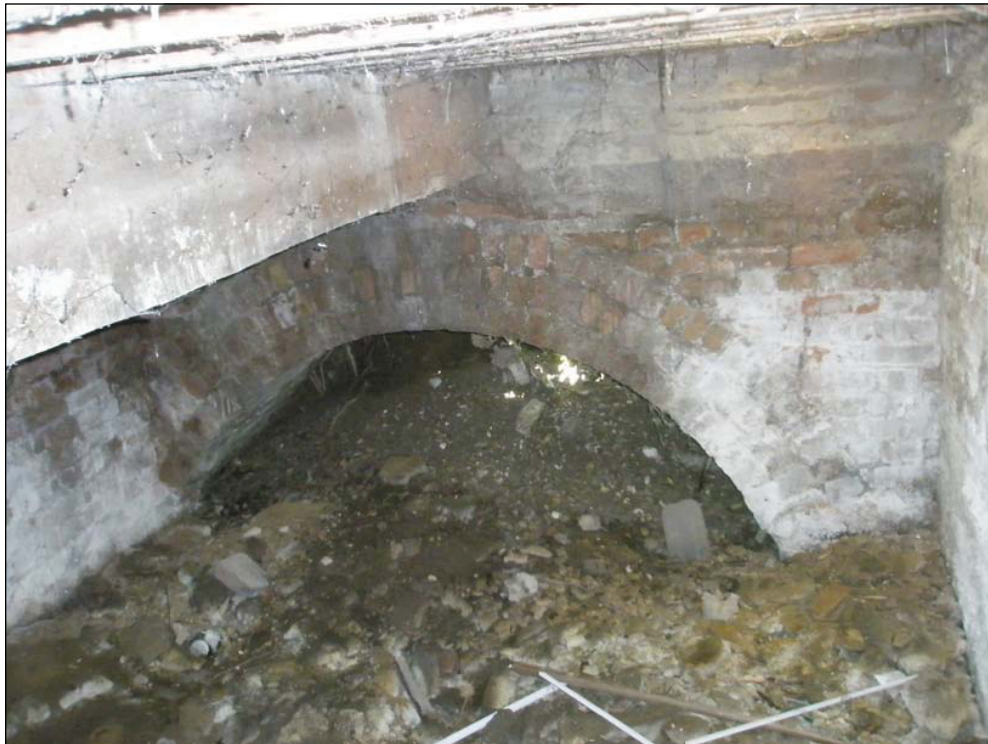
Plate 8: View under lower floor of Building A

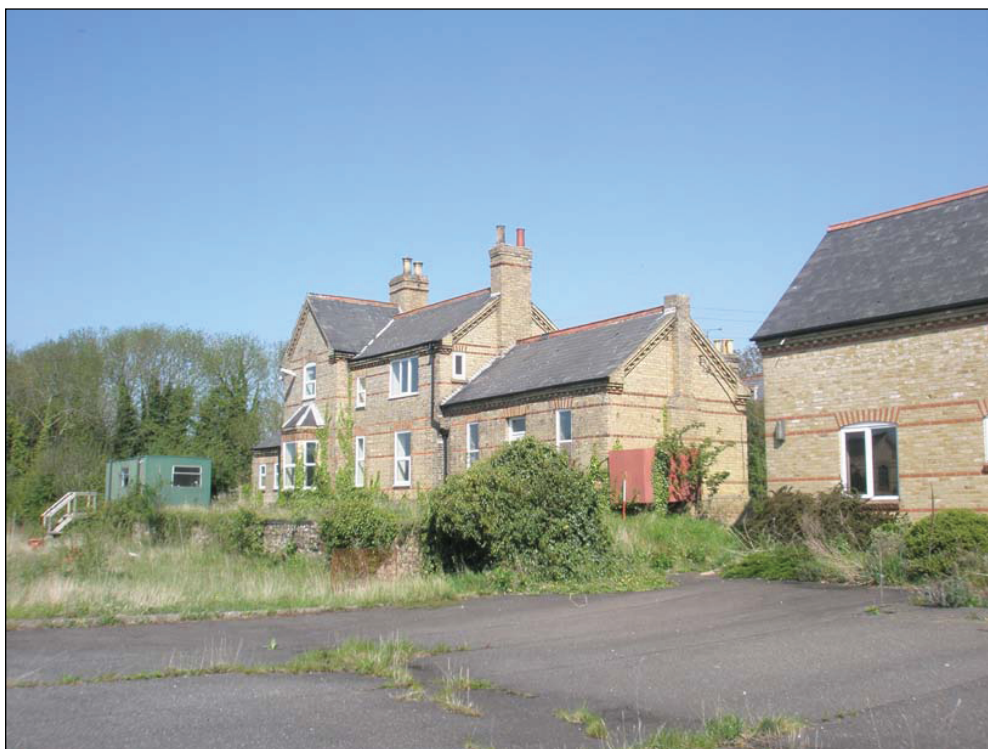
Building C (*Plate 9*) was the station building, which again incorporates the architectural details mentioned at the beginning of this section of the report. The roof is gabled at single storey levels, with an unequal gabled T-plan roof to the second storey section (*Plate 10*). There is a single storey hip-roofed bay window on the south side of the building, extending onto the platform.

All windows and doors have been replaced with modern double glazed/PVC windows. A large window has been inserted on the east of the south side of the second storey between 1955 (Brodribb, 2000, 178) and 1959 (Adderson and Kenworthy, 2000, plate 47).

The only other structure relating to the sites use as a railway station is that of the platform (*Plate 9*), much of which remains in-situ. The remaining structure is 77.3m long; meaning approximately 1/6th of it has been removed. Although obscured by plant growth, the structural arches mentioned above are again visible (*Plate 25*). This structure extends approximately 12m west of the development area, sloping down to ground level over approximately the last 4m (*Plate 26*).

Plate 9: South and east facing elevations of Building C

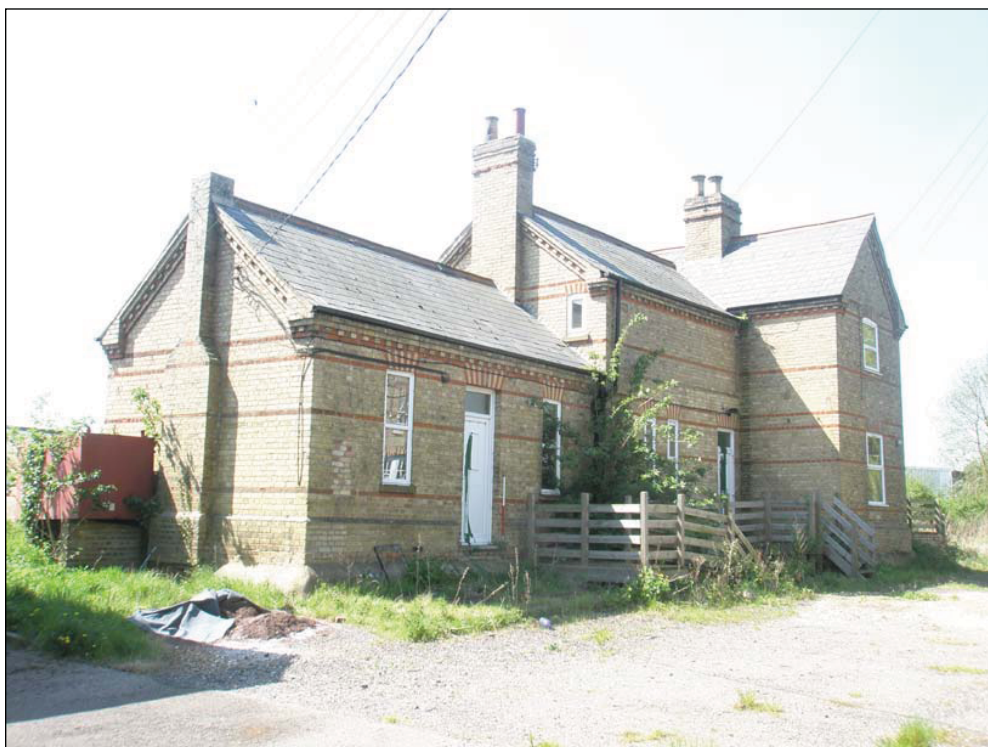
Several repairs/alterations have been made to this building, and are visible in the brickwork. The majority of these have occurred to the single storey section at the west end and to the lower storey of the west facing elevation of the central section (*Plate 11*). These include the blocking of a window, some reconstruction (indicated by the brightness of the white brick) and some rendering. There is also a small section of wall extending from the building to the west, indicating there was a previous structure in this location, possibly a place to store coal for the engines – this roofless structure and possibly an extension to the north of this west wing of the building are visible in a photograph taken in 1959 by R. M. Casserley (Paye, 1982, 31). There is a small opening with a wooden door hinged on two round-ended strap hinges on the west facing elevation (*Plate 12*). These date to the late 19th Century (Hall, 2005, 52) and so are probably contemporary to the construction of the building. One alteration, of which there is now only documentary evidence, is that this building once had two canopies that were removed during world war one. One extended south, the other north from the east end of the station building (Paye, 1982, 79).

Plate 10: East and north facing elevations of Building C

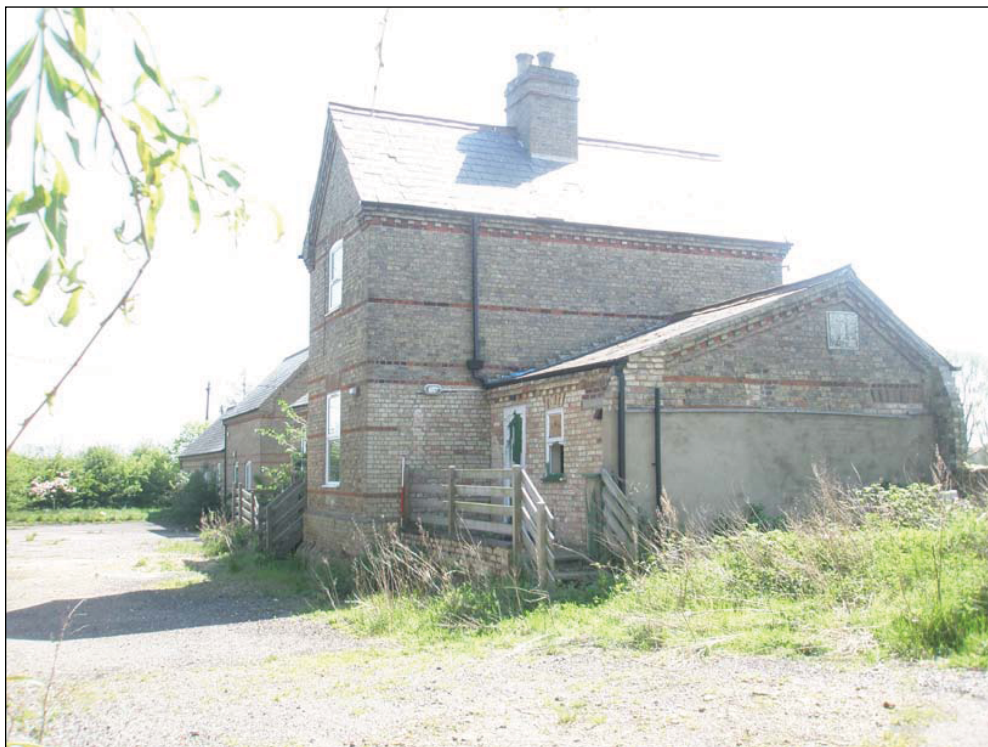
Plate 11: West and north facing elevations of Building C

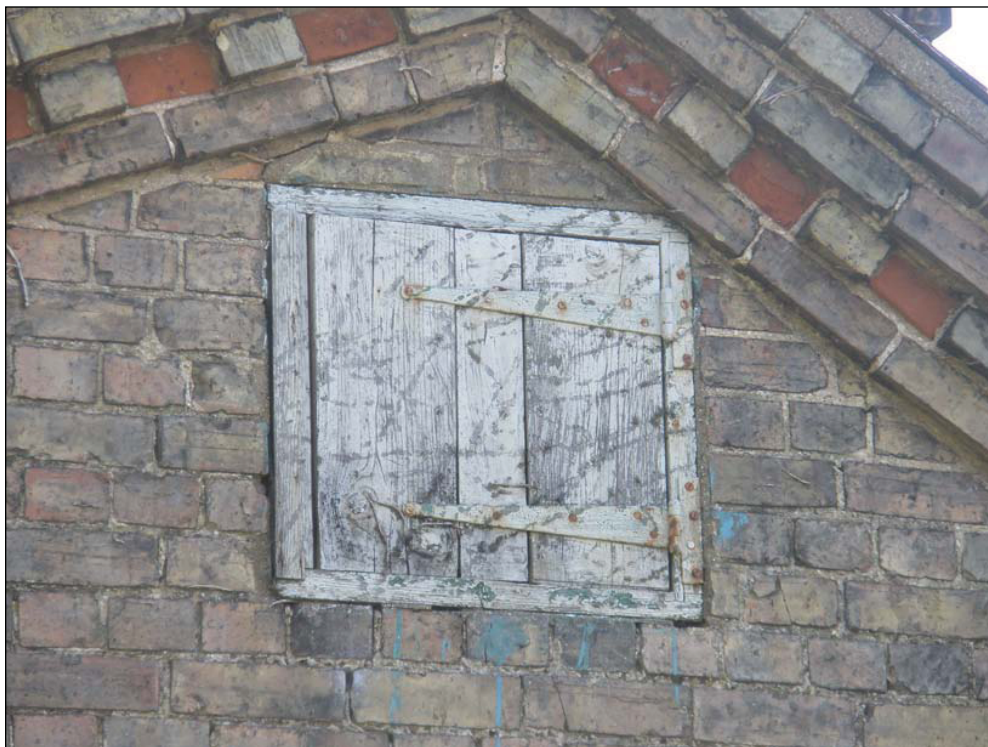
Plate 12: Detail of hatch in west elevation of Building C

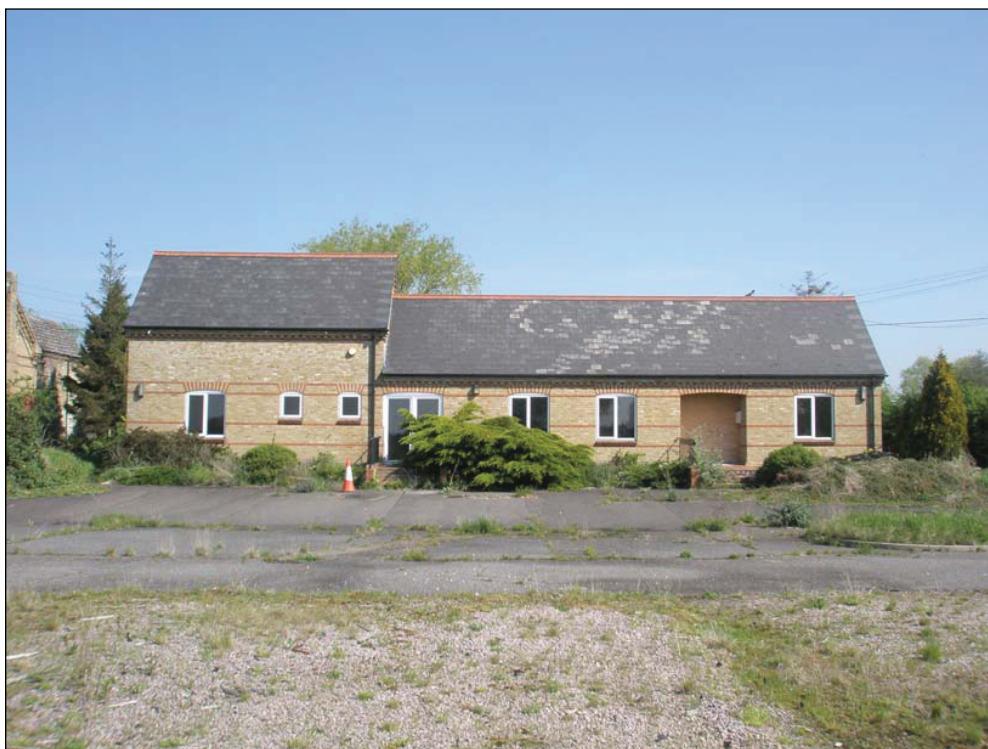
Building D (*Plate 13*) is situated directly east of the station building. The west end of this building (approximately 1/3 of the building) extends higher than the rest of the building, but there are only ground floor windows, indicating the whole building could be a single storey. The building is modern, having been sympathetically built using the architectural features seen on the original buildings on the site. The building has been used for offices, which is probably the purpose of its construction.

Plate 13: South facing elevation of Building D

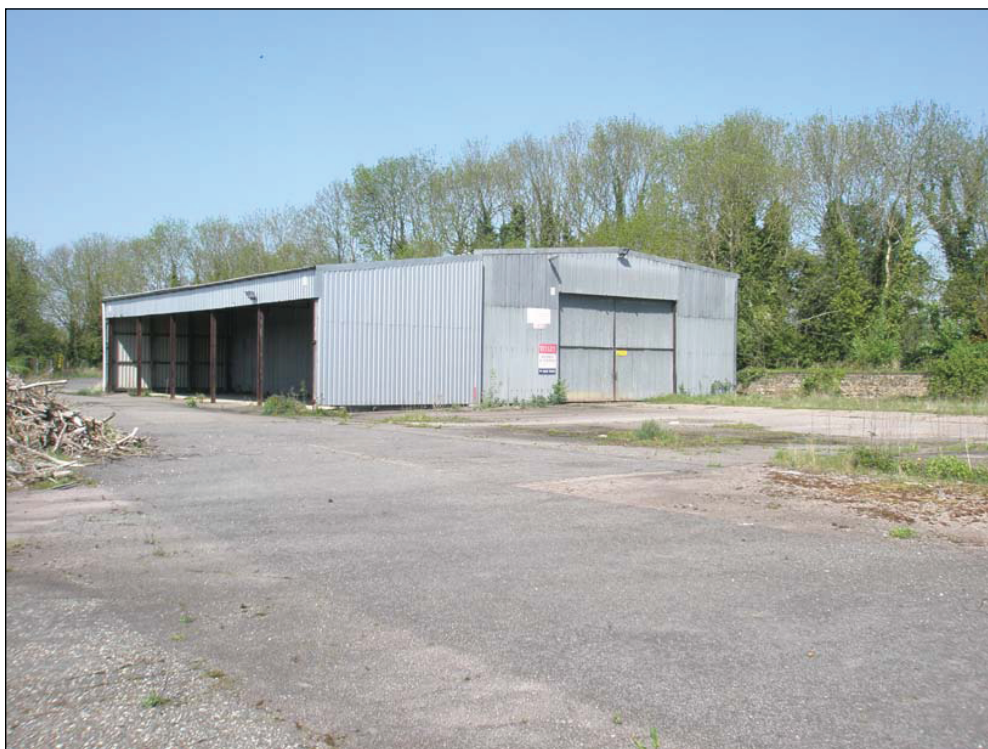
Building E (*Plate 14*) is not located in the development area, but is considered here to enable all the buildings on site to be analysed together. The building is a large steel framed storage unit, which relates to the use of the site as a timber yard, and so has been constructed in recent times.

Plate 14: South and east facing elevations of Building E

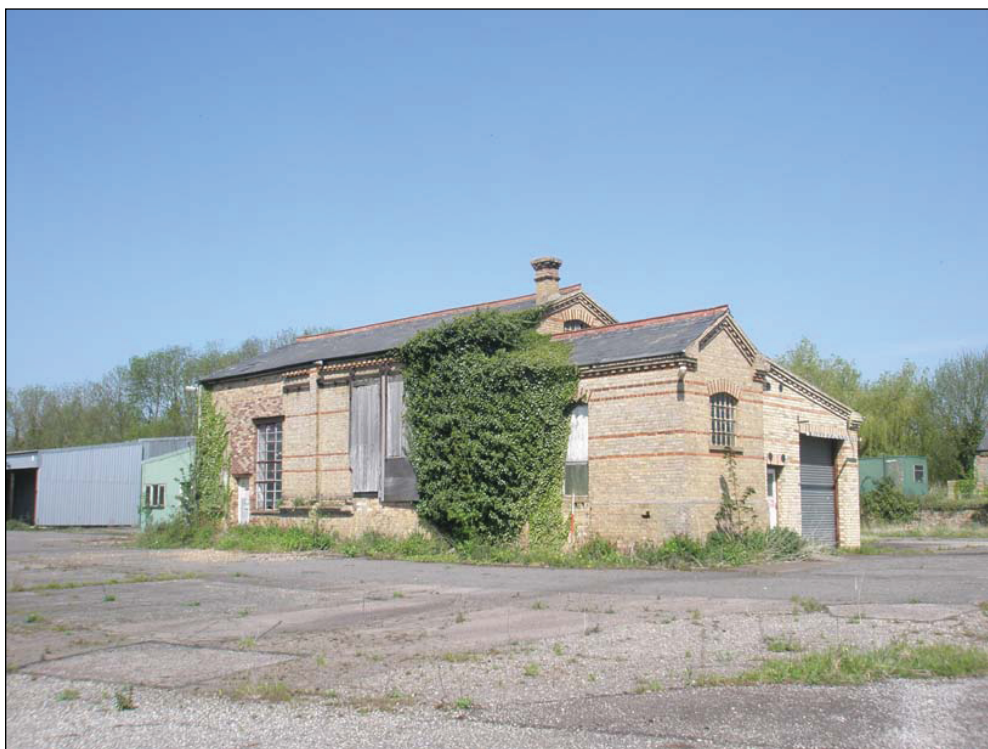
Situated to the south of the station building, Building F (*Plate 15*) was originally the goods shed and since the dissolution of the Stoke Ferry Branch this building has, until very recently, been used as a workshop for the processing of timber. The building has been extended – probably when it was converted into a workshop – to encompass the north-east corner where previously the track emerged from the goods

Plate 15: South and east facing elevations of Building F

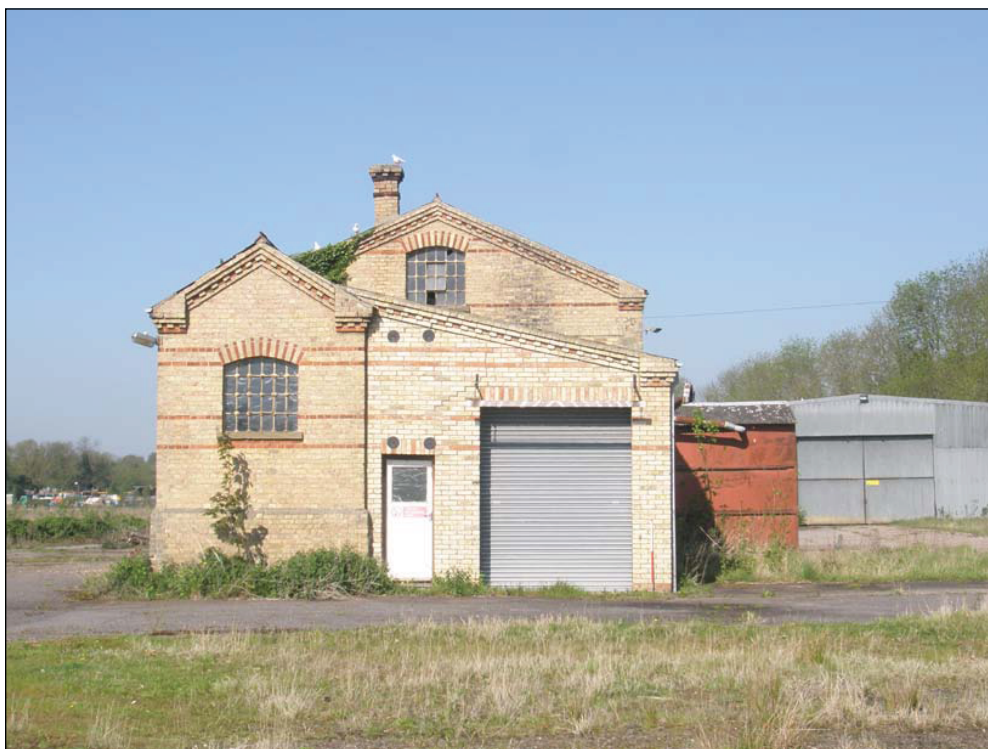
shed (*Plate 16*). This extension has been designed sympathetically, and could have been carried out at the same time as the construction of the office building (Building D).

Plate 16: East facing elevation of Building F

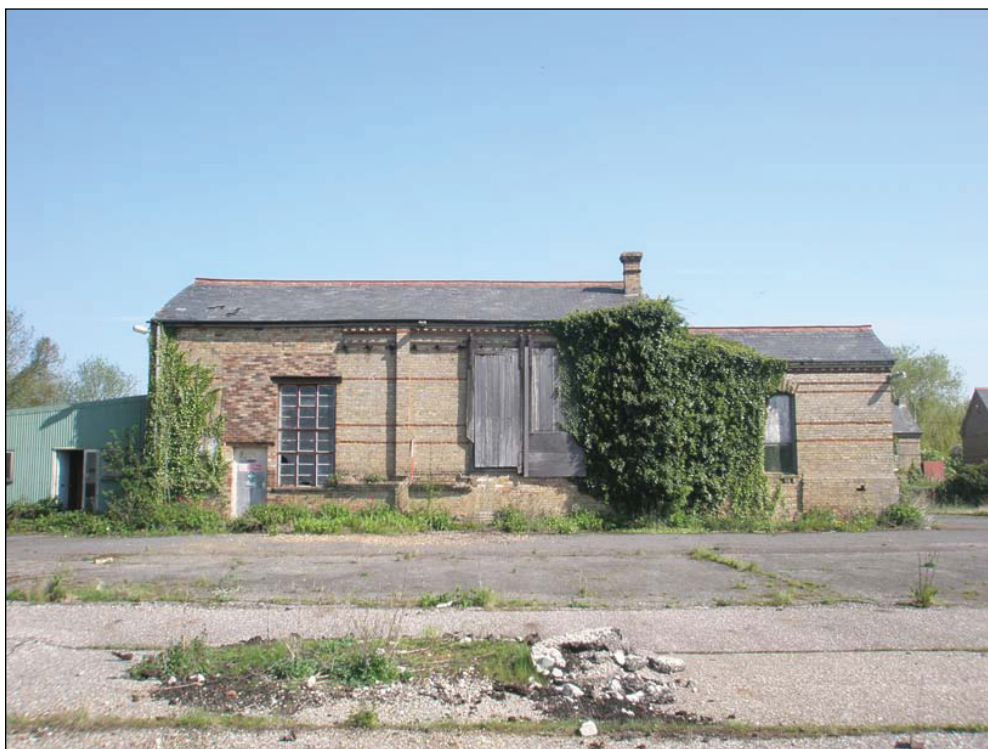
On the south facing elevation (*Plate 17*) a pair of large original wooden sliding doors survive (*Plate 18*), making it possible for goods to be unloaded through these at the correct height of the carriages. A similar sized opening has been bricked up to the west of this one (*Plate 19*), indicating that there would probably have been two of these openings to enable two goods carriages to be unloaded at any one time. The bricking-up of this opening has included a large window and a door. Protruding brickwork at the base level of these large sliding doors could have supported some form of platform onto which goods could have been moved from the carriages.

Much of the eastern end of the south facing elevation is covered in ivy, but it is clear from the blocking of an opening and some alterations to brickwork that changes have also taken place in this area. The base of this opening is at the same level as that of the large sliding doors, making it possible that any platform extended to this point and that this opening was once a door (*Plate 17*).

Plate 17: South facing elevation of Building F

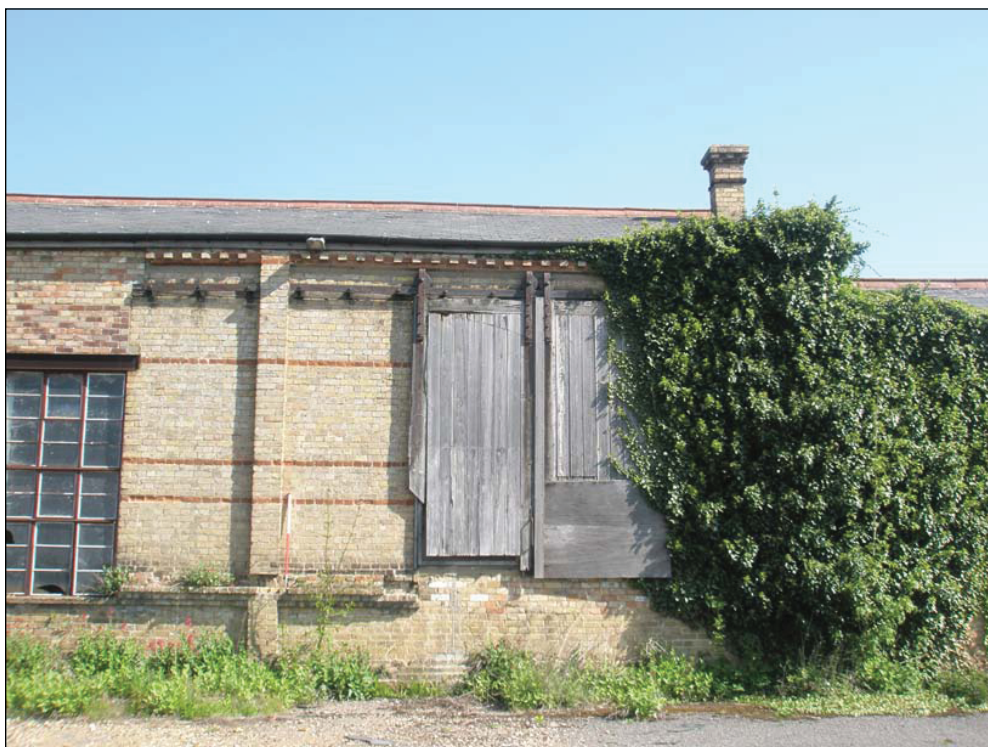
Plate 18: Detail of sliding wooden doors on south facing elevation of Building F

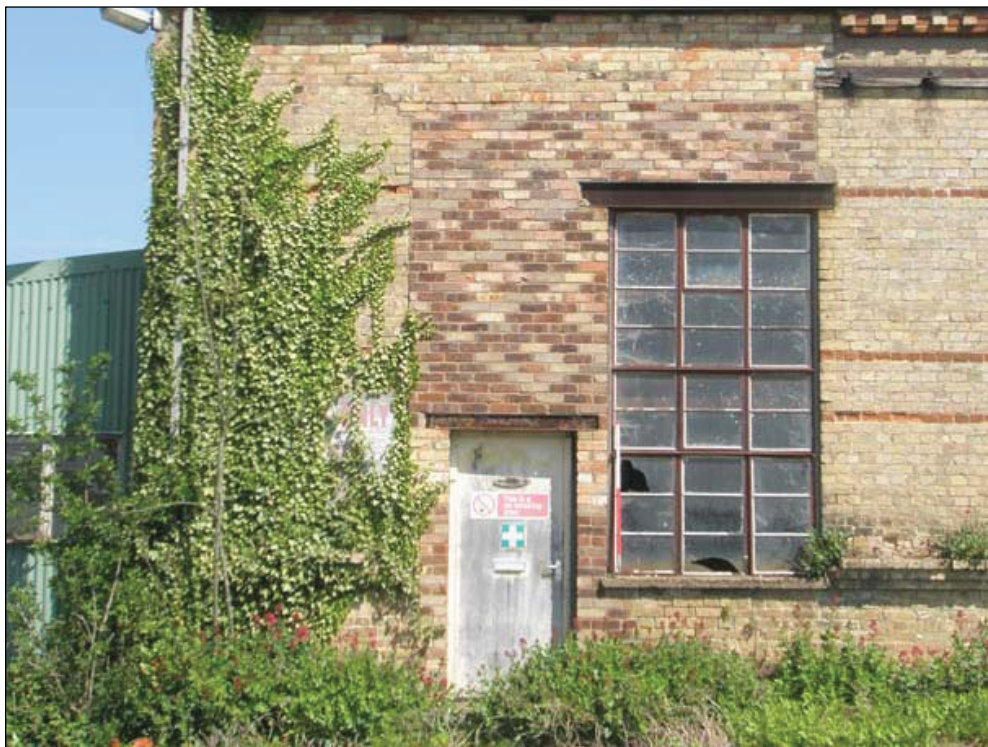
Plate 19: Blocked opening on south facing elevation of Building F

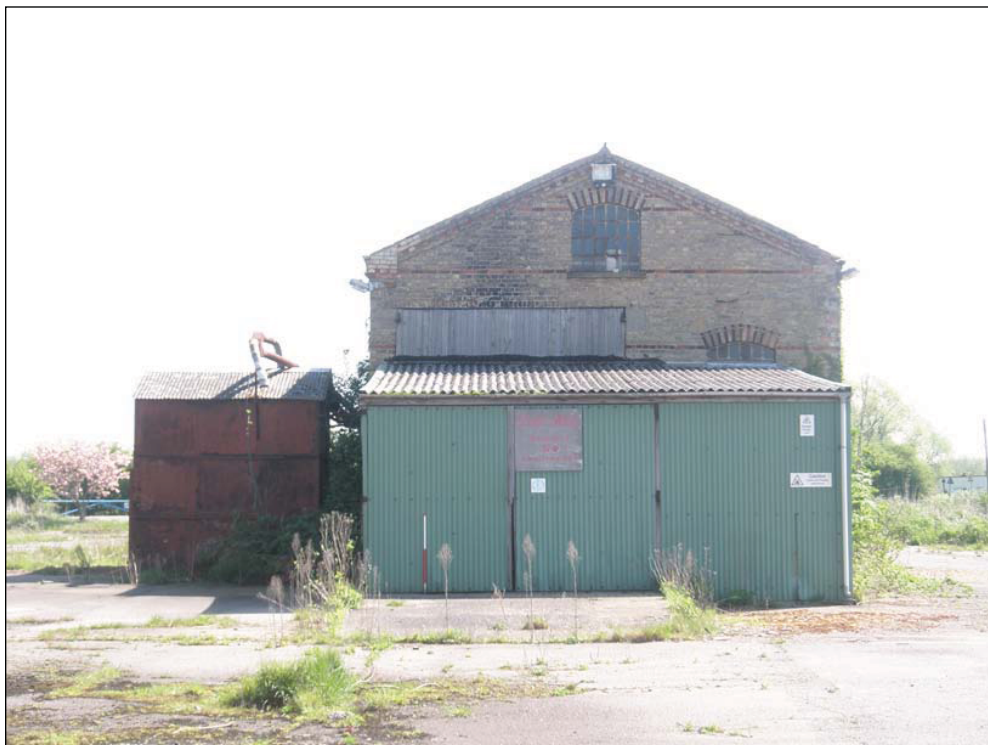
A modern corrugated lean-to shed has been built onto the west of Building F (*Plate 20*). It is clear from exterior views, and particularly interior views (*Plate 21*), that this was the location of a very large pair of wooden doors through which engines could pass. Parts of these doors remain because the lean-to shed has been constructed against them and the parts that were then enclosed have been sawn away.

Plate 20: West facing elevation of Building F

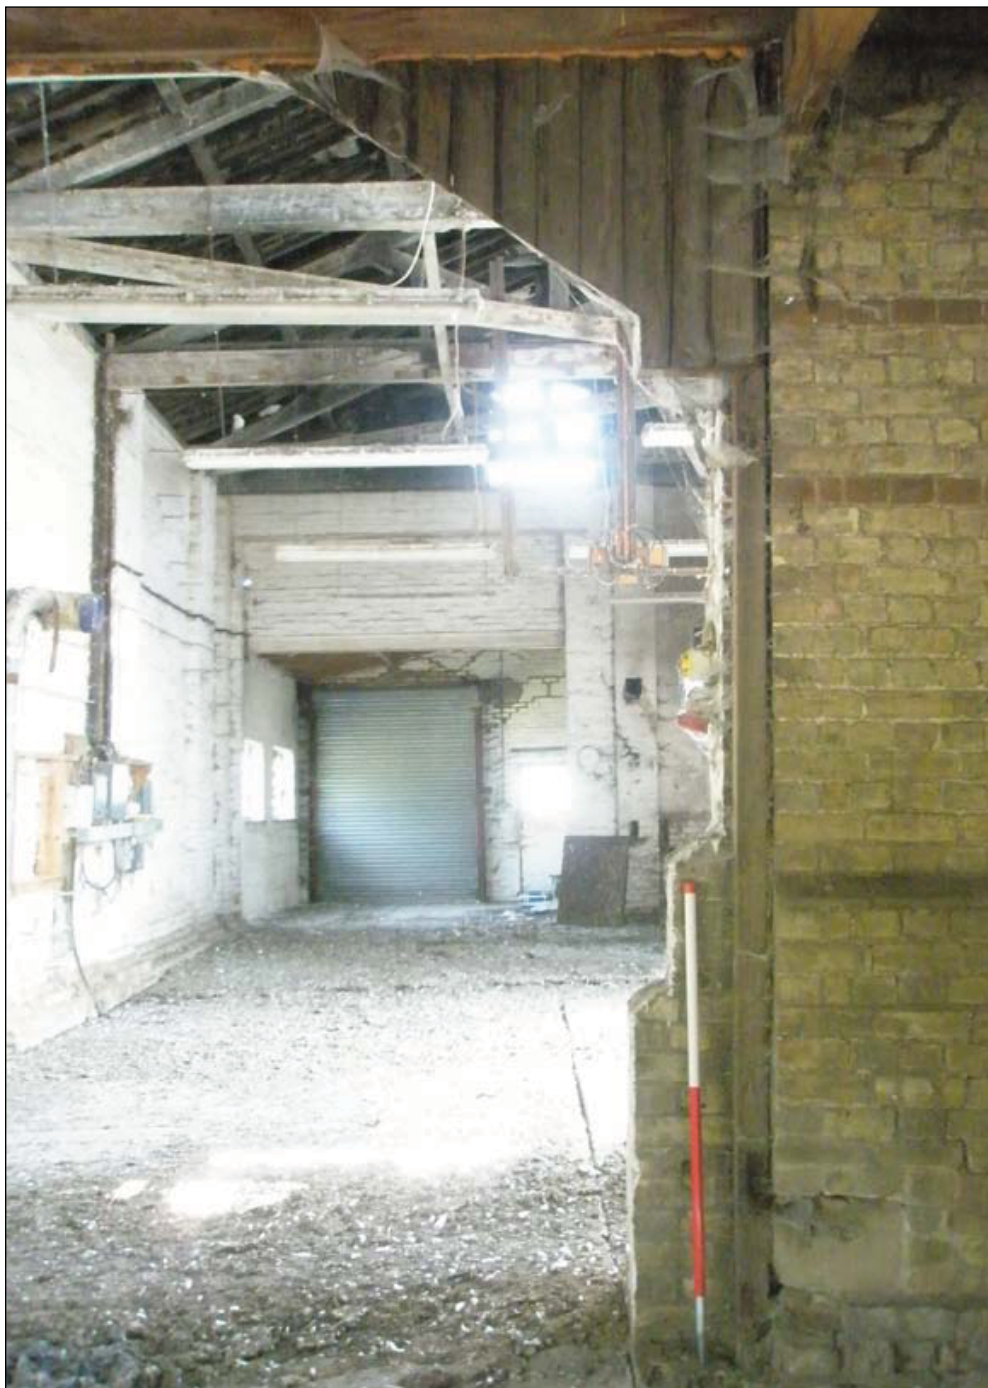
Plate 21: Detail showing remains of wooden door at west end inside Building F

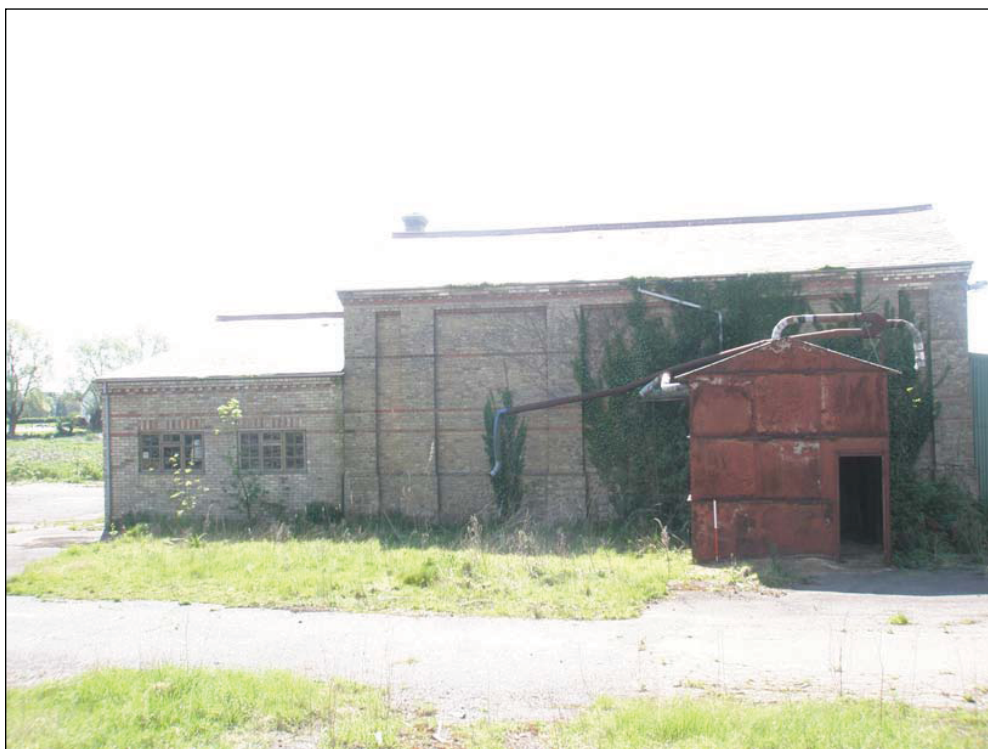
The north facing elevation (*Plate 22*) has several supporting rectangular pilasters extending to just below the stepped/dentillated stringcourses of the eaves.

Plate 22: North facing elevation of Building F

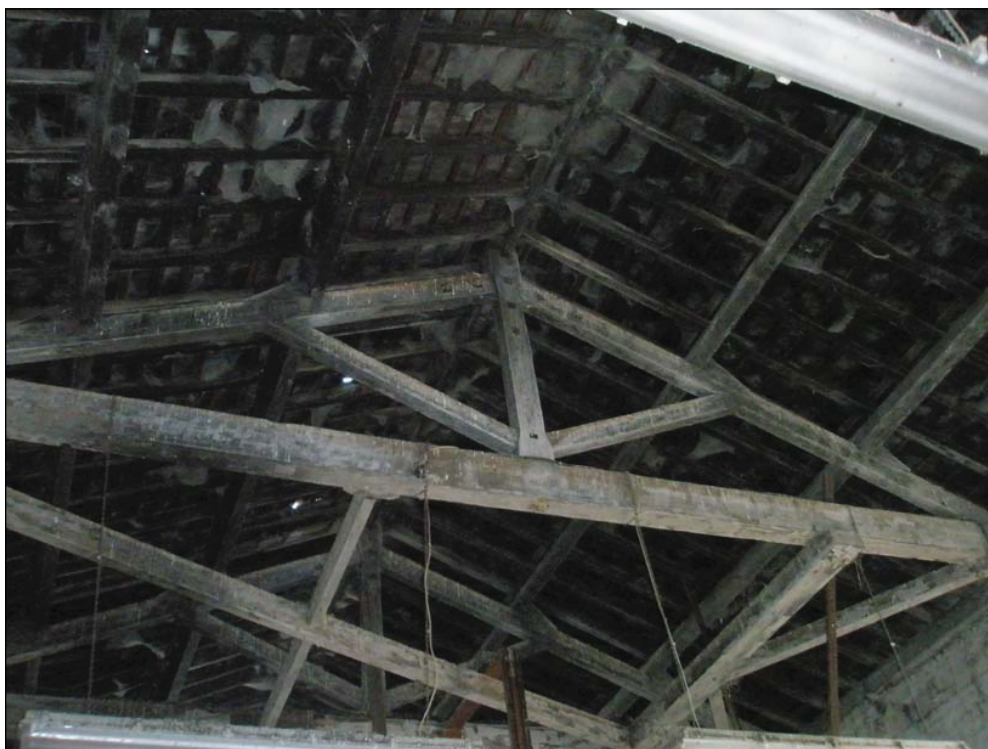
Access was possible to Building F, allowing some interior features to be viewed, but access was limited by large amounts of pigeon guano. It was possible to determine that the building has a king post and tusk tenon roof structure (*Plate 23*). The part of the original building that extended east from the southeast corner can still be seen (*Plate 24*), with steps up to the floor level that is in line with the base of the large sliding doors in the south elevation. Also visible in what was the north facing elevation of this part of the building are two further windows with original metal casements. No original machinery relating to the original use of the building was visible.

Plate 23: Detail of king post and tusk tenon roof structure in Building F

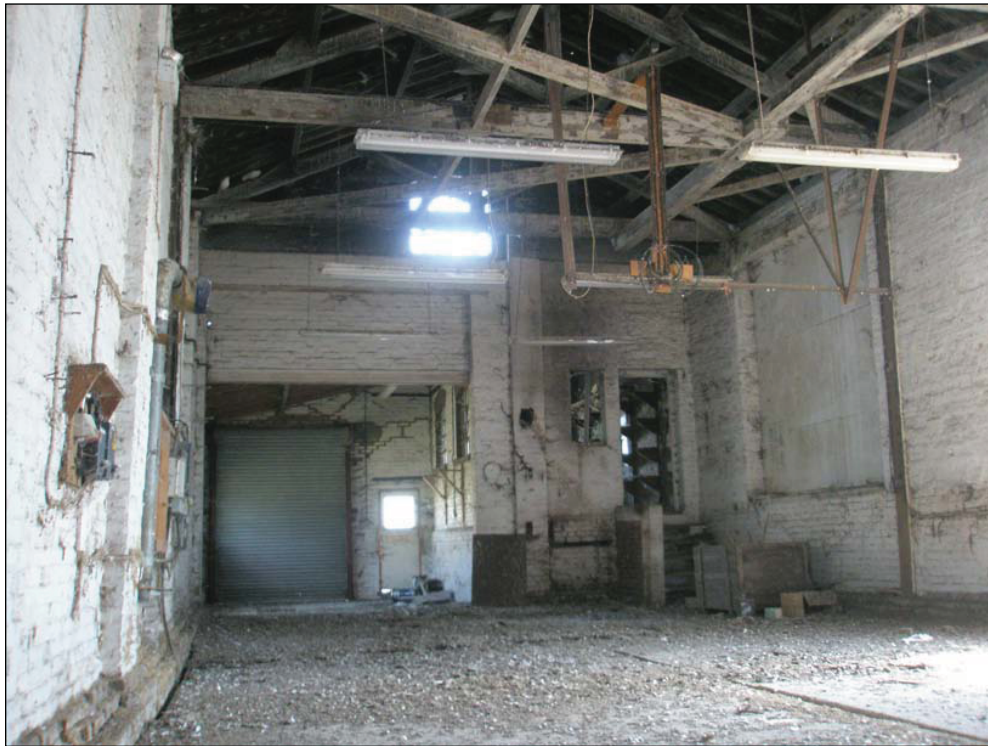
Plate 24: View looking east of the interior of Building F

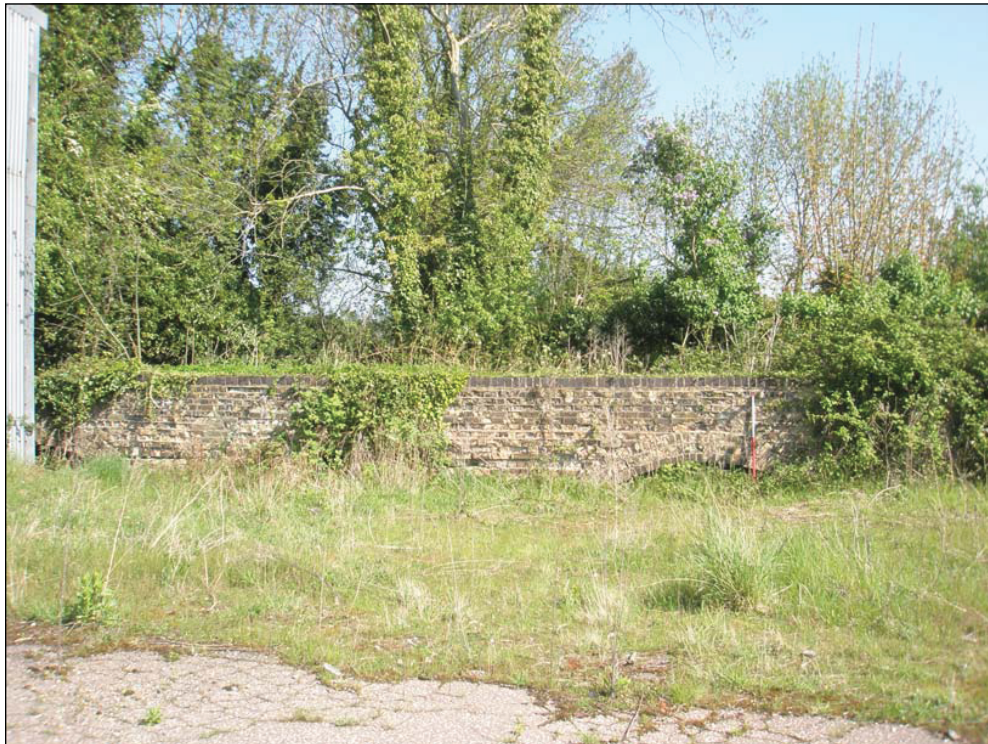
Plate 25: Part of the surviving platform

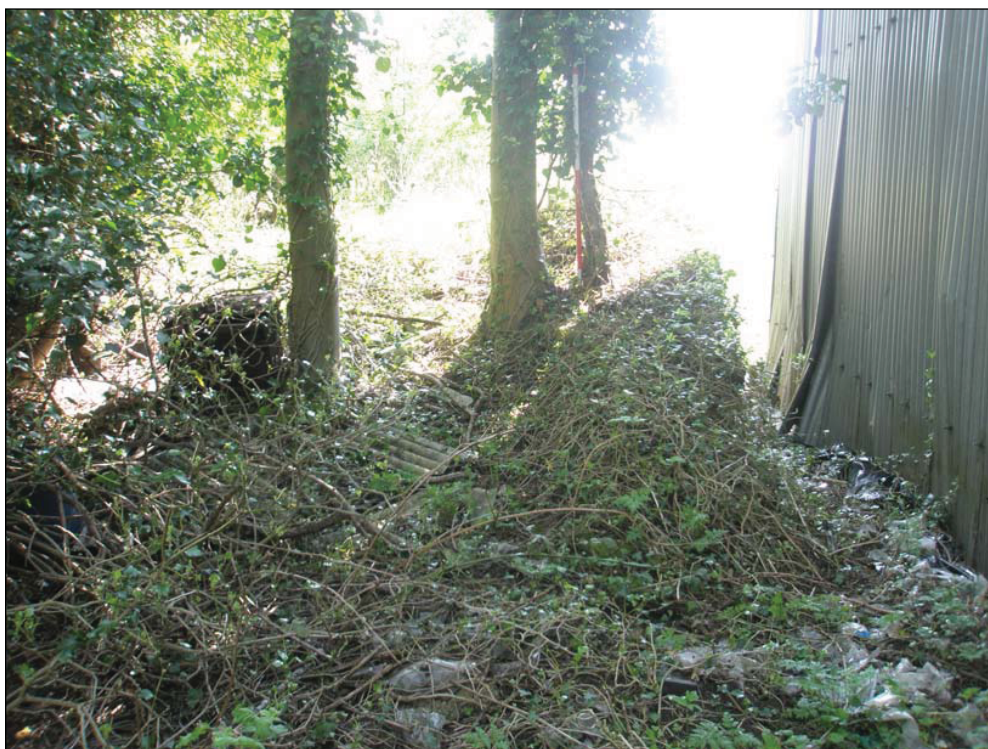
Plate 26: The west end of the surviving platform
