CAM ARC Report Number 1017

May 2008

The Threshing Barn, Chipping Hall, Chipping, Hertfordshire

Historic Building Recording and Archaeological Watching Brief

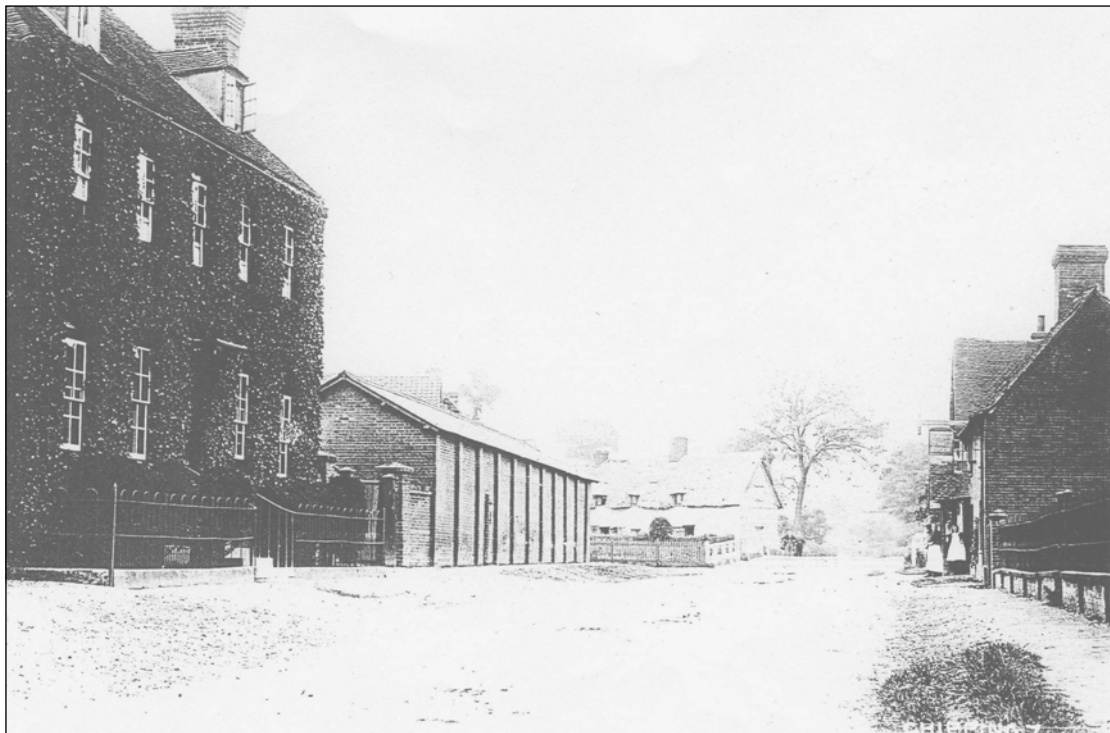
Figure 12: Black an White photograph taken in Chipping c.1907?

Other historic evidence available included black and white photographs stored at the HALS. Two photographs (Figures 12 and 13), thought to date to 1907 depict Popes Hall on the left side, looking almost exactly as it does today, with ivy covering much of the buildings frontage. These images clearly show buildings 5 (Popes Hall) and building 4, which are both, aligned along the main road. In the distance appears to be a much older thatched building and on the opposite side of the road, The Red Lion Pub (now The Countryman). The images taken in 1984 (Figures 14 and 15) show very little change to Popes Hall as it appears today (plates 16 and 17).

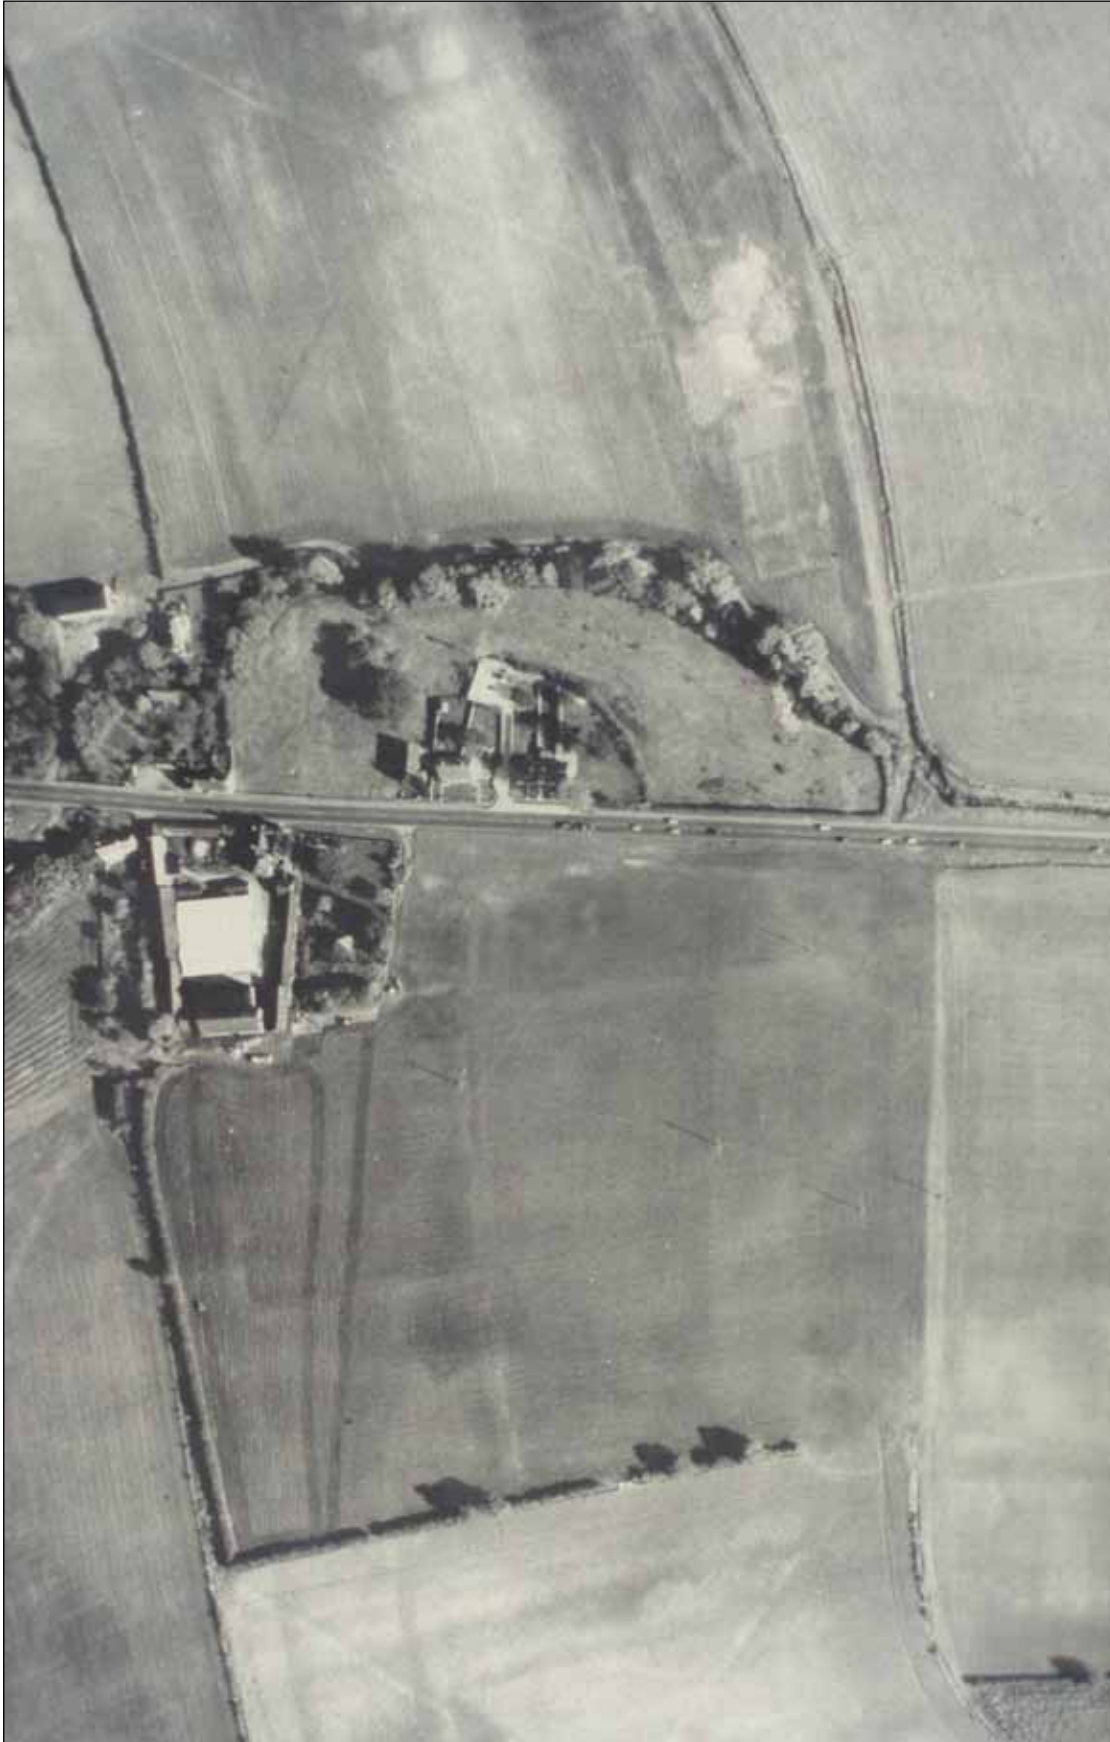
Figure 16: Aerial Photograph, 1971, from HALS

perspective when looking at the area. The aerial map of 1971 (Figure 16) does not show great detail of the farm buildings, however, the threshing barn can clearly be identified, as well as the two large barns first noted on the 1977 ordnance survey. The boundaries which are visible at the rear of the buildings (west) and also to the south, which are remnants of those tree lines and plots which can be seen on the 1st edition OS map. Chipping Hall cottages can also be recognised as well as The Countryman pub. Also of note, and potentially an area of further research, is the presence of what may be rectilinear cropmarks to the east of the brook. These cropmarks are also visible in the aerial image from 1980 (Figure 17). The image from 1990 (Figure 18) was perhaps taken at a different time of the year or day as the light is very different as are the field conditions. To the rear of Chipping Hall Cottages, this map shows a sub-oval, pond-shaped feature. This may simply be the result of an agricultural practice, however, it may be something worthy of further investigation at a later date.

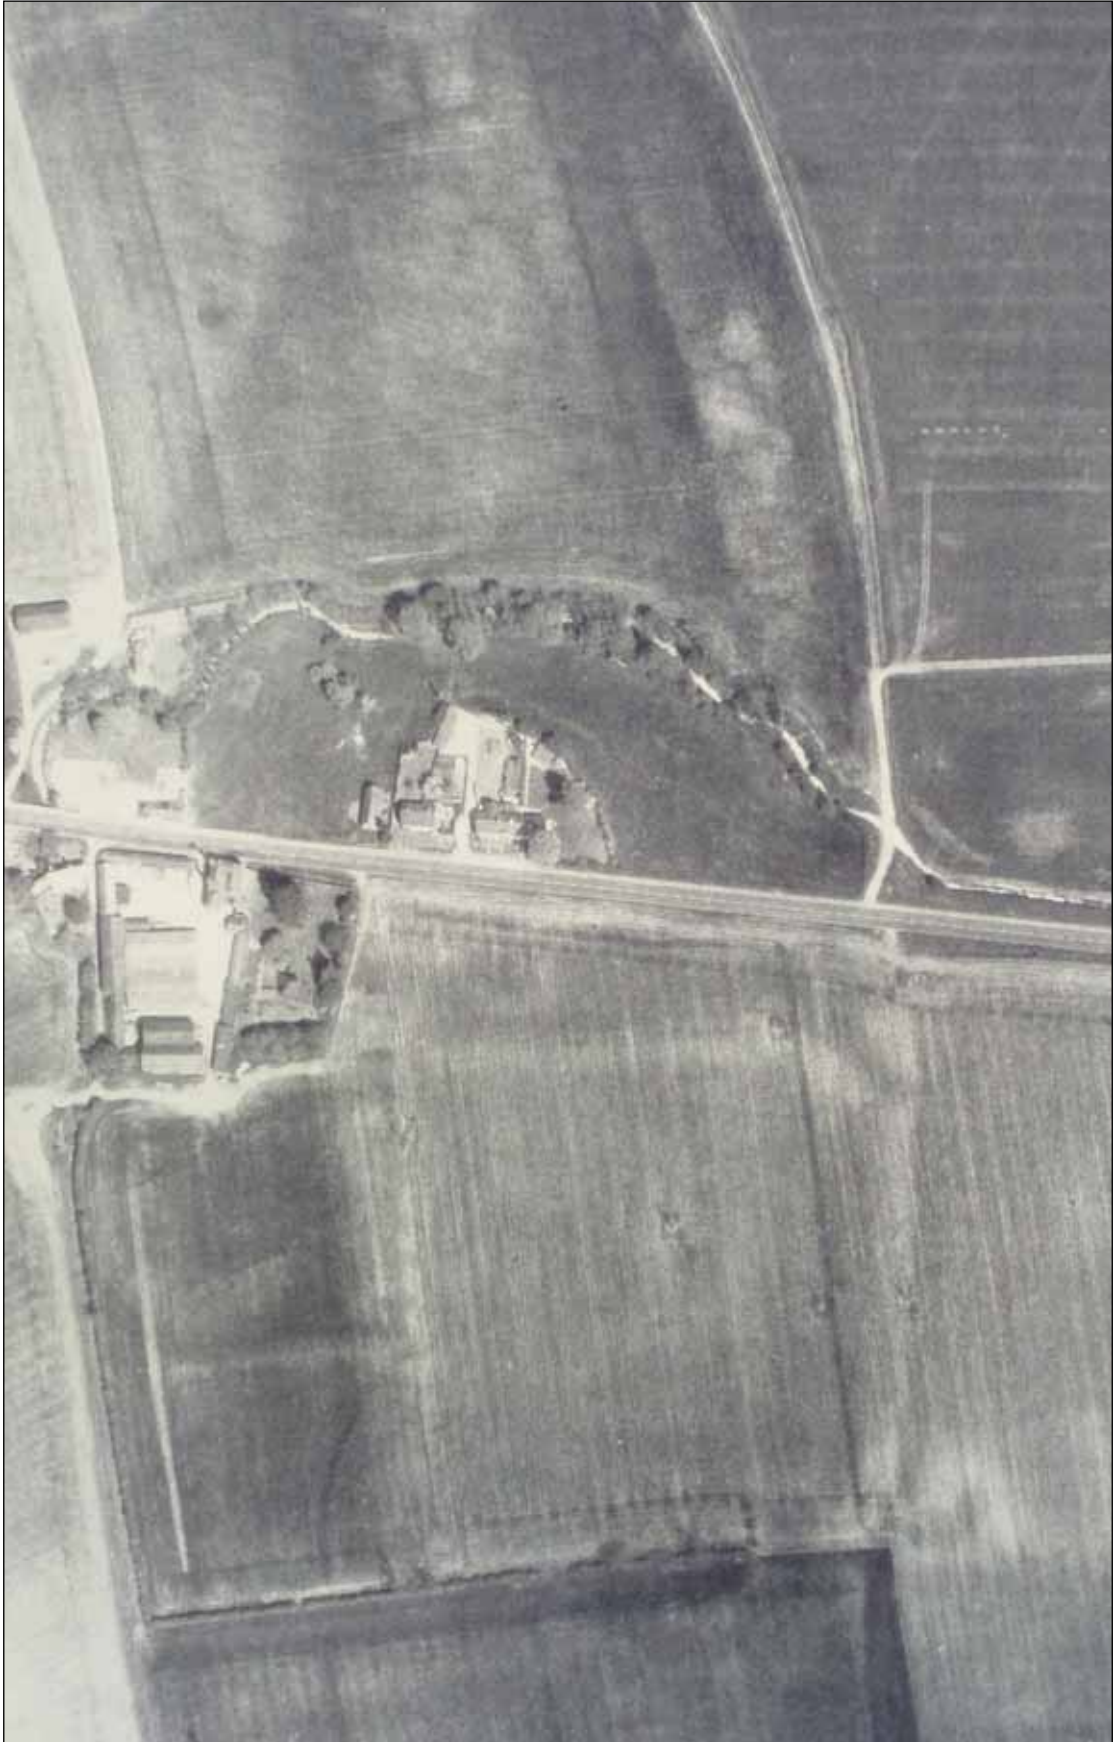
Figure 17: Aerial Photograph, 1980, From HALS

A series of aerial photographs taken in 1971, 1980 and 1990 (figures 16, 17 and 18), which were also held by HALS, gives a different

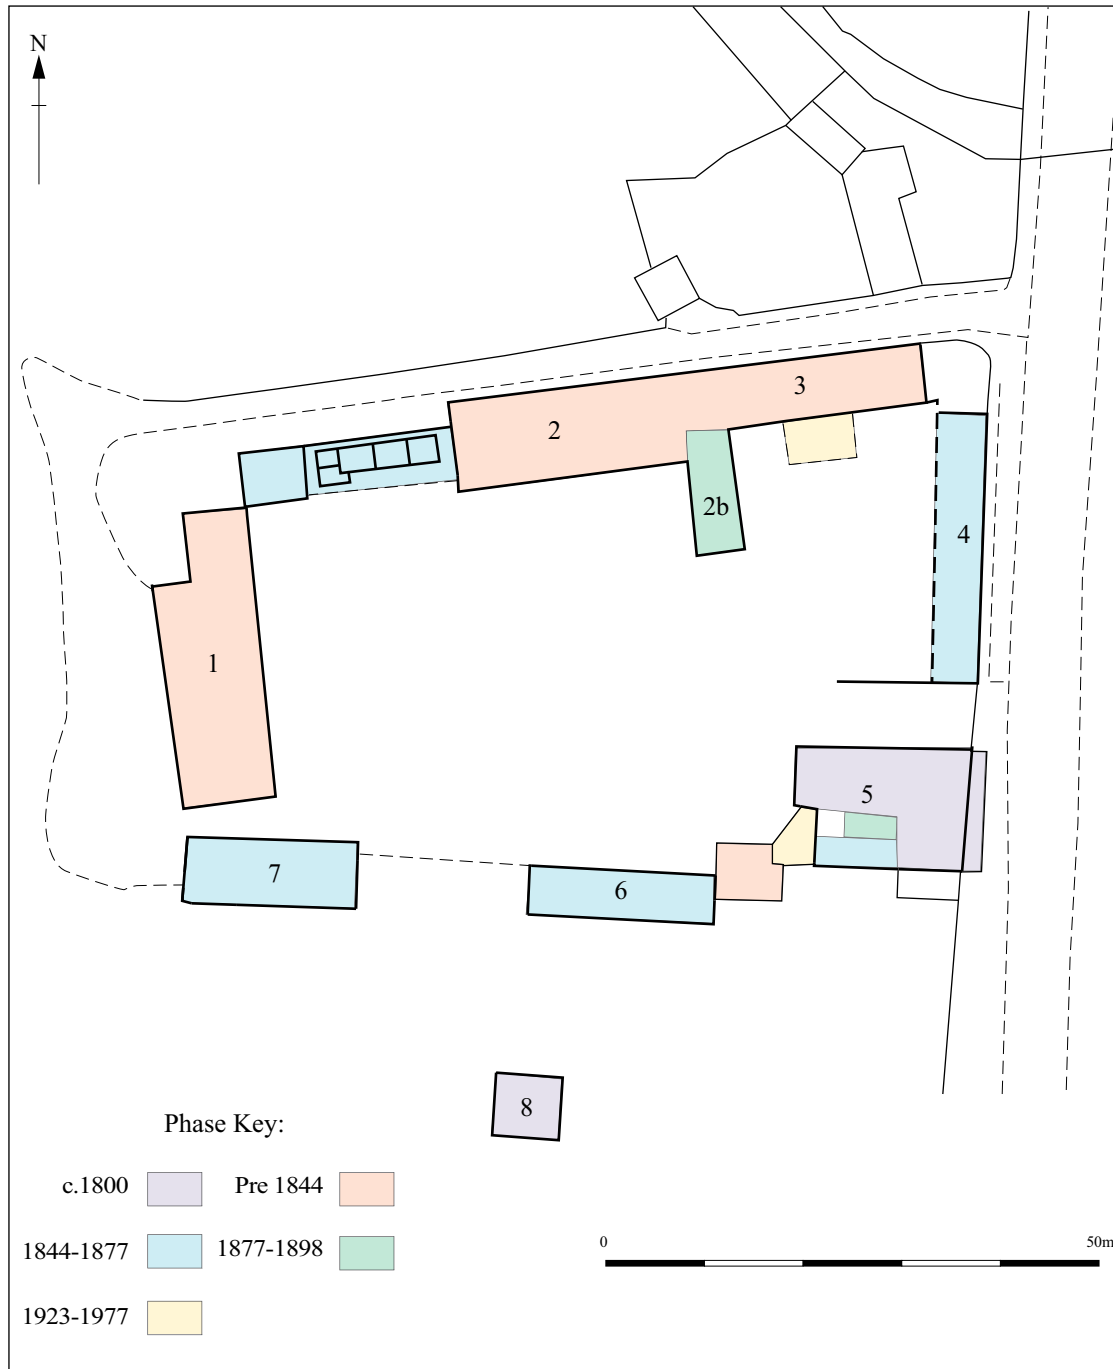
Figure 19: Plan showing development of Chipping Hal Farm buildings (existing buildings)

In order to conclude, it is necessary to provide a brief description of the development of Chipping Hall Farm (Figure 19).

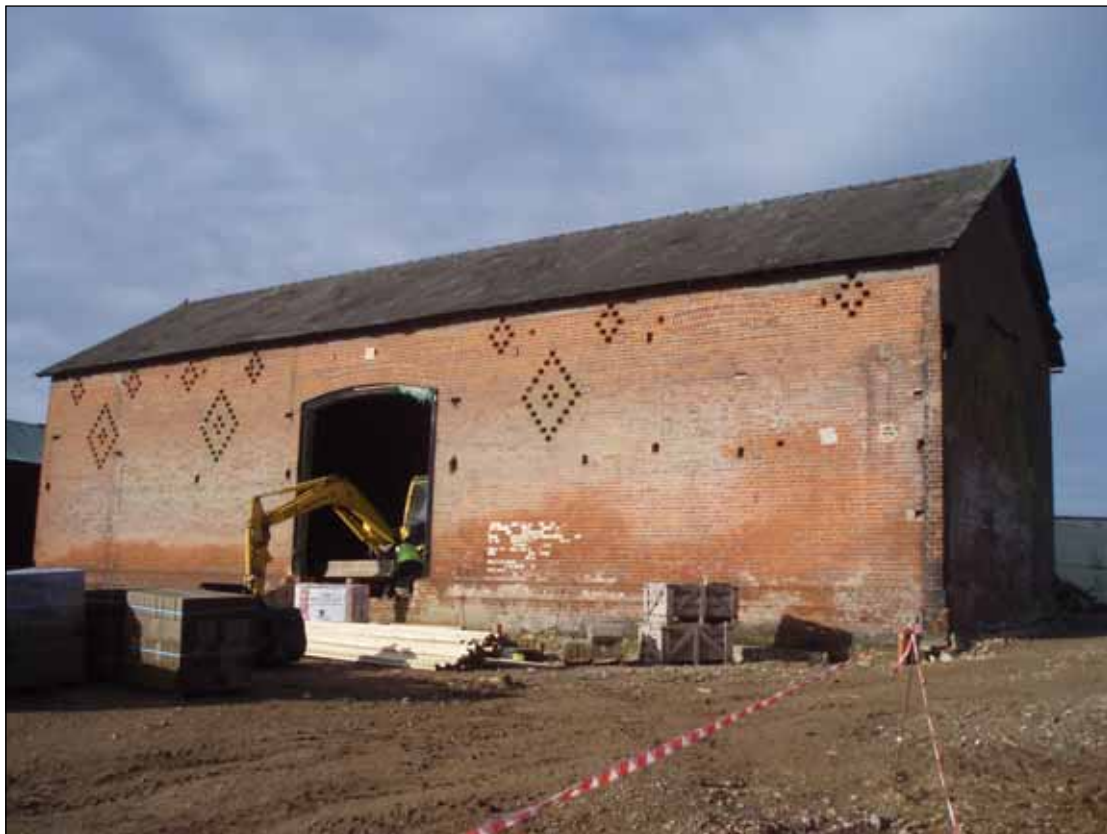
Plate 1: East facing elevation of threshing barn

Barn 1, believed to have been a threshing barn (plate 1) was constructed using a dark orangey-red un-frogged brick in an English bond on chalk and flint foundations. The average brick dimensions were 22cm x 7cm x 6.5cm and the mortar used was a light coloured loose, crumbly, sandy mix with crushed flint and stone inclusions. Voids created by omitting header-bricks created a number of diamond patterns on each side of the building. These have been interpreted as ventilation holes. The entire roof was covered with grey Collyweston slate.

This east-facing elevation of the barn fronted onto the farmyard (plate 1).

A large opening was centrally located within this elevation with an oak frame set within which would have supported a set of doors, now removed.

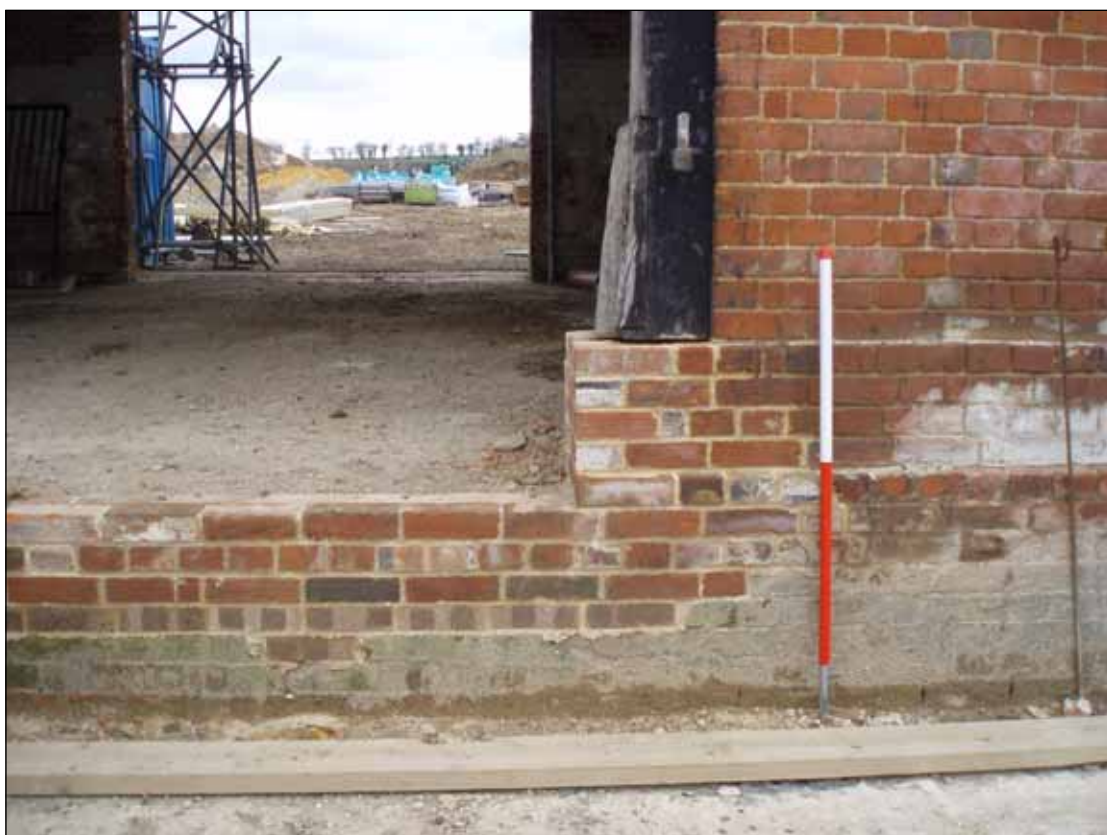
Plate 2: Brick plinths

The building was constructed on a double brick plinth (plate 2), the lower comprising seven course and four on the second. The foundations had been exposed at the time of visit, which revealed the barn was constructed upon brick and flint foundations.

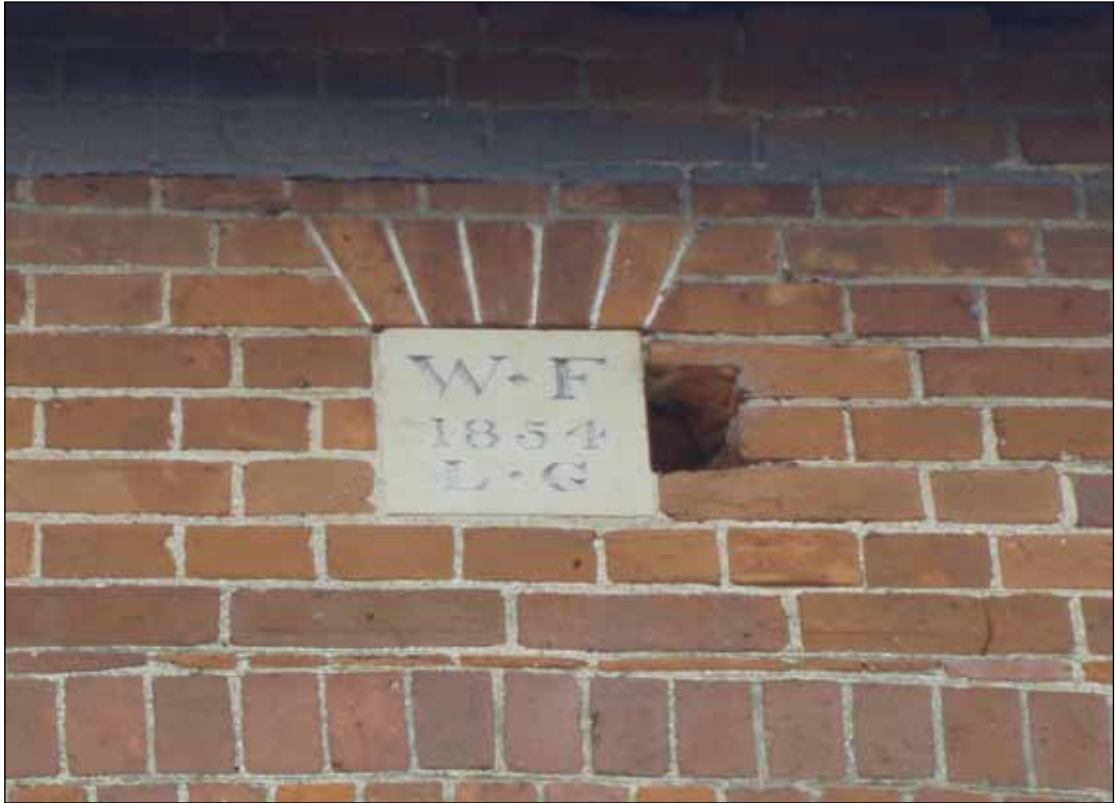
Plate 3: Datestone

Centrally located above the barn door was a datestone bearing the initials "WF" and "LG" and the date 1854 (plate 3).

The 1853 datestone on the outside of the barn (plate 3) suggests a date of construction or alteration. Many threshing barns had become obsolete and no longer needed by the 1850s (Wade-Martin 1981, pg 168) so it is unlikely that the barn was first built at this time. By looking closely at the east-facing elevation, there is evidence to suggest that alterations and changes have taken place. A window/opening has been blocked up. It also appears that the brickwork along upper courses of the wall may have been repaired or cleaned. If the barn was no longer used for threshing by 1854, it may have fallen into some disrepair, and the owner at the time may have chosen to undertake some alterations. The appearance of many barns changed at this time, some were re-roofed, some changed their function entirely. Many avoided demolition as they formed part of the estate farm. This suggestion certainly seems to apply to the barn at Chipping. It has already been suggested that the datestone was not a reflection of the original build, and may rather be a date of change of function.

The presence of the datestone on the barn, provides a date of 1853, however, there is evidence to suggest that it is not the date of the original construction, rather a date of alteration or perhaps to represent a date of change of ownership. The brickwork above it looks as though it has been contemporarily constructed around the datestone, however, on closer inspection, there are signs that these bricks may have been cleaned or replaced when adding the stone. It looks likely that the roof has been replaced and it is possible that the datestone was added at this point. It is not unusual for people to add datestones at a point of alteration or adaptation. Other work has been carried out

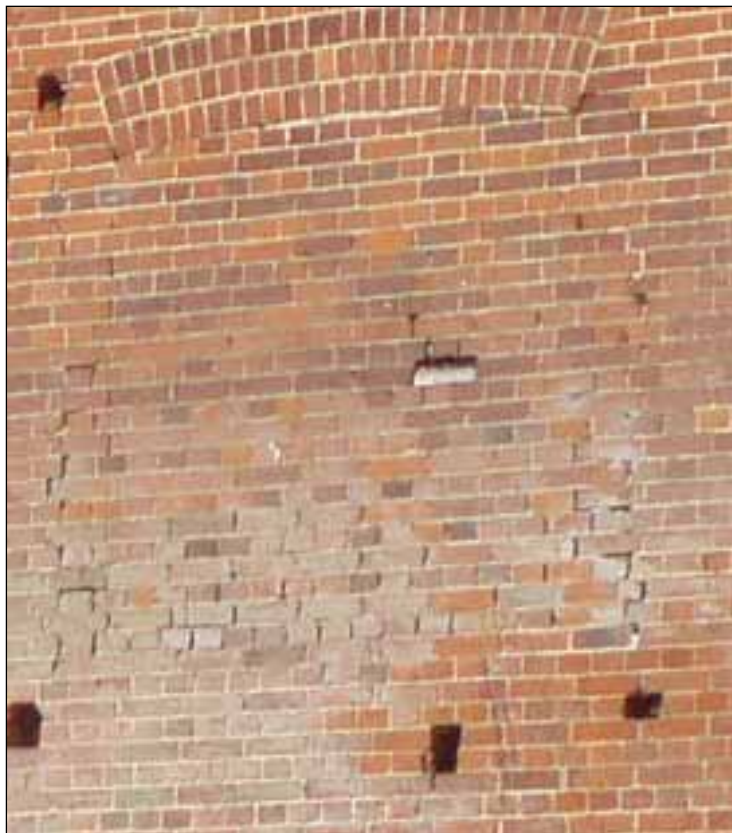
Plate 4: Blocked up window

A blocked up opening/window was located to the right of the doorway (plate 4). This window measured 1.70m wide and 2.14m high, set beneath a three-course brick arch. The archway suggests that the opening is contemporary with the original build and was blocked at some point after.

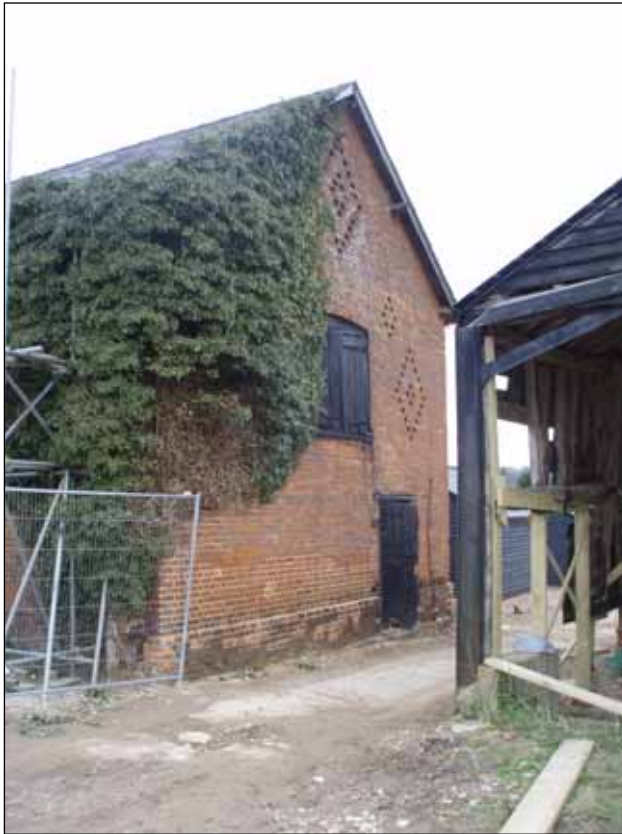
Plate 5: South facing elevation of threshing barn

The south-facing elevation (plate 5, Figure 3) was partially covered with ivy on one side. It measures 8.5m wide and 8.75m from the current ground level to its highest point.

Higher up within this elevation was an opening with wooded shutters comprising vertical wooden panels secured with iron hinges. This opening was set beneath a three-course brick arch and appeared to be contemporary with the original build.

Three large diamond ventilation holes were present; one each side of the opening and one set above it, and two smaller ones were located in between.

From this side of the barn, it was possible to see the pitch of the roofline which was moderately gentle with a c.30° slope. The gradient on which the barn was constructed was also clearly visible from this side. Figure 3 demonstrates how the site of the barn slopes downhill from west to east.

At the south-facing end of the barn was a window-like opening with wooden shutters. Pitch holes were often found at the ends of barns such as this, used to pitch the corn or hay directly into the barn from a cart or wagon standing outside. This might be necessary if the barn doors needed to be kept shut, if access was restricted or if perhaps there was already a cart loading on the threshing floor.

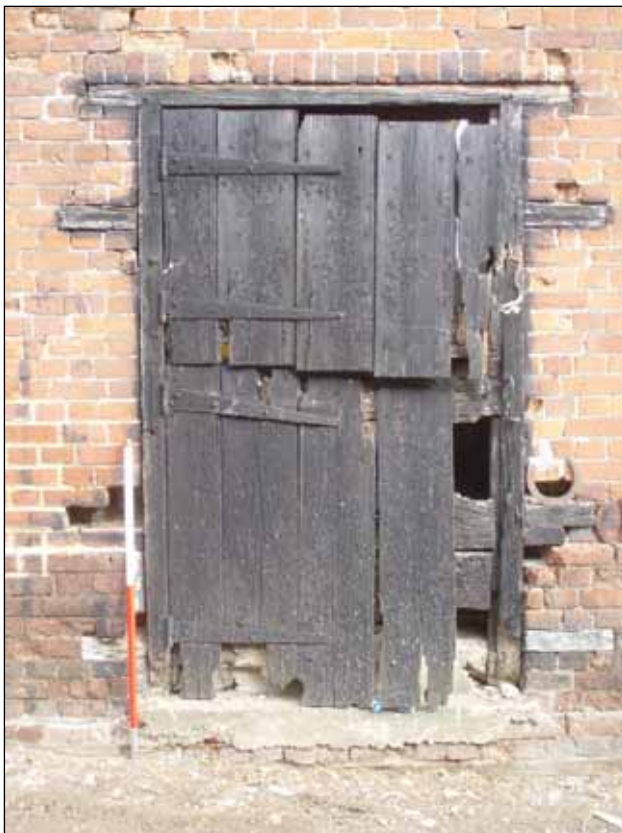
Plate 6: Door in south facing elevation

A wooden two-part stable-style door was located for ground floor access (plate 6). This door was made from a number of vertical panels held together with horizontal struts on the inside secured with square-headed nails. Four hinges, two on each part of the door held the door onto iron brackets set into the wooden doorframe. The hinges match a dated example from Suffolk dated 1745 (Alycock and Hall, 24). A number of pieces of wood had been set into the brickwork to attach the frame.

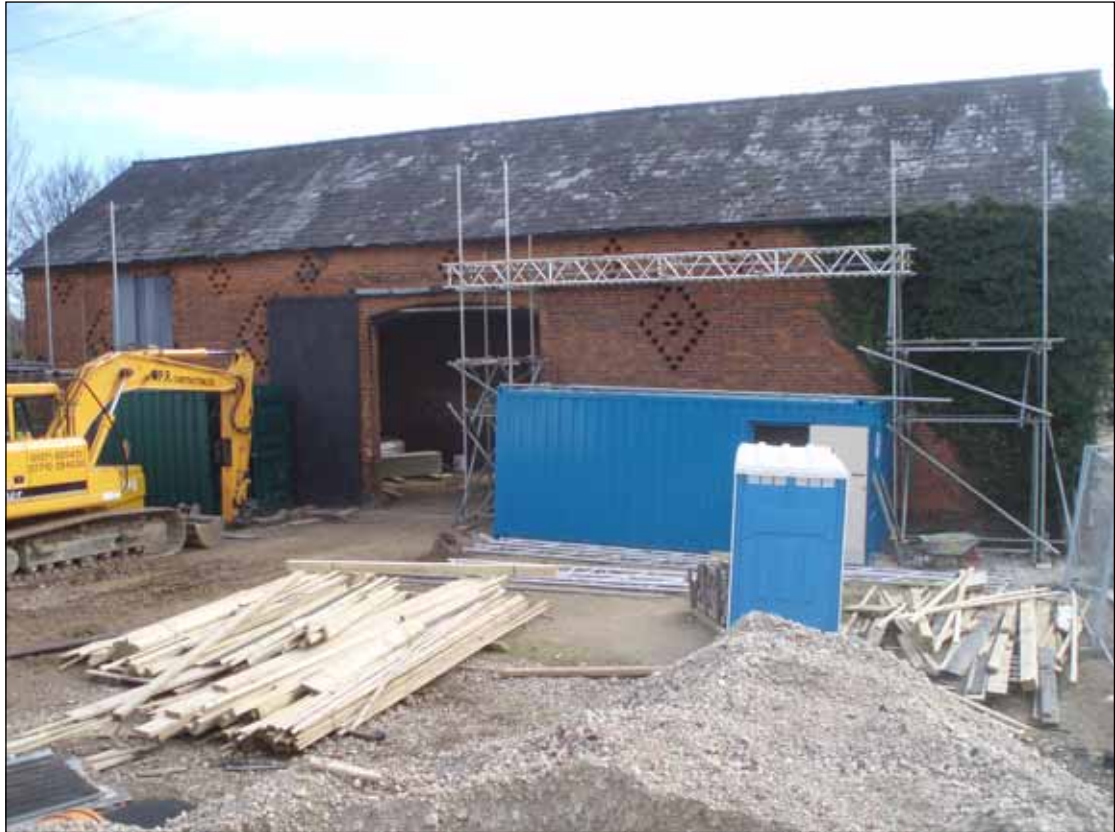
Plate 7: West facing elevation of threshing barn

At the time of visit, the west-facing elevation was covered with scaffolding (plate 7), making photographing the external elevation of this side of the barn difficult.

The door opening on this side was directly opposite that on the eastern elevation, with the same dimensions. A sliding iron door and fittings have replaced the original doors and an iron runner has been secured into the ground in order to slide the door open.

Similarly to the eastern elevation, there were two rows of diamond-shaped ventilation holes; a row of small diamonds along the roofline, four to the left of the doorway and a row of larger ones; two to the left of the door and two to the right (there was one on the right of the eastern elevation due to the window/opening).

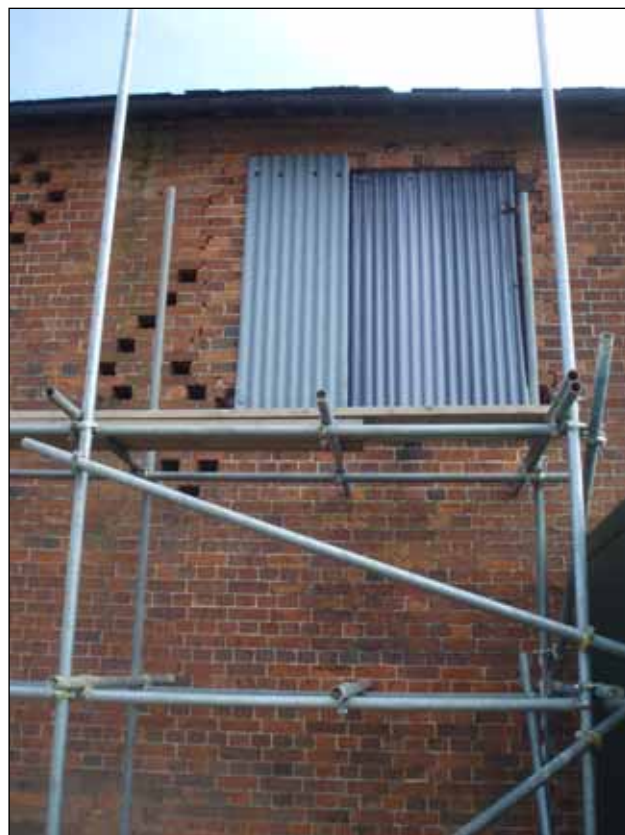
Plate 8: Inserted opening in west facing elevation

A window/opening has been inserted after the construction of the barn, on the far left, truncating one of the diamond patterns (plate 8). This window would have created an opening opposite that on the eastern side (which was original), however it was slightly smaller in size.

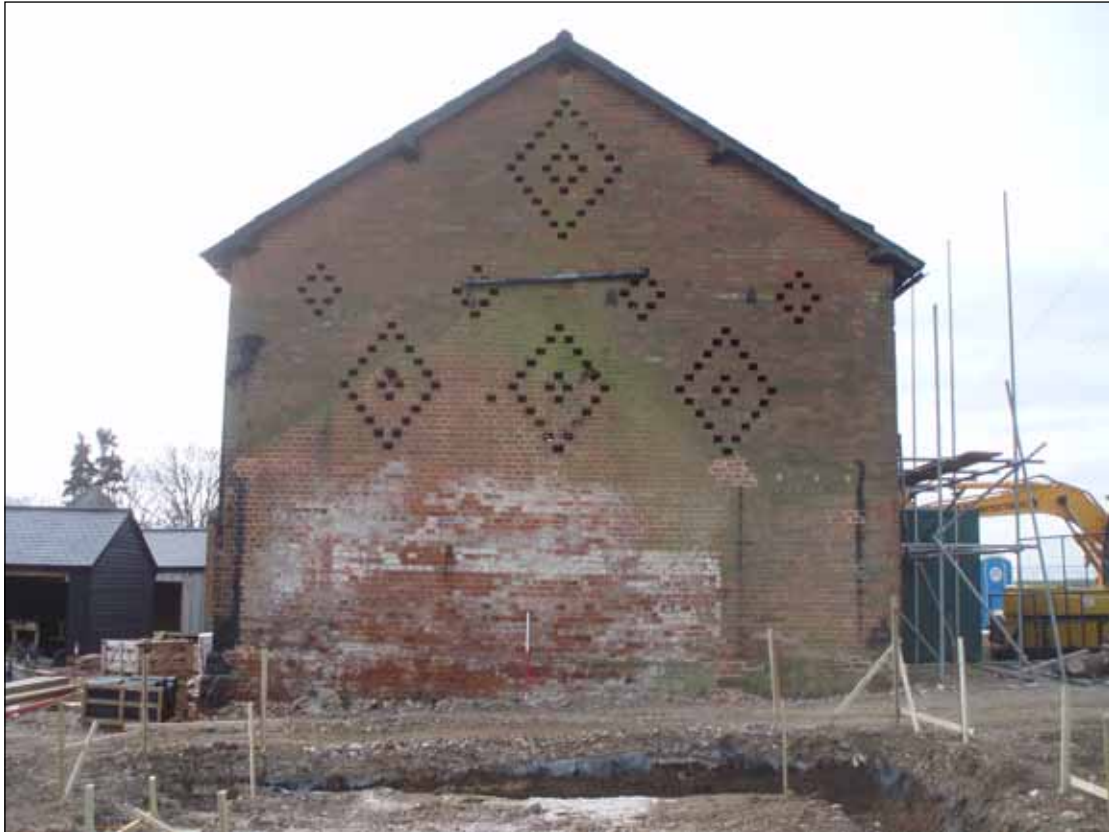
Plate 9: North facing elevation

The north-facing elevation displayed a different pattern of ventilation holes to the opposite south-facing side (plate 9). Ghostlines of what appear to have been two previous buildings were visible. The impressions of what was a steep pitched roof of an earlier building were recorded, with green algae staining from water damage on the roof. Evidence of putlocks to support the scaffolding during construction were clearly visible as well as two bricked up voids which would have keyed the new building into the barn. This suggests that the now removed building was later, not part of the original barn build. The current ordnance survey map (figures 1 and 2) suggest that there was another building against the northern gable, however this was not present at the time of the survey.

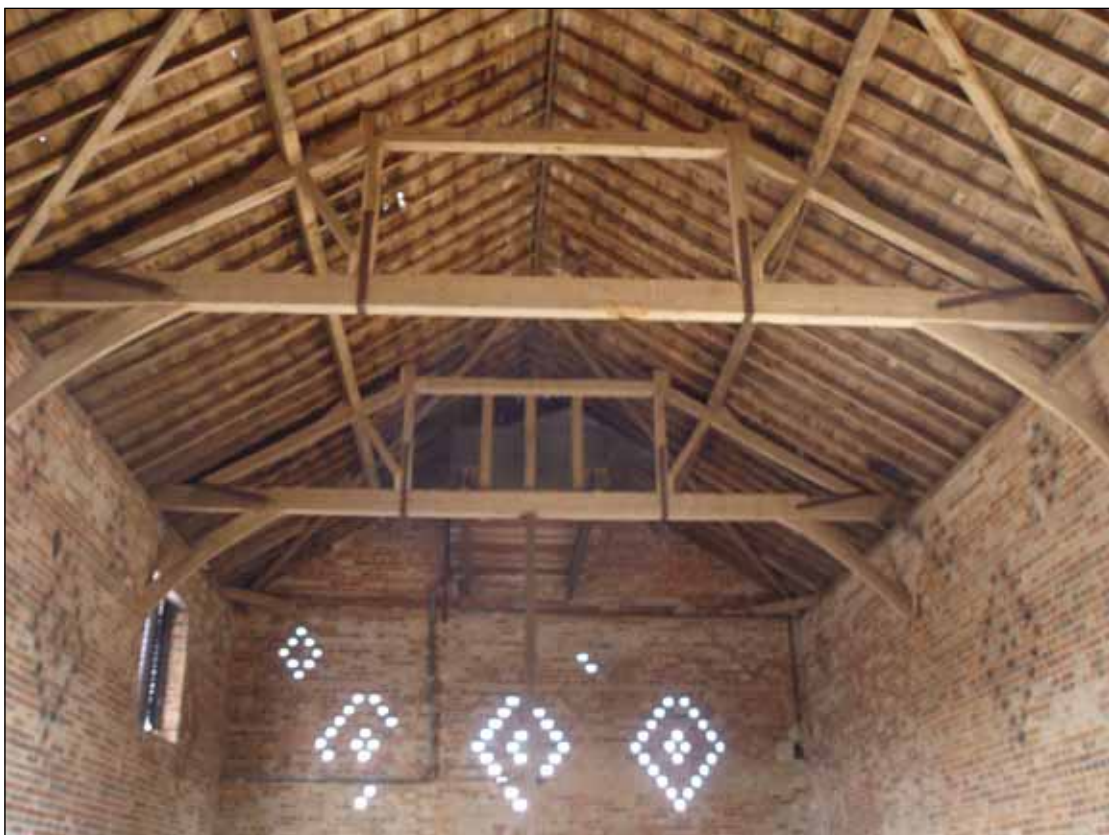
Plate 10: Roof construction of threshing barn

The roof construction comprised four tie-beams with down braces and queen posts supported by horizontal collar beams (plate 10). A wooden lintel spanning the entire inside of the barn was built into the construction in order to support the roof. Iron bolts and straps were used rather than traditional pegged mortice and tenon joints; this was commonplace in the 18th and 19th centuries (Harris, 2006, pg 85).

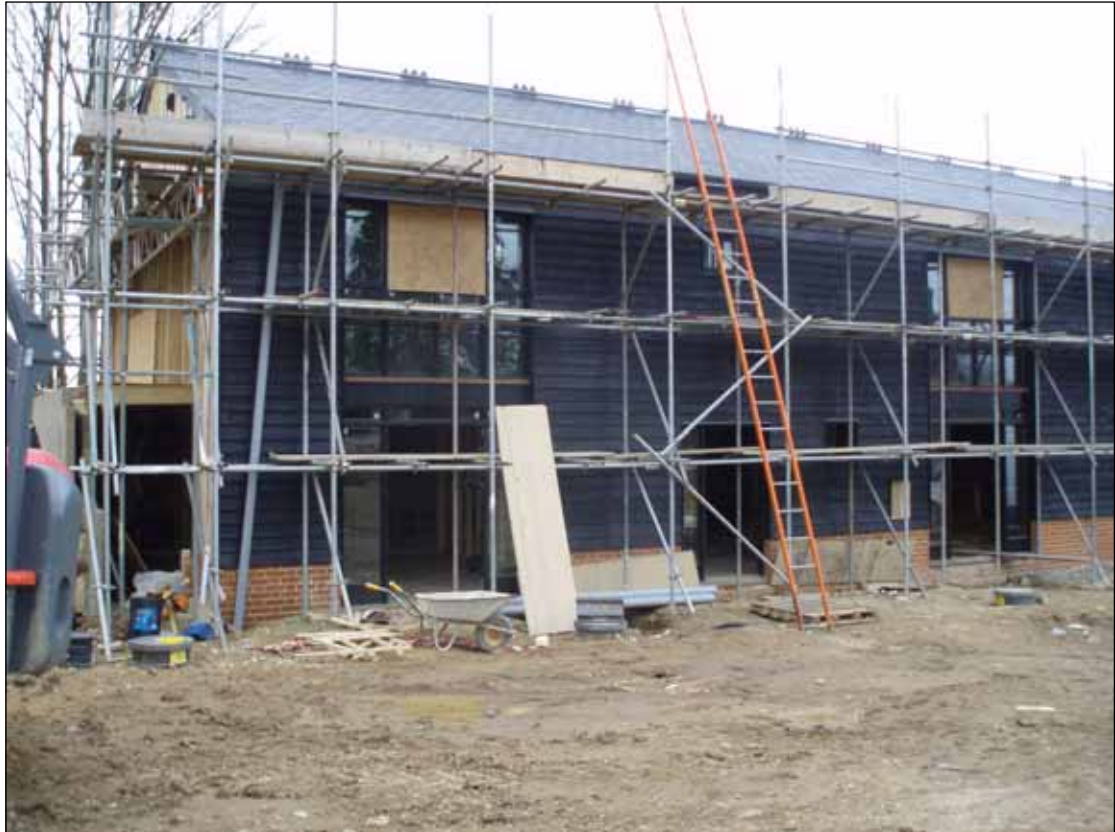
Plate 11: Building 2

Building 2 (plate 11) (see Figure 2 for location) was undergoing conversion at the time the survey was carried out and was not easily accessible. It was a requirement of the brief (Tinniswood 2008) that Building 2 underwent a brief recording of any original surviving elements.

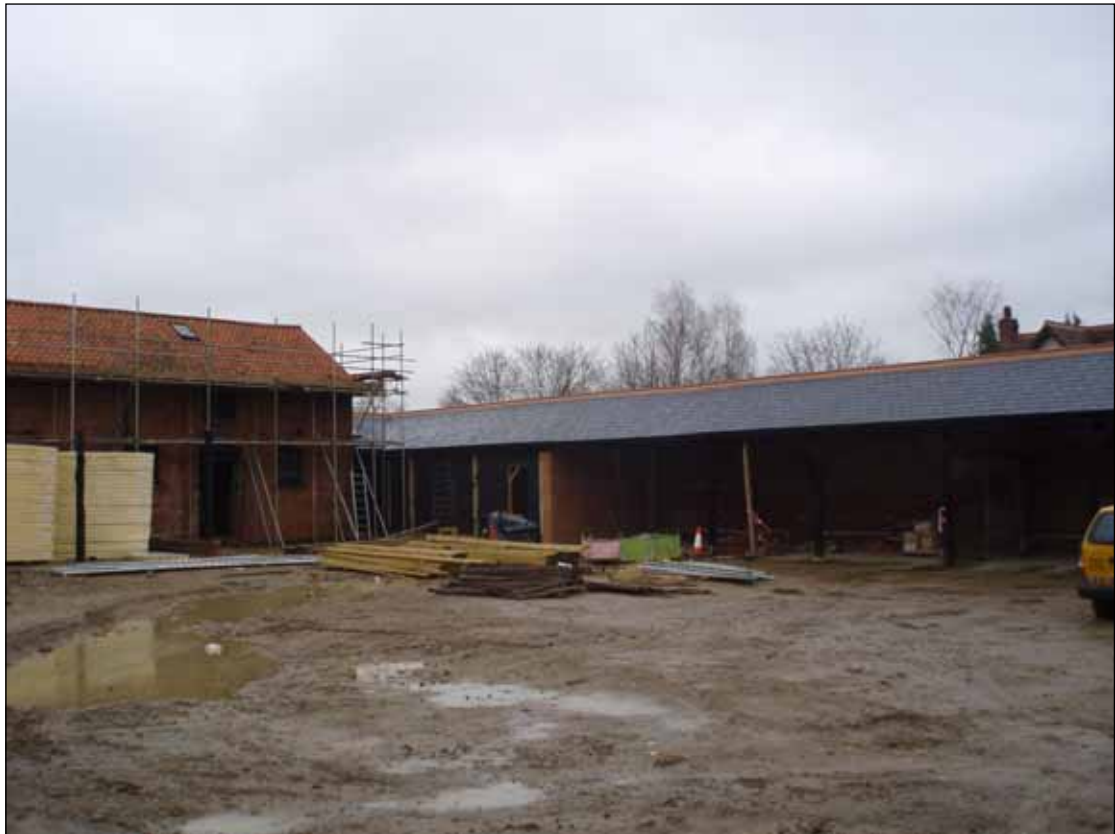
Plate 15: Building 4

Building 4 (plate 15) (see Figure 2 for location) had also been recently re-roofed. It appeared to retain its original rear wall and internal posts, but much of the rest had been replaced or altered. This building may have originally been used as stables or an open cart shed.

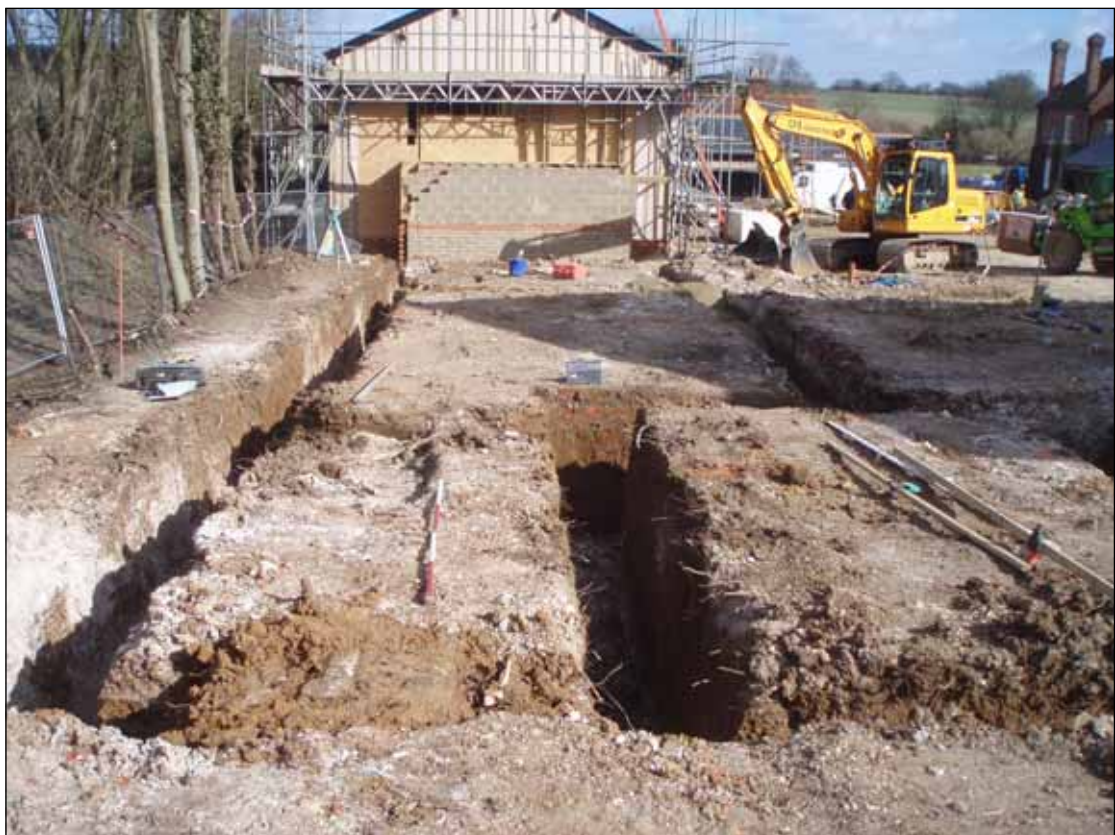
Plate 24: Footings for extension to building 2

The footings were laid out by the client in the location of the new extension (plate 24). Trench depths varied between 2m at the eastern end and 1.5m at the western end of the excavations. Natural chalk was reached at between 1m and 1.3m below the ground surface.

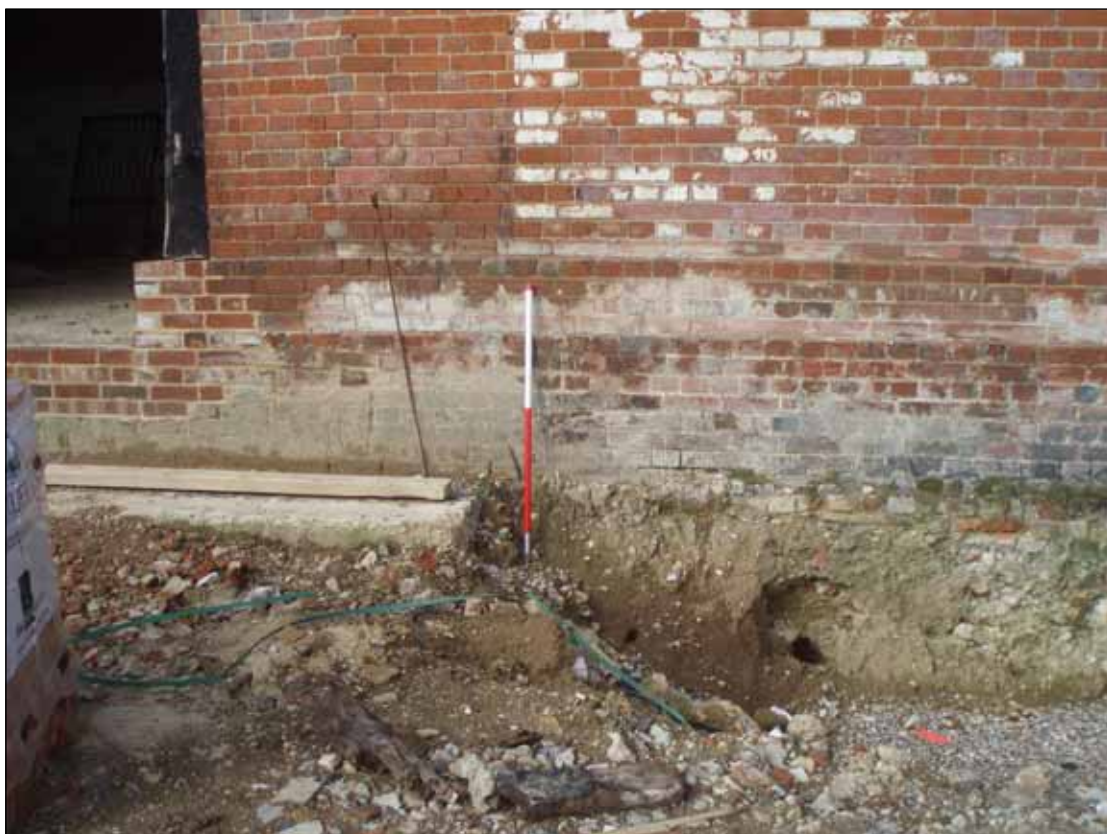
Plate 25: Footings for threshing barn exposed during groundworks

A trench had been machine dug in front of the threshing barn, This revealed chalk and flint foundations (plate 25)
