HISTORIC BUILDING SURVEY OF
A BARN AT PRAYORS MANOR
PRAYORS HILL
SIBLE HEDINGHAM
ESSEX

**HISTORIC BUILDING SURVEY OF
A BARN AT PRAYORS MANOR
PRAYORS HILL
SIBLE HEDINGHAM
ESSEX**

Client: Edward Parsley Associates Ltd on behalf of Mrs Capel Cure

FAU Project No.: 2399

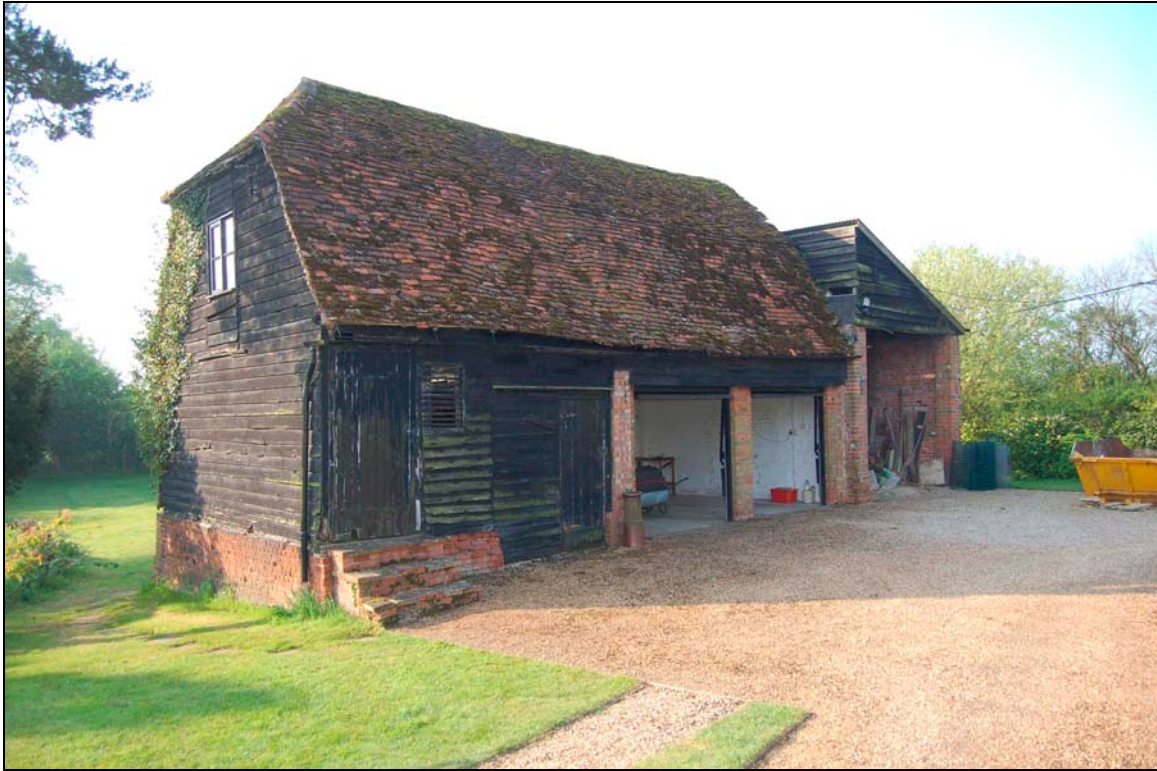
Plate 1 Granary viewed to south

Where original walls remain, they are set on a brick plinth constructed from English-bonded 9" soft red bricks, indicative of a 19th-century date (Ryan 1996). The plinth is highest at the north-east end, where the ground slopes down towards the pond. It has a pegtiled gambrel roof, half-hipped to the north-east (plate 1).

The main **north-west elevation** (plates 1 & 2) faces onto the driveway and grounds of the house. On the left side are modern brick steps leading to an original strap-hinged, ledged and braced boarded door, opening onto the stairs to the first floor. Separated by a wooden air vent is a modern doorway, which, unlike the other, is cut through the plinth. The door here is braced and boarded and set on steel T-hinges. A wide wooden lintel over the door corresponds to a break in the boarding that suggests there was a wider doorway here before, probably for carts (plate 1). Beyond the doorway to the south-west, brick piers have replaced the studwork walls to create two garage bays with electric doors.

has been inserted just below the hip, occupying the position of a former loading-door, whose outline may still be seen below the window (plate 1).

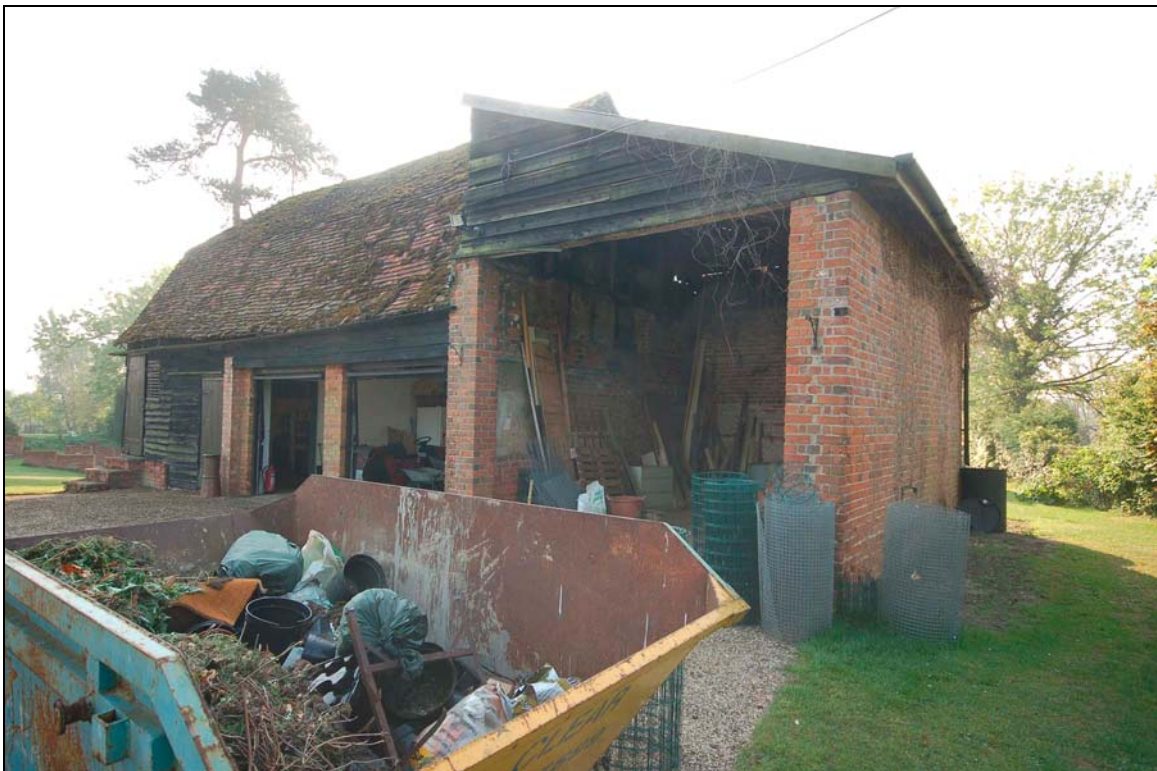
Plate 2 Granary viewed to east

The building comprises a timber-framed and weatherboarded granary and a tall square brick structure, not mentioned in the List description, but possibly a former kiln to an earlier malthouse, not previously identified (plates 1 & 2).

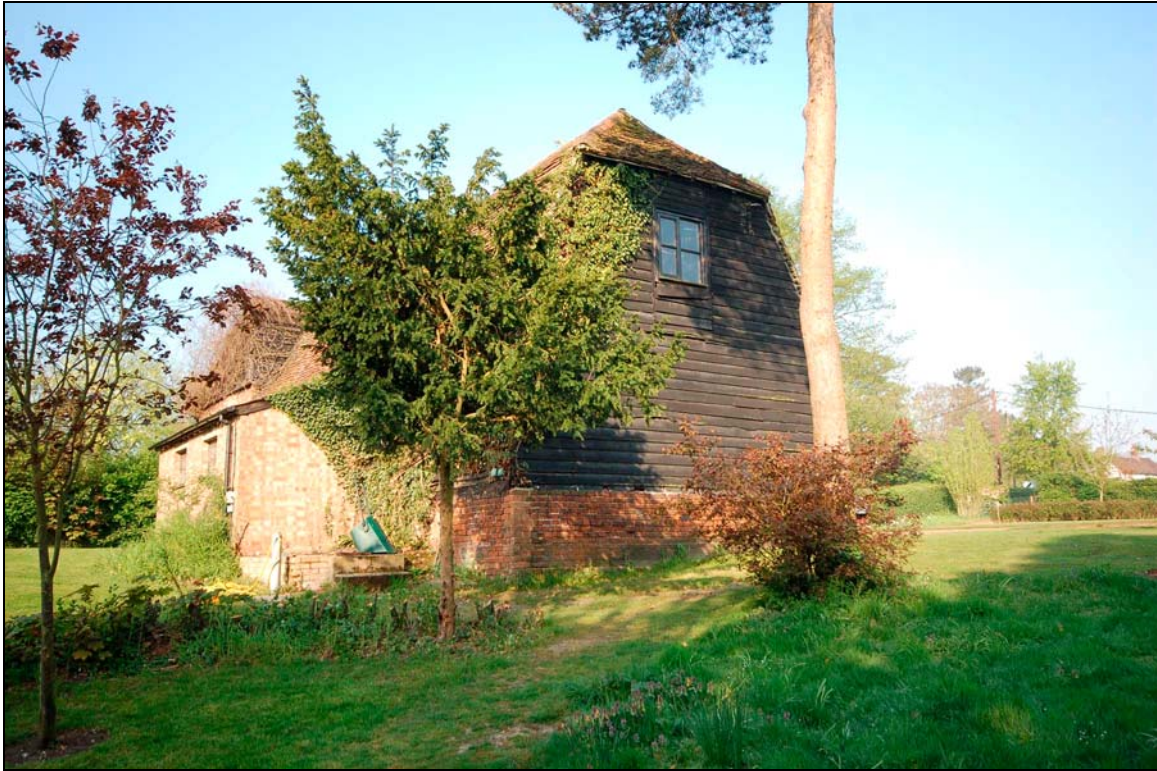
Plate 3 Granary viewed to west

The half-hipped **north-east elevation** (plate 3) has been altered very little, leaving the brick plinth and weatherboarding largely intact. However, a modern four-light casement window

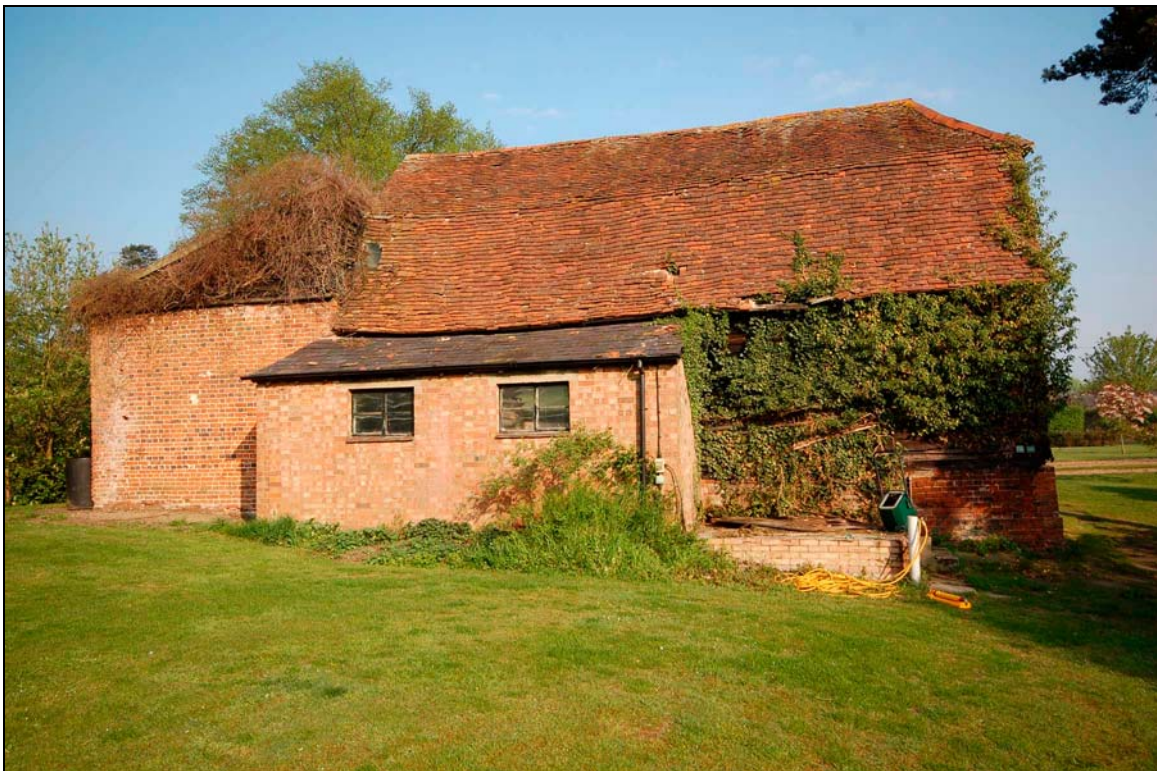
Plate 4 South-east elevation

Much of the **south-east elevation** (plate 4) is obscured by a modern single-storey extension, built from Fletton bricks, which is to be retained in the conversion plans. It has modern casement windows and a lean-to slate roof. Next to it is a redundant Fletton-brick base to a former greenhouse. Ivy covers the external cladding.

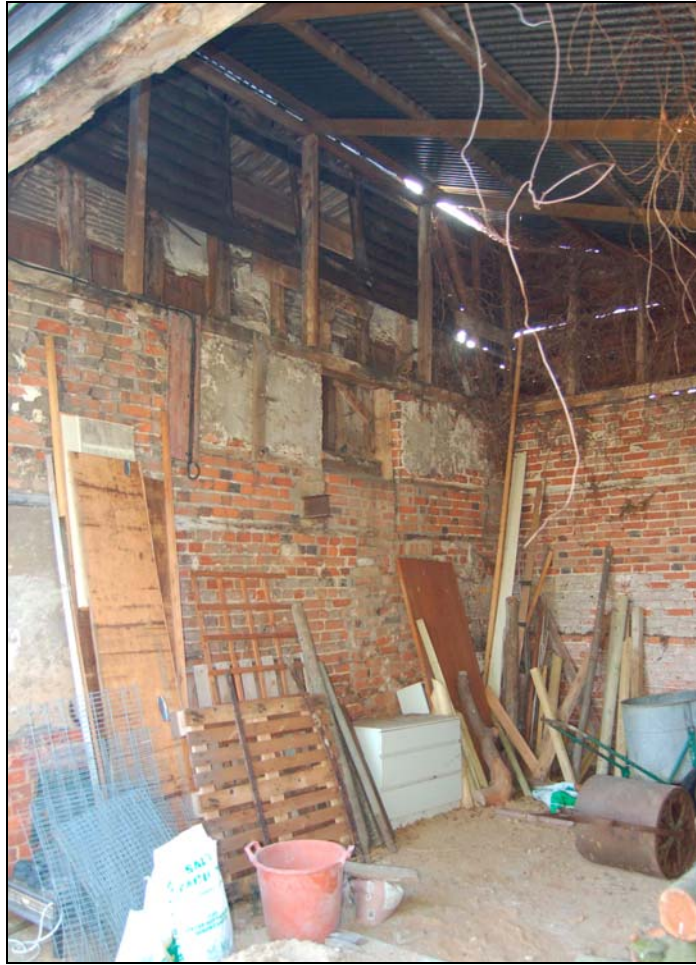
Plate 5 South-west wall of granary and former kiln interior

The **south-west elevation** is built onto the north-east brick wall of garage (2) and is essentially part of the interior of building 2, though is worth mentioning here. The shared brick wall below eaves level shows redundant features associated with former use (plate 5), namely a blocked ground floor former doorway and wall hatch/window (fig. 5), and a first floor loading door (fig. 6). The wall plate that supports the granary gable rests on the top of the brick wall, with studs rising up to the ridge, the upper part of which is still clad in weatherboarding. Above the hatch, midway up the gable, are the remains of a wall vent that would have provided through-ventilation to the granary (plate 5).

At the south-west end (plate 12) there are several features of note. Here, the gable next to the former kiln is lime-plastered on crude laths to the top of the bins. At floor level is a long partly-blocked hatch into the brick structure, interpreted as a former loading hatch onto the kiln floor, which was subsequently blocked when the granary was established. There are still fixtures for small doors on the outside of the wall and evidence for a low, partly blocked access door in the open part (plate 5). The surviving wall vent above it has a hexagonal

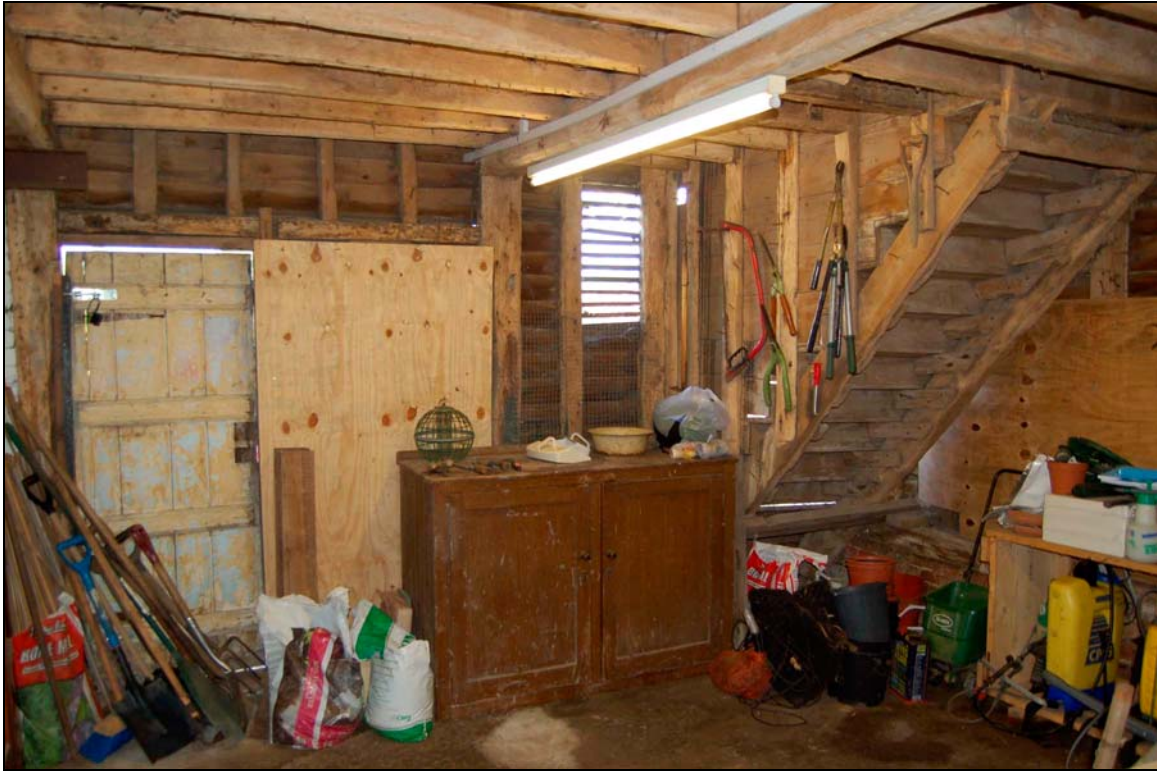
The stair is enclosed by 9 inch elm boards, neatly fitted around the treads, leaving the underside exposed (plates 6 & 7).

Plate 6 Interior of garden store viewed to north-east

Plate 7 Interior of garden store viewed to north-west

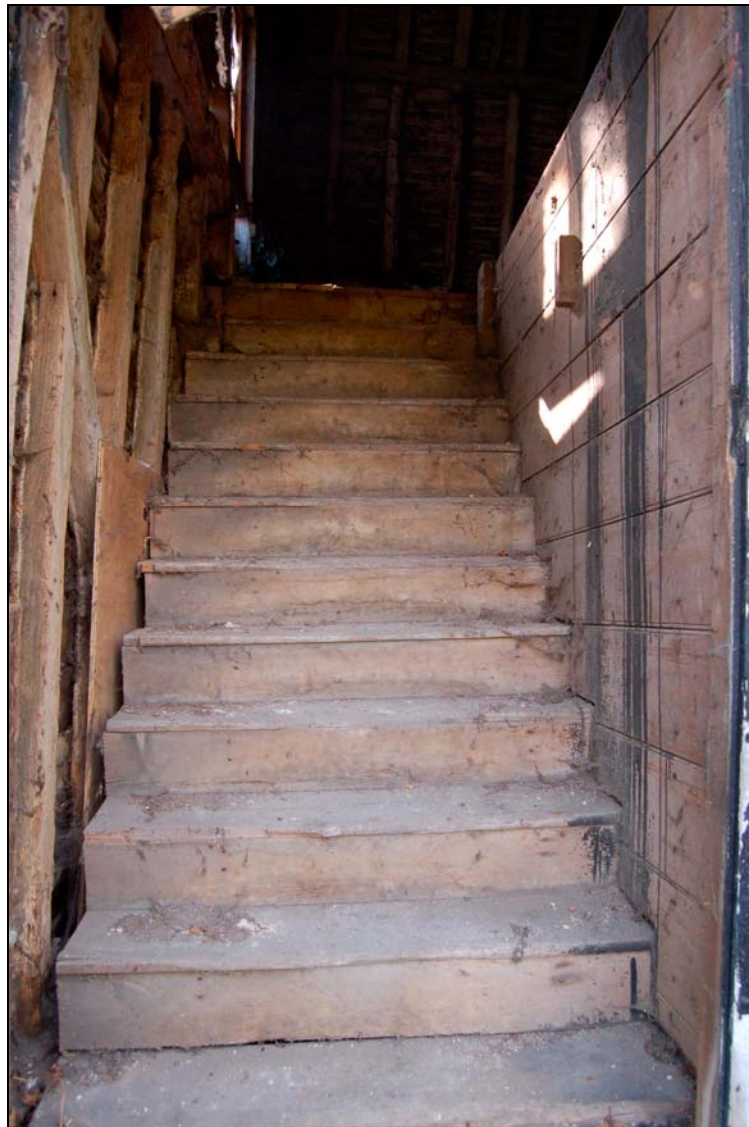
Plate 10 Granary stairs

Entry onto the first floor was by the stairs in the north-east bay (plate 10) but there was also a loading door on the north-east gable, perhaps associated with a hoist or lucam that is no longer present.

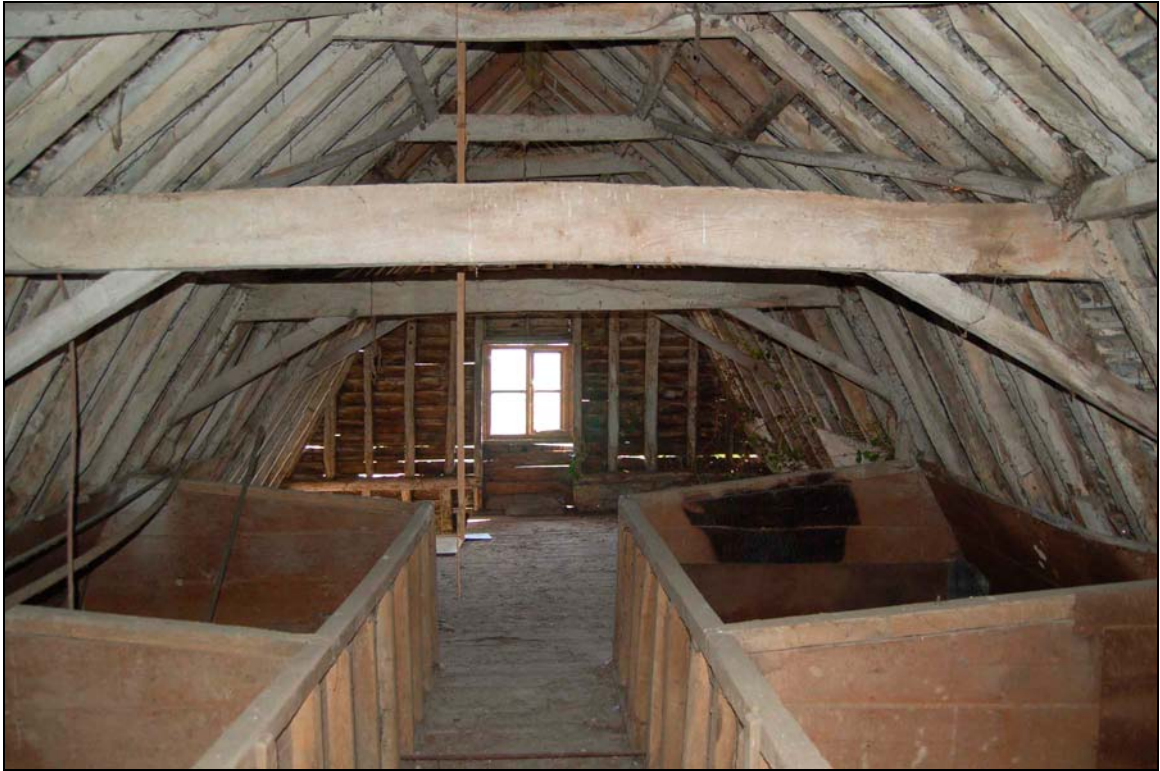
Plate 11 Granary interior viewed to north-east

The first floor (plates 11 & 12) survives with no obvious modern disturbance. At this level there are four slightly wider c.5m bays, represented by narrow roof trusses. The first two bays are open-plan with 9 inch floor boards, a few of which are in poor condition and boarded-over. A small, 35cm-wide trap door with crude wrought iron T-hinges, perhaps to supply the horses below with feed, is located in the second bay (fig. 5, plate 13). There is no sign of any other trap doors.

Within the north-east gable is a former loading door, shown by a break in the wall, which was blocked when the modern window was fitted (plate 11).

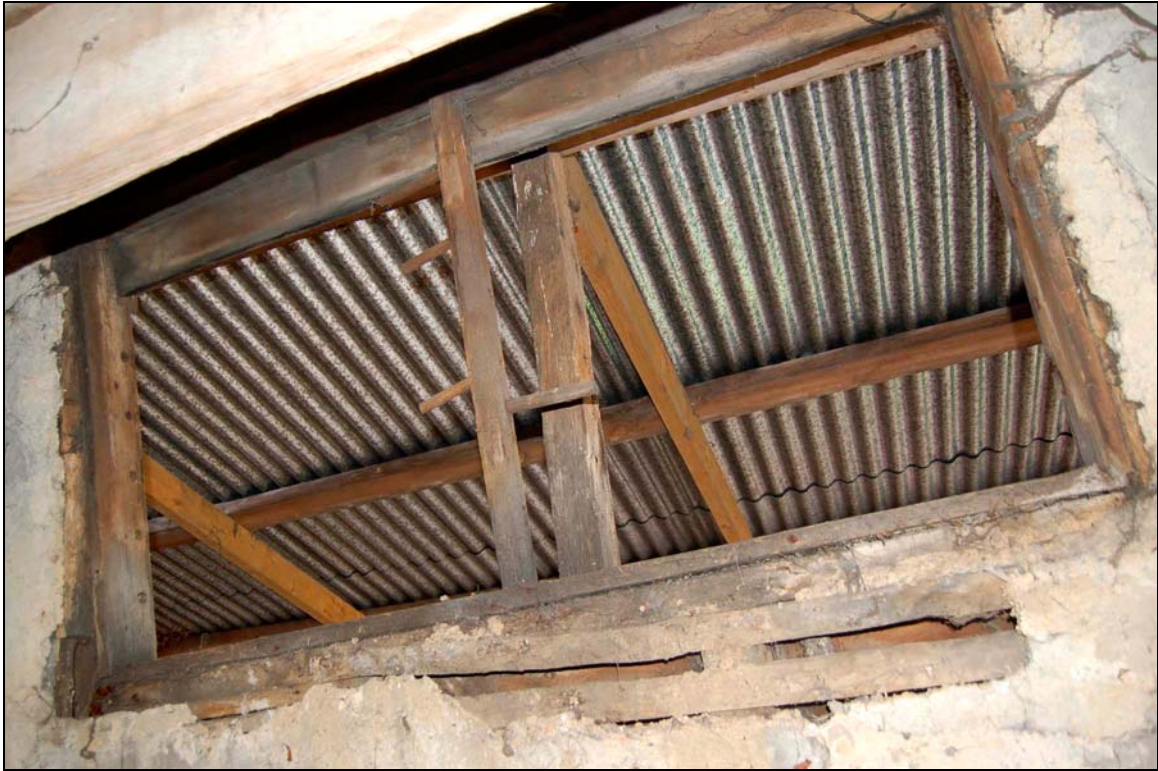
Plate 15 Former vent at south-west end of granary

central shaft that originally held doweled wooden grills, short pieces of which remain (plate 15).
