# HOUSE EXTENSION AT PLEACHFIELD, VICARAGE ROAD PLESHEY ESSEX

## **ARCHAEOLOGICAL MONITORING**

October 2010

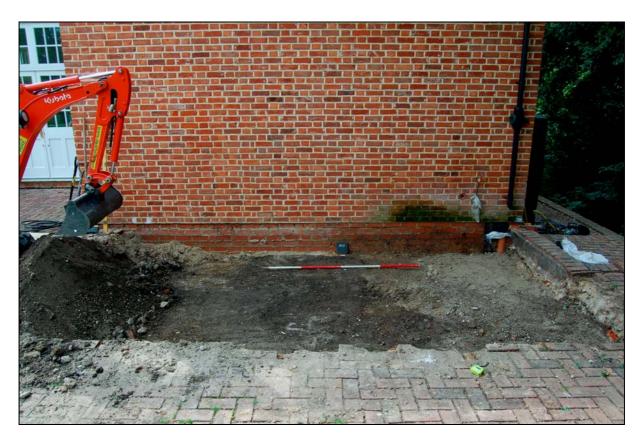
Plate 1 Monitored area viewed to south-west

Up to 0.5m of modern bedding (context 1) was removed by machine onto a dark silty clay 19th-century garden soil (context 2) overlying natural chalky boulder clay (context 3) that sloped downwards towards the ditch (fig. 1, plate 1). The north-western end of the trench was occupied by modern brick rubble and sand behind the retaining wall for a patio built against the slope of the ditch (plate 2). No archaeological features were observed to represent either occupation of the site or the earthwork bank, and all finds were post-medieval or modern in date.

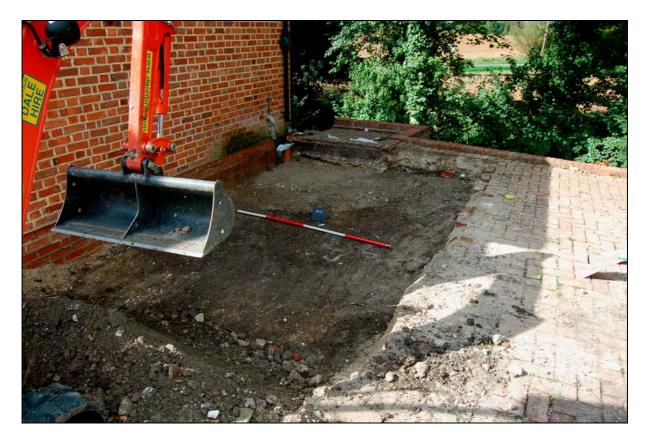
Plate 2 Monitored area viewed to north-west, overlooking the bailey ditch
