FERNHALL LANE RISING MAIN WALTHAM ABBEY

ARCHAEOLOGICAL MONITORING

Fernhall Lane Rising Main, Waltham Abbey, Archaeological Monitoring HER Summary Report

Prepared for Optimise / Thames Water

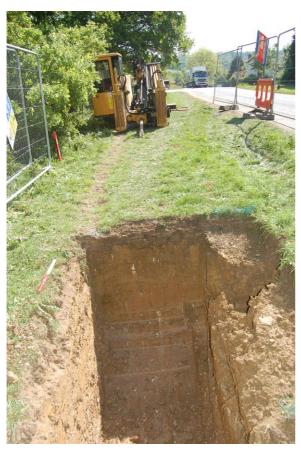
Plate 1. Pit 1 (looking east)

The launch/receptor pits were excavated by a wheeled excavator with a bladed bucket. They were 1.2m wide 2-3m long and 1.5-1.8m deep. Topsoil and subsoil were 0.3-0.4m thick and rested on an underlying deposit of clay with chalk and flint pieces. There were fewer inclusions in the clay encountered in the pits to the east of Fernhall Lane. The British Geological Survey map the underlying clays as Lowestoft Formation (the chalky clays) and London Clay, the latter the cleaner material encountered in the pits to the east of the road (Fig. 2).

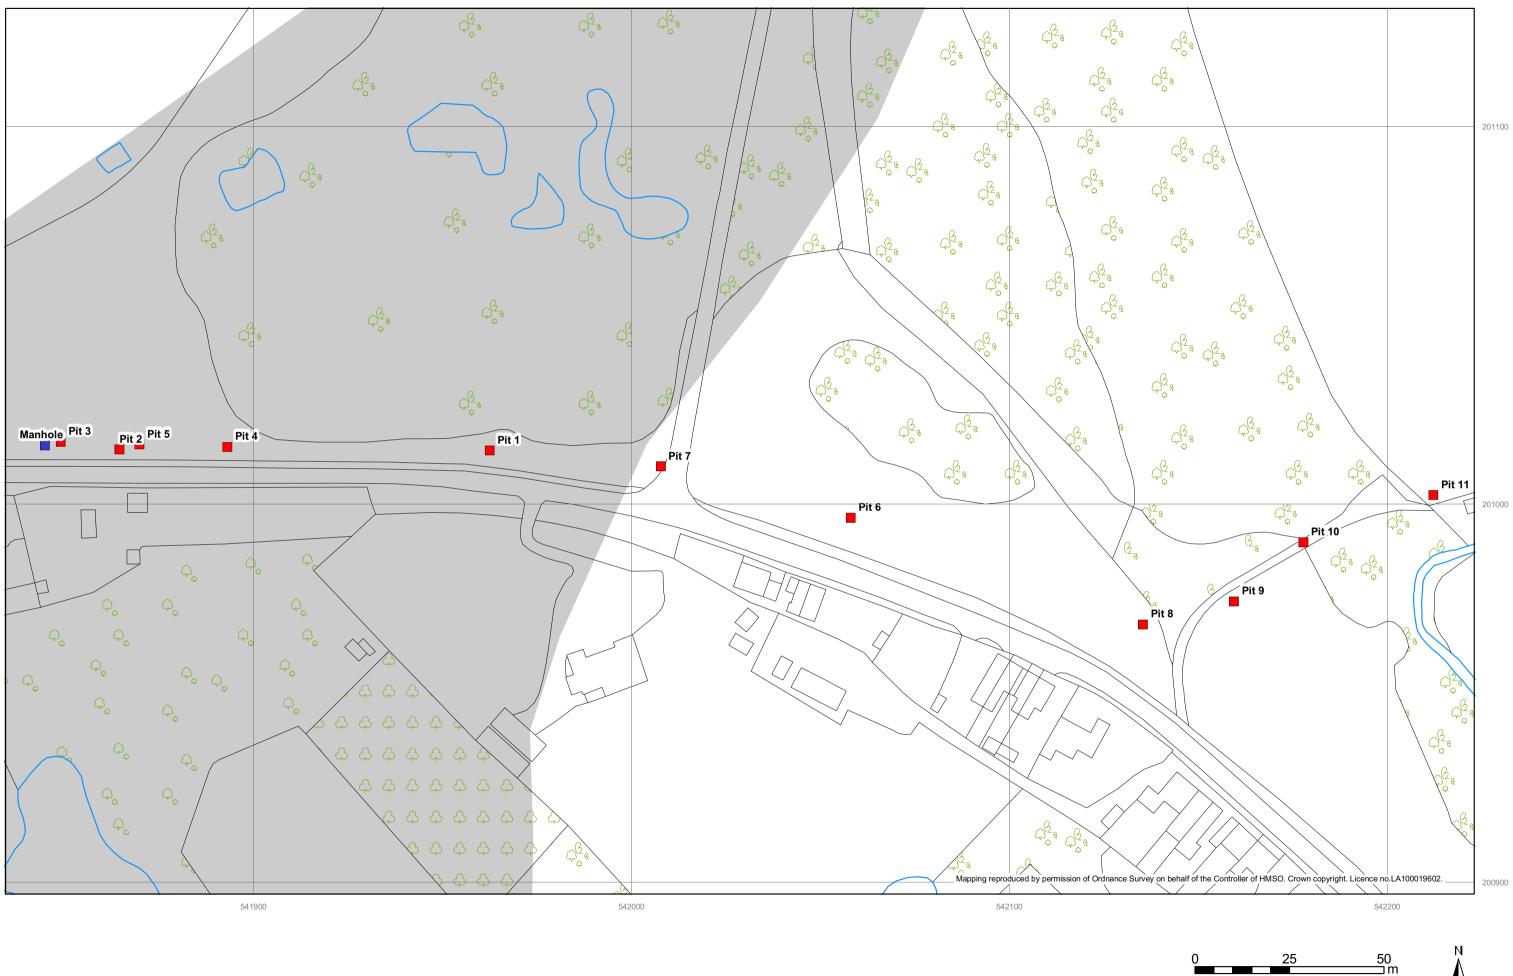
Fig.2. Extents of Lowwestoft Formation Deposits, derived from BGS mapping

rested on an underlying deposit of clay with chalk and flint pieces. There were fewer inclusions in the clay encountered in the pits to the east of Fernhall Lane. The British Geological Survey map the underlying clays as Lowestoft Formation (the chalky clays) and London Clay, the latter the cleaner material encountered in the pits to the east of the road (Fig. 2).
