**LAND ADJACENT TO 1-3 EASTERN ESPLANADE
CANVEY ISLAND
ESSEX**

ARCHAEOLOGICAL MONITORING

Land adjacent to 1-3 Eastern Esplanade, Canvey Island

HER Summary Report

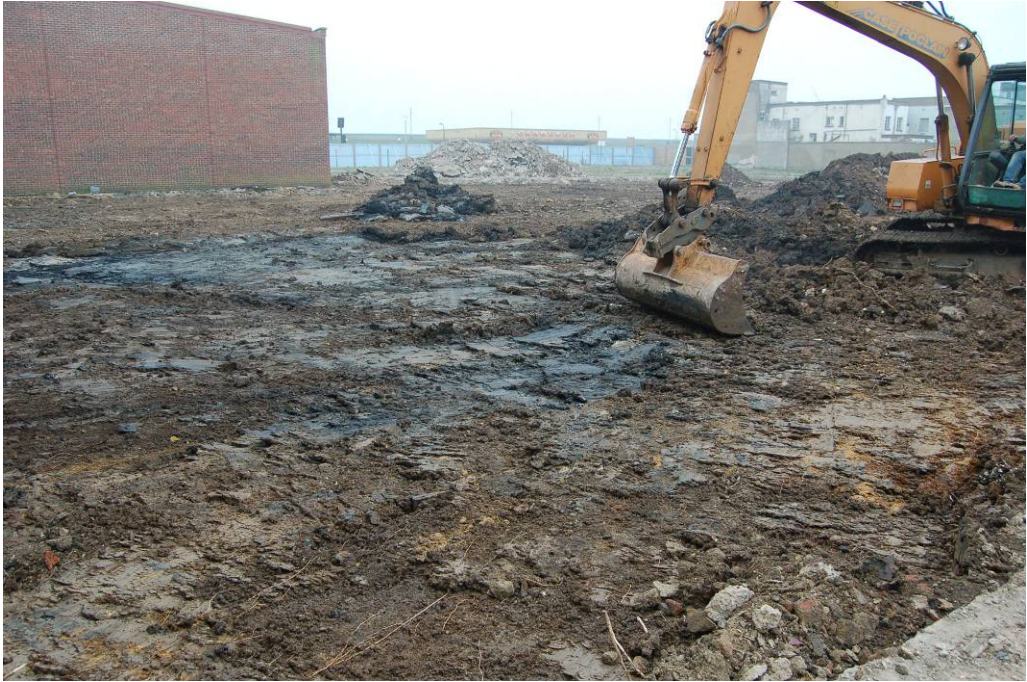
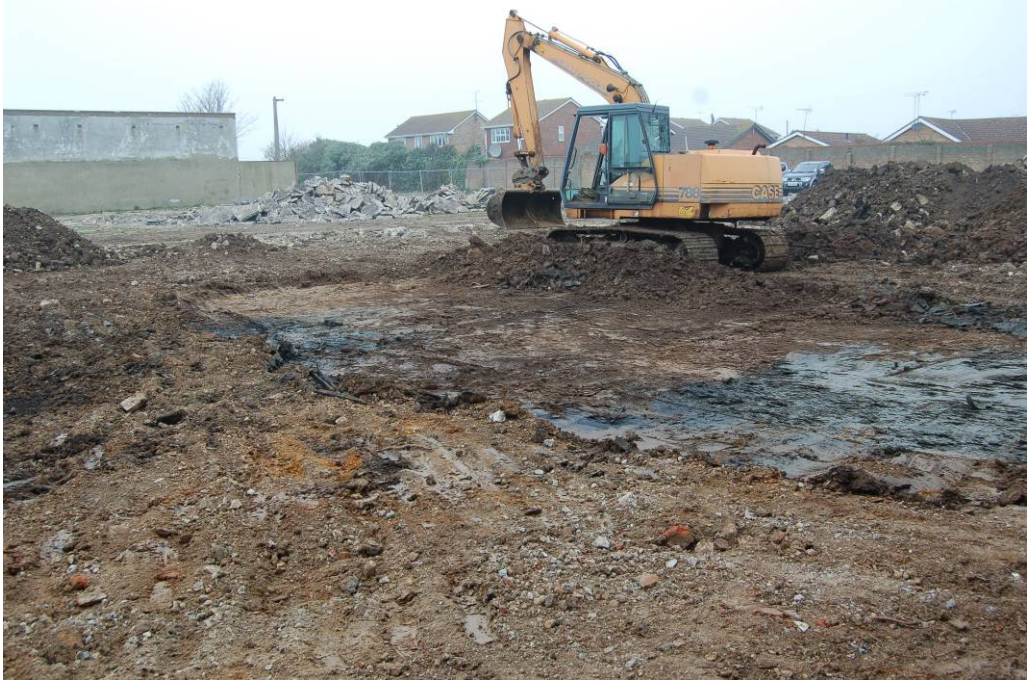
Plate 1 and 2: Levelling following the removal of hardstanding, Block C

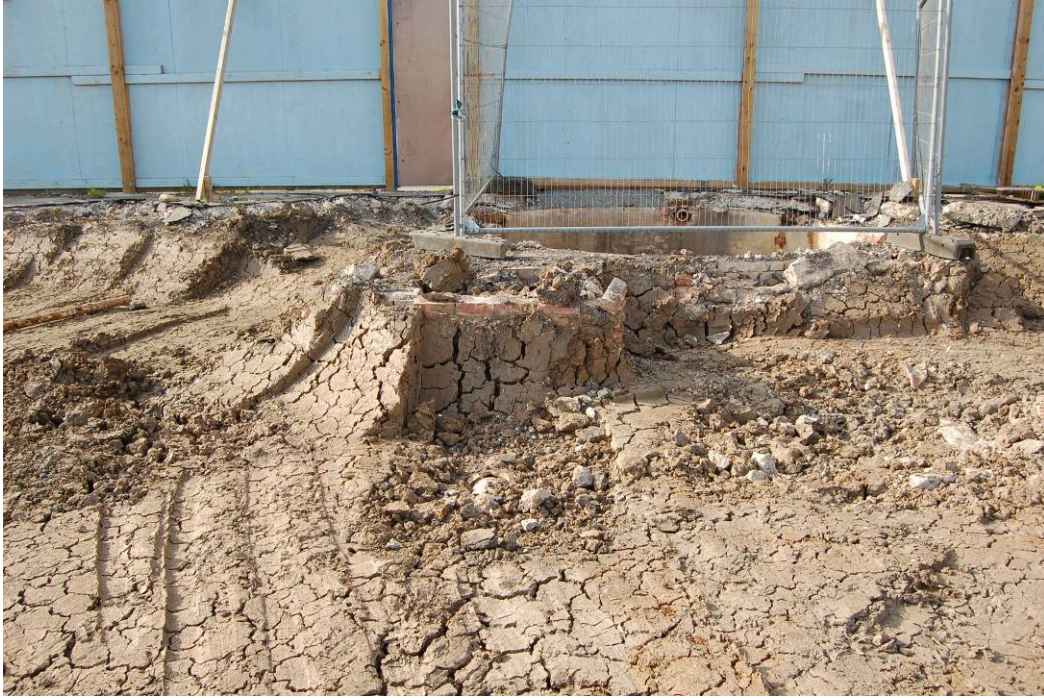
No archaeological features were identified in any of the building plots. In each case the natural subsoil, where exposed, comprised greyish brown alluvial clay, consistent with British Geological Survey mapping. In the case of Block A this was relatively undisturbed, although it was crossed by a number of services. Blocks B and C were heavily disturbed by modern services, particularly drains, and patches of black 'oily' clay were noted, along with patches of hogging and crushed hardcore. Blocks D and E, along the frontage, were heavily disturbed and crossed by numerous services, they were also the site of a large concrete-lined drain access shaft and the pad foundations of the two-storey casino.

Plate 3: Concrete lined access to drains, located on the frontage between Block D and E

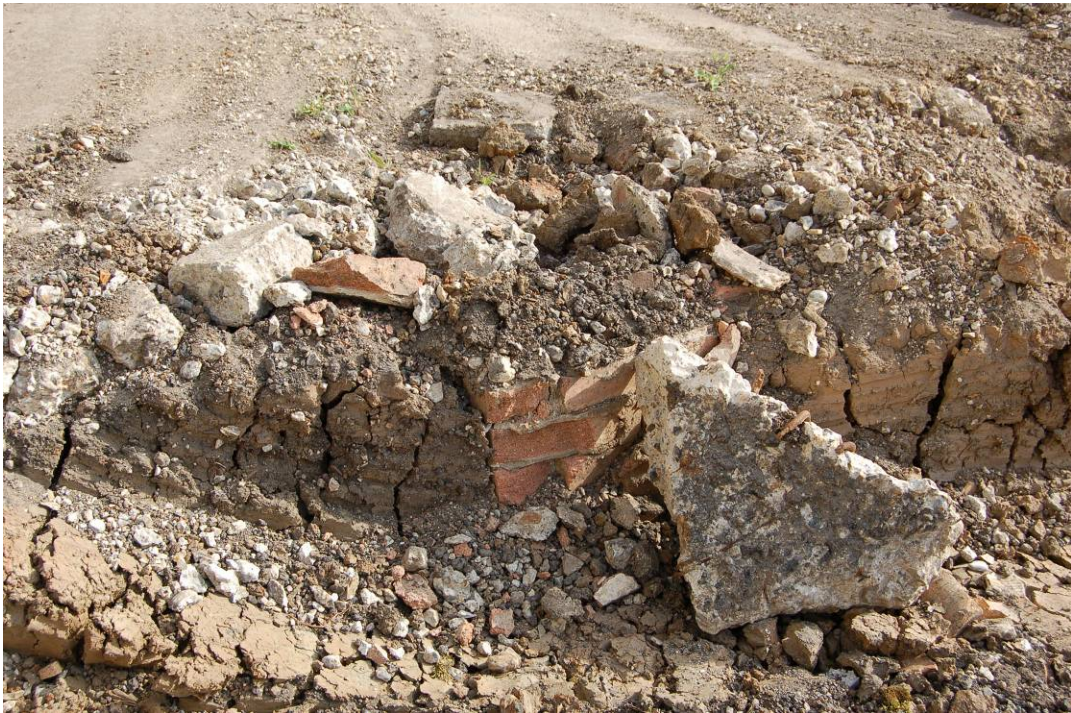
Plate 4: Remnant of brick pad footing from the 1930s casino
