**MANÈGE AT COLEMAN'S FARM
LITTLE BRAXTED ROAD
RIVENHALL**

ARCHAEOLOGICAL MONITORING

June 2011

HER Summary Report

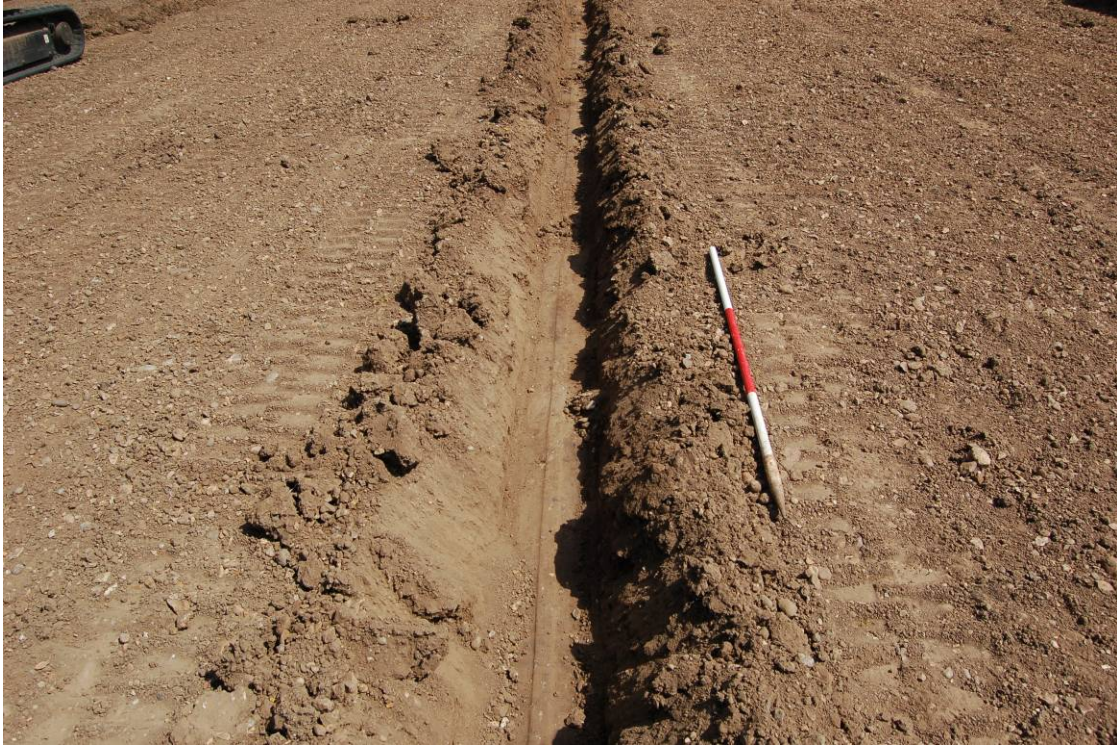
Plate 3: Detail showing location of Ditch 2 in drain run

Features 2 and 3 comprised similar areas of sands and gravels in an orangish brown/gray silty sand, 2m and 3m wide respectively (Fig.2). This material may be the fill of the two trackway ditches which were identified on the cropmark plots (Fig. 3) although it is noted that the projected alignment of the features noted in the field differs from that of the cropmarks, although this is not surprising given the limited visibility. No dateable artefacts were recovered.
