**LAND OFF TYLERS CLOSE
WEST OF GREENWAY
BUNTINGFORD
HERTS**

ARCHAEOLOGICAL EVALUATION

**Essex County Council
Field Archaeology Unit**

JULY 2011

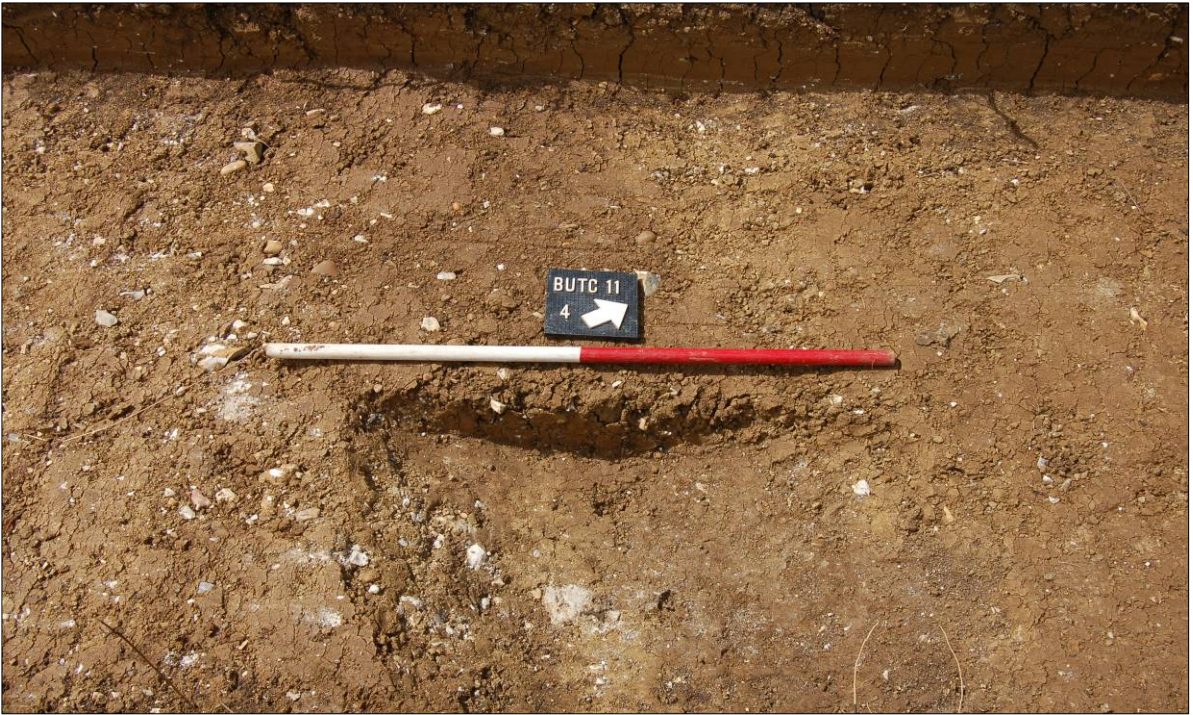
Plate 1: Ditch 4 – Trench 5 (1m scale)

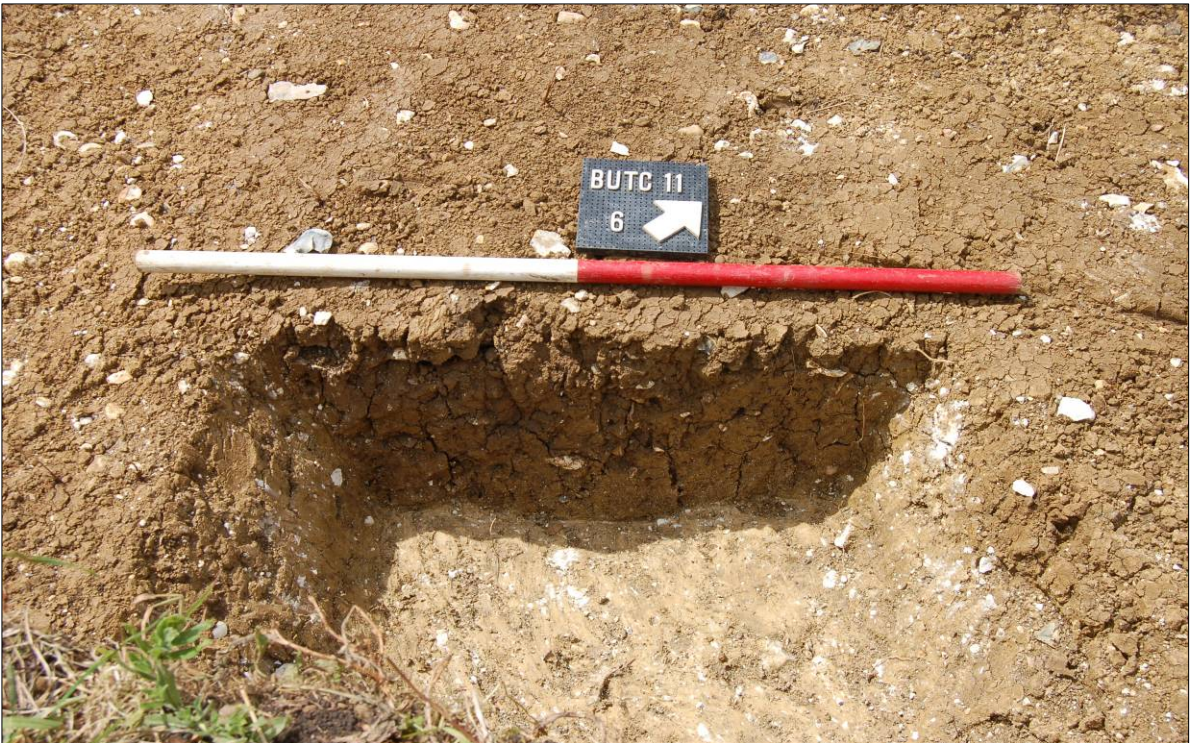
Plate 2: Ditch 6 – Trench 5 (1m scale)

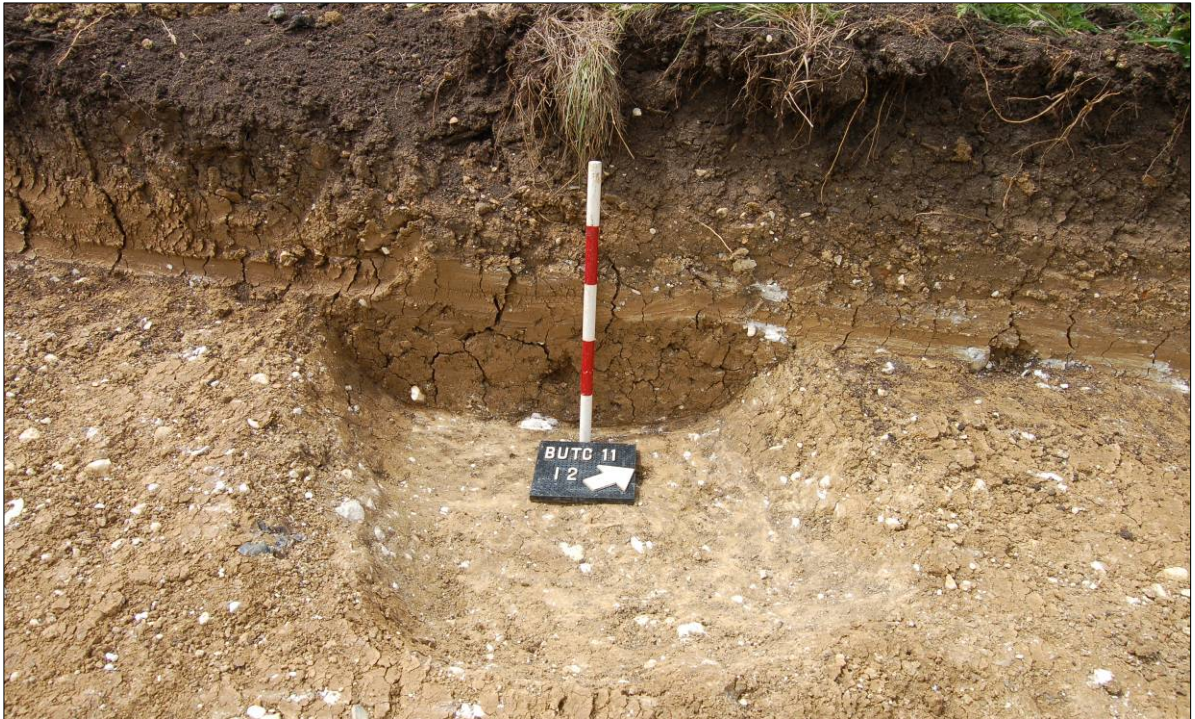
Plate 3: Pit 12 – Trench 5 (0.5m scale)

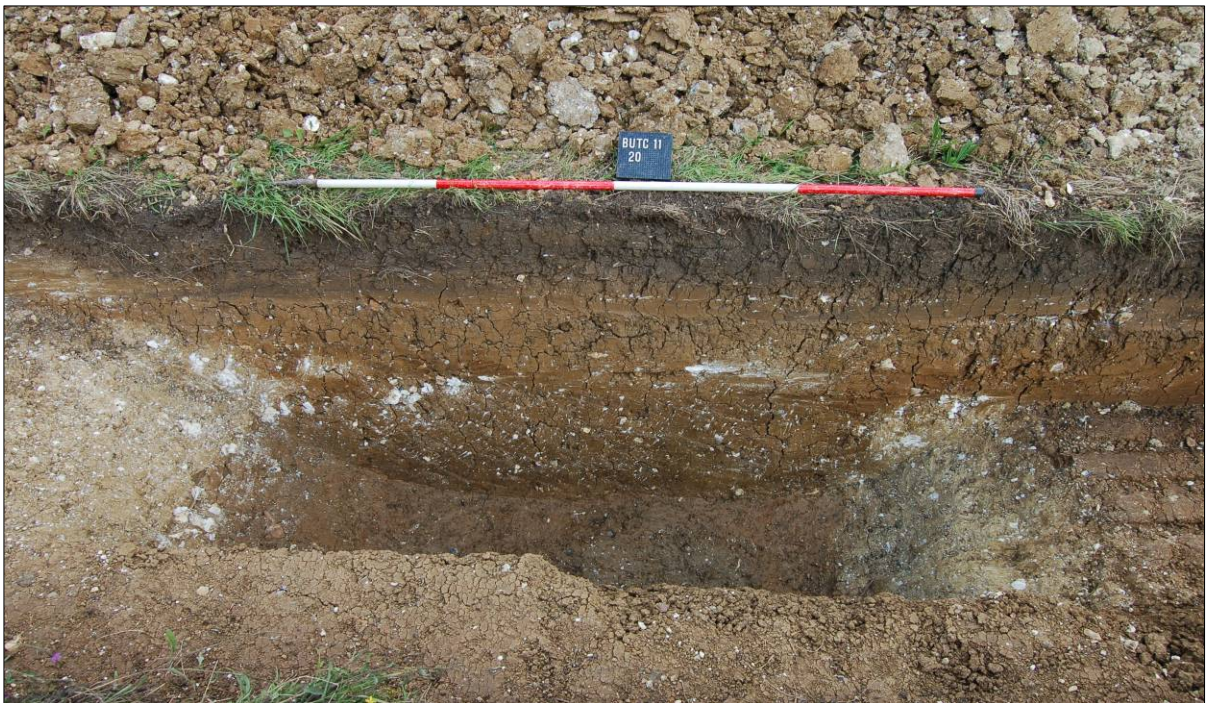
Two features were identified at the south end of trench 14. Ditch 20 (Fig. 5, Section 3), aligned east/west, was 2.98m wide by 0.7m deep, with 45° sloping sides and a flat base. Several sherds of 12th to 15th century pottery and roof tiles, as well as a piece of residual, Roman roof tile, were found in its mid greyish brown sandy clay fill (21). Poorly defined gully (35) was 0.45m wide by 0.08m deep and ran north-west/south-east across the south end of trench 14 and east end of trench 15. No finds were recovered from its dark greyish brown silty clay fill (36). Both features were sealed by a probably colluvial layer (32), which was observed at the south end of trench 14 and along the whole length of trench 15. The layer

A total of thirteen sherds, weighing 77g were excavated from four contexts. Ditch 20 and gully 34 produced pottery most likely dating to the 13th to 14th centuries, although most is abraded and undiagnostic. Finds in ditch 20 include examples of Sandy Orange Ware, two of which show lenses of white clay in the fabric, similar to fabrics found at Thaxted, not far away in north-west Essex. A sherd of South Hertfordshire Greyware showing rilled external

Plate 4: Ditch 20 – Trench 14 (2m scale)
