**5-11 WORSHIP STREET
ISLINGTON
LONDON EC2**

HISTORIC BUILDING RECORD AND PHOTOGRAPHIC SURVEY

Report 2359

September 2011

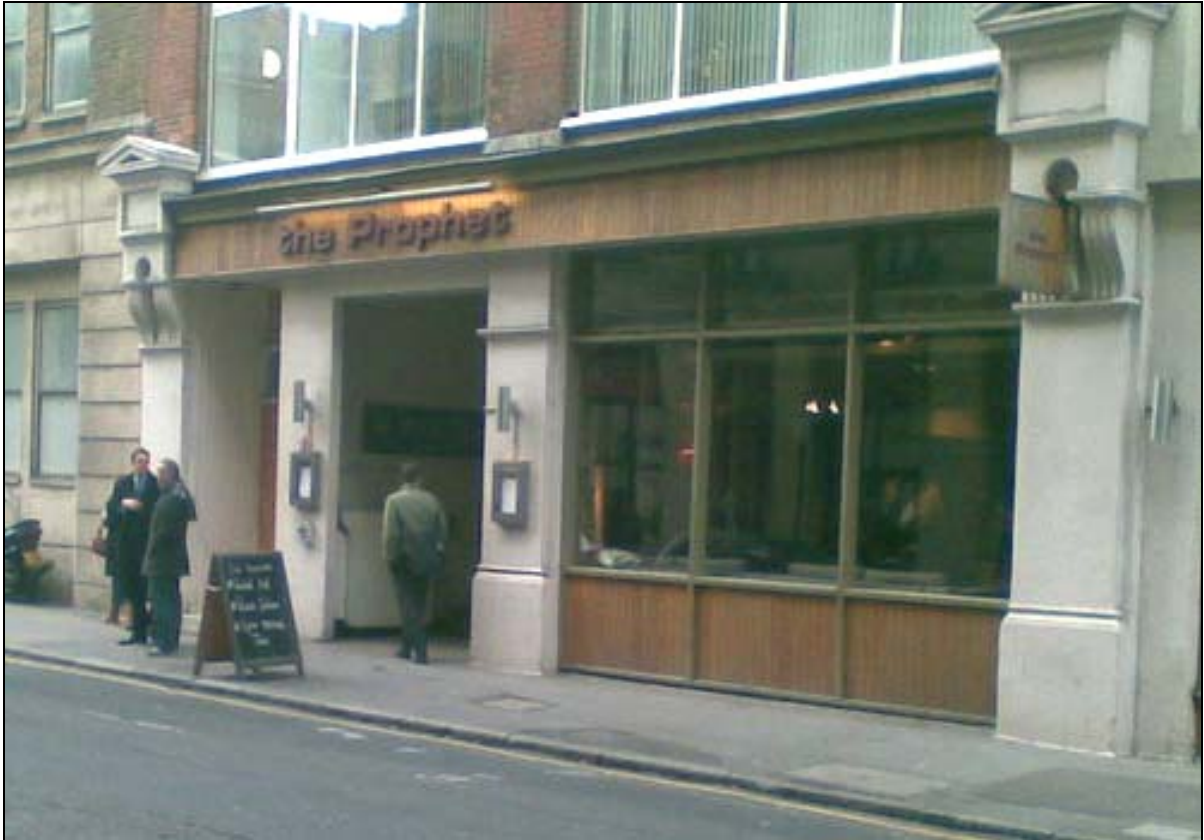
Plate 1: Nos. 5-7 viewed externally before the fire (www.restaurantvoucherslive.co.uk)

At ground level (plate 5) there are three square limestone piers, the outer two of which terminate in projecting Classical-style corbels (plate 1). The corbels have scrollwork decoration and connect to a narrow moulded band (plate 6). Such features are common to the late 19th/early 20th century shops and businesses along City Road (plate 7), but tend not to have survived along Worship Street. Otherwise, the façade on this level is modern, though

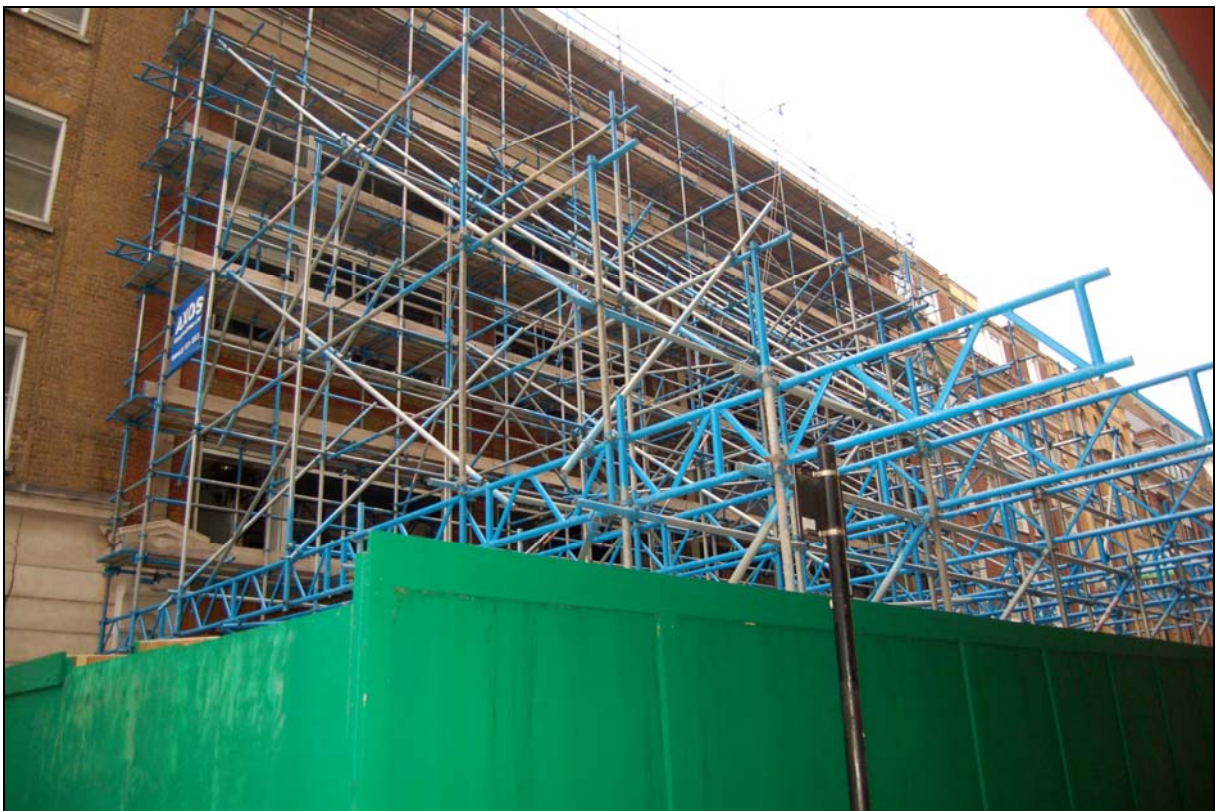
Plate 4 Scaffold across facade

The main Worship Street façade is covered in scaffold (plate 4). Although difficult to see it is built in pier and panel construction on four broadly identical levels, apart from the ground floor whose original form was altered when the bar was created.

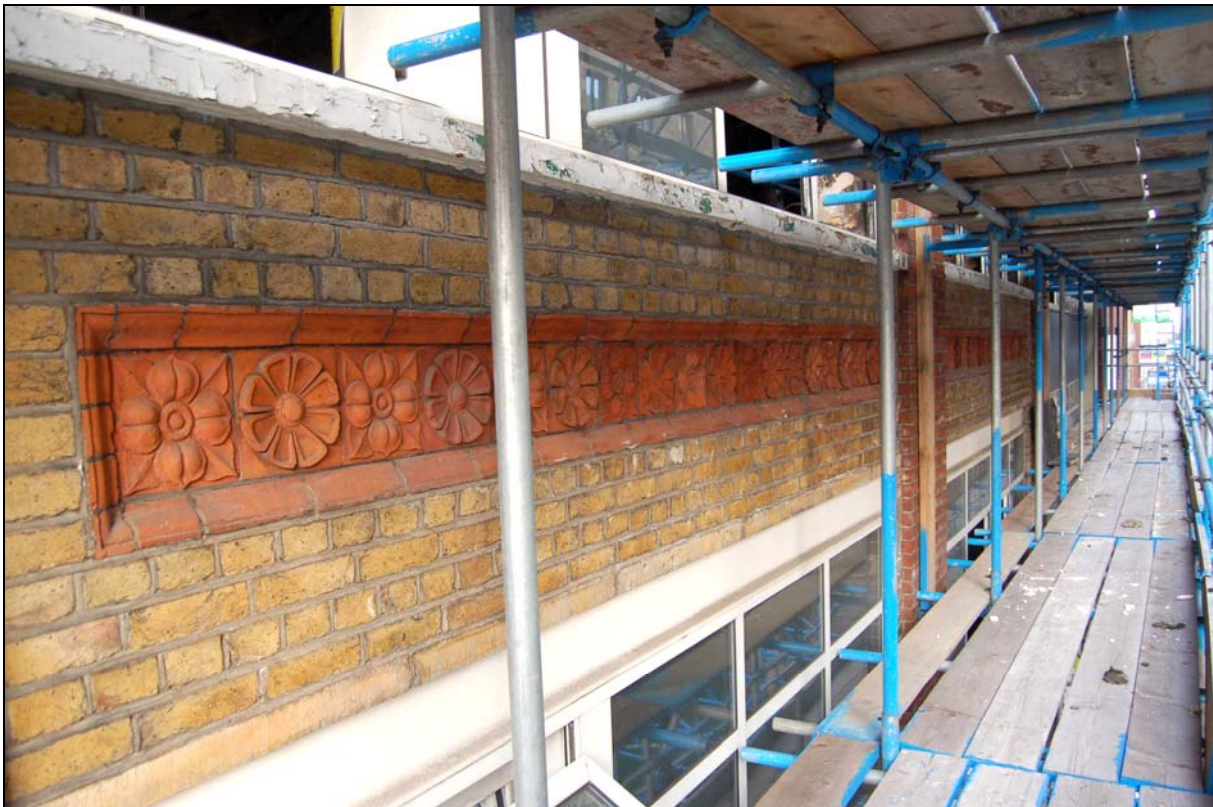
Plate 8 Terracotta frieze

The piers continue from first to third floor in English bonded red brick, with contrasting panels of Flemish bonded yellow stock brick between. Large modern windows are inserted within the panels that sit within original apertures, with codestone sills and iron lintels representing the frame. Above the lintels on the first and second floors are long terracotta floral friezes between the piers (plate 8). Again, similar features can be seen on buildings along City Road and form part of the character of the Conservation Area.

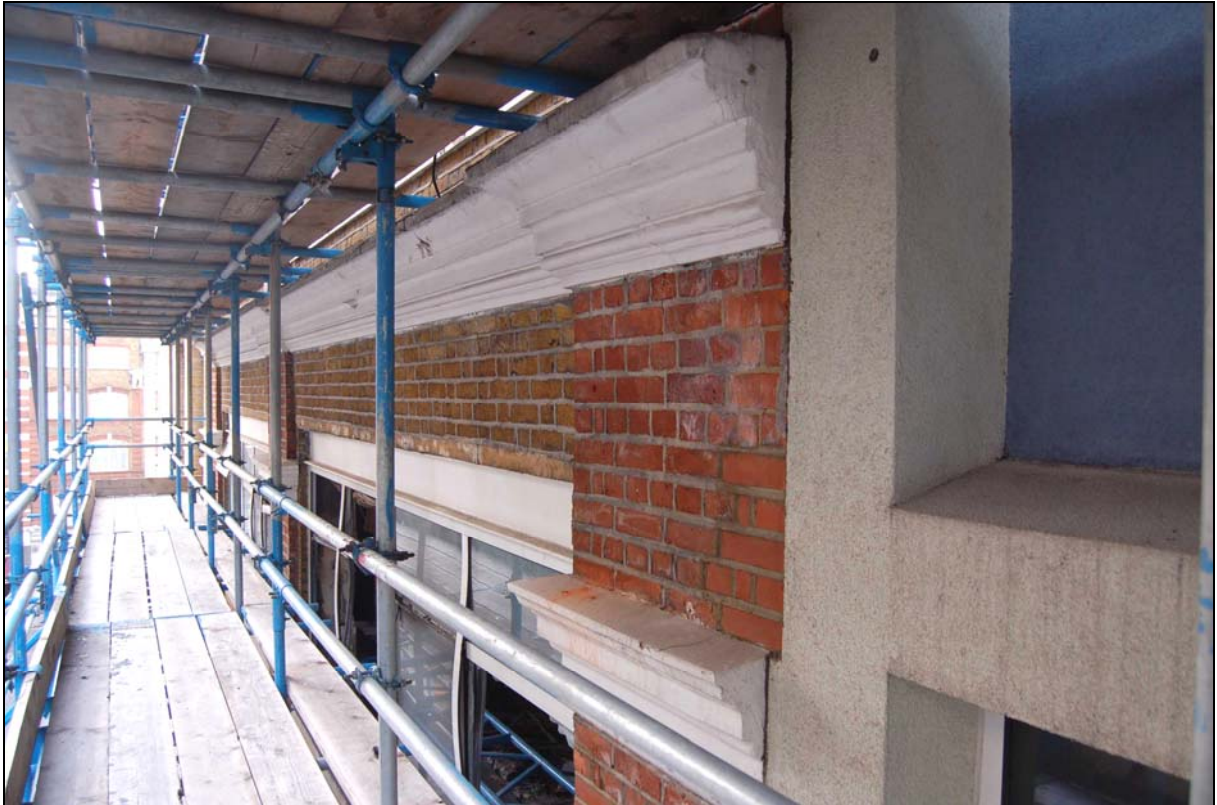
Plate 9 Cornice to original roofline

The late 19th century structure finished on the third floor with moulded limestone capitals to the piers at sill height and a moulded cornice above (plate 9), the height of the original roof. In the modern build above, the pier and panel form is continued in modern yellow and red bricks onto the fourth floor and mansard roof (plate 10) but neither displays any features architectural interest.

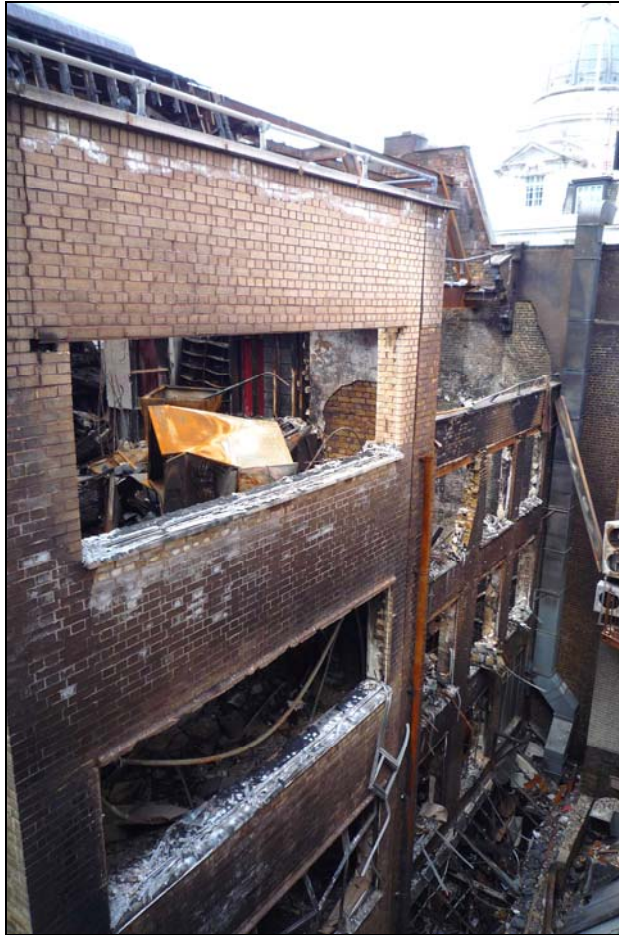
Plate 11 Fire-damage rear elevation viewed to south-west

The rear (north) elevation was not viewed in the survey but photographs supplied by the architects show a simpler form built entirely of yellow stock bricks on four levels, with three windows per floor (plate 11). Part of the outline of the original roof can also be seen in plate 11 below the modern Mansard roof.

The rear and side walls are built of brick (plate 11), part of which to the back at least, incorporates late 19th century brickwork.

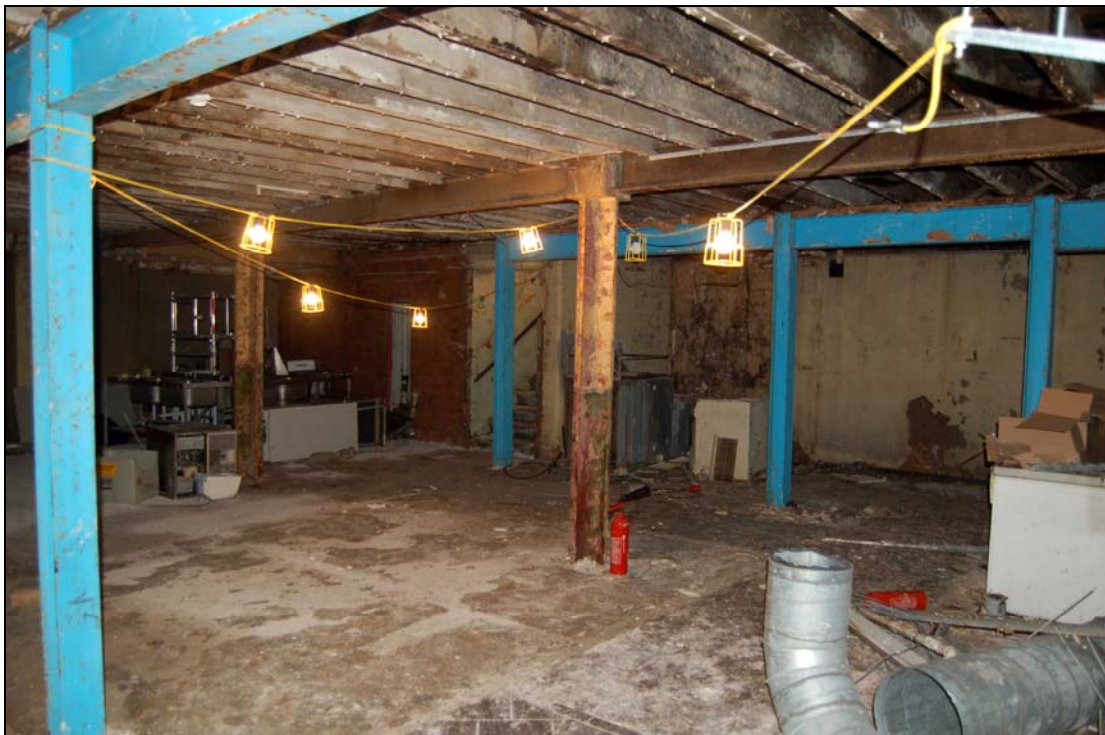
Plate 12 Basement under nos. 5-7 viewed to south-west

The basement is entered by steps beside the main entrance. Originally this level was divided into two bays by a heavy iron joist frame but since the fire a steel frame has been added, to support the floor above (plate 12). Exposed late 19th century brickwork was observed in the dividing wall between nos. 7 and 9, laid in English bond, which was often used in industrial buildings for its strength. Beneath the stairs is a storage area, retaining an original doorway (plate 13), inside which is an old plaque on the south wall that reads 'Providence Row 17' (plate 14). The location of the plaque and its stainless steel frame indicate it was fitted to the wall in the modern period, perhaps as a feature of the bar, although it was potentially salvaged from one of the earlier buildings on the site or elsewhere along the street after Providence Row was renamed Worship Street.

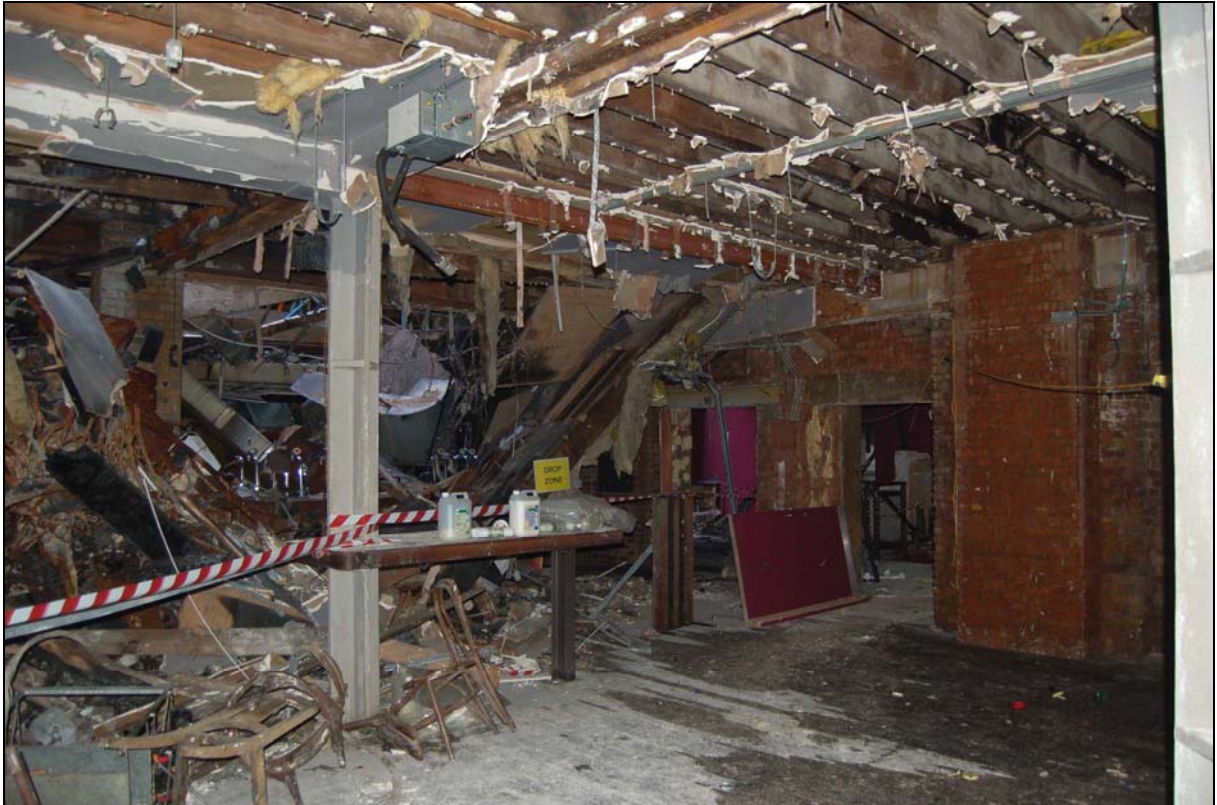
Plate 15 First floor of nos. 5-7 (bar) viewed to east (nos. 9-11)

The rear of the ground floor is covered by the drop zone for debris and fire-damaged material from the upper floors (plate 15) and was not accessible. The east wall of the building contains yellow and red stock bricks in a crude form of English bond. All doorways between this and No. 9, where the bar finished, have concrete or steel lintels, dating either to when the buildings were amalgamated or when the bar was created.

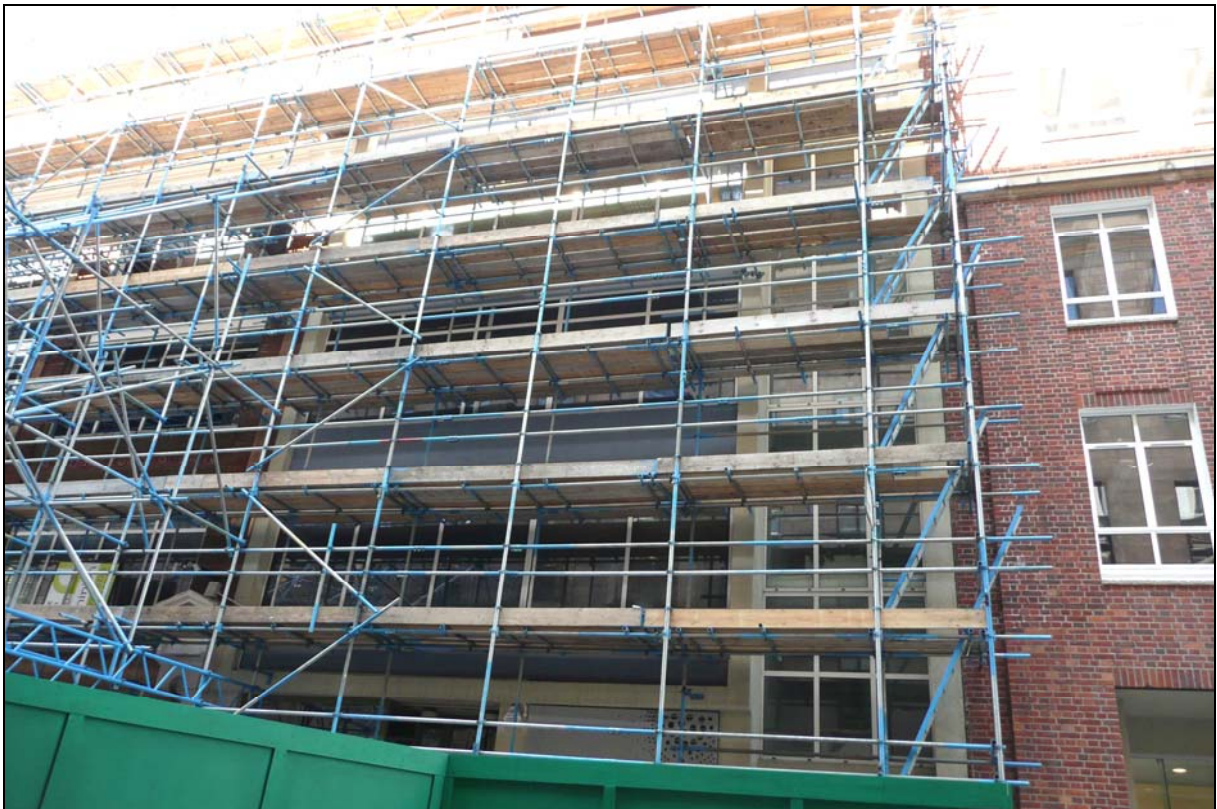
Plate 16 9-11 under scaffold

9-11 Worship Street was rebuilt in the 1950s to replace a bomb-damaged late Victorian industrial building, built soon after 5-7 in the 1890s and likely to have been of similar construction and design. Since refurbishment in the early 2000's, the basement and ground floor of No. 9 was part of the bar while the storeys above formed part of Henry Thomas House, whose main entrance was at the front of no. 11. Like its neighbour, the façade was covered in scaffold during the survey (plate 16).

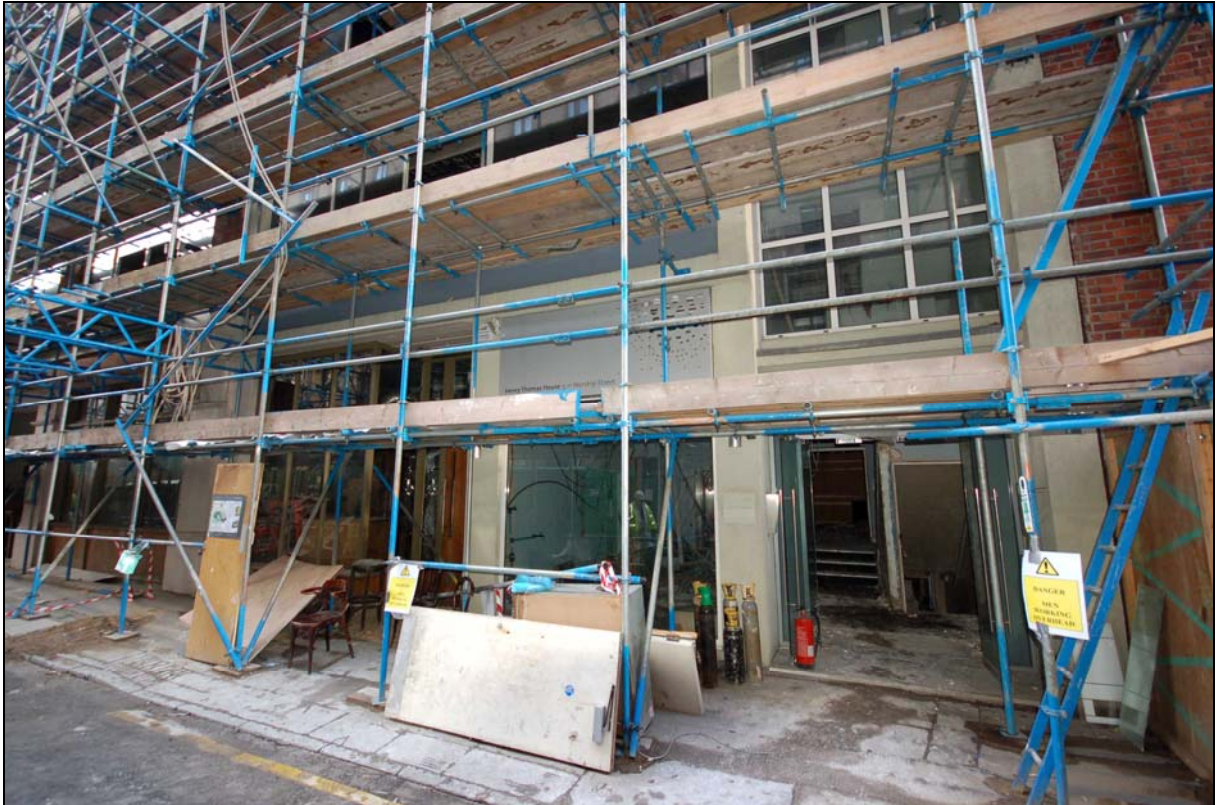
Plate 17 Ground floor frontage of nos. 9-11

The structure is built on a reinforced concrete frame. Apart from the modern glazing and entrances on the ground floor Worship Street façade (plate 17) each level up to the fourth floor is characterised by wide modern office windows (probably fitted in 2002/3 with those next door), with blue panels in between (plate 16). The only exception is the stair bay to No. 11 which is glazed above the main entrance, up to the top floor.

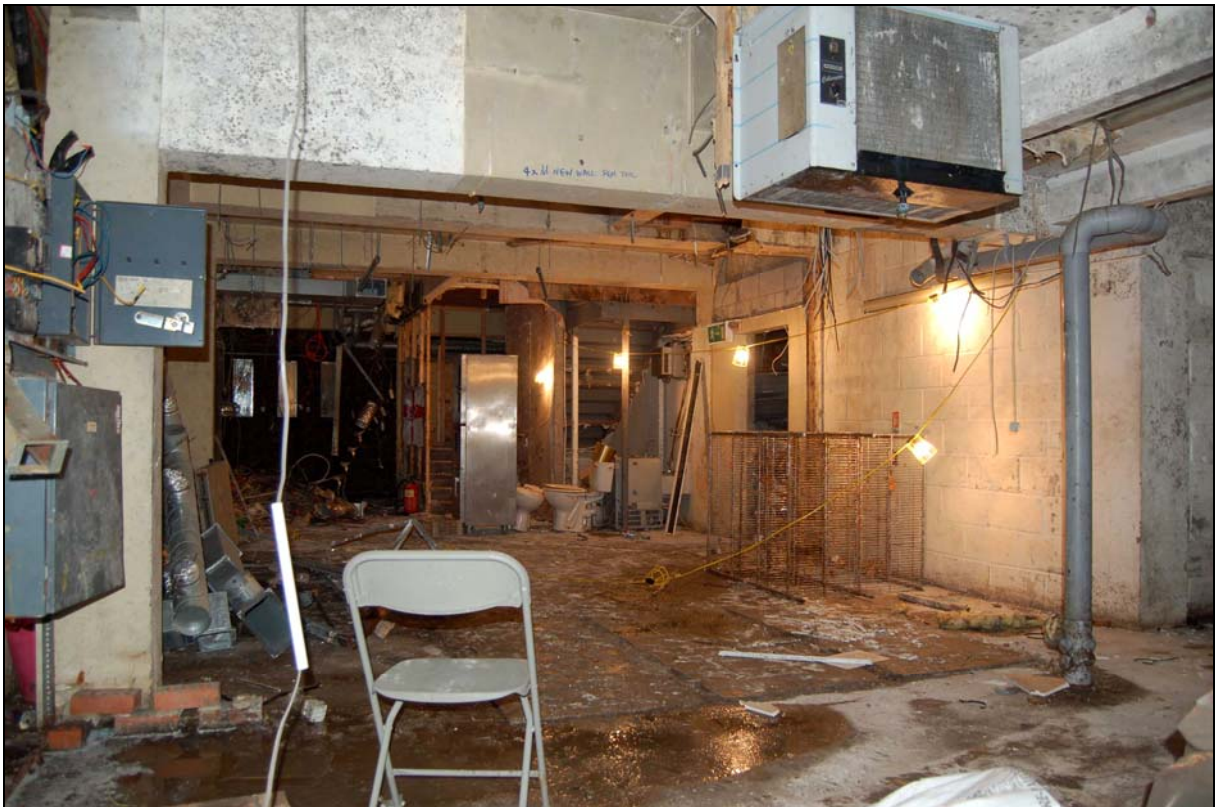
Plate 18 Basement of nos. 9-11 viewed to north (former toilets)

The basement of No. 9 previously housed toilets which had been stripped out before the survey, leaving the bare cast concrete frame, concrete floor and concrete block lift shaft (plate 18). At this level the rear wall is built of old red and yellow stock bricks in the same random English bond form as the wall between the two buildings (plate 19), but it is unclear how far this extends to ground level. There is a straight joint between the two buildings, confirming their different construction dates, though it is likely they were built not long after each other.

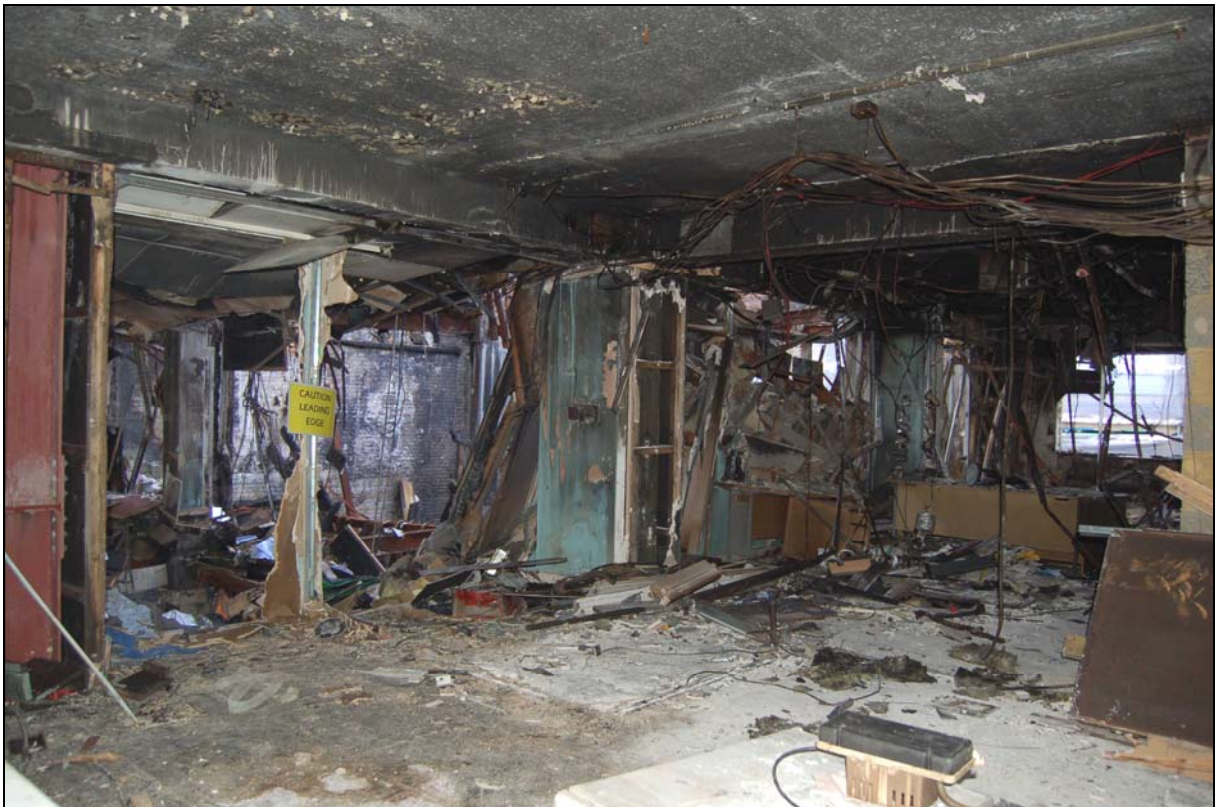
Plate 19 Upper floor of nos. 9-11

The interior retains no notable features on the ground floor or levels above (plate 20).
