**ALL SAINTS' CHURCH
GREAT CHESTERFORD
ESSEX**

ARCHAEOLOGICAL MONITORING AND RECORDING

SEPTEMBER 2011

ECC FAU project number: 2444

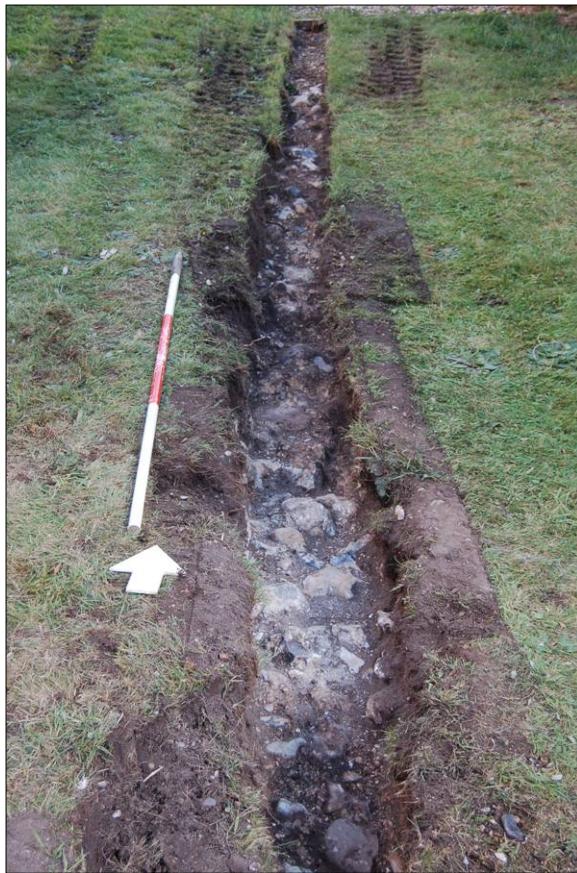
Plate 1. Wall 4,
Trench 2

All of the wall remains looked similar and were constructed of medium to large flint stones and gravel bonded in a yellowish white mortar. They were buried 0.15 to 0.25m below ground surface but the trench was not deep enough to uncover their bases. Wall 3 was 1.6m wide and ran east-west, seemingly aligned on the south wall of the church. West of the tower, the trench ran along what is postulated to be a north-south aligned foundation, Wall 4, exposing it for a distance of 5.4m (Plates 1 and 2). Consequently, its true dimensions were not established. 0.75m-wide, flint-and-mortar wall 5 was exposed to the south of the Lady Chapel, near its doorway. Although similarly constructed to the wall foundations further west, it is unlikely to be associated with the structure of the church; a Roman date is more likely given that a similarly aligned wall fragment has previously been found further south in the graveyard (Ennis 2001).

Historical evidence and previous excavation (Germany 2006) indicates that the structures discovered in the water supply trench are parts of the medieval west end of the church that collapsed or was demolished in the late 14th/early 15th century. Wall 3 presumably formed the south wall foundation of the continuation of the south aisle and wall 4 must have been remains of the east wall of the earlier tower/the west wall of the earlier nave. These wall foundations have been demonstrated to be substantial and to survive at a shallow depth below existing ground surface level. The recorded remains closely coincide with the layout of the removed medieval tower and west end of the nave as depicted by the RCHME (1916) and it seems likely that they have been exposed previously.

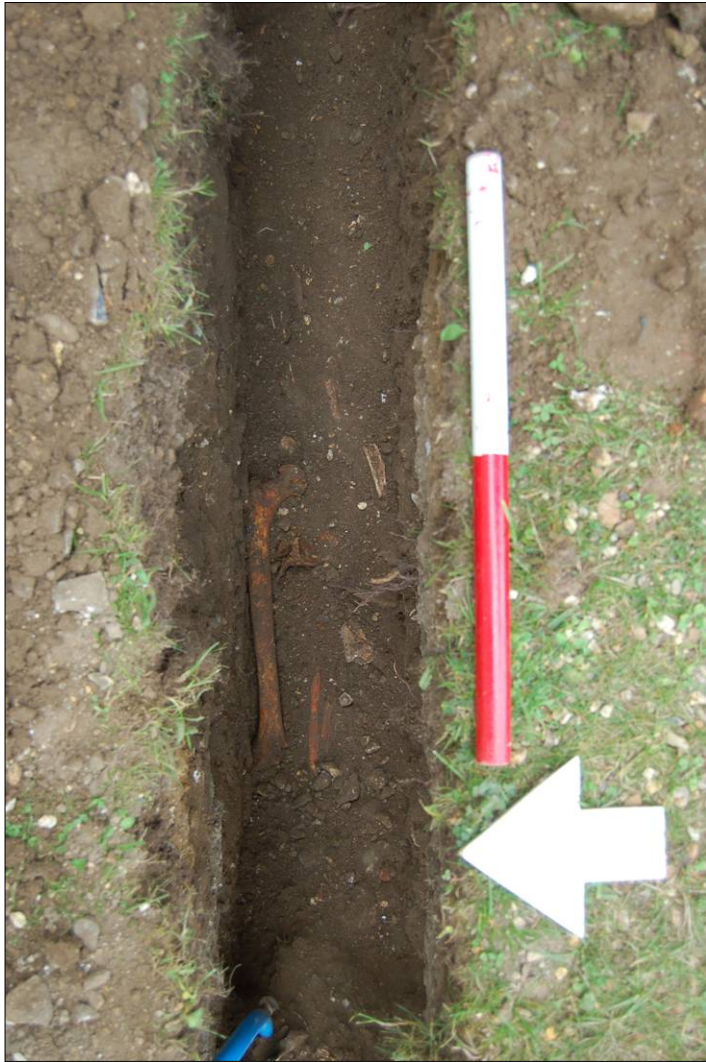
Plate 3. Grave in trench 2

Further west of Wall 5, the left arm and leg bones of an east-west aligned inhumation were revealed (Plate 3). These human remains were encountered 0.7m below the ground surface. No grave cut was observed and no artefacts were discovered in its vicinity.

Only two graves were observed to be truncated by the service trenches. Grave cuts were not discernible within the homogenous churchyard soils and no artefacts were found in direct association with the human remains; though their medieval or post-medieval date is likely. As these burials were encountered at only c.0.6-0.7m below the ground surface, it is entirely possible that further inhumations are present at a greater depth.

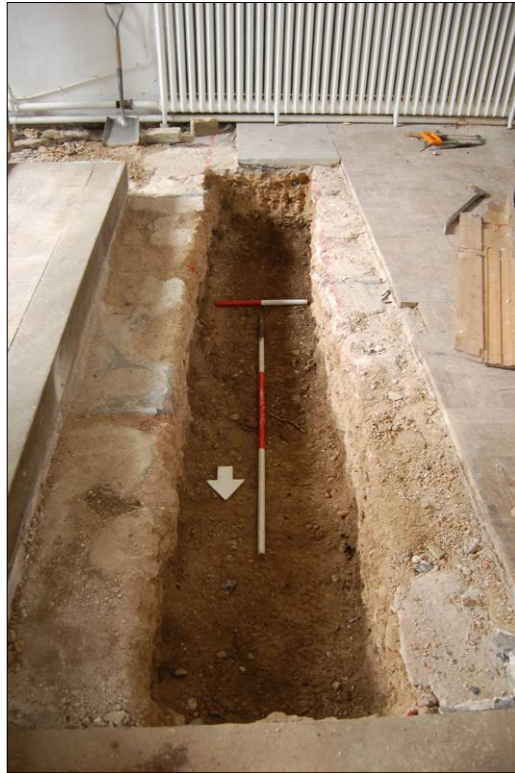
Plate 5.
Trench 3

Two small trenches, making an L-shape, were excavated inside the Lady Chapel (Fig.1). A 4m-long north-south aligned trench for the screen foundation (trench 3) was positioned 2.25m west of the chapel entrance. It was 0.6m wide and excavated to a depth of 0.5m.

deposits, trench 3 contained several disarticulated human bones concentrated in its south end. A few items of post-medieval coffin furniture, fragments of medieval glazed floor tile and medieval/post-medieval tile were recovered from trench 3.

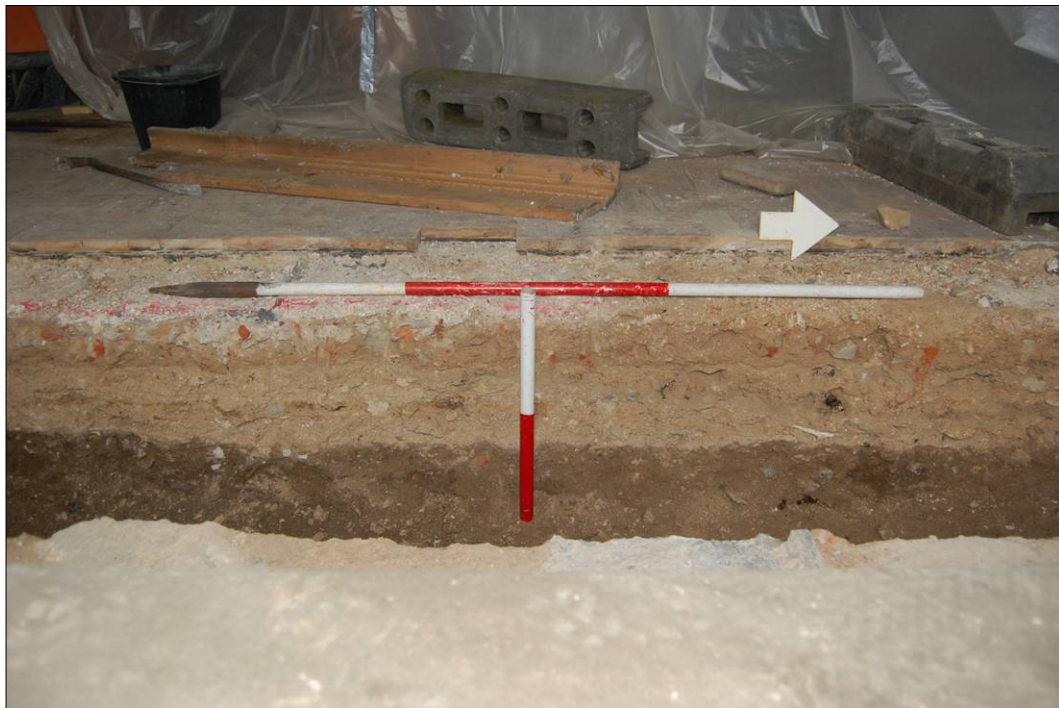
Plate 6. Section through Lady Chapel floor, Trench 3

These works showed that the floor of the Lady Chapel was made of 0.06m thick slab stones, which were lying on 0.03m thick layer of concrete, which in turn overlaid 0.28m of hardcore. The subsoil was directly underneath but the further deposit sequence was not exposed (Fig. 2. Section 1; Plates 5 and 6). Whilst trench 4 was not deep enough to reach archaeological

Monitoring of the interior groundworks within the Lady Chapel has established that the present floor is of modern date. The presence of residual artefacts, including disarticulated human bones, indicates that the ground has been disturbed, perhaps repeatedly and particularly when the Victorian restoration works took place.
