ST MARGARET'S CHURCH WICKEN BONHUNT ESSEX

ARCHAEOLOGICAL MONITORING AND RECORDING

Doc. Ref.	2451rep
Report Issue Date	October 2011
Circulation	Wicken Bonhunt PCC
	ECC Historic Environment Management
	Essex Historic Environment Record
	Saffron Walden Museum (in archive)

ST MARGARET'S CHURCH, WICKEN BONHUNT, ESSEX ARCHAEOLOGICAL EXCAVATION AND MONITORING

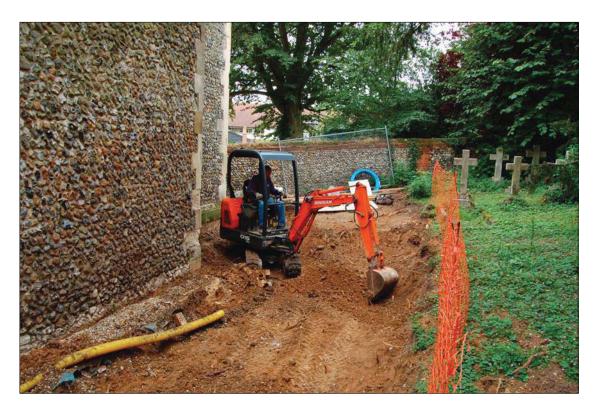
Plate 1. Extension footprint under excavation, looking west

The kitchen/toilet extension footprint was located at the northwest corner of the church, against the bell tower and the west end of the nave (Fig.1; Plate 1). It measured 9m by 5m and was excavated to a depth of 0.7 to 0.8m. The topsoil consisted of a 0.35m-deep greyish black compact clay sand, which overlaid a 0.3m-thick layer of greyish brown compact clay sand subsoil which in turn overlaid the reddish brown compact clay sand natural deposit.

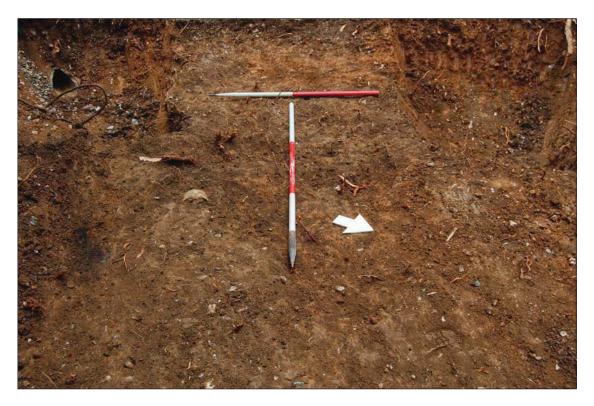
Plate 2. Extension footprint and Grave 3

The excavation of the extension's footprint uncovered eleven south/west-north/east aligned inhumations (Fig.2). The extents of grave cuts and fills could not be readily discerned/recorded due to the lack of clarity created by the contractor's machine strip (Plate 2). Most graves were located by the exposure of portions of the skeletal remains that they contained (Plates 3 and 4). It is possible that other burials were present at greater depth. The located graves were fairly evenly spaced and there were no surviving gravestones indicating their presence. The depth of the burials, ranging from 0.25 to 0.8 m, affected the preservation of the bones, which varied from very poor to good respectively. One probable coffin nail was recovered from the fill of grave 11 and a few unstratified pieces of pottery were collected during the general ground reduction of the extension footprint.

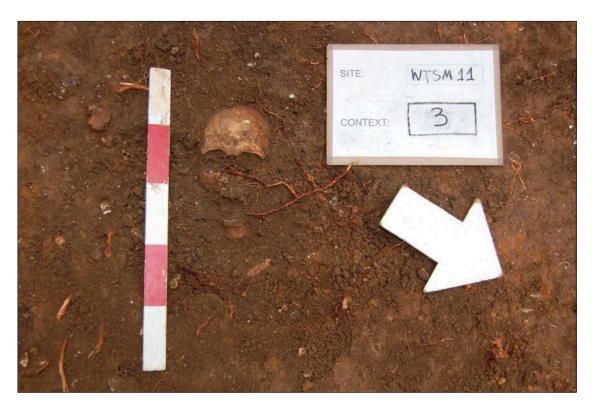
Plate 3. Detail of Grave 3

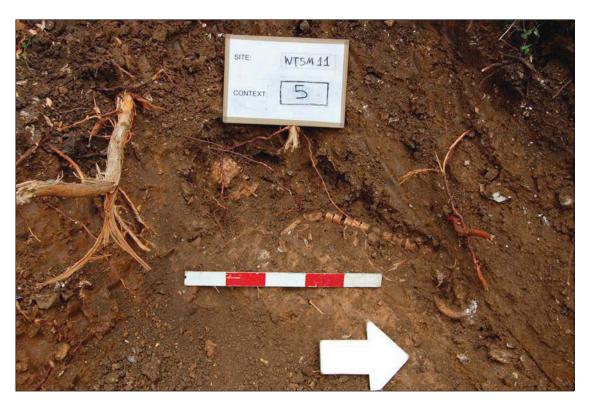
Plate 4. Detail of grave 5

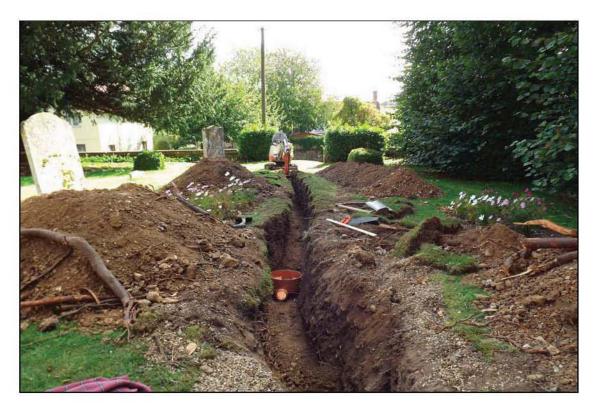
Plate 5. Drainage trench, looking south-east

The drainage pipe trench extended southwest-wards away from the extension footprint, then around the tower and south-eastwards towards the pathway to run along it to the churchyard gate and the road beyond (Fig.1; Plate 5). It measured 43m long by 0.3m wide and 0.7-0.8m deep. The recorded stratigraphic sequence comprised 0.1m thick turf (or a layer of gravel where the trench encroached upon the footpath), sitting on top of 0.2m dark greyish brown fairly compact silty sand topsoil which overlaid 0.5m of reddish brown fairly compact silty sand subsoil - presumably a graveyard soil. The natural deposits were not reached. The trench cut through two human skulls that presumably belonged to two graves aligned parallel to the church's axis. One (Grave 12) was found immediately off the south-west corner of the tower at a depth of 0.4m (Plate 6) and the other (Grave 13) c.5m south the porch at a depth of c.0.7m (Fig.2). Relatively small amounts of disarticulated human bones and several fragments of unstratified medieval tiles were also recovered from elsewhere along the drainage trench.

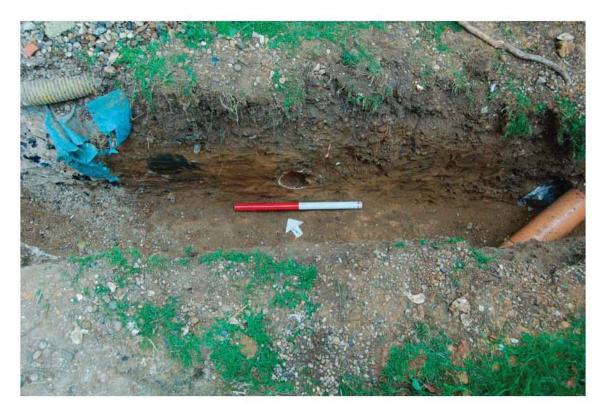
Plate 6. Grave 12 in drainage trench section
