**ARCHAEOLOGICAL MONITORING AT**

**ARLEY HOUSE, DUCK STREET**

**WENDENS AMBO**

**August 2011**

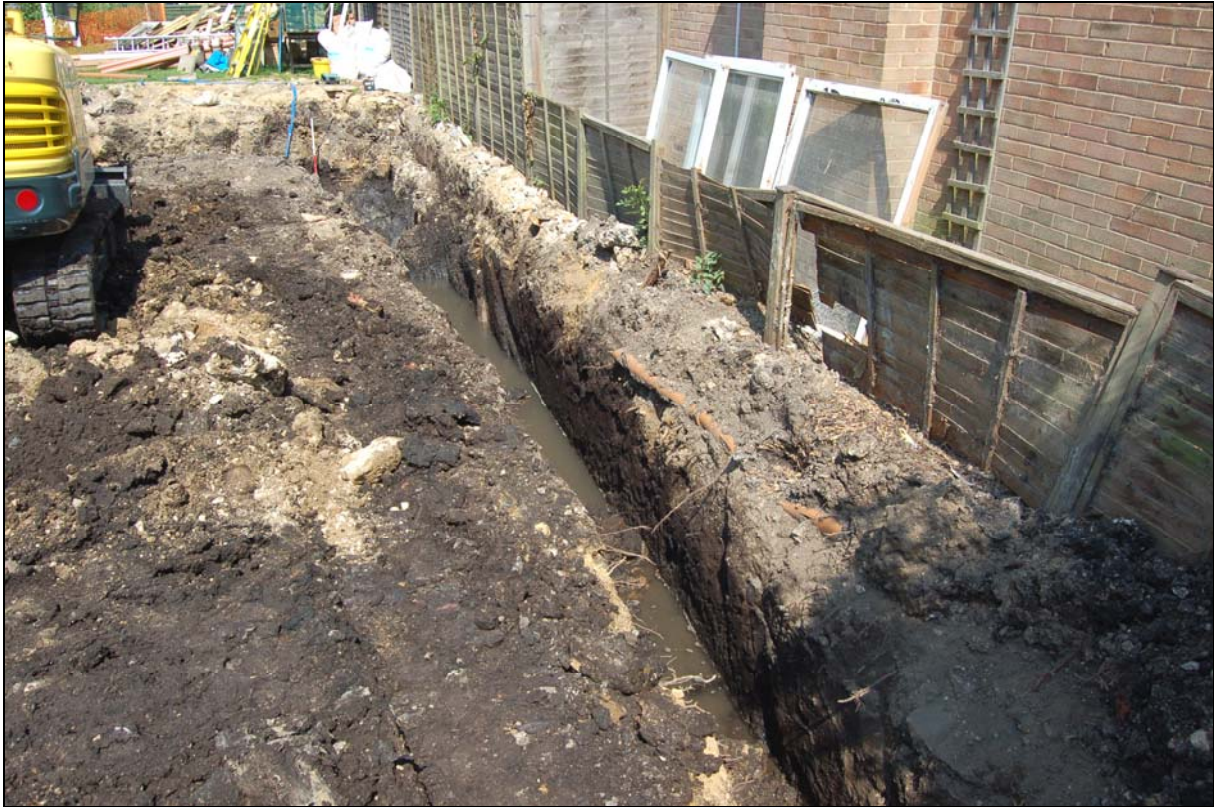
Below the concrete slab/foundation was a 1.4m thick organic clay deposit (context 3, plate 1). This was an unexpected discovery and was sampled for environmental remains. Below context 3 was a natural grey clay subsoil, located 1.6m below ground level. Excavation continued through this deposit to a depth of 1.8m (fig. 3 & plate 2).

Plate 1 Working shot during excavation through organic deposit 3, viewed to north-west

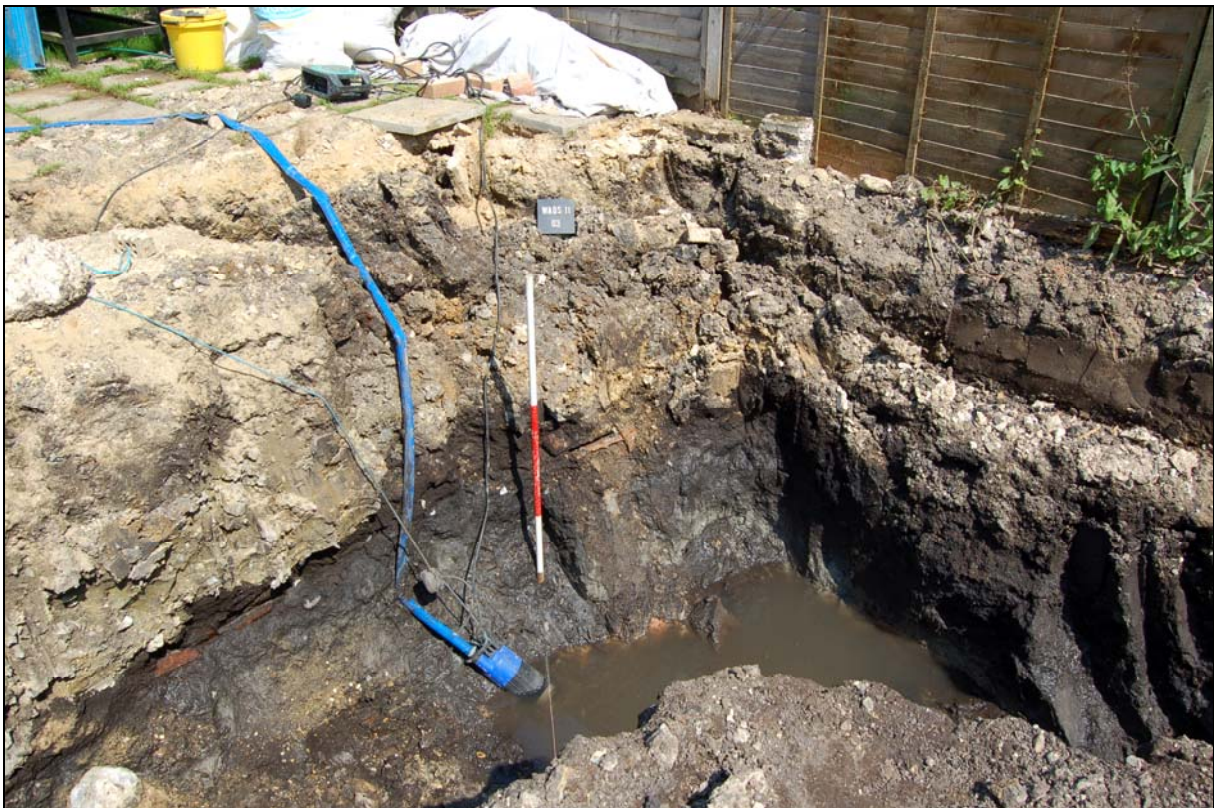
Plate 2 Context 3 in north corner of monitoring trench (1.5m scale)
