**BADGER EXCLUSION SCHEME
MOUNT BURES CASTLE MOUND
MOUNT BURES
ESSEX
ARCHAEOLOGICAL MONITORING**

**Essex County Council
Field Archaeology Unit**

SEPTEMBER 2011

ARCHAEOLOGICAL MONITORING

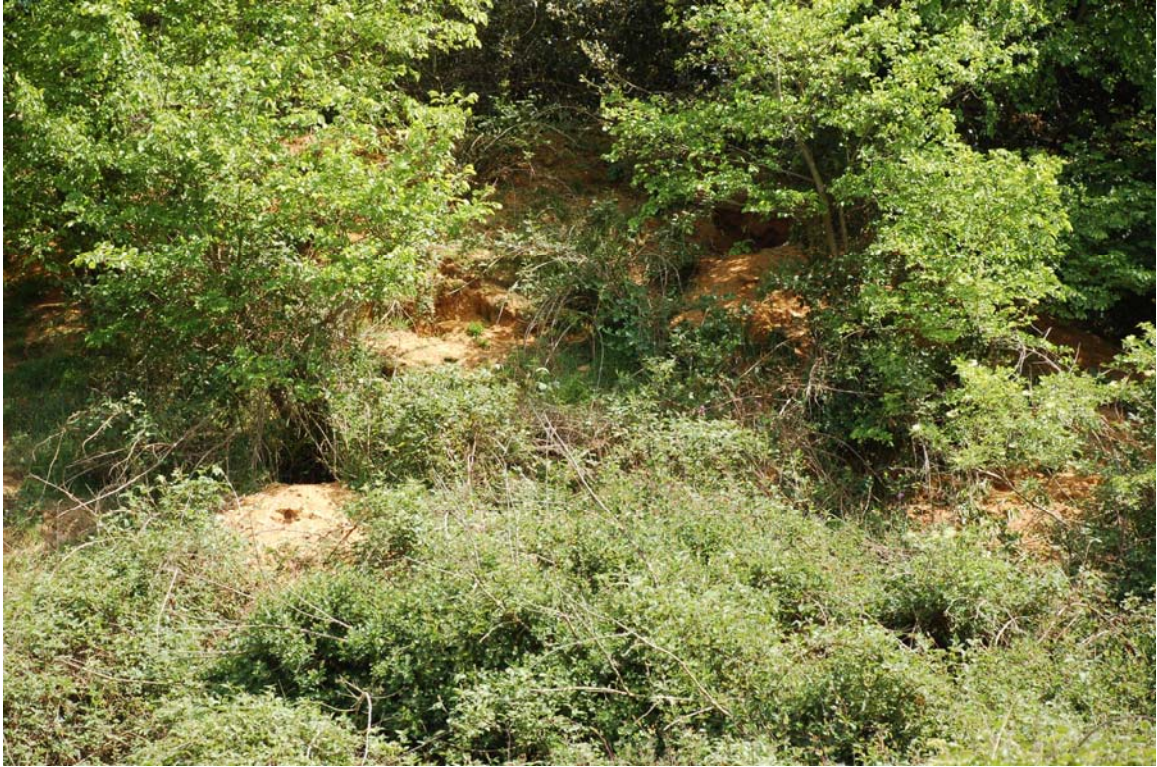
The motte, built with the sands and gravels excavated from the surrounding area, has been utilised by badgers since at least 1997 (Clarke 1997). The burrowing of these animals has caused damage to the monument (Plate 1) and it was considered that should such burrowing continue the motte was in danger of collapse. A scheme was devised to exclude the badgers from the motte and adjacent ditch by means of specialised fencing and to relocate them to a new artificial sett. As the construction works associated with this scheme lay within an area of archaeological potential, and partially within the Scheduled Monument itself, a programme of archaeological monitoring was undertaken during groundworks in order to mitigate any impact on the archaeological record.

Plate 1 Badger setts excavated into the west side of the motte

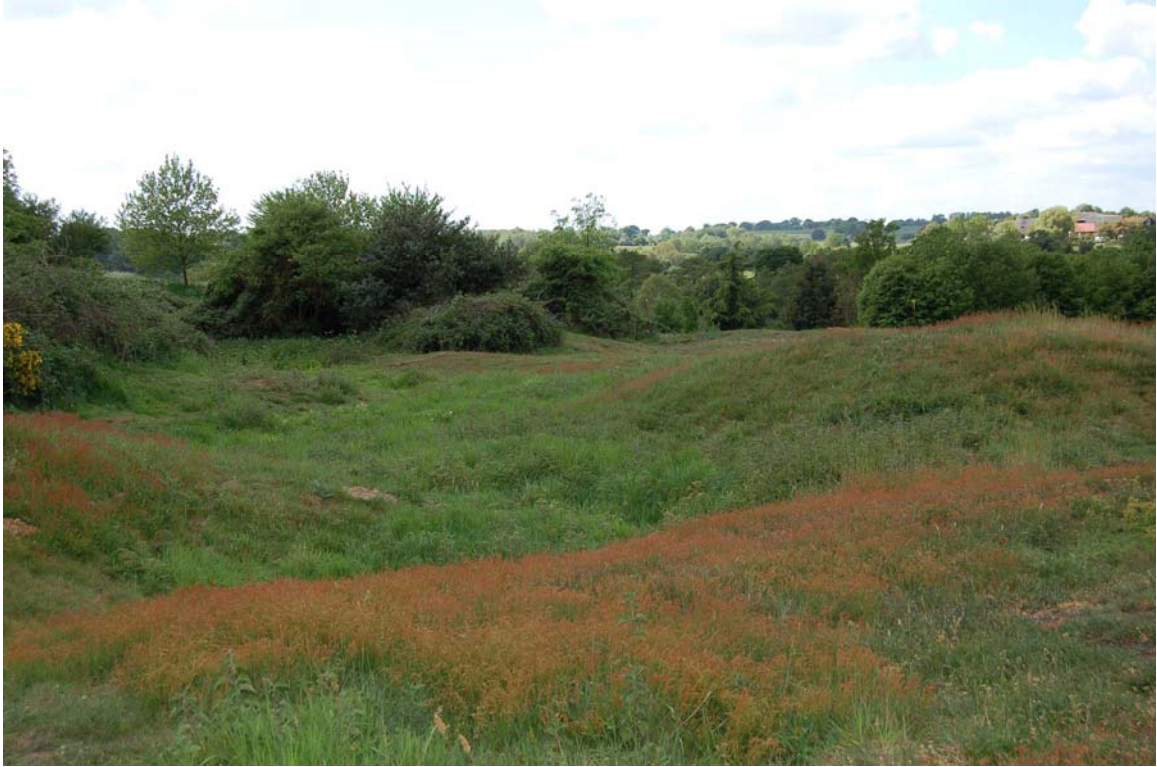
The motte is surrounded by a dry ditch c. 3.5m deep and between 10m and 12m wide. There are a number of irregular earthworks on the northern and western side of the ditch (Plate 2 and 7) which are thought to be the result of sand and gravel digging. One of these large pits is identified as a 'Sand Pit' on the 25" 1st Edition of the Ordnance Survey (1876).

Plate 2 Ditch and irregular earthworks to the west of the motte

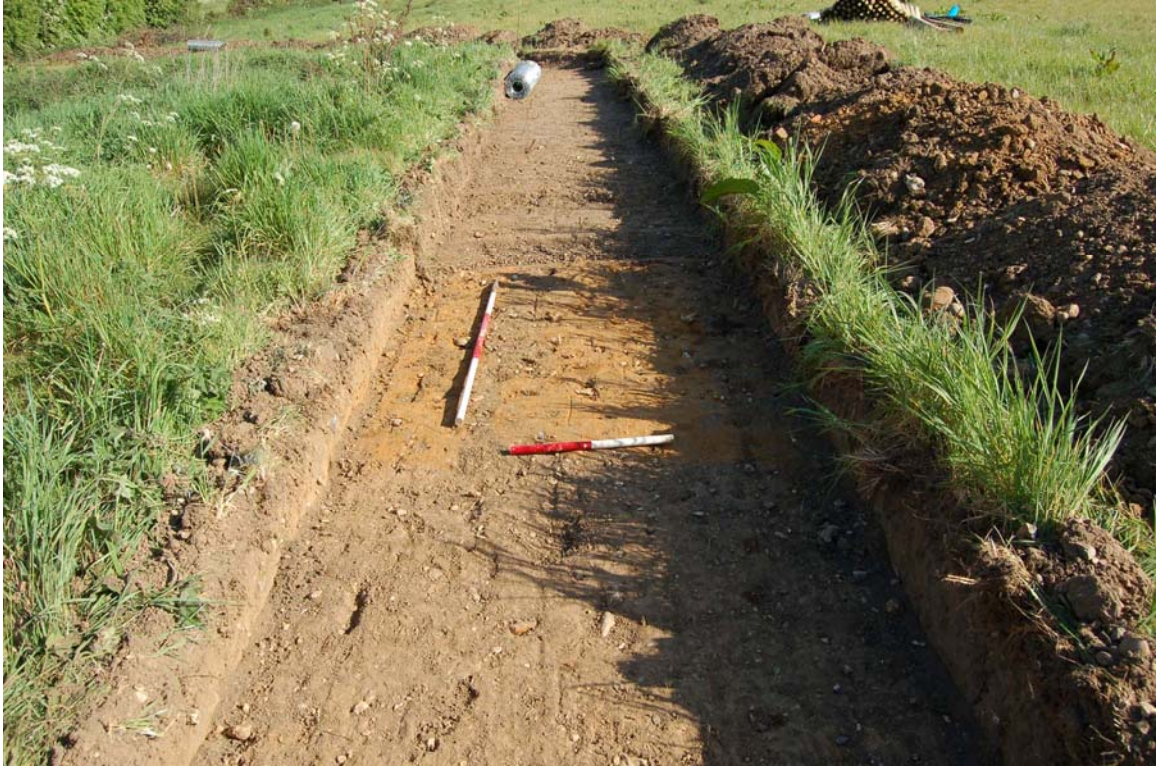
The archaeological monitoring of fencing trenches identified a single archaeological feature, of probable modern date. Located in the second length of trench excavated (L2 on Fig. 2; Plate 3) this feature was 1.3m wide and sand filled, with pieces of plate glass, ceramic

Plate 3 Trench for the horizontal section of the fence, showing modern feature (looking north)

- The route of the fence was set-out around the motte
- A trench was excavated on the outside of the fence line, to a depth of 0.2m (Plate 3)
- Wire fencing was laid in the trench with a section bent up to join the upright section of the fence (Plate 4)
- The trench is backfilled, burying the wire fencing (Plate 4)
- Fence posts are put in; the straining posts on the corners are placed in augured holes and the remainder are driven in
- Wire fencing is attached to the posts and tied to the horizontal section of fencing

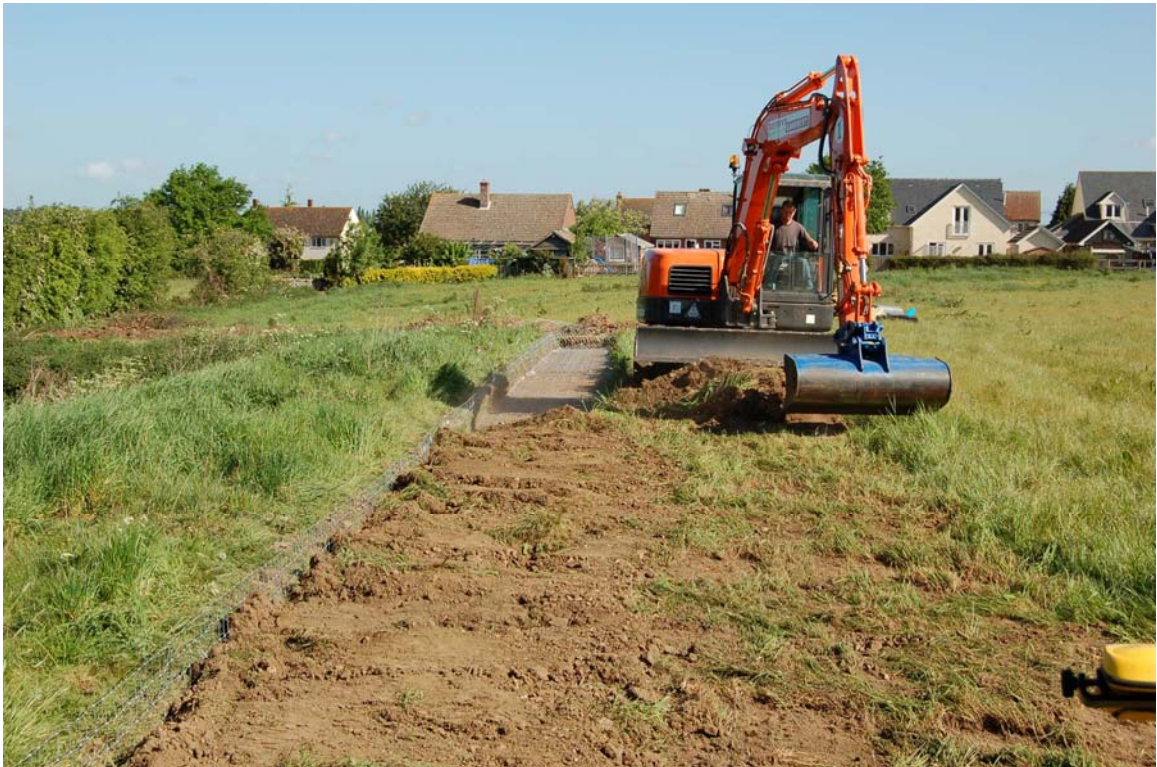
Plate 4 Trench (as above) being backfilled after the fencing has been laid in it. The upstanding wire on the right will link to the vertical section of the fence

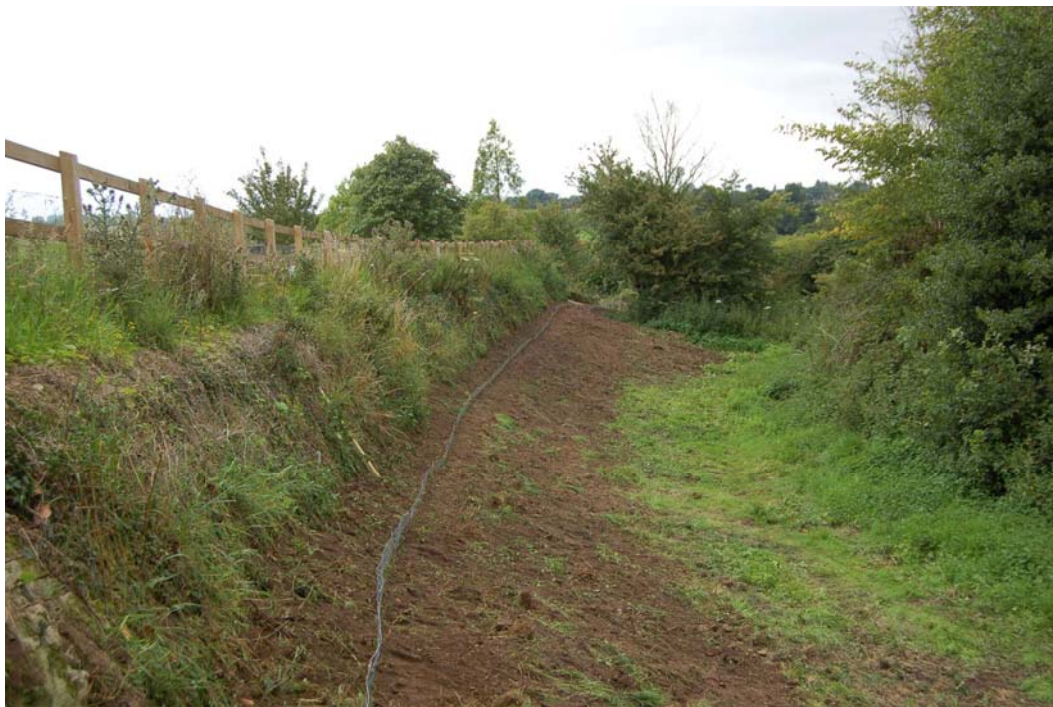
No archaeological features were noted in the trench running along the base of the churchyard wall (Plate 5 and 6). Again ground reduction was not carried out to a sufficient depth to expose any archaeological features, although here was a considerable amount of post medieval and modern debris along this trench, presumably having been tipped over the churchyard wall. This included brick and tile, glass, broken glass jars and a light-bulb. As the material was unstratified and clearly post-medieval/ modern it was not retained.

Plate 6 Backfilled trench along the churchyard wall
