THE FORMER T.D. RIDLEY & SONS BREWERY
HARTFORD END
FELSTED
HISTORIC BUILDING RECORD

Essex County Council
Field Archaeology Unit

September 2011

HISTORIC BUILDING RECORD

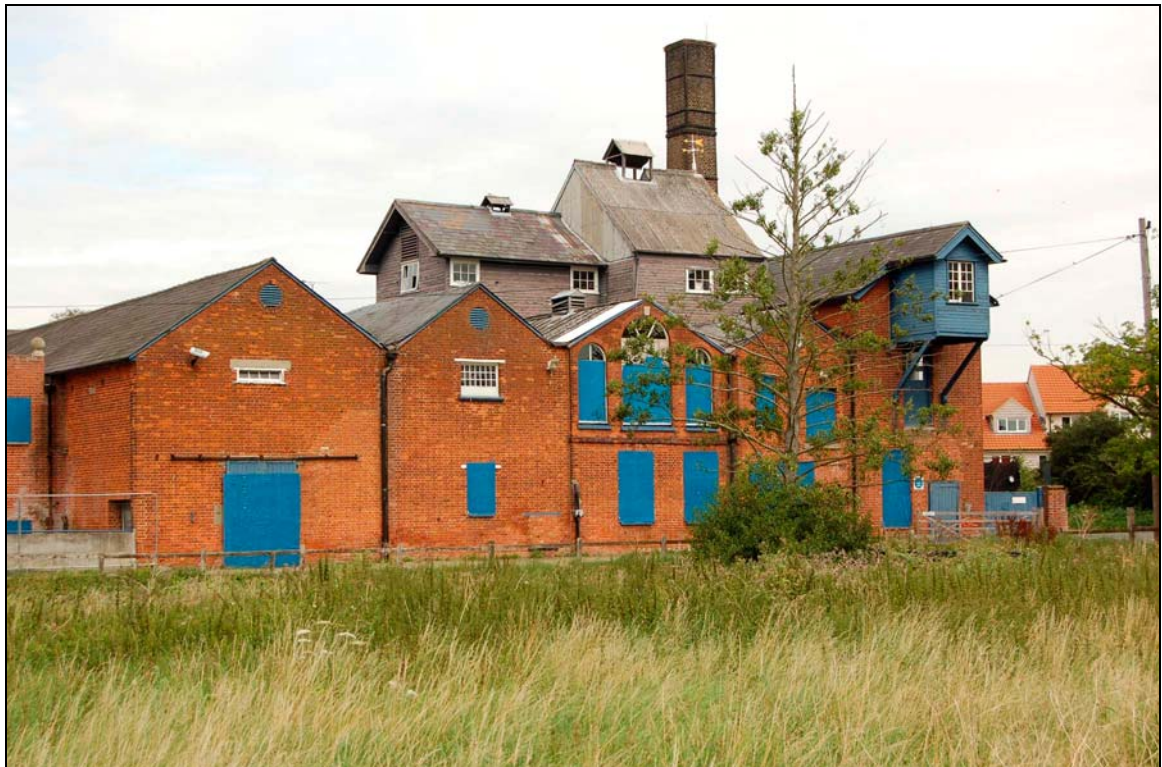
Plate 2 Brewhouse viewed to north

The main brewhouse façade occupies this elevation, facing onto the river and viewed from Mill Road and the southern approach to the complex (plates 1 & 2). It comprises the five gable ends of the brewhouse ranges, with the central gable projecting slightly forwards and having a higher standard or decor. Each gable is different according to function. The central gable is the grandest and least altered, with its three arched windows lighting the first floor and the keystone over the central window bearing the inscription 'T.D.R. 1843' (plate 3), referring to the founder. Another inscription has been carved into the brick band between the two floors that reads 'W.W.R. 1843', clearly a reference to William Ridley (plate 4). The windows below, that light the ground floor, are oddly unsymmetrical given the importance of this elevation, and are the more regular multi-pane sash windows with segmental arch brick heads. The surrounding brickwork is coursed in Flemish bond with evidence of lines for tuck-pointing, much of which has weathered-out. The roof is topped by a ridge lantern (plate 2).

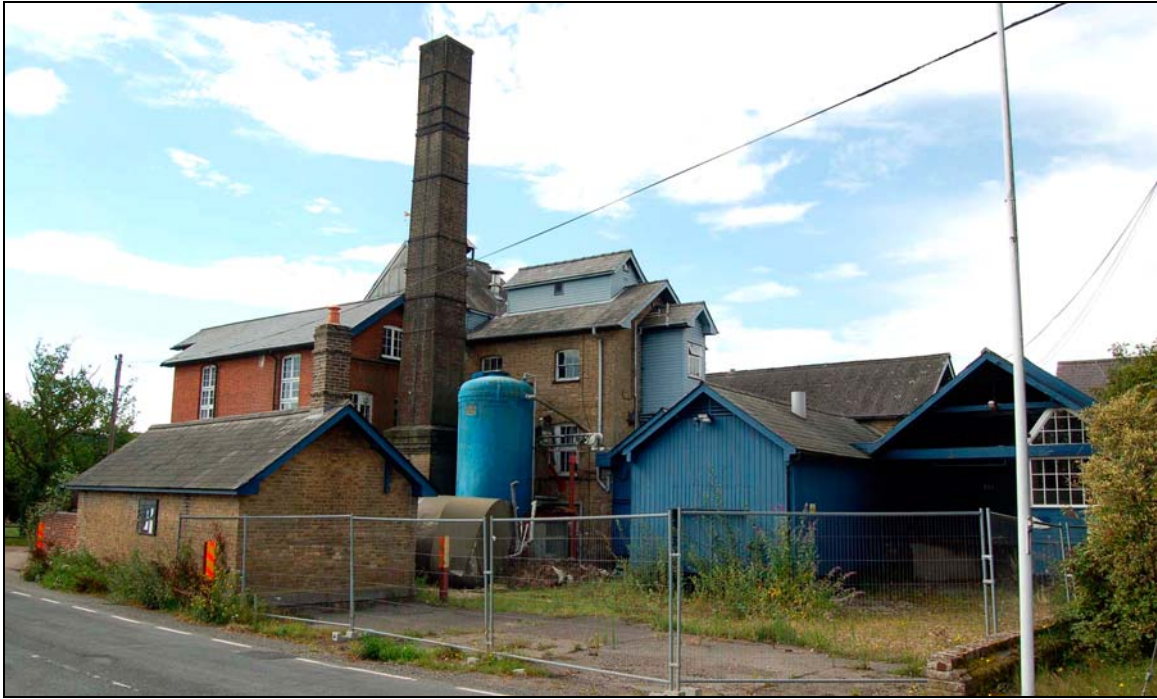
Plate 7 Brewery complex viewed to north-west

The north-east elevation (plate 7) is perhaps the most interesting and complicated sides of the brewery since it performs many different roles from the core brewing areas to the dispatch area and offices. From the road, it is partly obscured by the cooper's shop and chimney. The elevation begins with a continuation of the boiler room. Around the base of the walls and around the yard are removed tanks and heaps of spoil from several test-pits dug to view the foundations. They show quite deep stepped foundations in yellow stock brick below the red brick walls. Fenestration is characterised on both floors by tall six-light casement windows, more likely to date from the later part of the 19th century. The gable end of the

boiler house on the north-west side is partly obscured by the chimney, but displays similar, though more uniform and shorter, casement windows and a blue segmental-arched door with fanlight into the room from the yard (plate 7). The original covered flue from boilers to chimney at the base of the wall was blocked and replaced by a modern steel pipe fitted through the partly-blocked ground floor window (plate 8). This probably dates to 1970 when two oil-fired boilers replaced the existing coal-fired Lancashire boilers, installed when the tower was rebuilt in the 1920's (Peatty 1992). The chimney is built of yellow stock bricks in English bond and is square and tapering slightly to the top. It is strengthened by bolted iron rods around the sides at irregular intervals. Originally there were two ground level arched exhaust points, facing the boiler and engine rooms (fig. 6), both of which have been disturbed by modern groundworks here, making closer inspection unsafe. One led into the boiler room and the other into the postulated engine room (fig. 6).

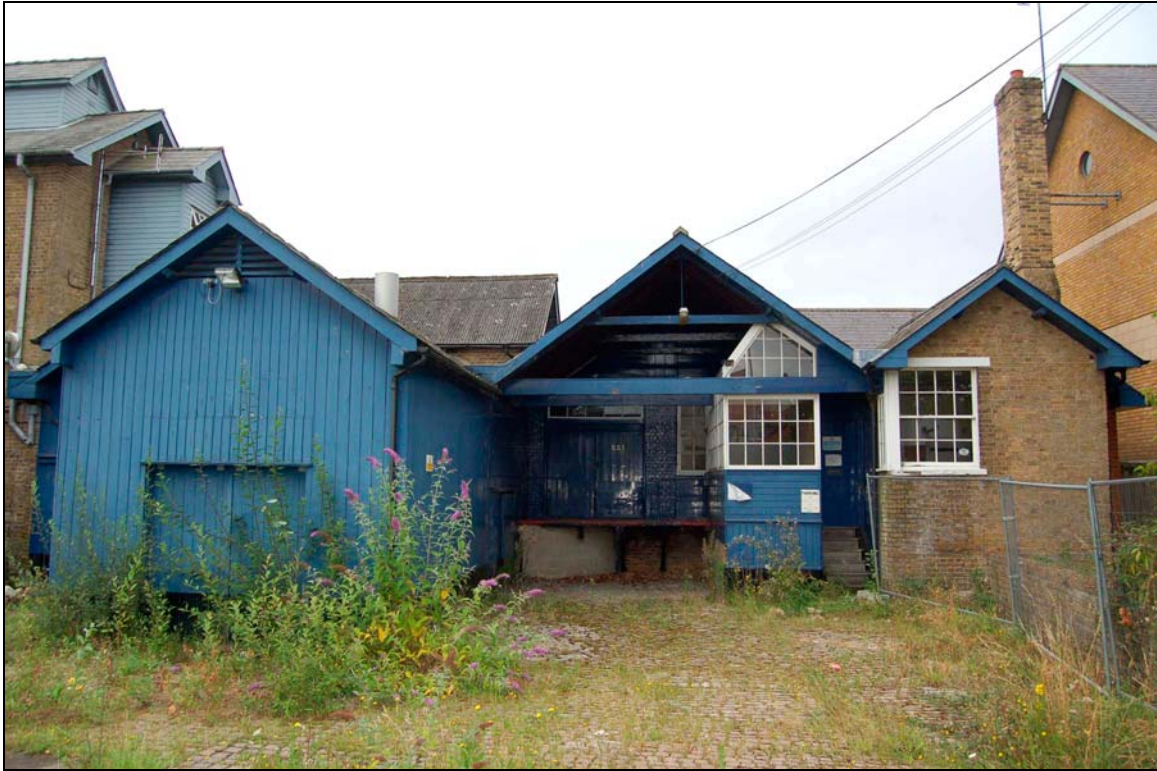
Plate 9 Dispatch/offices area viewed to north-west

Following on from the brick-built brewhouse is the original single-storey dispatch area and brick-built brewery offices (2), which have changed very little since Victorian times (plates 9 & 10). The dispatch area, timber-built, and painted blue with a black band at the base, occupies three gabled bays (35° pitch) facing the roadside, the central one of which projects onto the granite-paved barrel yard. Both this and the bay to the south are enclosed with vertical matchboarding and have boarded doors that lead into the cask repair area, with wooden vents set into the gables. The third bay is open to accept carts and contains the wooden loading platform and loading doors. A fixed multi-pane window is situated above the loading doors and another more conventional window, lighting the office corridor, is located between it and the clerk's office. The clerk's office, enclosed within the bay, is fully-lit with multi-glazed panels and has a slate internal roof (plate 10). Wooden beams and collars pass through and beside it, providing a rare example of exposed trenched collar purlin roof structure, a feature which appears to be used throughout the complex. Between the clerk's office and brick-built office is the main office entrance through the clerk's office (fig. 6). Finally, the brick-built office at the end (room 15, fig. 7) has a single sash window facing onto the yard and two smaller ones on the north-east elevation, straddling the chimney. Other office elevations are now hidden by the modern office building of 1990 which is described separately later in this report.

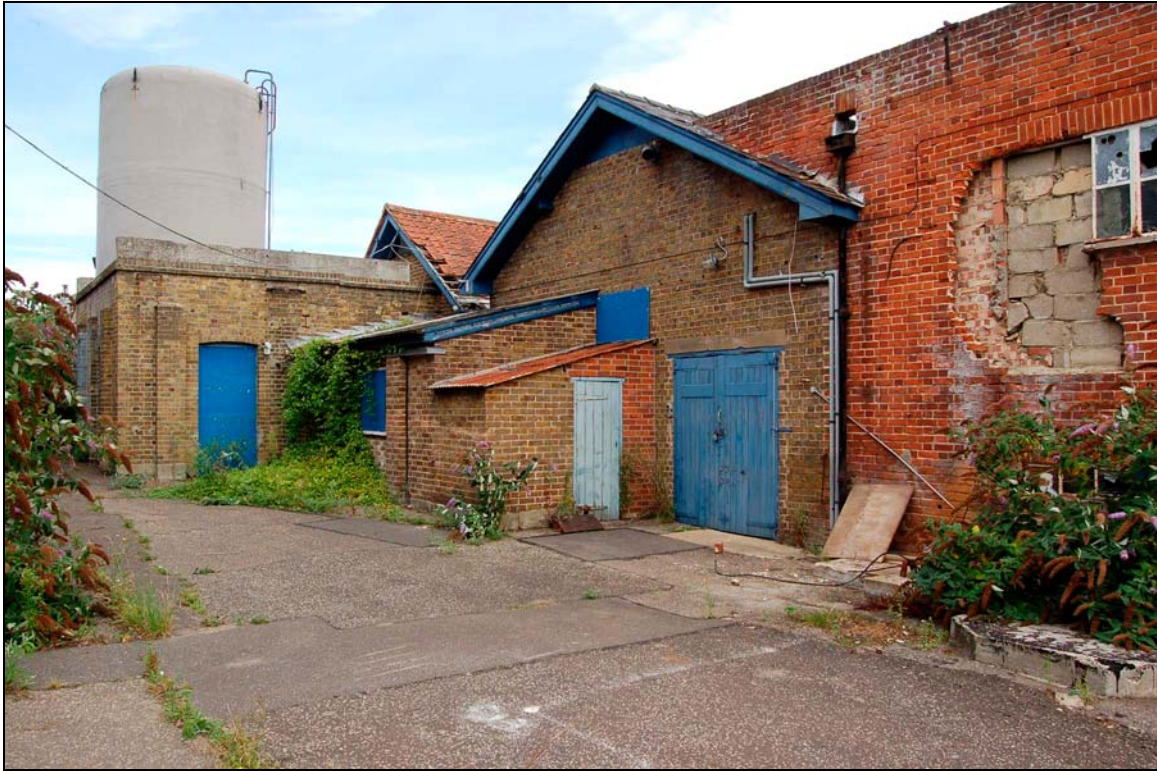
Plate 13 Part of south-west elevation

The 1938 conditioning rooms are built onto the cold stores and partially over its roof (plate 13). Where the conveyor to warehouse 14 has been removed the building fabric of Flemish bricks on the inside of the wall cavity and red bricks on the outside can be seen (plate 13). The elevation shows window ranges on both levels though part of the upper window towards the south end is taken up by loading doors, which are probably original (plate 6).

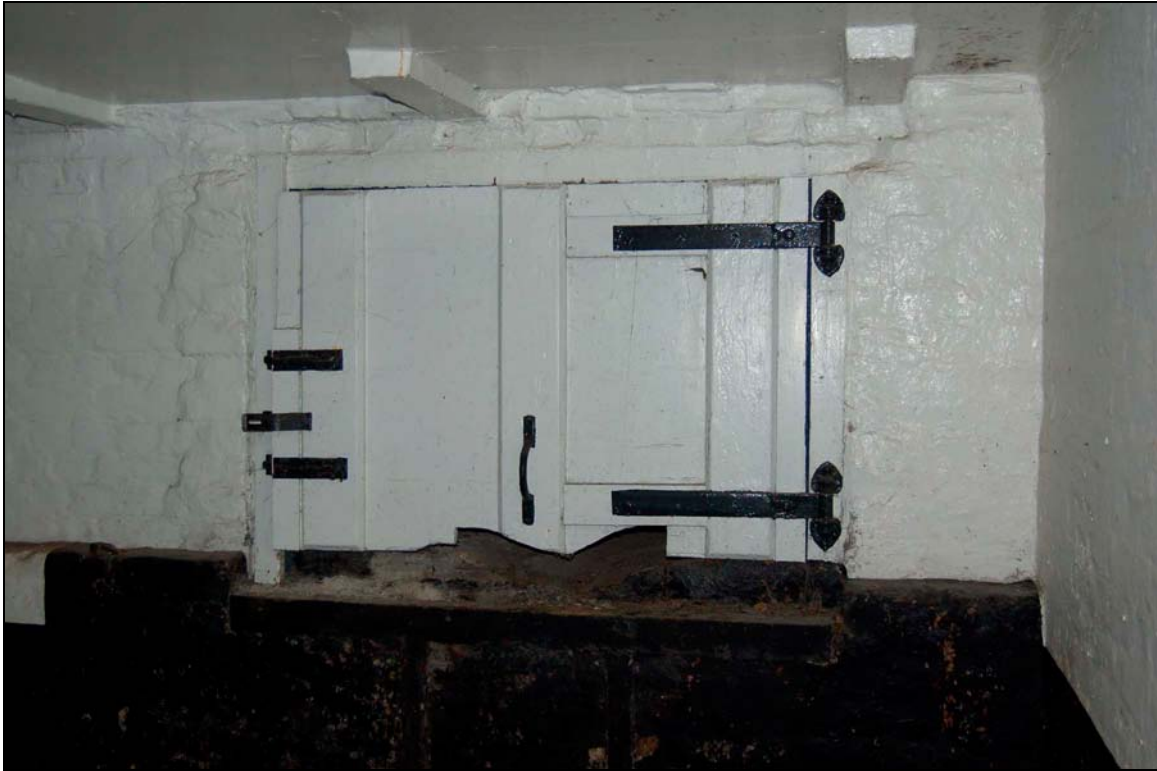
Plate 27 Door from cask repair area into cask fill room

thickness as those in the bottling plant, but are shorter and have winged heads. The upper part is painted red and the lower part painted black, at the same height as the walls that continue the white/black theme. On the fourth and fifth bays the bridging joist is thicker at 0.45m (3 joists wide) and carried on paired columns to bear the weight of the dispatch area above. At the south-west end of the room are original doors leading into the bottling plant below the baulkhead (fig.6). At the opposite end is the barrel door, through which repaired or empty barrels could be returned to the cask room for refilling from below the loading platform or the cask repair area via a curved compact mortar barrel run (fig. 6). The door has cast iron strap hinges with a central handle and lock-bolts on the opposite side. The cut-out at the bottom was probably for a wooden ramp to roll the casks into the cask fill area (plate 27).

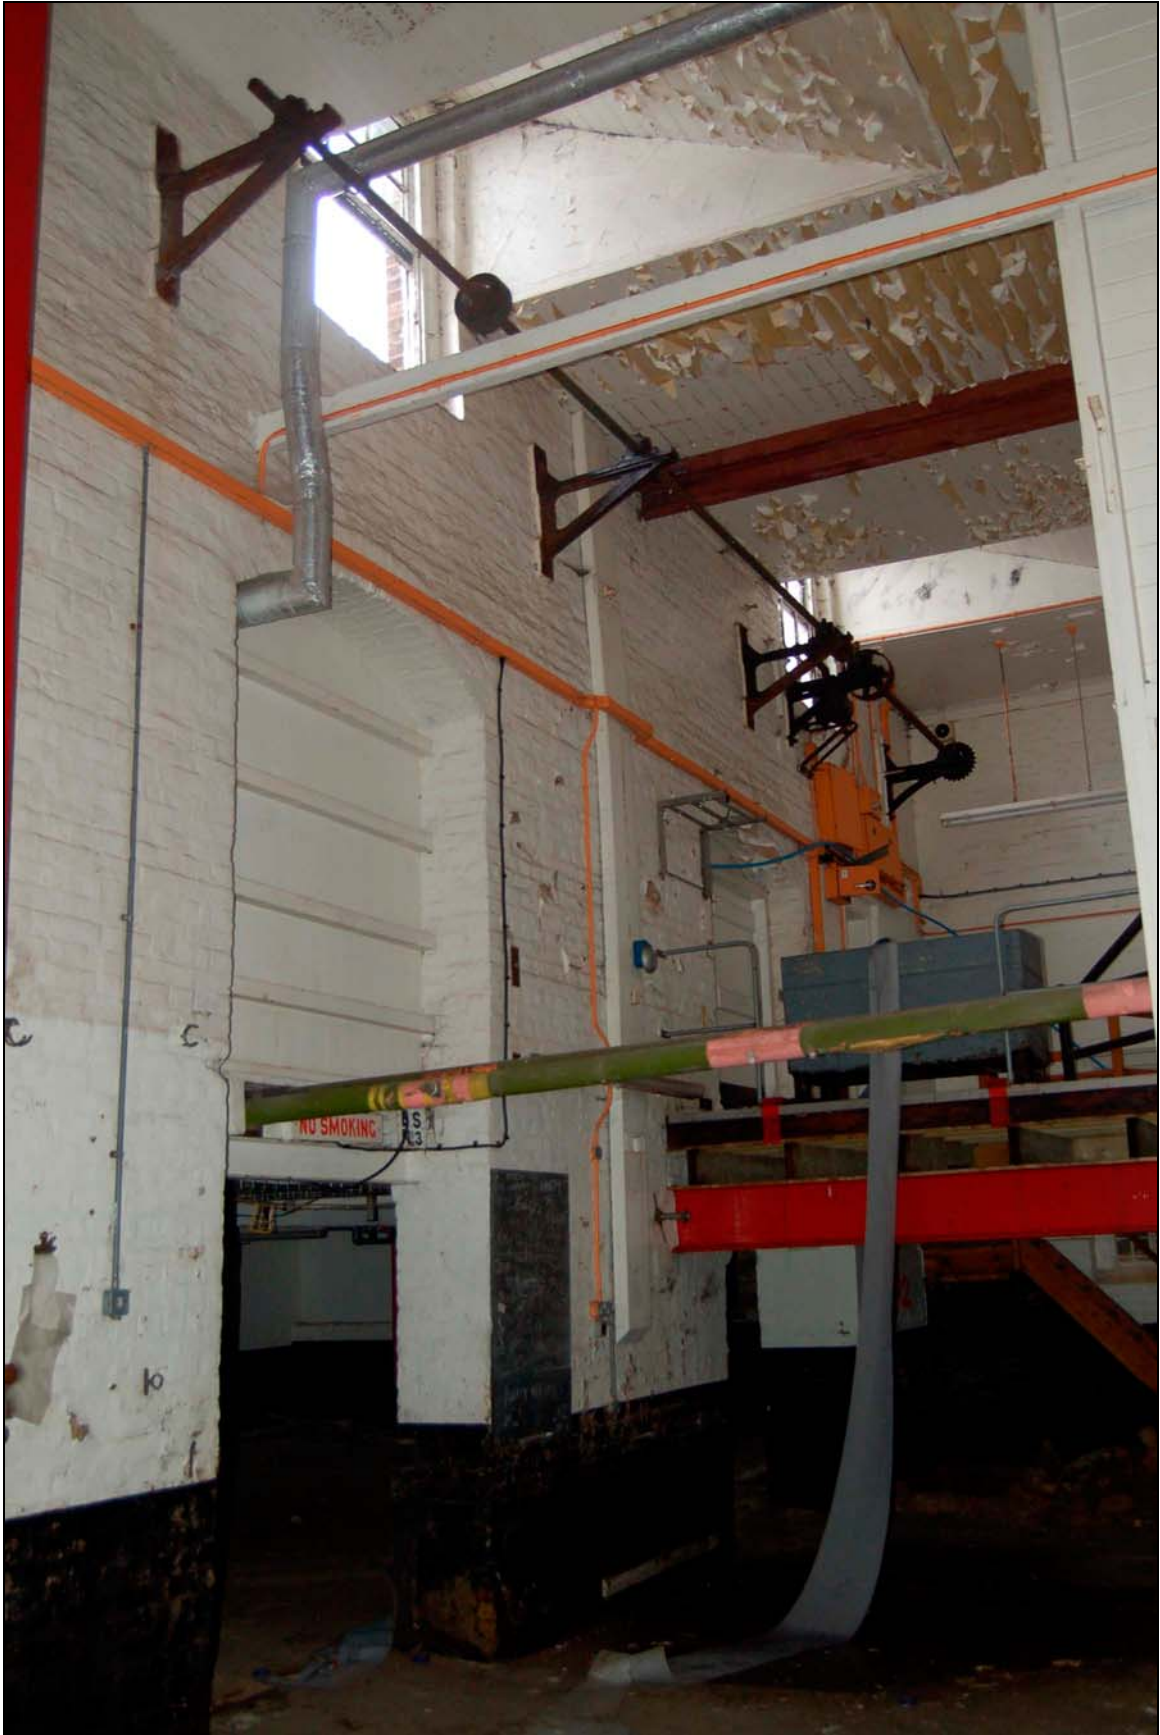
Plate 37 Line-shafting for cask hoists viewed to north

Process flow of the Victorian brewery, from delivery of the raw materials to dispatch of the beer, is discussed separately under its own heading in section 5.0. The Victorian machinery (cask hoists, chain hoist, elevators, etc), was powered by a steam engine (noted in Booker 1974) through a system of line shafts and drive bands, which was common in factories and other industrial buildings from the middle of the 19th century. Understanding of power transference within the brewery is based on limited information: the surviving (and blocked) bearing boxes (annotated BB in figs 6-8) for line-shafts, a length of which still survives, and blocked (presumed) band apertures (BA in figs 6-8) that enables drive to be transferred by drive band from shaft to shaft (one room to another) or from shaft to machinery by drive wheel, all emanating from the engine room. Due to the low level of survival of such equipment, a full understanding is not possible and it is likely that different elements relate to changing set-ups in the brewery. After the brewery was electrified (date unknown), machinery was driven by individual electric motors and subsequently many elements of the inter-linking power drives were removed, and apertures often blocked.

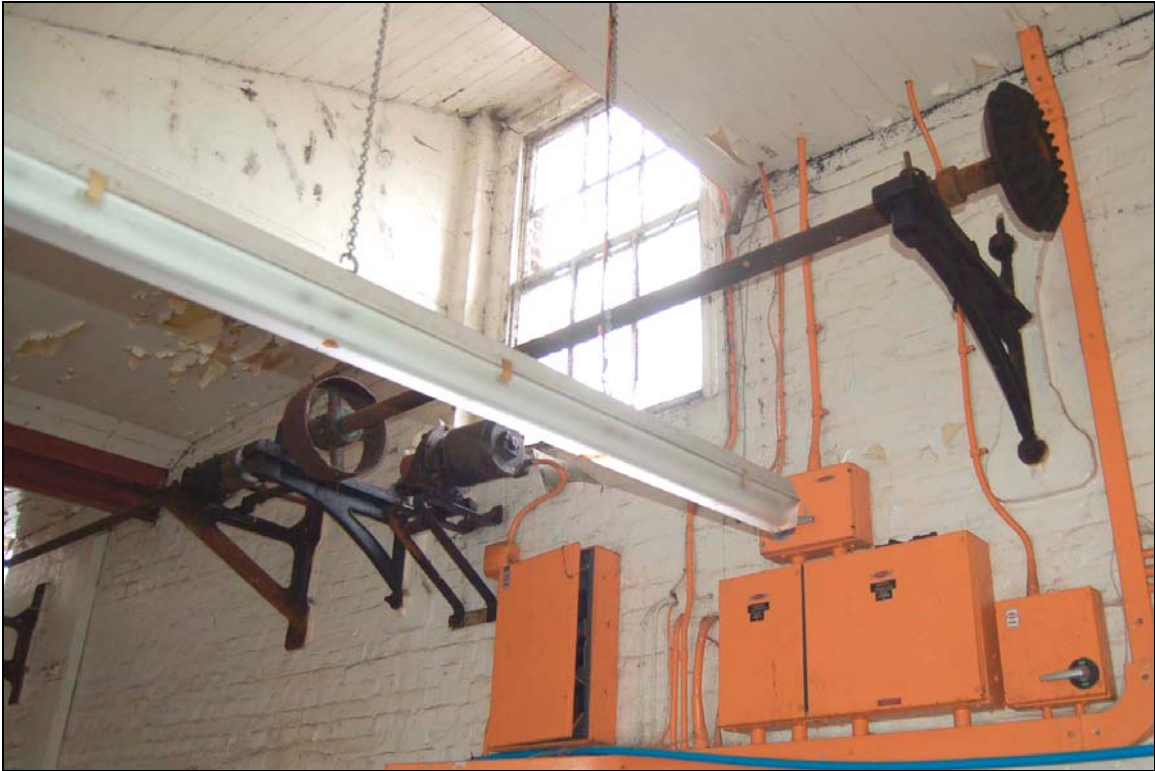
Plate 38 Moss Gear motor and gearing for vertical shaft

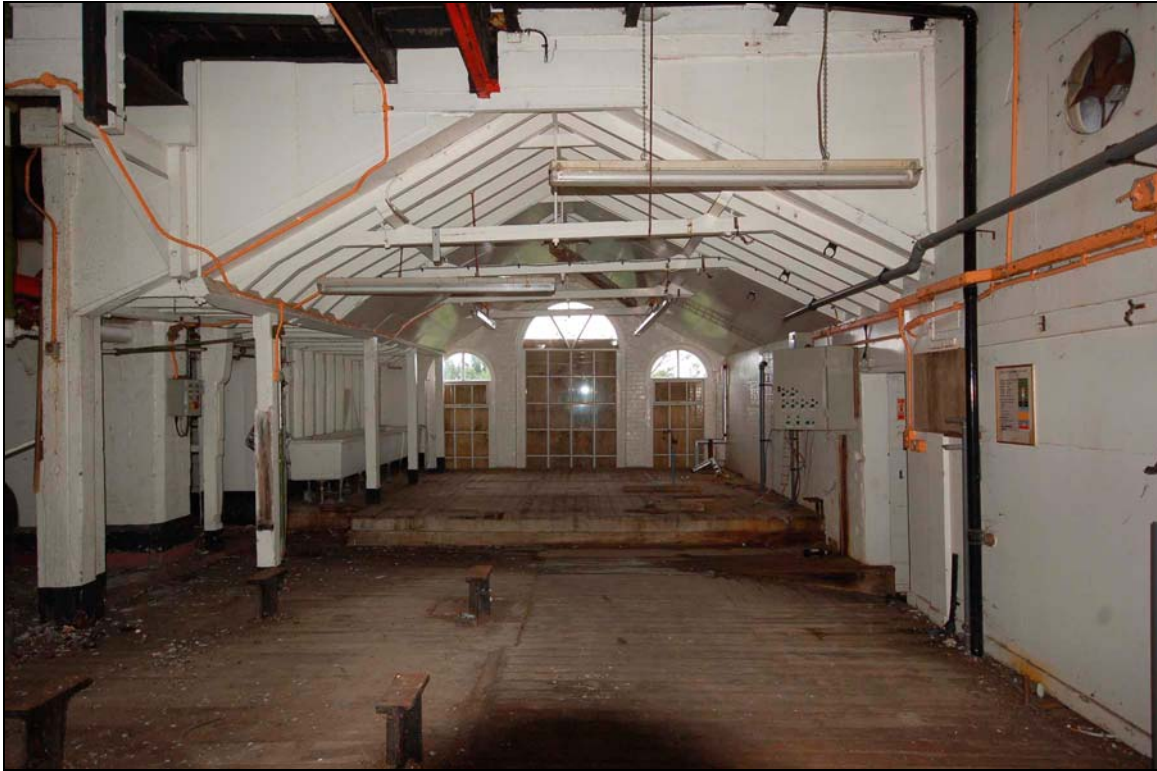
Plate 42 First floor of brewhouse and main gable viewed to south-east

The only existing access into the brewhouse is from the timber staircase behind FV 8 which leads into the hopback area. The hopback was removed with the rest of the metal and all that remains is the feet of its iron base, suggesting a tall rectangular tank that extended up through the second floor (figs. 7 & 8). Other fixtures and fittings around it have also been removed, including the stainless steel modern pipes that would have transferred the strained wort into the fermentation tanks. To the south-east is the main gable with its three arched windows (plate 42). A raised area before it has impressions in the floorboards suggesting it was occupied by storage bins of some kind (fig. 7). Along the primary-braced wall to the north-east is one of the modern sterilising tanks also seen in the conditioning rooms. The roof frame over the gable is a simple collar purlin type (with cleats) bolted to the rafters either end and to the apex by an iron rod (plate 42).

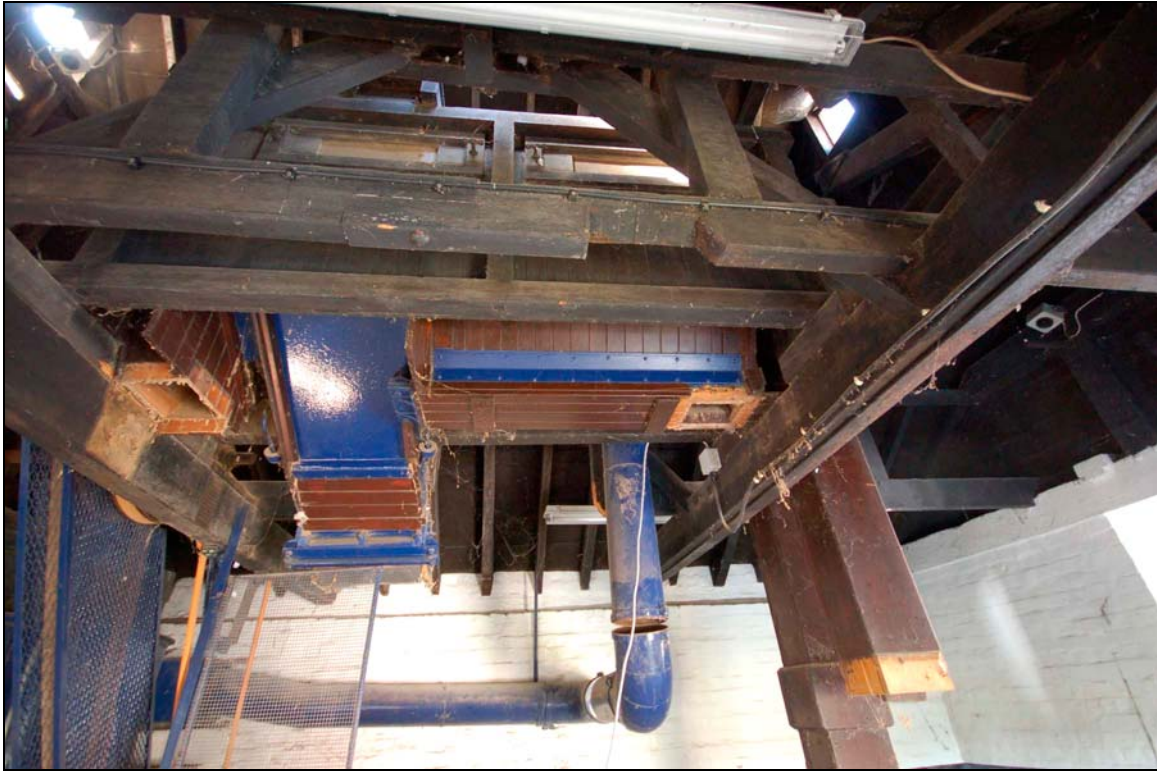
Plate 58 Malt mill and chutes viewed to south-west

Mill room 17 is the best preserved area of the brewhouse and contains important Victorian machinery. To get there, sacks of malt were taken from the malt store by barrow down a long wooden ramp (fig. 8 & plate 56) and emptied into a hopper. The hopper is timber-clad and divided into two parts. The open hopper into which the malt was emptied feeds down into the base of the Boby elevator via the wooden chute seen in the room below, then up into the malt mill (plate 57) where the malt is cracked and screened through a revolving drum to remove foreign matter. Cracked malt was then dropped by a wooden chute into the top of the main hopper, whilst foreign matter originally fell down a second chute next to it where it was bagged up and taken away (plate 58, left), an activity more recently undertaken by a 'NALDER AND NALDER' of Wantage machine which sucks the foreign matter through a pipe at the bottom of the mill and into a small silo before bagging (plate 56).

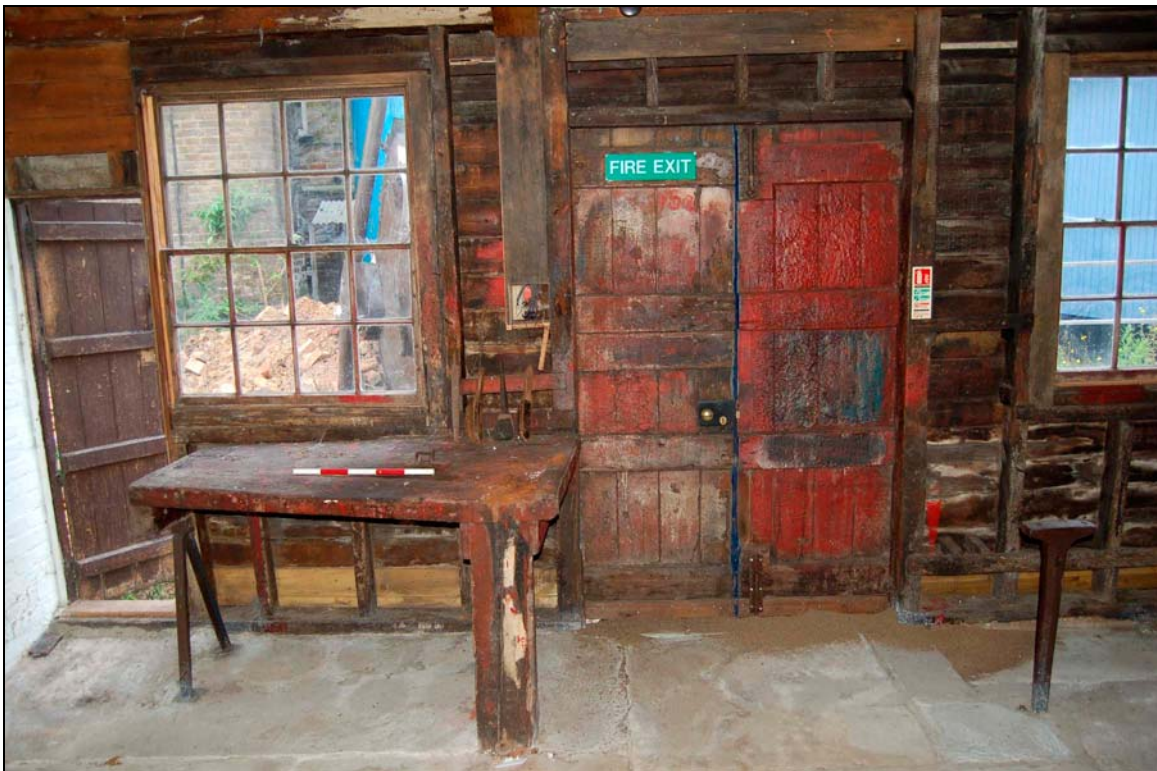
Plate 63 Main elements inside cooper's shop

The internal layout comprises the workshop and a storage area at the back over two bays. The workbench, which has seen plenty of use, is situated between the two doors in front of the window (fig. 11, plate 63) to receive the light. Housed in a makeshift rack are tools of the trade: wire brushes, a spike for making holes in the bands and files. The vice is missing from the workbench. On the other side of the main doors is a cooper's iron, embedded into the stone floor (plate 63, right). The hearth is at the north end, but appears to have been modified as part of the museum experience. The small attic above has been modified too, but was probably used to store timber. The south end contains no fixtures or fittings.

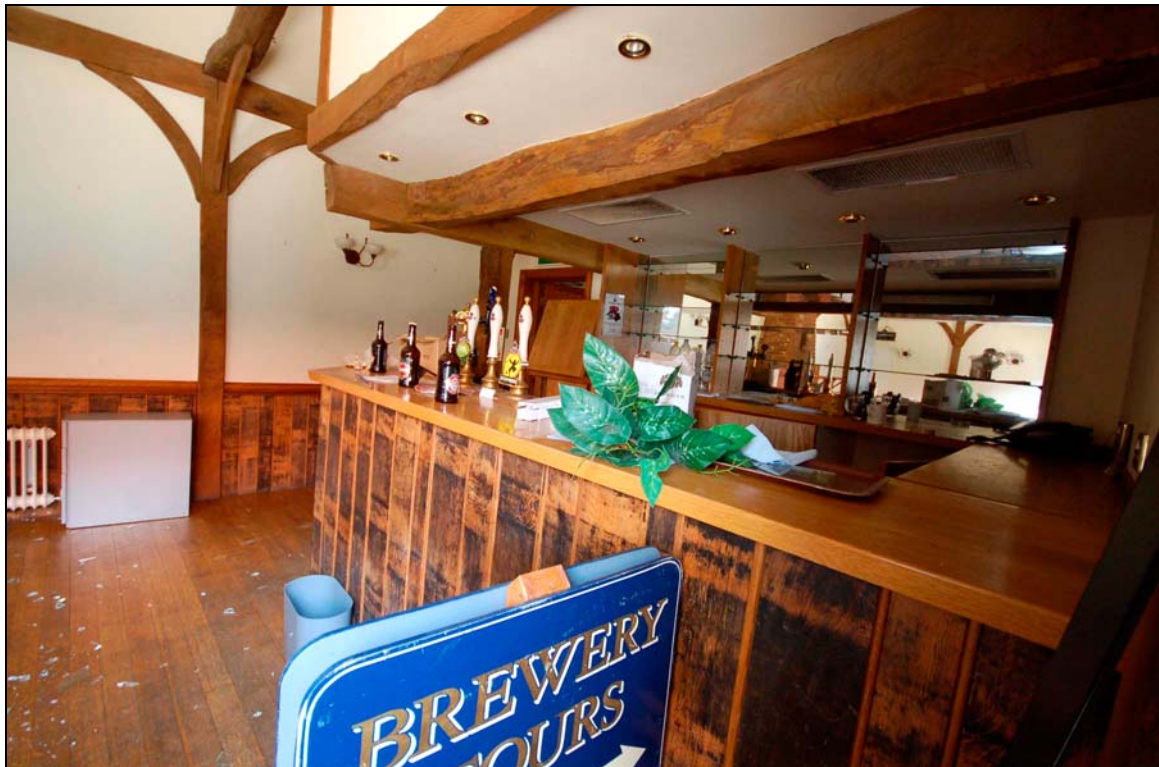
Plate 69 Clockhouse bar

Participants on the brewery tours that were conducted in the latter would end their visit at the clockhouse with a drink. This building replaced a partly open-sided structure evident from historic maps and was built in the same style, with its timber frame, brick plinth, weatherboard sides and a slate roof (plates 11 and 68). The main gable facing the road is plastered and has the TDR inscription above a clock that was perhaps sited somewhere inside the brewery originally (plate 68). The interior is designed to have a country pub feel to it, with exposed timbers and panelling. The bar is at the south-west end (plate 69).
