**GREAT OAKLEY METHODIST CHAPEL  
HIGH STREET  
GREAT OAKLEY  
ESSEX

HISTORIC BUILDING RECORD**

**September 2011**

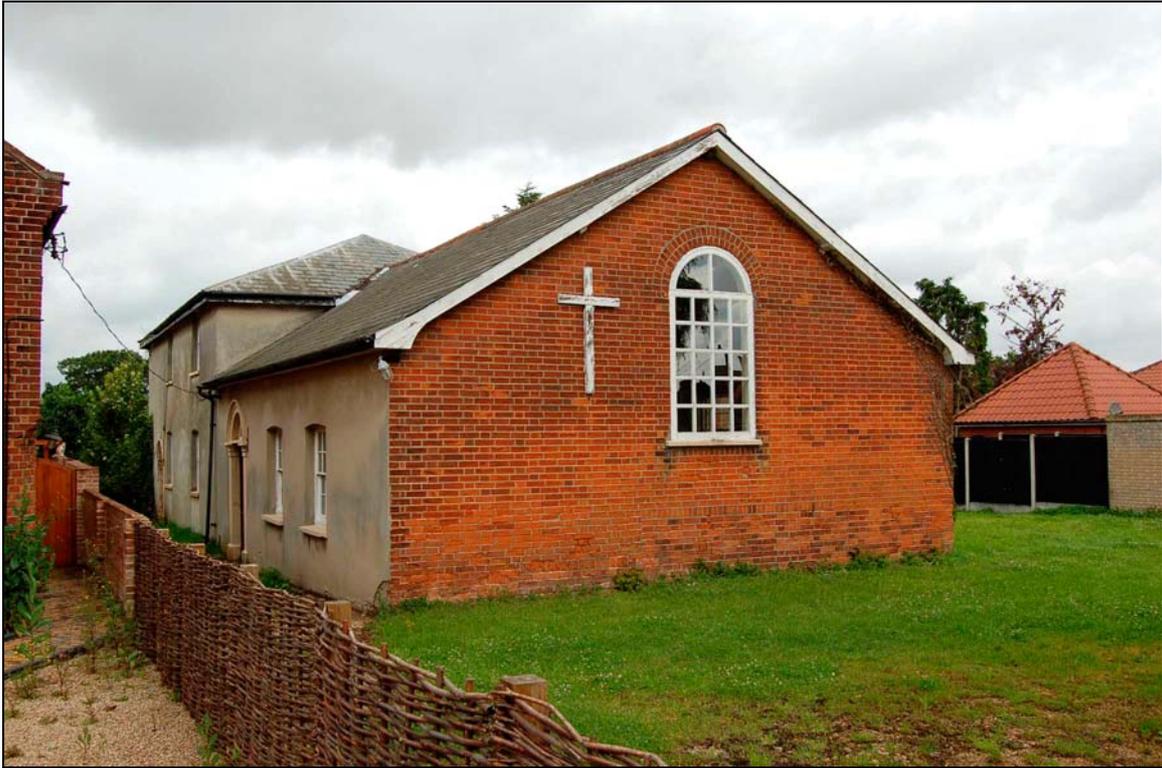
Plate 1 South-east elevation

The side elevations are uniform, with two eight-over-eight pane sash windows lighting each of the floors. Ground floor windows have cambered heads and employ obscured glass in the bottom sashes, while those above are built under the projecting eaves (plate 1). Some of the original timber sills have been replaced in codestone.

The schoolroom forms the main elevation facing the road, obscuring the whole of the original chapel frontage. Its dominant features are the south window and simple wooden cross. The window is fixed, with multiple panes and a semi-circular arched head created from two neat rows of headers (plate 1). This is a modern window, similar in character to the others but with thicker glazing bars, that replaced a window of the same size and shape since there are no intrusions into the surrounding brickwork. However there is some disturbance in the brickwork below the window where the courses do not run true and bricks have been added on edge to level up (plate 1).

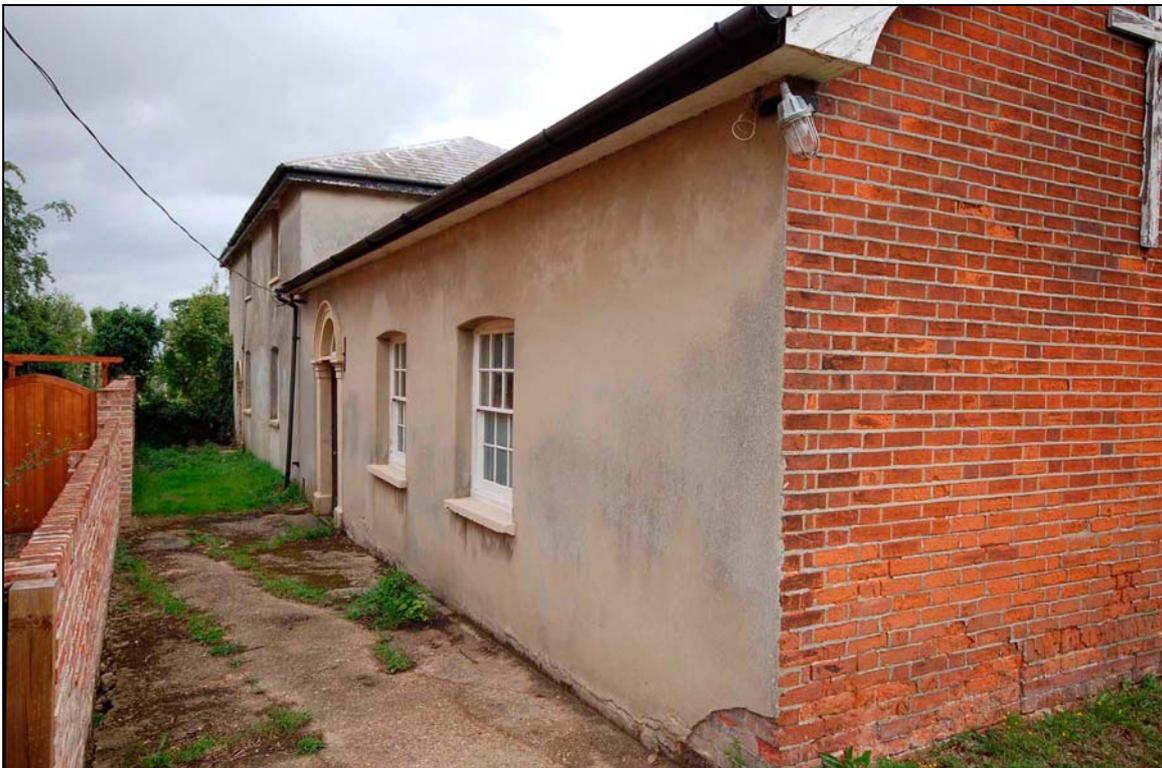
Plate 2 South-west elevation (schoolroom)

The south-west side wall forms the long, cement-rendered elevation of the schoolroom and chapel (plates 2 & 4). Set centrally on the schoolroom side is the main doorway into the building; an imposing feature with Georgian-style square pilasters and arched moulded head containing an interlacing lancet-style fanlight around a heavy semi-panelled door (plate 3). This interlacing gothic design is a Regency form, but was used up to the 1840s (Hall 2005) and may suggest the schoolroom was constructed slightly earlier than believed. Two tie plates have been added either side of the arch at a later date and there is a small iron boot-scraper sited on the ground on the left-hand side. The style of the main entrance is mimicked by the smaller side entrance on the north-west end of the chapel elevation that has the same style of doorcase around an unusual arched four-panelled door (plates 4 & 5). As the chapel is earlier, it is likely the schoolroom entrance copied the side entrance in a slightly grander form.

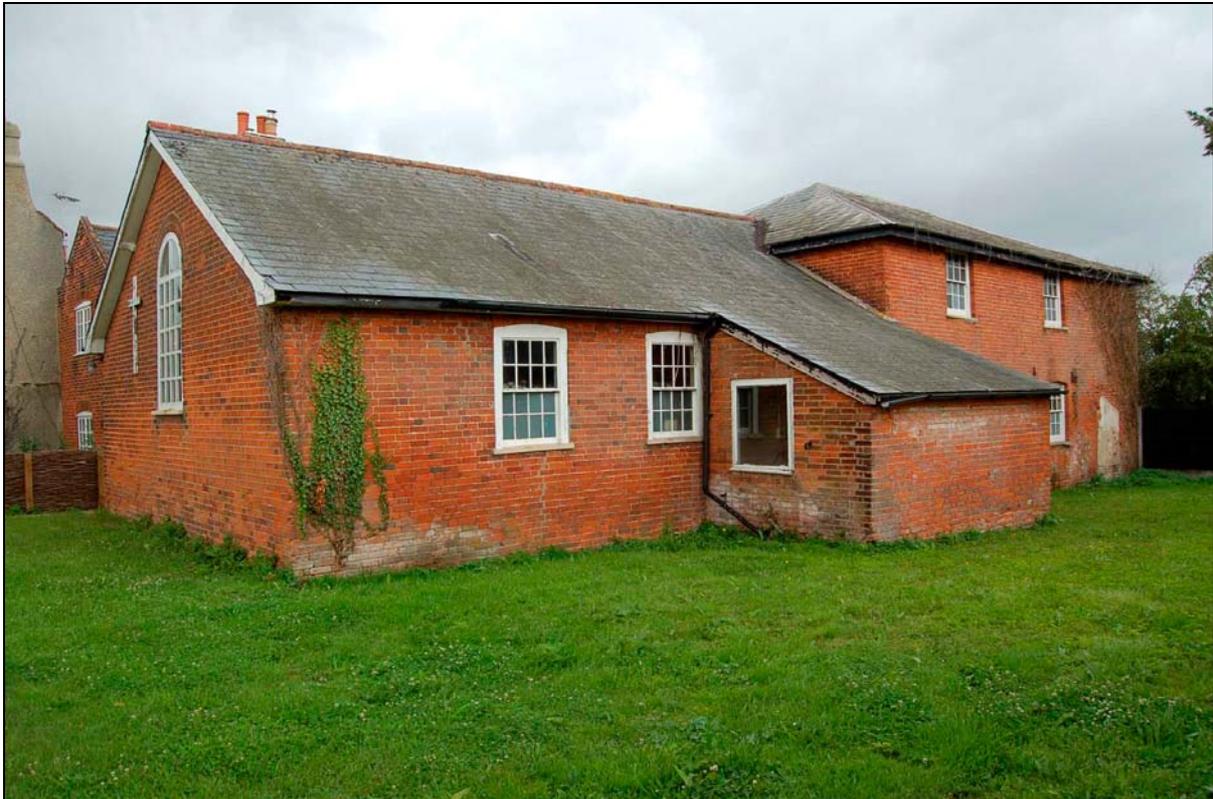
Plate 7 North-east elevation

The north-east elevation is not rendered although some brickwork has been re-pointed over the original lime mortar. Windows on the north-east elevation of the schoolroom (plates 7 & 8) are equally-spaced with those on the opposite side but are set 0.5m higher up to the eaves. Almost half of the schoolroom elevation is taken up with the kitchen. The kitchen has few external features apart from a modern window replacement over the sink on the south-east side, somewhat out of proportion with the others, and the doorway at the back (north-east), with an original ledged and braced utility door that retains all original fixtures and fittings (plate 8).

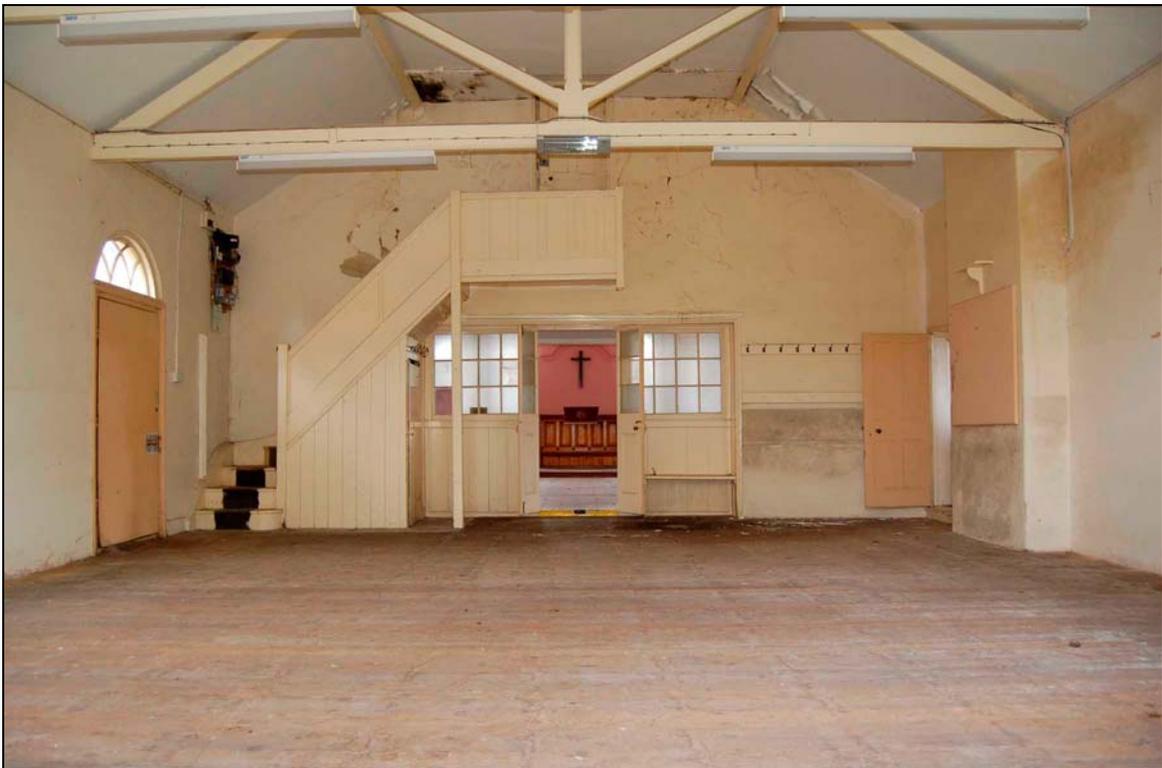
Plate 9 Interior of schoolroom viewed to north-west

On the right-hand side of the doors is a waiting area, where there is a low wooden bench, and to the left is the stair up to the first floor gallery (fig. 3 & plate 9). The stair, close to the main entrance, adopts a quarter-turn form and has a panelled balustrade. The top landing extends outwards from the gallery doorway, with a moulded four-panel gallery door situated directly above the ground floor doors into the chapel. On the newel post at the bottom are fittings for a stair guard to prevent children from ascending (plate 9).

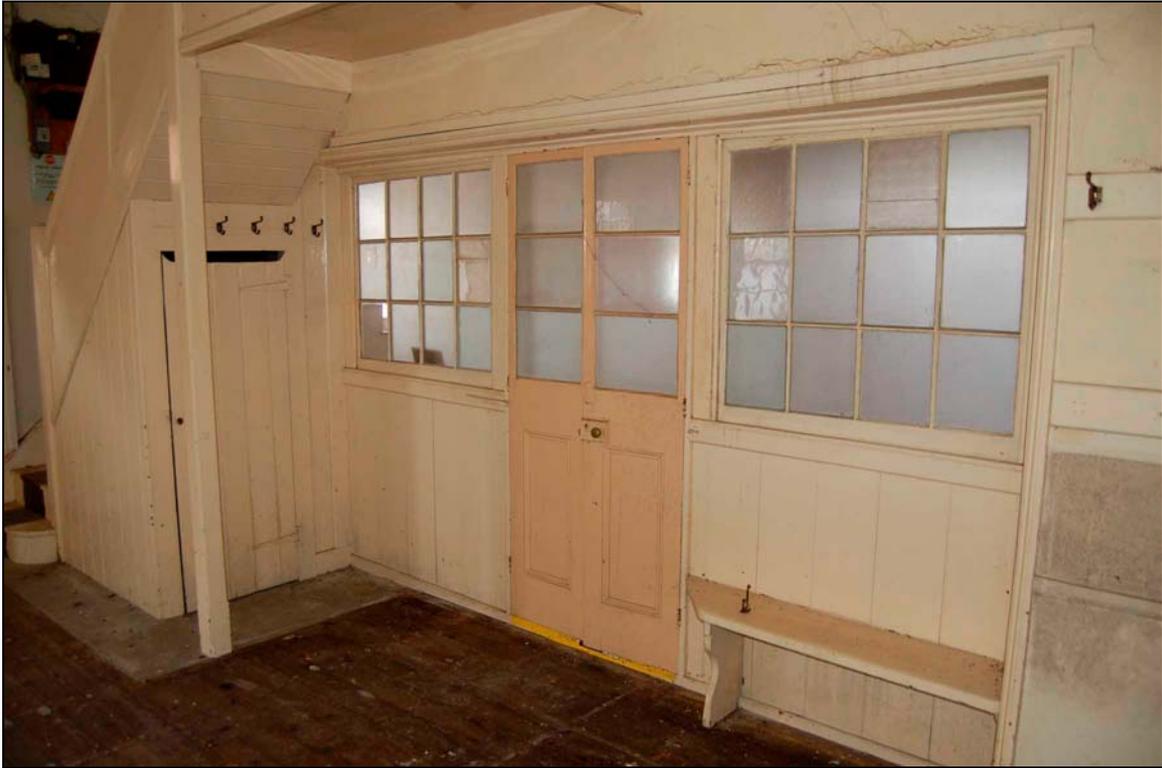
Plate 10 Screen between schoolroom and chapel

Below the stair is a small cupboard whose ledged and braced door has a fancy cut-out at the top, presumably for air-flow (plate 10). The door is fitted with rudimentary iron T-hinges; above it is a row of well-preserved curved metal coat hooks. Inside the cupboard is a modern shelf but no earlier fittings.

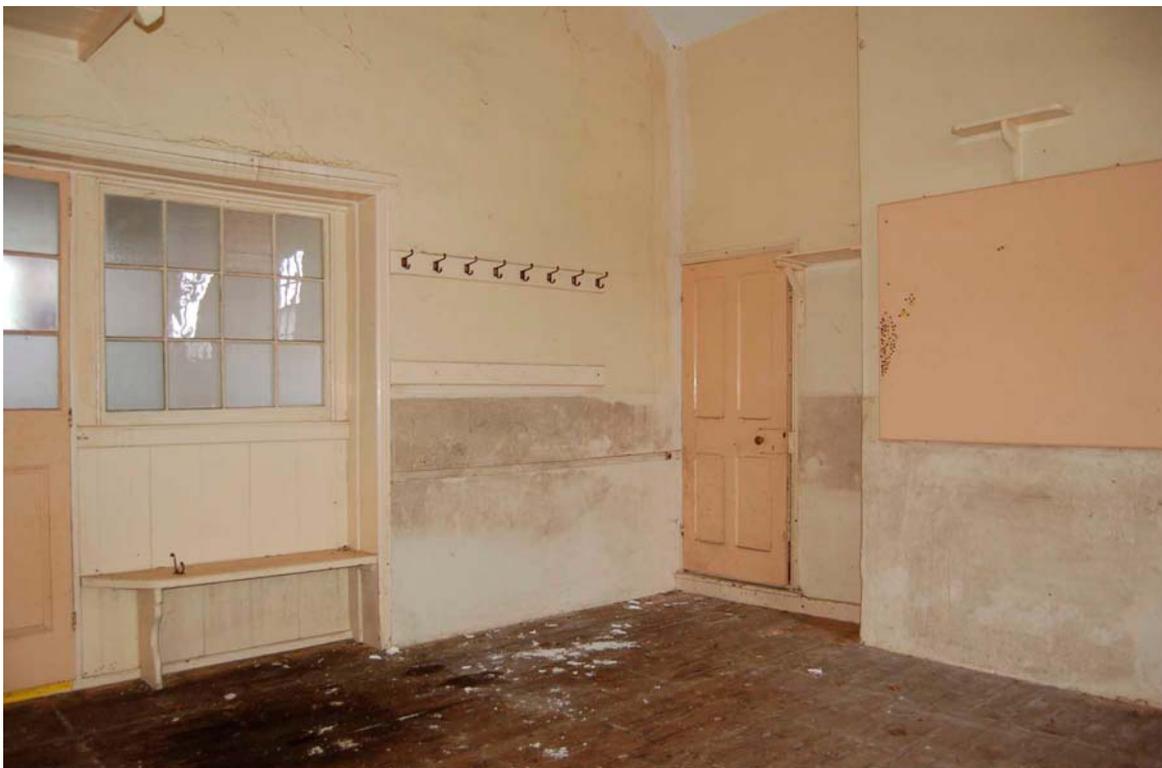
Plate 11 Historic fixtures around entrance to kitchen

Beside the doorway into the kitchen is another row of coat hooks (plate 11). The doorway into the kitchen is a plain four-panelled type, reflecting its more utilitarian nature. Beside the doorway is a chimney breast for the old fireplace, which would have heated the schoolroom. The fireplace is now blocked-up and the chimney no longer remains. High up over the fireplace and between the breast and doorway are two original narrow wooden shelves that probably supported pictures of a religious nature (plate 11).

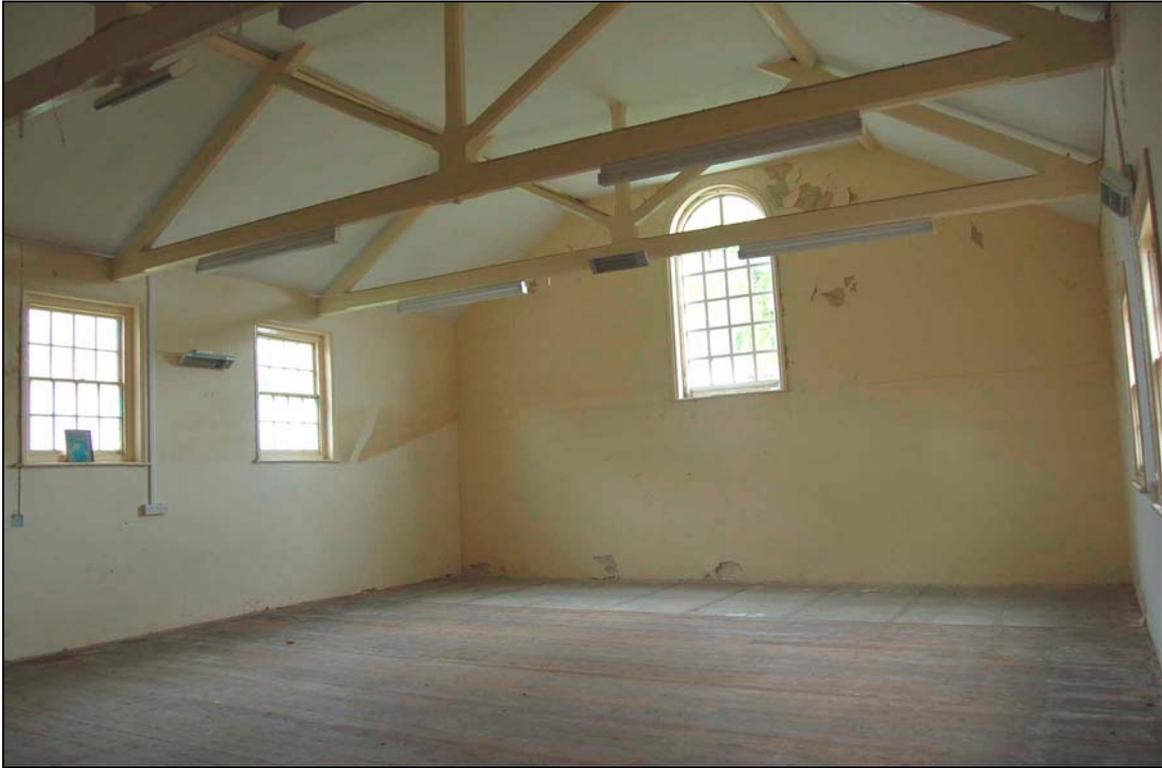
Plate 12 Interior of schoolroom viewed to south

Viewed to the south-east from the chapel, there are few fixtures and fittings remaining inside the schoolroom (plate 12). The roof trusses of the schoolroom are fully-exposed and the wooden floor is original, though its boards finish some 2m from the south-east end (fig. 3). Here concrete was added between the floor joists in the modern period (fig. 3 and plate 12). The size of this exposed area suggests originally there may have been a dais here, like in the chapel, presumably used either by the teacher or as a stage.

The roof frame is built from bolted king post strut trusses in machine-sawn timbers, suiting the later 19th century date of the schoolroom (plate 12).

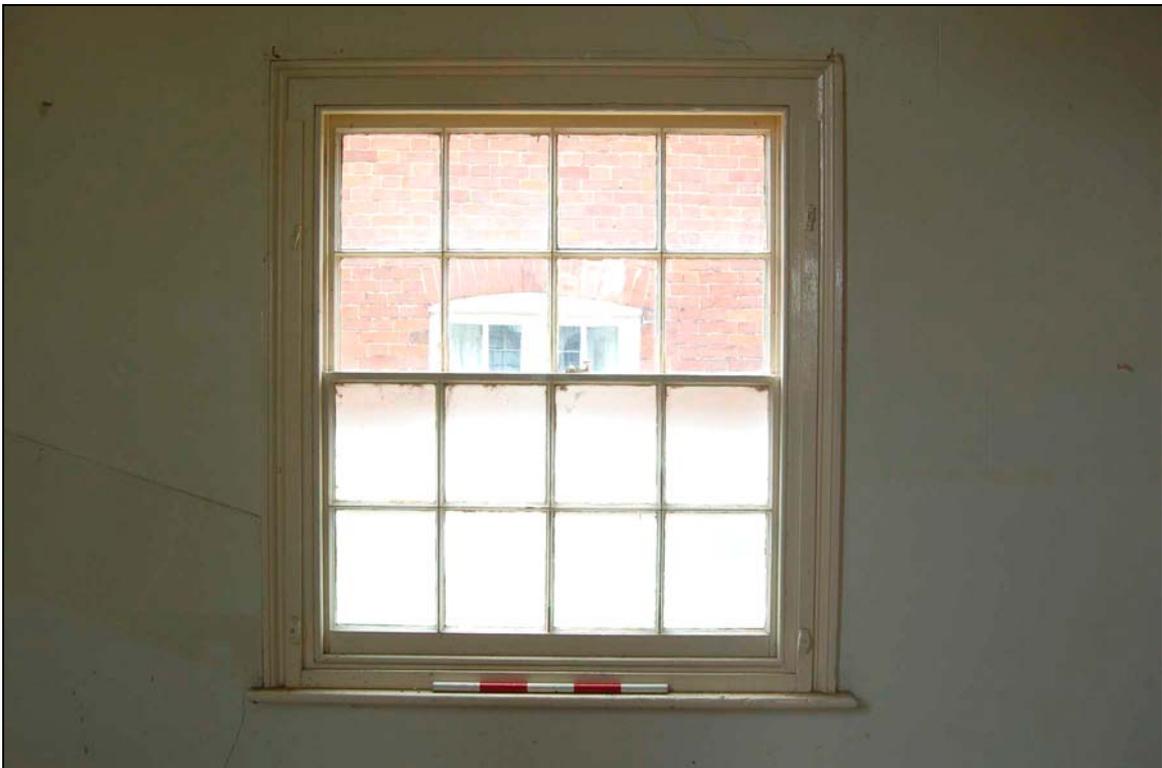
Plate 13 Window on south-west side of schoolroom (0.5m scale)

The arched window at the south-east end is clearly modern and there are fittings in the window arch for the original top-opening window. The windows on either side of the schoolroom are identical apart from those on the north-west side are lower in height. They have metal fixtures for wooden shutters on the sides and later hooks for blinds at the top (plate 13).

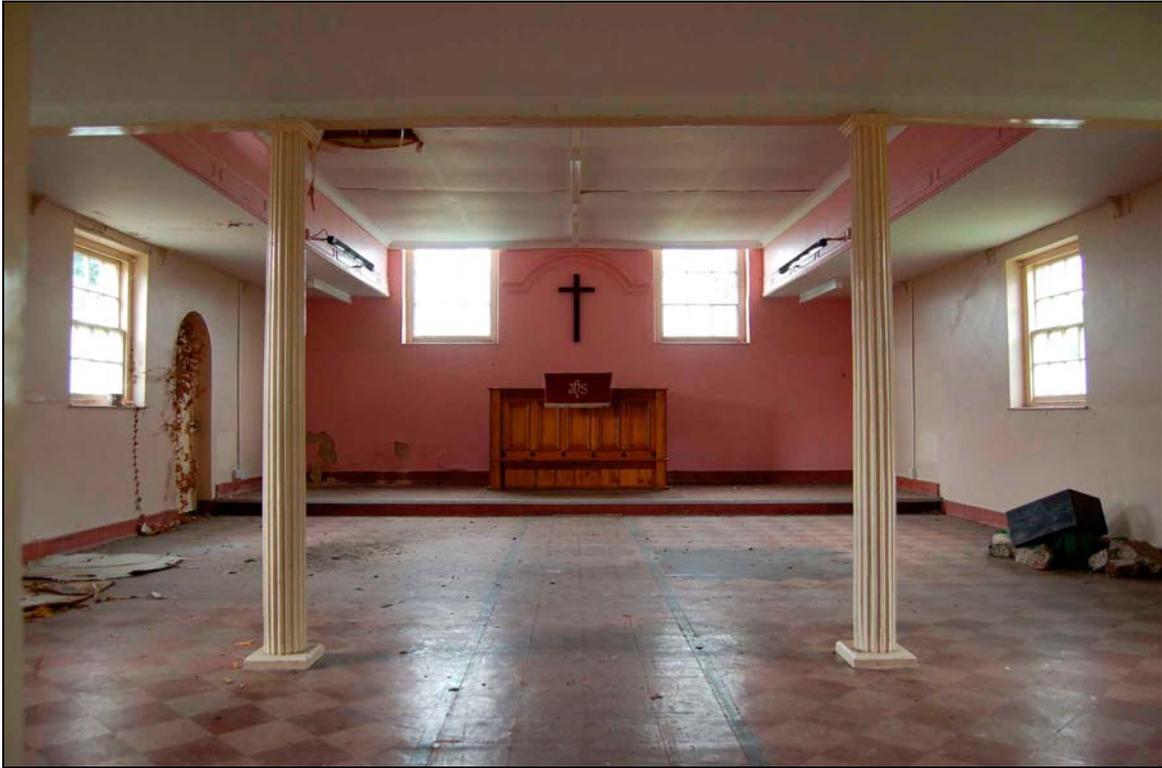
Plate 14 Interior of chapel viewed to north-west

The floor is tiled in 9-inch red and cream-coloured quarry tiles laid in a diamond pattern, except for the aisle and dais (plates 14, 15 & 17), which have red tiles within a black tile border. Around the base of the walls is a coved tiled skirting, likely to be modern, contemporary with the tile sills of the chapel windows. The windows have metal fixtures for calico blinds.

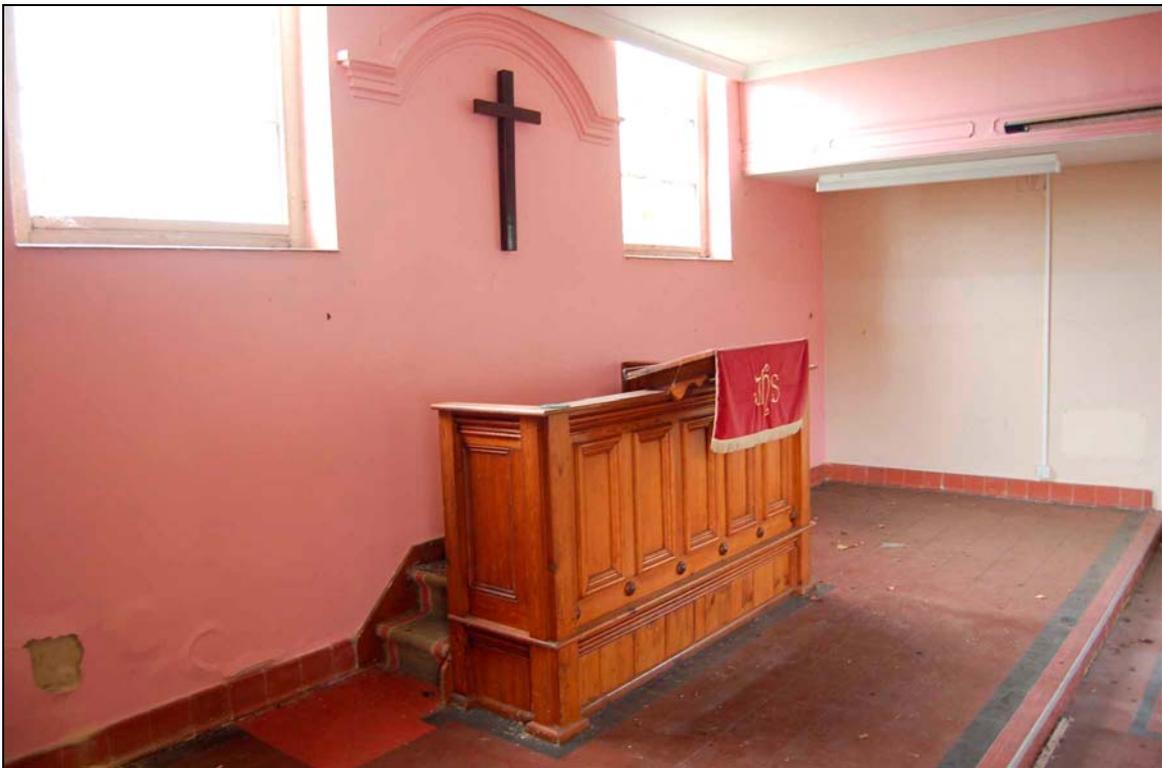
Plate 15 Pulpit

The dais contains a pine panelled pulpit with integral lectern in the centre. The south-west side of the pulpit is open, presumably giving direct access from the chapel side door (plate 15). The interior of the side door has been boarded over and ivy has managed to penetrate through the frame, but otherwise the door is intact and is a nice feature. The lectern still has the cloth over it

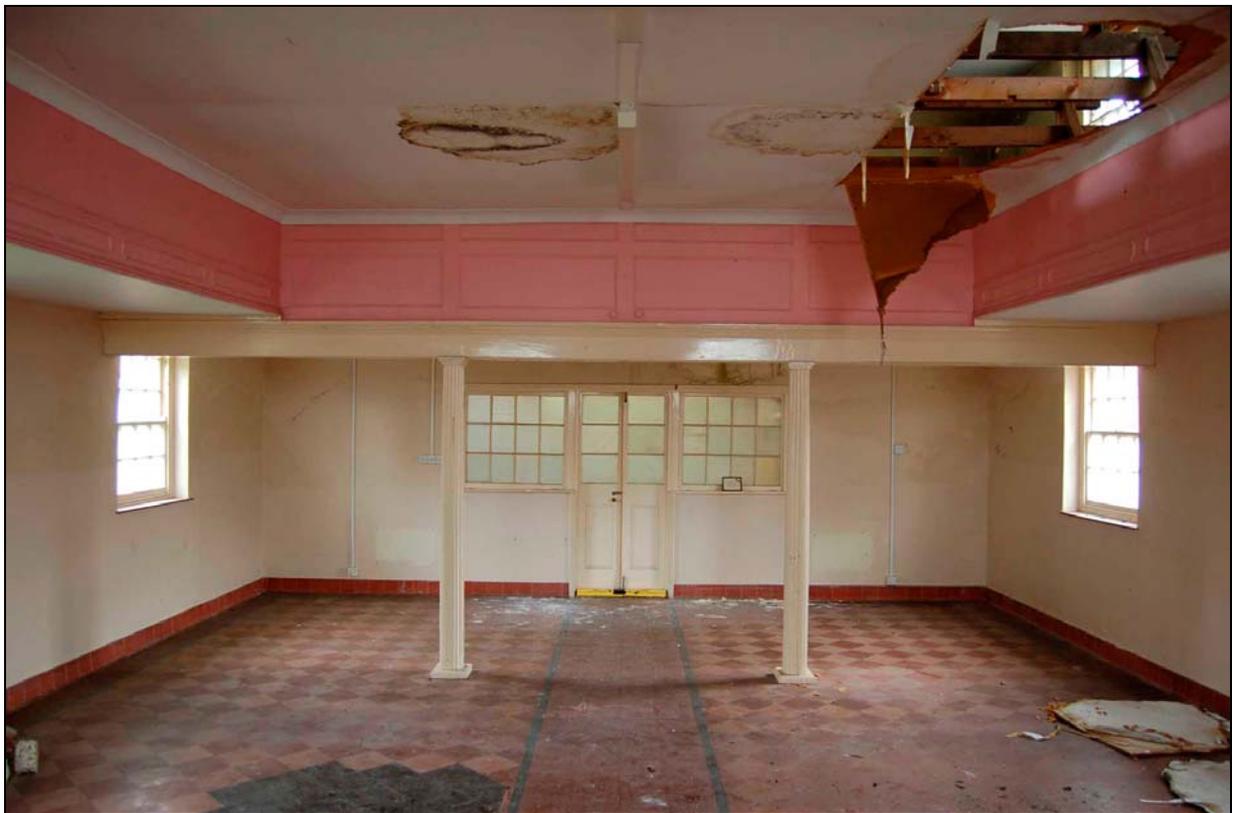
Plate 17 Chapel viewed to south-east

The gallery above is believed to have been built in two phases, which accounts for the fact that the panelling of the main gallery is different to the side galleries (plates 17 & 18). The main, or back gallery, is deeper than the side ones and slopes downwards from the back wall towards the pulpit. It is supported at the front by two fluted wooden columns upon stepped capitals (plate 18) while the side galleries are supported on iron T-joists, the ends of which can be seen on the north-east elevation. Panelling on the back gallery is in a plain sunken rectangular form, whilst the side galleries have narrow lozenge bands to top and bottom (plate 18).

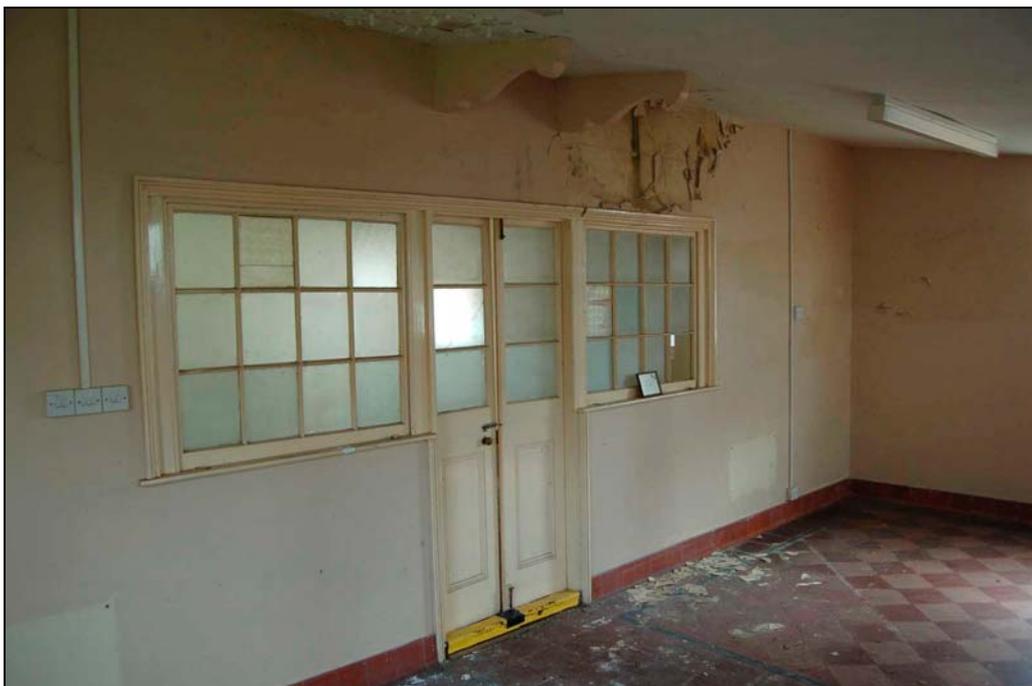
Plate 19 Screen viewed to south-west inside chapel

The light panels of the doorway screen are detachable on this side and the doors have locking draw-bolts. Just in front of the screen are two carved consoles that provided additional support over the doorway (plate 19).

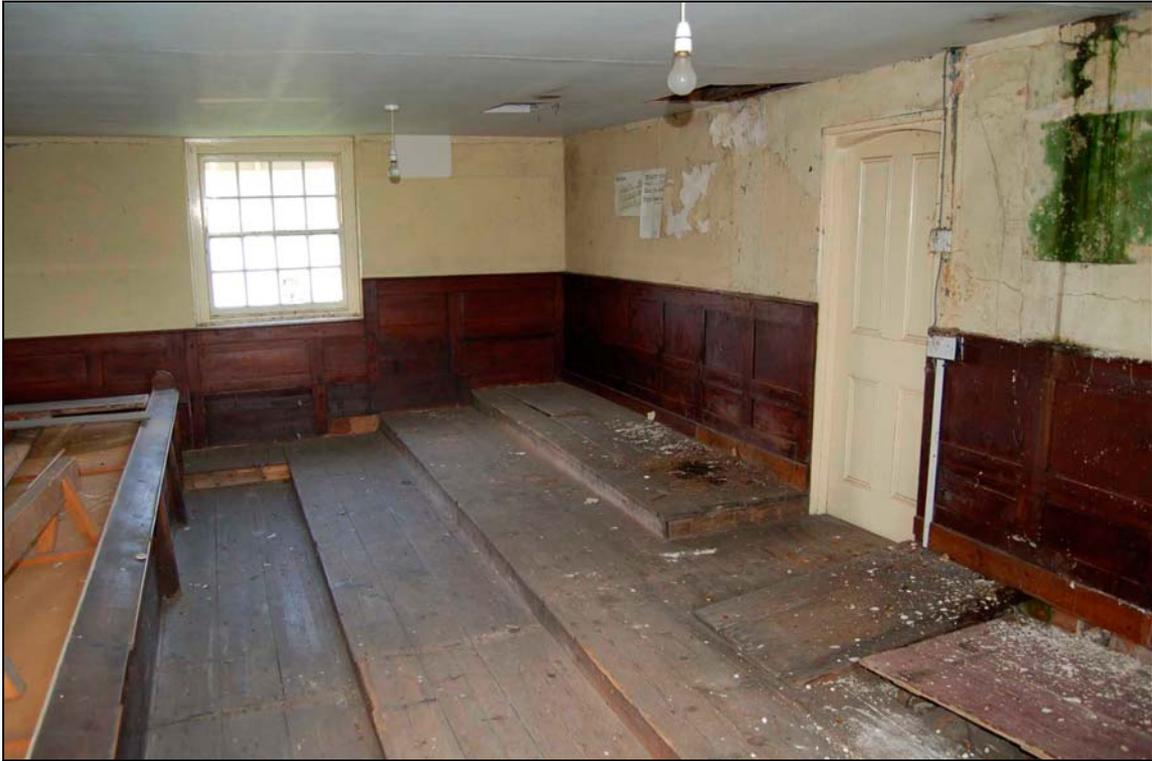
Plate 20 Original back gallery viewed to east

All seating has been removed on the back gallery, exposing only the four tiers (fig. 4 and plate 20), but the side gallery seating remains. Originally the timber partition at the front (plate 21) extended all the way across, but it was cut back when the side galleries were added and the ends are now finished with ovolo-carved terminals (plate 22). Members of the congregation sitting at the front of the gallery could lay their hymn and prayer books on its sloping top.

The bottom parts of the first floor walls are fitted with 0.9m-high dark-stained panelling, below vague remains of stucco decoration. Wall panelling around the back gallery comprises oblong panels (plate 20) while the side galleries comprise alternating square and rectangular panels (plate 23), in 9 foot (2.8m) long sections. Part of the floor in the south corner was disturbed when new electricity cables were inserted (plate 20, right).

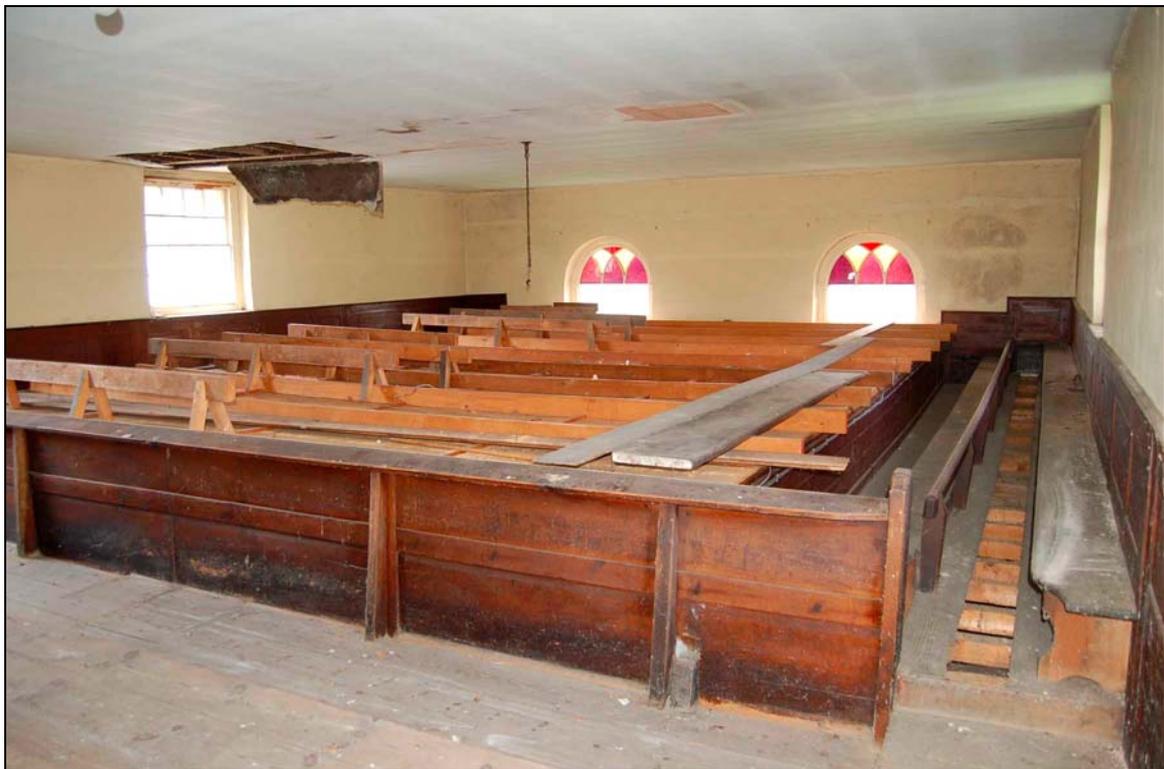
Plate 21 First floor viewed to north-west

The north-west elevation lies on the boundary of the chapel grounds and the garden of 'Crooked Acres' at the back, and was recorded from a nearby public footpath. This aspect shows the building at its most distinctive as a chapel (plate 6). This side is also rendered and contains two large multi-pane windows with interlacing lancet heads in the same style as the fanlight over the main entrance. They contain red and yellow-tinted glass that define the lancet heads, best seen from the inside (plate 21).

The false ceiling between the galleries is a modern feature added as a safety or heat retention measure after the chapel phase of use finished. The ceiling is made from hardboard fitted to the undersides of long joists that span the gallery walls (plate 21).

The ceiling to the first floor is plasterboarded, replacing a former lath and plaster one. Overhanging the gallery space is the old chain for a hanging lamp or candelabra (plate 21), the only early light fitting observed in the survey. The roof structure was partially observed through a hole in the ceiling and showed two phases of development; four pegged king post trusses from the original roof and the existing later nailed collar purlin frame (plate 24). All the later timbers are machine-sawn.

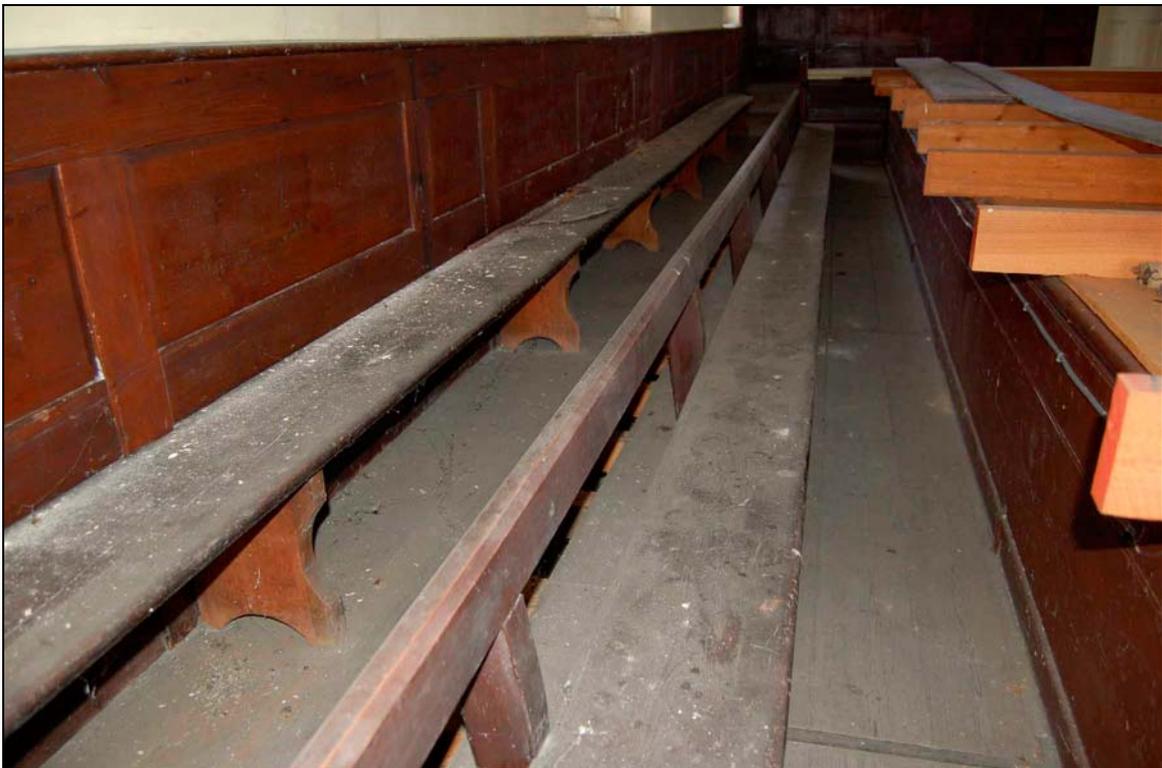
Plate 23 Side gallery seating viewed to south-east

The side galleries retain their long wooden benches, arranged on two tiers. The benches on the top tier are fixed to the walls, while the bench in front has a simple single-rail back to it (plate 23). The benches are only 250mm wide, and legroom is limited. Although the seating is austere, the legs are carved (plate 23), applying detail where it would not normally be seen.
