**THE SHOREFIELDS SCHOOL  
(THE FORMER OGILVIE SCHOOL OF RECOVERY)  
HOLLAND ROAD  
CLACTON-ON-SEA

HISTORIC BUILDING RECORD**

**December 2011**

**FAU Project No.:** 2502

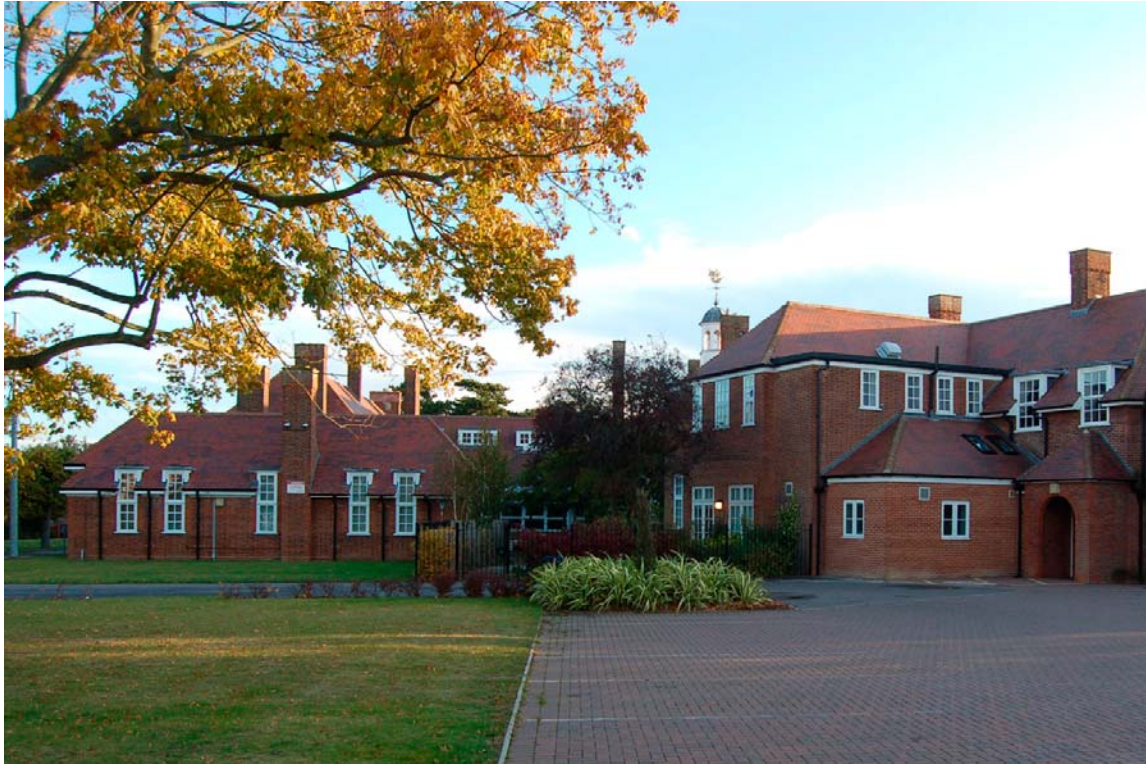
Plate 7 South-west elevation of isolation wing (left) viewed with rear of school

Lucarne windows light the isolation rooms on this side in the form of five casements/tilting windows, one below the other (plate 7). This type of window is also prominent in the school/hospital side, but larger. Their arrangement suggests a central window is missing, but this is not the case since behind it is an internal wall. Similarly the chimney stands in front of an internal wall, though it is unlikely to be here just for show. The same windows are also present on the north-east sides of the isolation blocks, drawing in the light and fresh air into the rooms.

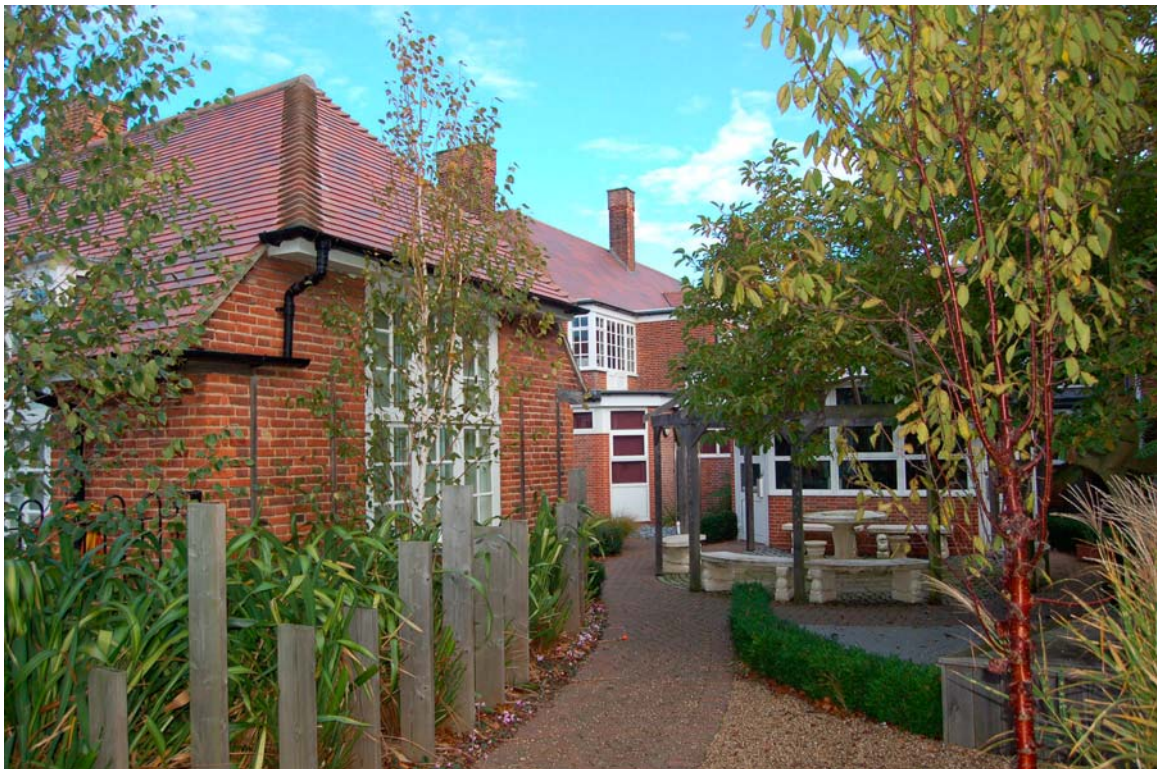
Plate 8 Isolation wing viewed to north

Much of the rear/south-east elevation is hidden from view by modern additions, mainly the recently-built library and gym. The only exposed historic elevations are the lucarne windowed isolation room (plate 8), flat-roofed nurse's room of the isolation wing (now deputy head's room) that show domestic-style casements and the present kitchen, that is fitted with replaced utilitarian metal casement windows.

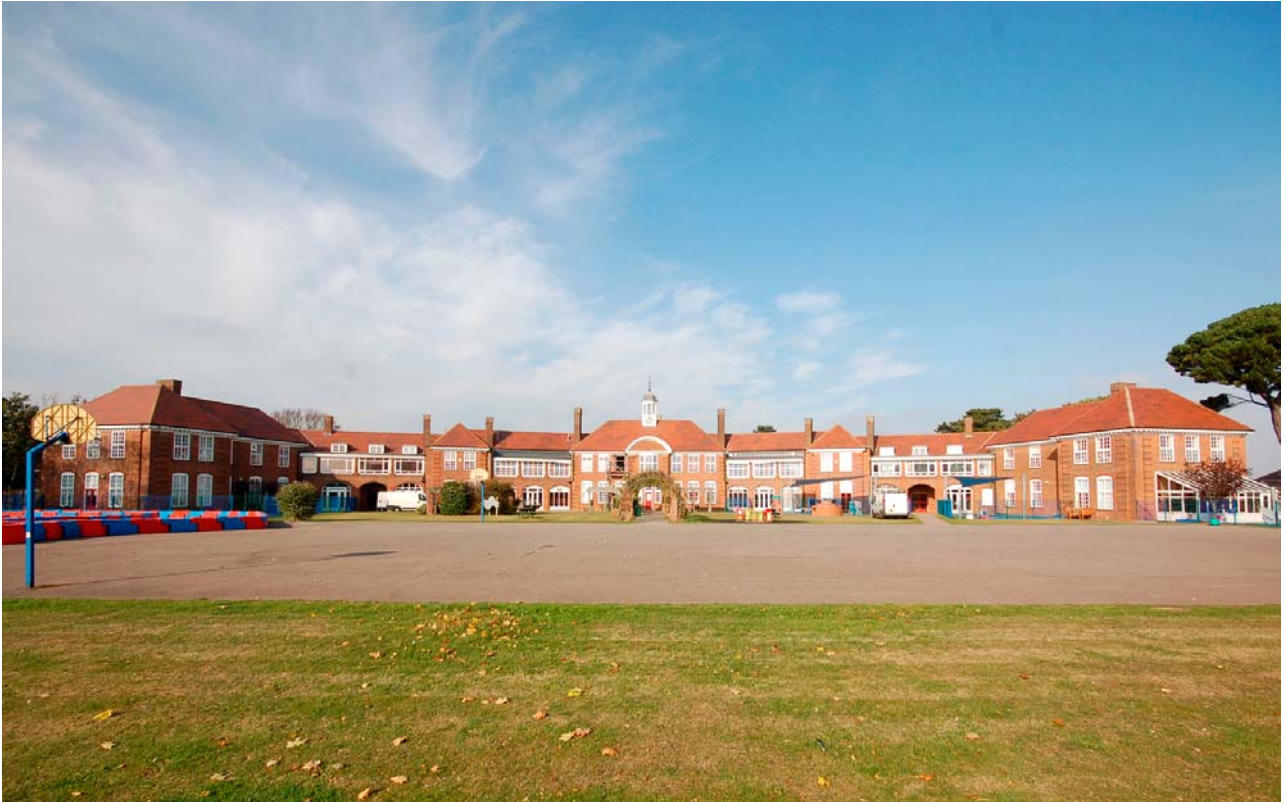
Plate 9 South-east elevation of school

The school has a grander aspect than the Admin building (plate 9), particularly the central block at its heart. The **central block** (plate 10) comprises three bays, the central one of which projects outwards and is further distinguished by its rusticated brickwork on the corners, first floor oriel window, dentilled bowed arch and eaves board hipped roof and the clock tower with its golden ship weather vane, an early emblem of the school (appendix 1).

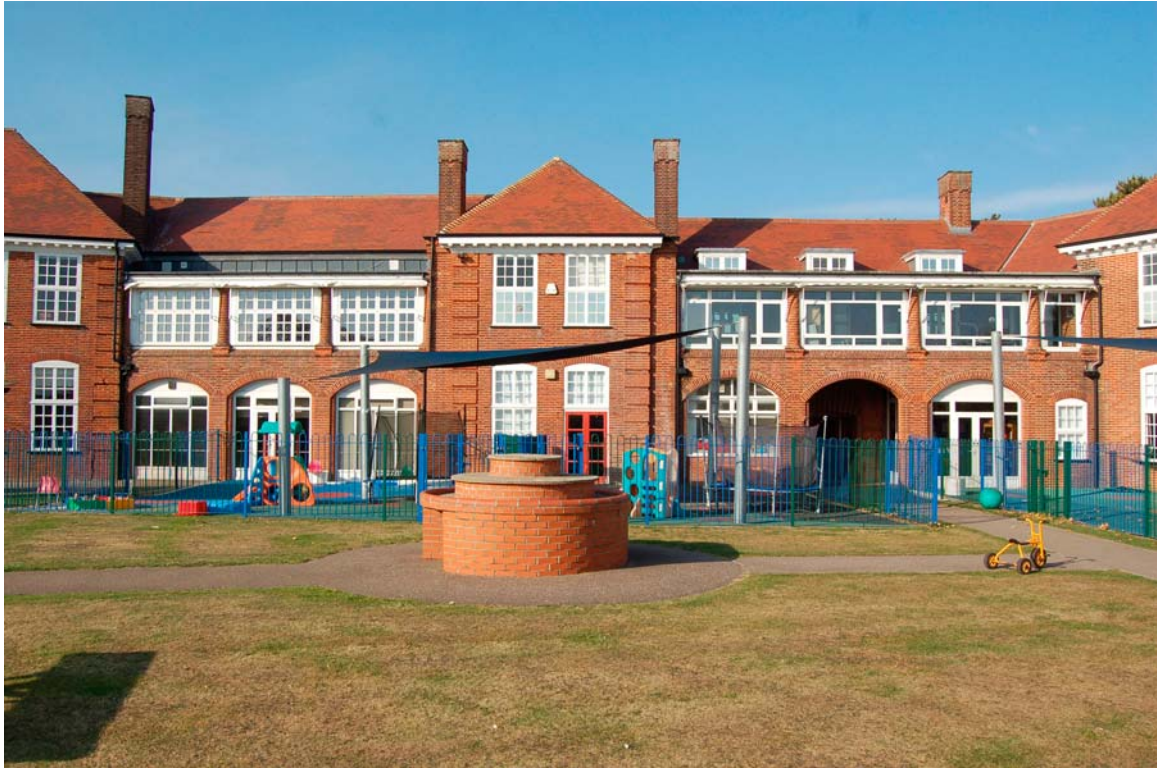
Plate 11 Dormitory block between verandah ranges (north wing)

The projecting dormitory blocks between the verandahs on each side have similar architectural themes to the central block, primarily the rusticated brickwork and dentilled eaves. Fenestration is identical and there are also tall chimneys either side to heat the dormitories (plate 11).

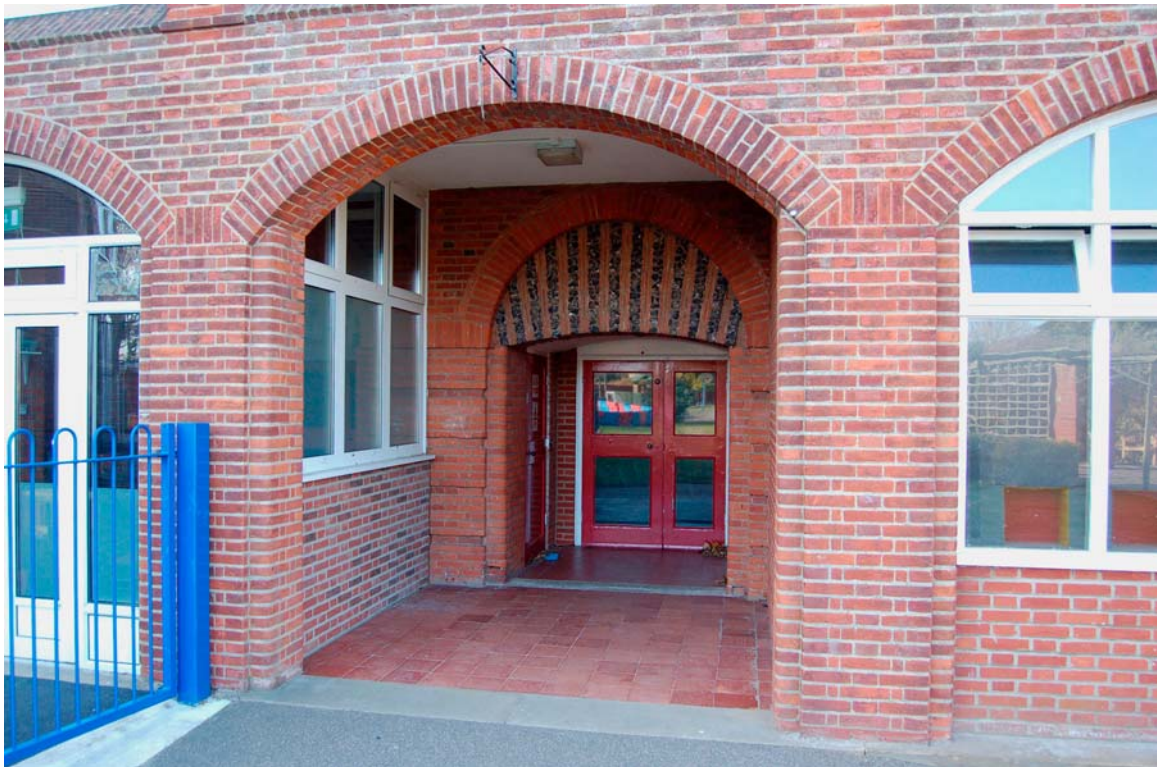
Plate 12 Playground entrance with blocked former verandah either side (south wing)

Entrances into the school (historically boys to the north and girls to the south) are located in the middle archways of the outer verandah ranges that connect to the 1921 wings, and remain intact. The open entrance bays retain the quarry tile floors that formerly extended either side into the verandahs. Beyond this is an open porch entered beneath an interesting semi-circular arch with its flint and brick vertical banding rusticated brickwork jambs (plate 12). The entrance doors are probably original.

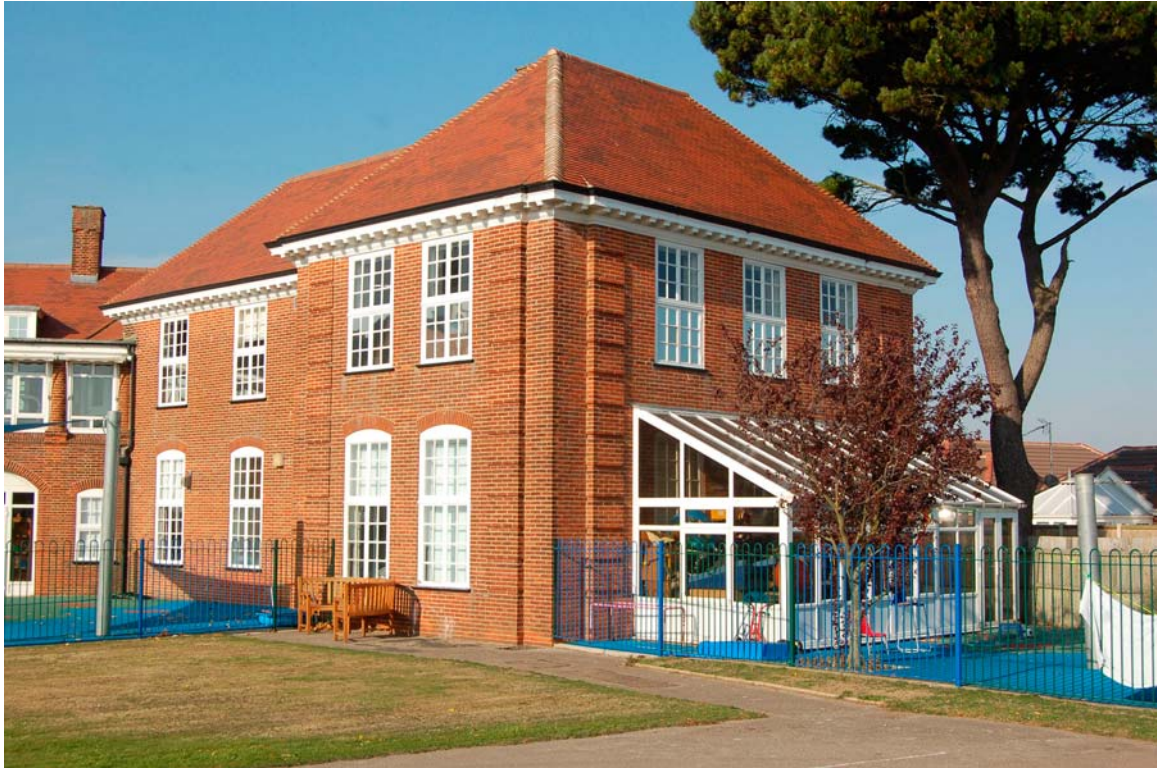
Plate 17 North wing extension viewed to north

The 1921 extensions comprise two short three-bay ranges with cross wings at the ends and follow the style of the dormitory blocks of the main school building. Elevations on the **north-east, south-west and south-east sides** have the same fenestration (pair of double casements below a single tilting window), dentilled eaves and hipped roofs, and the end block also has rusticated brickwork piers, like the main blocks, on all sides (plate 17). Entry points are located on the south-east elevations and contain original centrally-placed doors under the usual square fanlights, leading out into their own separate playgrounds. The door in the north block now leads initially into a modern lean-to 'conservatory' (plate 17).
