**FORMER BUTCHERS SHOP AT
131 HIGH STREET, BILLERICAY
ESSEX**

HISTORIC BUILDING RECORD

Essex County Council

Field Archaeology Unit

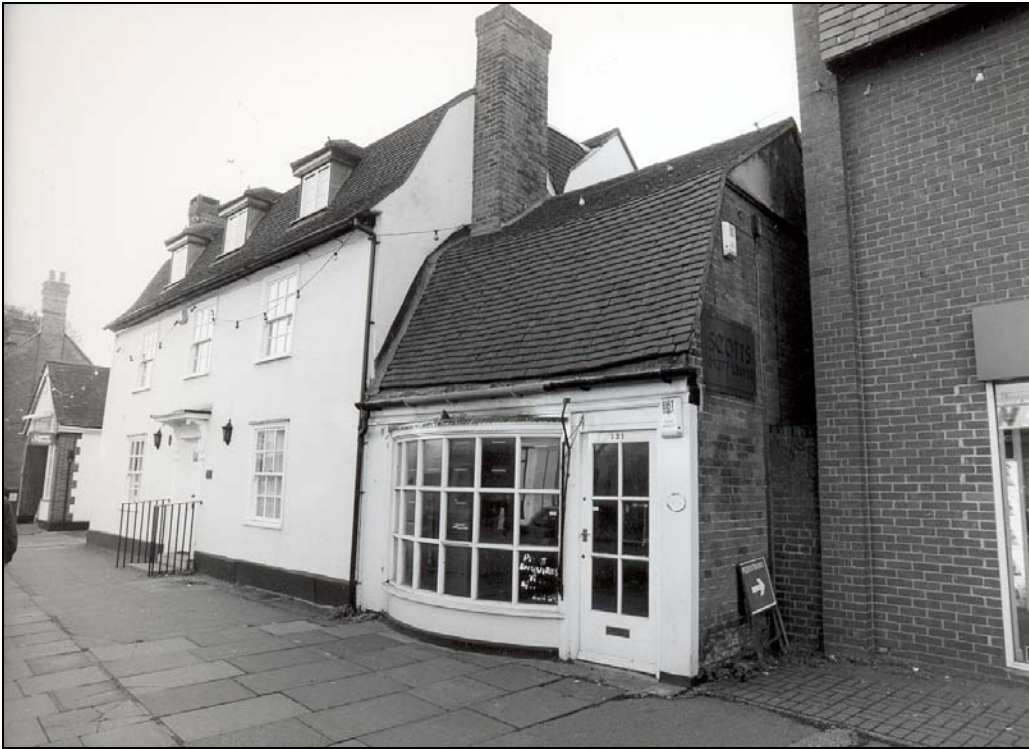
Plate 1: 133 and 131 High Street viewed from north-east

Facing onto the High Street, this was the prominent, public side of the business. The listing groups number 131 with 133, The Old Shambles (plate 1), but does not make specific reference to it. Traditionally the shambles were markets for the slaughter, butchery and the sale of meat. Architecturally its plain-tiled mansard roof and brick build reflects the character of the main building. Like the main building, the east elevation, or shop façade, is rendered, obscuring constructional detail. The prominent features on this side are a large six by three light ovolo-moulded bow window and a modern two by six light plain shop door (plate 2). Both door and window are surmounted by a cavetto and bead-moulded wooden entablature, onto which modern awning fixtures are attached. No other historic features were noted on the shopfront.

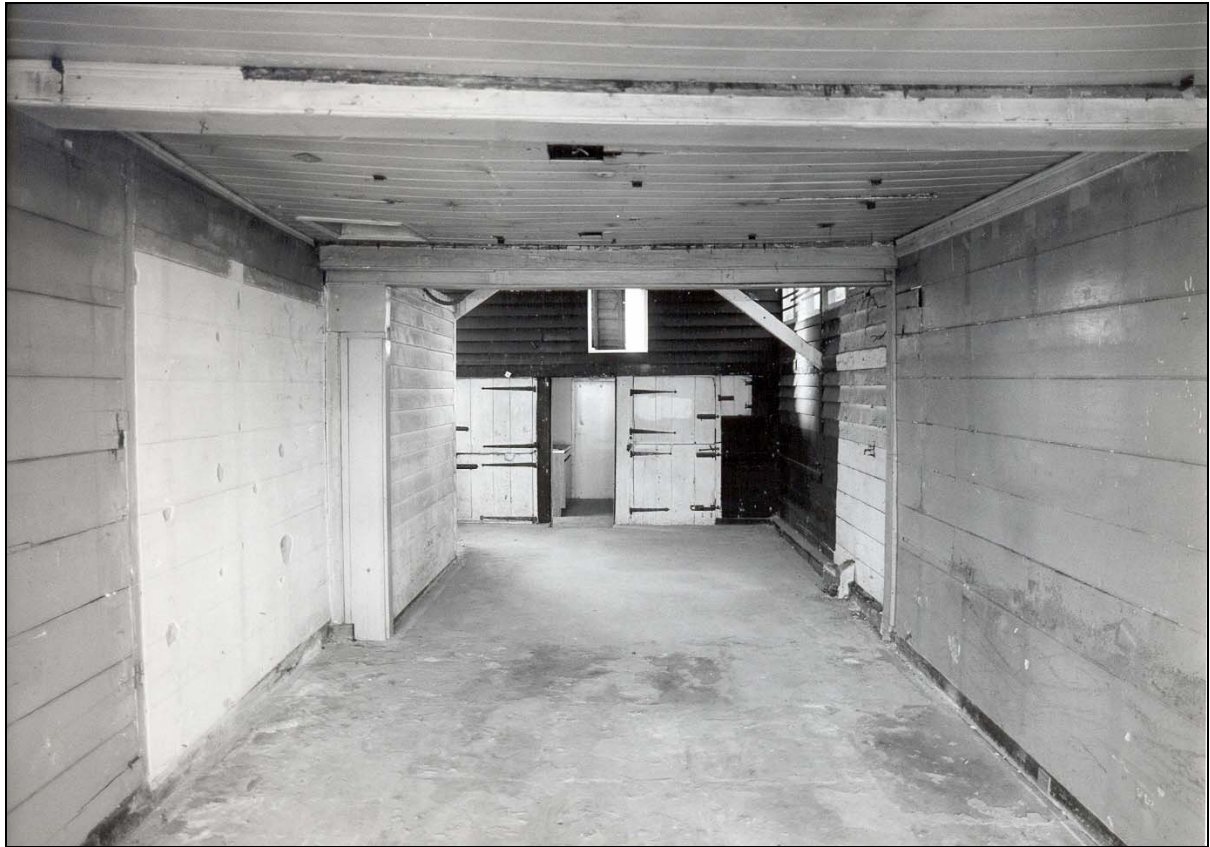
Plate 3: Shop interior viewed from east toward slaughterhouse

Internally the shop is divided into two approximately 3.7 x 2.7m bays demarked by 0.25m wide boxed beams. Both walls and ceiling are clad in horizontal matchboarding, 255mm or 10" wide and beaded, with moulded timber cornice above (plate 3). This style of cladding, used for hygiene reasons, was a common feature of 19th century butchers shops (Morrison 2003). Either side of the chimney stack (which is also clad) are blocked areas of walling that formally linked to the main house forming one room around a central fireplace. The smaller one to the east may represent an earlier blocked doorway. The blocking to the west is modern, comprising breeze block beneath a stucco-effect render (plates 3 and 4) and is to be removed as part of the redevelopment.

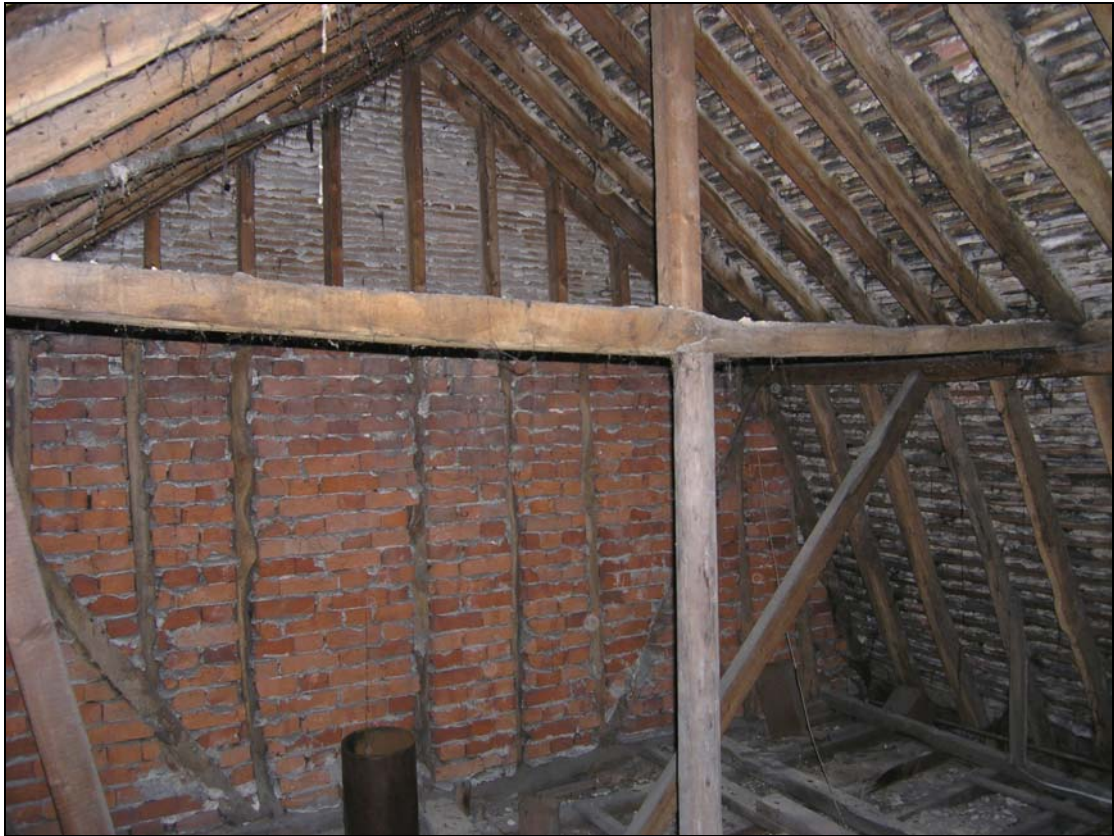
Plate 5: Loft above shop

Large York sandstone flags, varying in size, cover the floor. Above, a hatch leads into the loft, where the roof truss is exposed, as well as the internal gable wall. This has an internal timber frame not apparent from outside (plate 5) and a lath and plaster upper section corresponding to the rendered area mentioned previously (5.2.2). The loft is likely to be contemporary. The hatch, similar in style and dimension to the hayloft hatch in the stall area, appears a secondary insertion. Inside there are no floorboards, only bare joists. Inspection established a basic roof frame of thin winnowy rafters set at two levels, reflecting the change in pitch of the roof (plate 5). Each set is attached to its own plate and both plates sit within the break of pitch. The upper plate contains a series of mortises set at c.0.35m intervals, in line with the rafters (plate 6). These originally held collars. Two collars remain, one in the centre and another beside the chimney breast to the south. The first of these has additional support from a later, twin-sectioned, king post (plate 5). The collars appear to have been replaced by crude diagonal struts connecting from central floor joist to plates either side by birdsmouth joints. The dating and reason for this change is unknown. However, it is speculated that this occurred when the 19th century extension was built. It is possible that any floorboards were removed at the same time to form the new hayloft floor over the stalls to the rear.

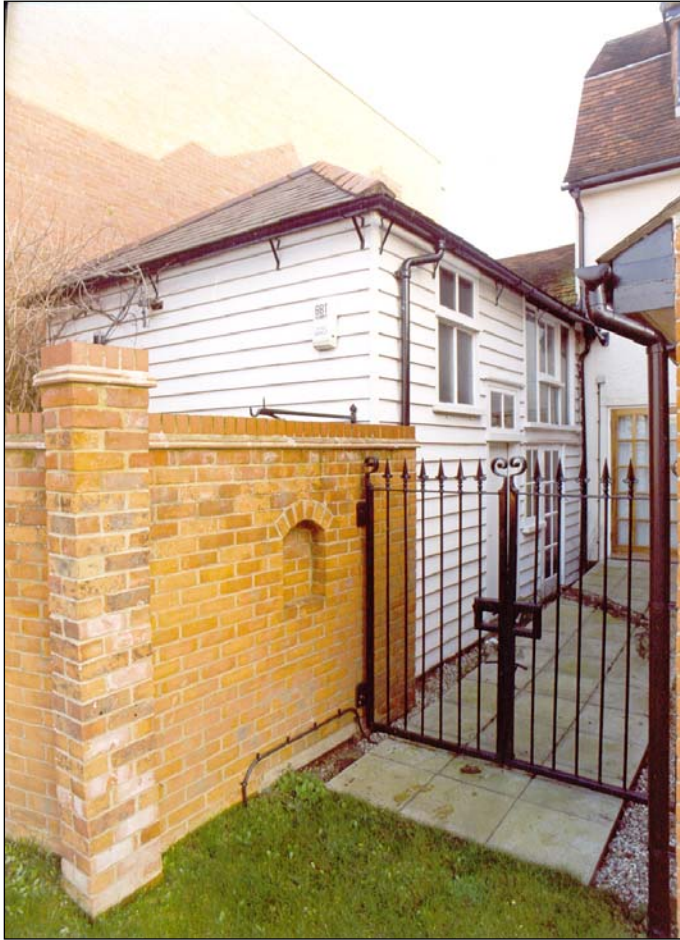
Plate 7: Slaughterhouse viewed from south-west

Externally the slaughterhouse is very different to the shop. It is timber-framed with weatherboard cladding and a low pitched Welsh slate roof, hipped to the west (plate 7). All except the east elevation, which connects to the shop, carry windows glazed in frosted glass, perhaps as a regulatory requirement.

The two doors on the south elevation provide access from the working area and stalls onto the narrow yard between this and the rear of number 133 (plates 7 and 8). That to the east is glazed with eight panes of frosted glass. The second is plain. Between the two doors is a fixed four pane window. At first floor level are two further sets of windows. The larger, set above the glazed door, has four fixed lights set around a twin-light centrally-hinged vent. A small two-light oblong top hung sash acts as a fanlight to the second door. A fourth, further to the west, lights the hayloft to the rear. This is a two-light oblong top hung sash of identical proportions over a larger, fixed, two-light window (plate 8).

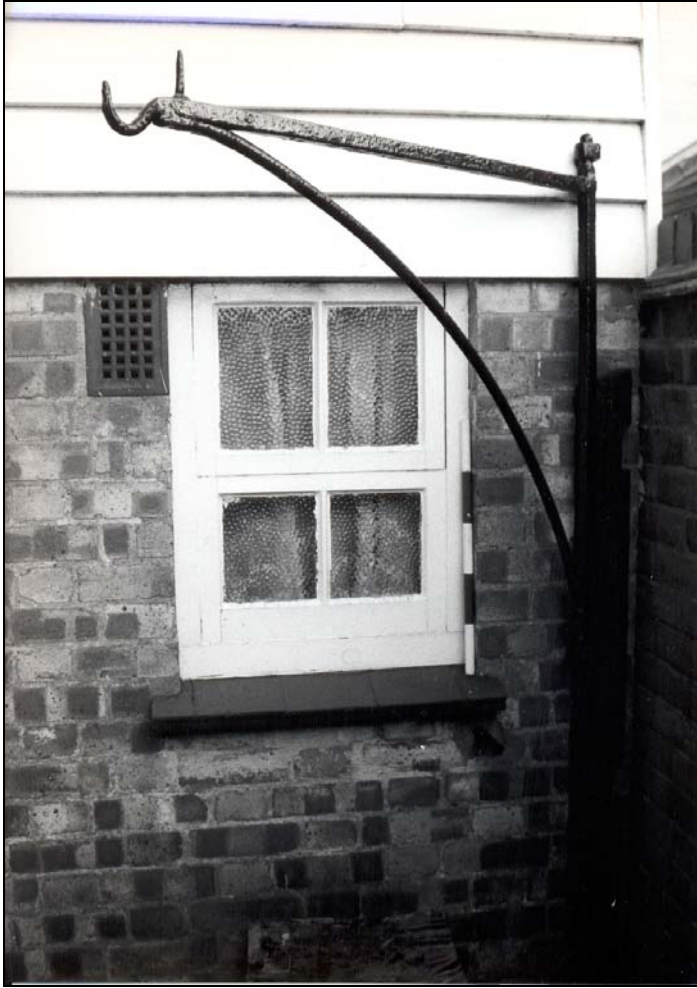
Plate 9: Meat hook on west elevation

The western end of the slaughterhouse opens out into a small modern yard area (plate 9), so small that no general photographs could be taken of the elevation. Its lower part, from the base of the internal hayloft down, is a later construction, built from 20th century fletten bricks, with a contemporary central doorway and flanking windows. The former stalls were situated inside. The use of later construction materials shows this end of the building was originally open-sided. Attached to the south-west corner is a wrought iron meat hook (plate 9). It stands to a height of 2m, just above the yard wall and, attached to a wooden post, has a 1m wide arm that swings through 180°. The curving end hook is complimented by a second vertical spike. Its precise function is unknown, but its light-weight frame suggests it was used to hang game or poultry. In Victorian times, as it is today with some traditional butchers, only those animals ready for sale were hung outside the front of the shop.

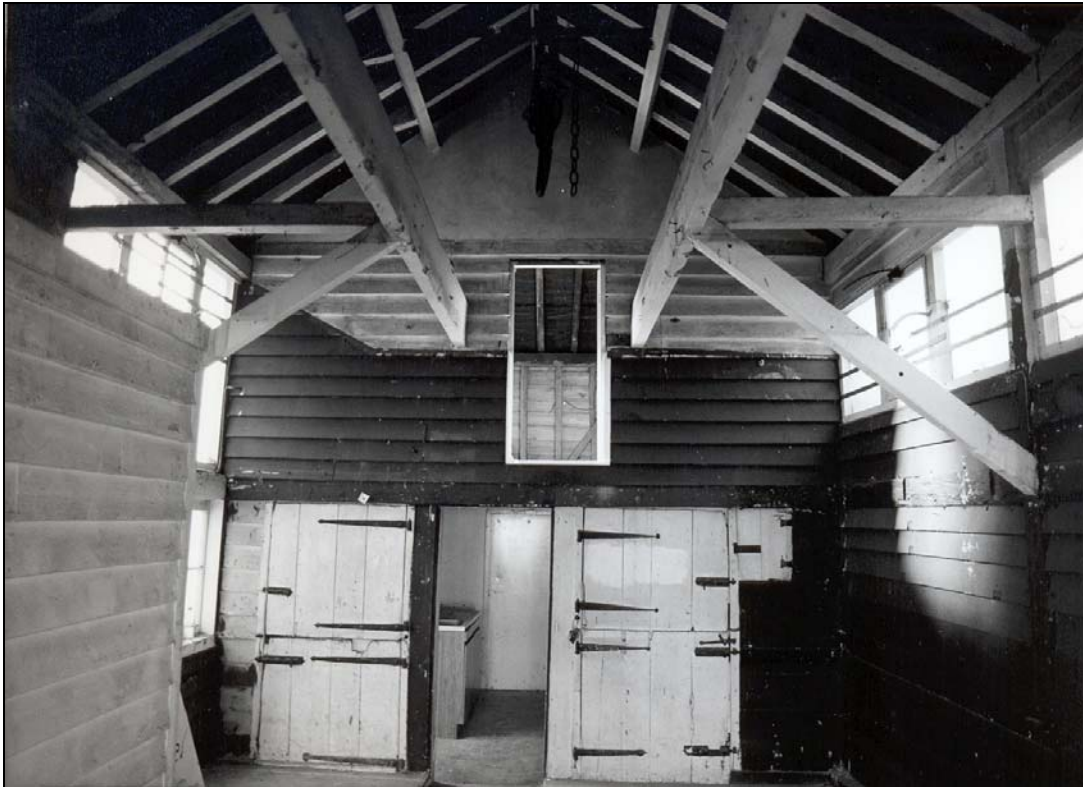
Plate 10: Working area

The working area comprises one large single bay 4m wide between the shop to the east and stalls to the west (fig. 2). Reflecting its more utilitarian role and status to the shop, the interior is clad in weatherboarding rather than horizontal panelling (plate 10). As mentioned before, prior to stripping out, the cladding was mostly hid. In plate 10 the sudden change on the west wall from black to white reflects the extent to which the roof truss and fixtures were concealed by modern boarding.

The working area is linked to the former stalls by a central doorway positioned between two heck doors, both original features (plate 10). Animals were led from the stalls into the working area through these. Both doorways, as well as an inspection hatch to the north, are now blocked (fig. 2),

yet the doors have been retained as features, which is unusual. The heck doors are carried on crudely-fashioned strap hinges with rough spearhead terminals and have heavy bolts. The inspection hatch, in the right of plate 10, has butterfly hinges and would have acted as a means of keeping an eye on the animals.

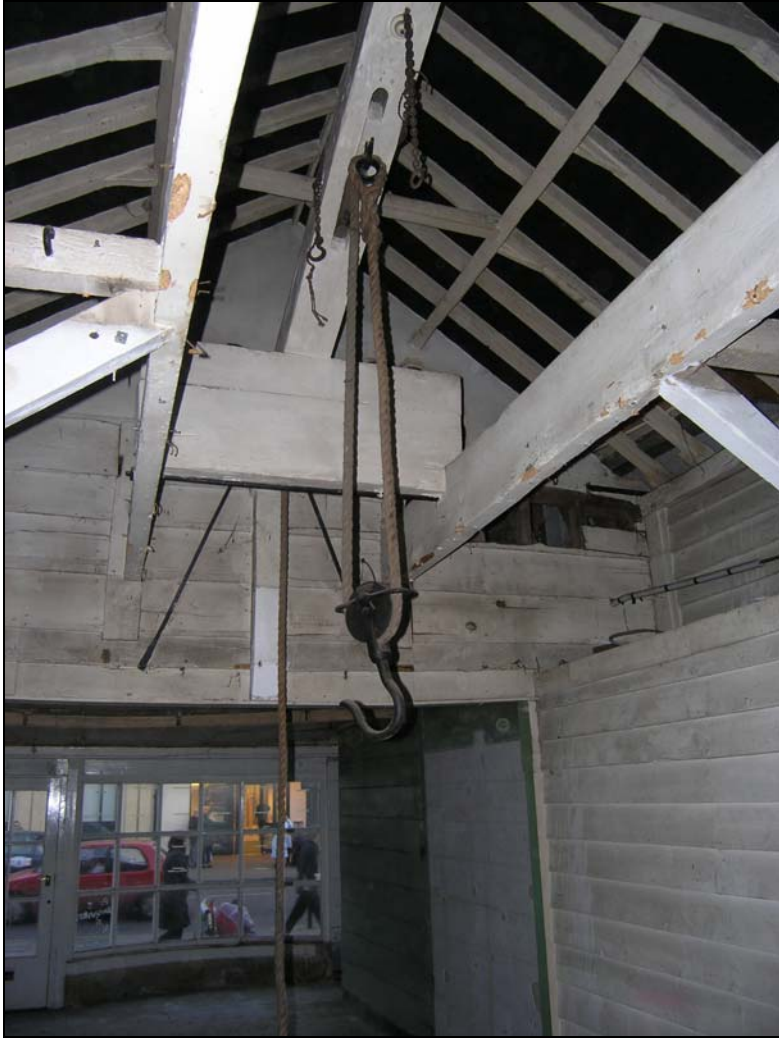
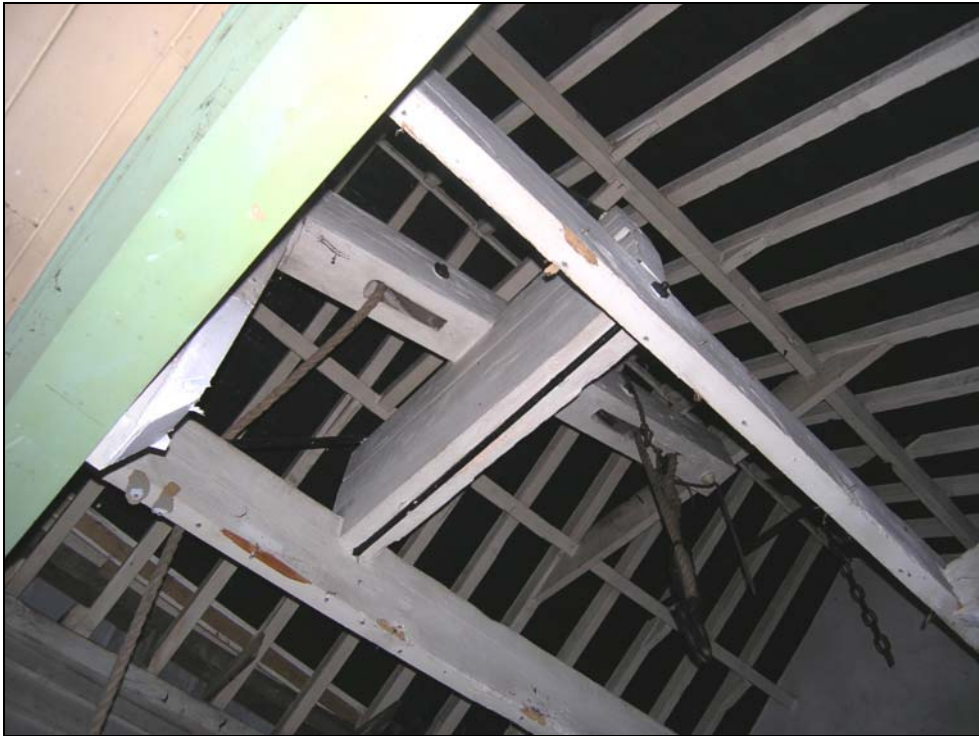
Plate 11: Meat hoist

The eastern part, open to the shop area, contains the main butchery-related feature of the building: the meat hoist (plates 10-12). The hoist was used to raise the heavy carcasses after slaughter for preparation and is in full working order. The hoist is set up inside the roofspace, supported centrally on a cross-piece resting on two heavy parallel beams that run the length of the area, braced either side (figs. 2 and 4). It works on a rope and pulley system and is set at an angle of 30° to maximise height within the working area. A chain hangs in front. One end of the rope is anchored by a hook to the end of hoist. The other part, holding the hook, runs up through a slot in the timber, over a wheel (partly observed), along a groove along the top of the hoist to a second wheel. It then runs back down and onto the floor (plate 12, fig. 3), although originally there was probably some form of tying off point to the side. There is no indication of maker's marks on any of the hoist ironwork, suggesting it was probably locally made at the blacksmith shop.

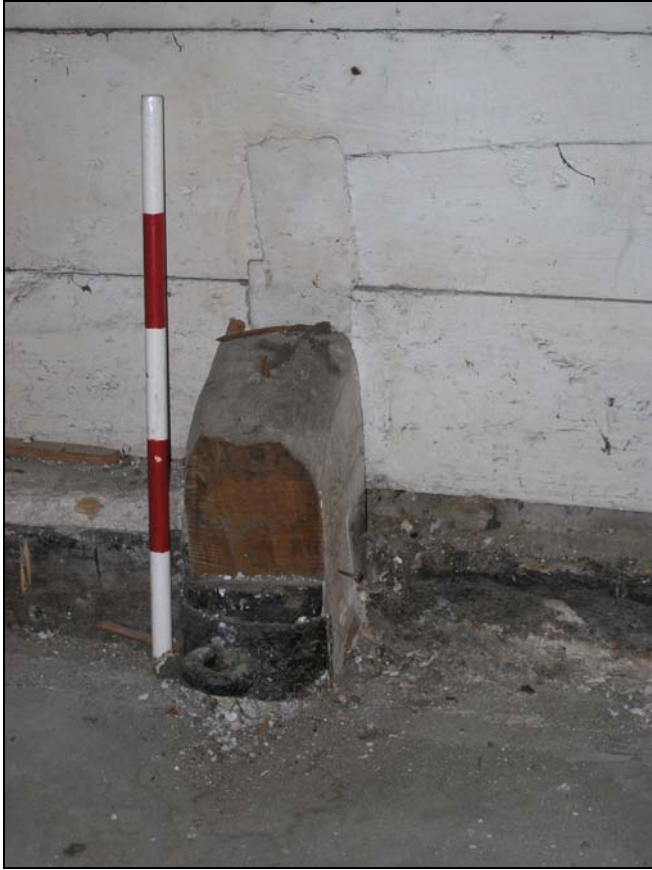
Plate 13: Tethering point

The second tethering point, to the east, is more robust. It is formed from a thick iron ring strapped to a thick wooden post. A blocked area in the boarding above may provide evidence for an earlier post (plate 13).

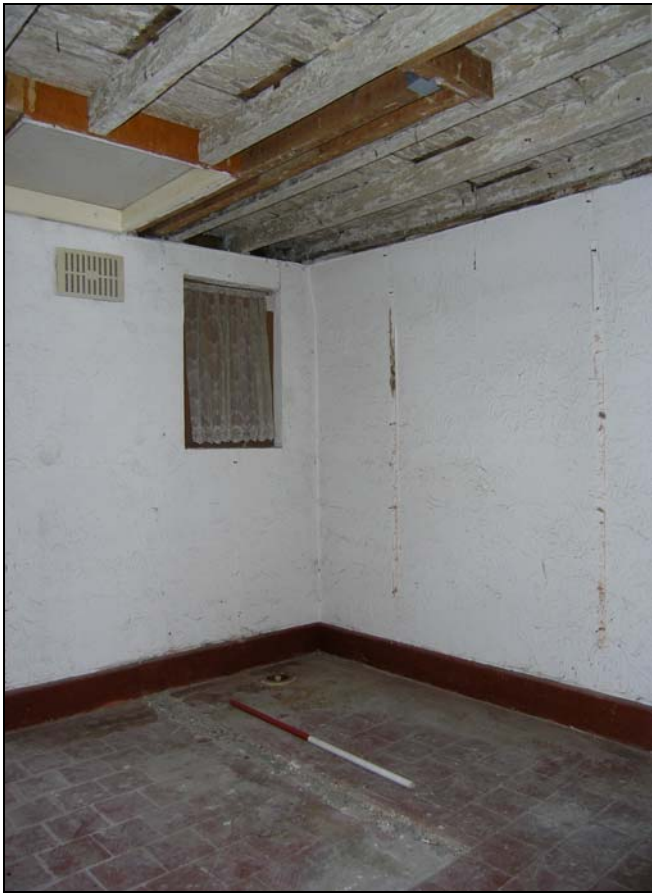
Plate 14: Area of former stalls

Originally the extant heck doors led into two stalls at the west end, where the animals were kept before slaughter. Exposed ceiling joists and floorboards in this area are limewashed (plate 14), presumably another early hygiene control. Stall divisions are represented by empty mortice holes in two of the longitudinal ceiling joists. They define a narrow central walkway (0.5m wide) between stalls (fig. 2). After their removal, presumably when animals ceased to be killed on-site, the open west end was closed off with a new brick wall and the internal walls plastered over. A tiled floor was added (each 0.15m/6" square), sloping downwards toward a circular drain in the north-west corner of the room. The scar to a possible brick partition remains, apparently zoning off the area around the base of the ceiling hatch (fig. 2). This may be a later development, post-dating the butchers shop.

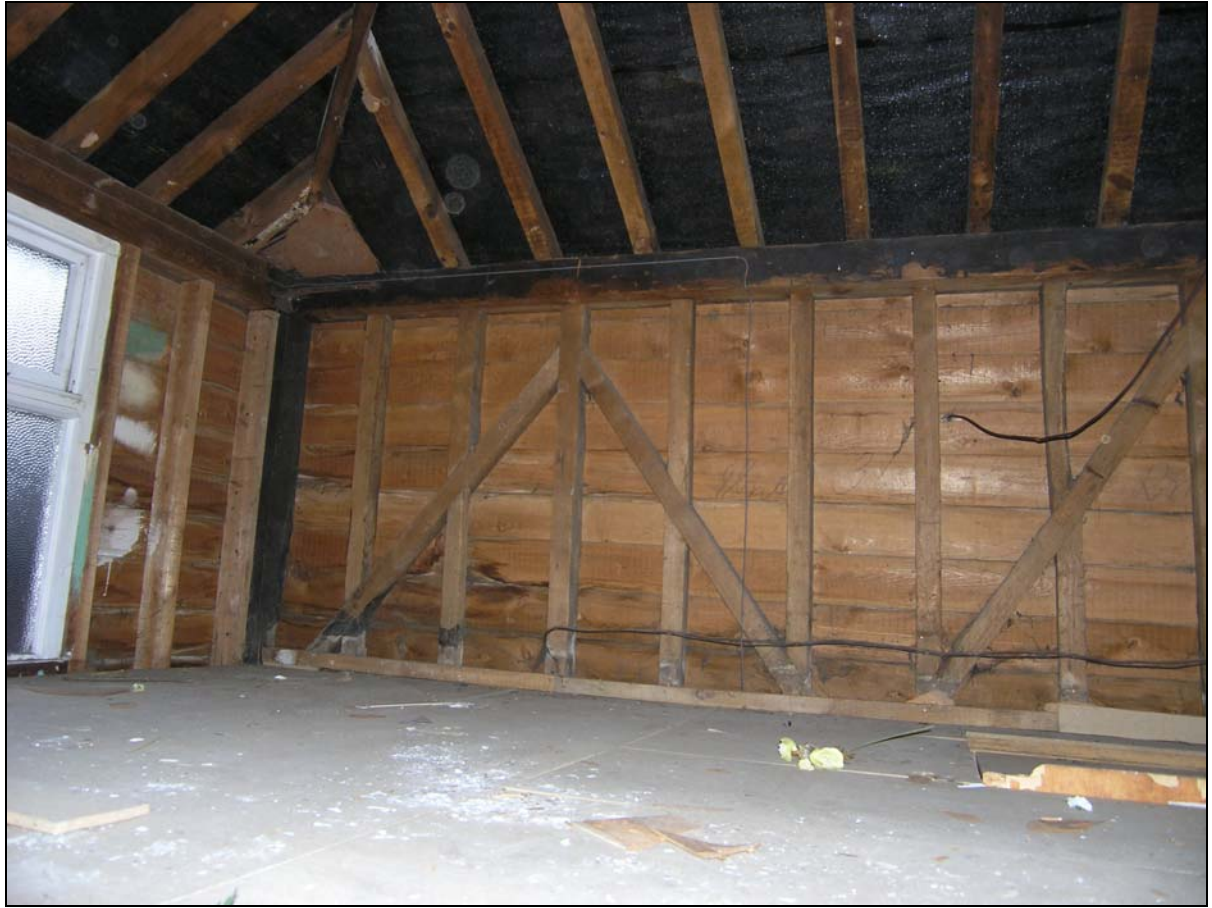
Plate 15: Former hay loft

A ceiling hatch leads up to the former hayloft. The hayloft can also be reached from the working area by a central doorway, with the aid of a ladder (plate 10). Bedding straw could be forked down to the stalls from the hatch or onto the working floor around the tethering points. The room is currently empty. This was a clean area and is the only part of the building where the timber wall framing is exposed. It has primary-braced machine-sawn timbers with nail fixings, typical of 19th century utility buildings. The main structural elements, corner posts and plates, are however pegged for extra strength.
