ARCHAEOLOGICAL MONITORING AND RECORDING
AT THE PROPOSED
HADLEIGH 2012 LONDON OLYMPIC LEGACY VISITOR CENTRE
ESSEX

Essex County Council
Field Archaeology Unit

MAY 2012

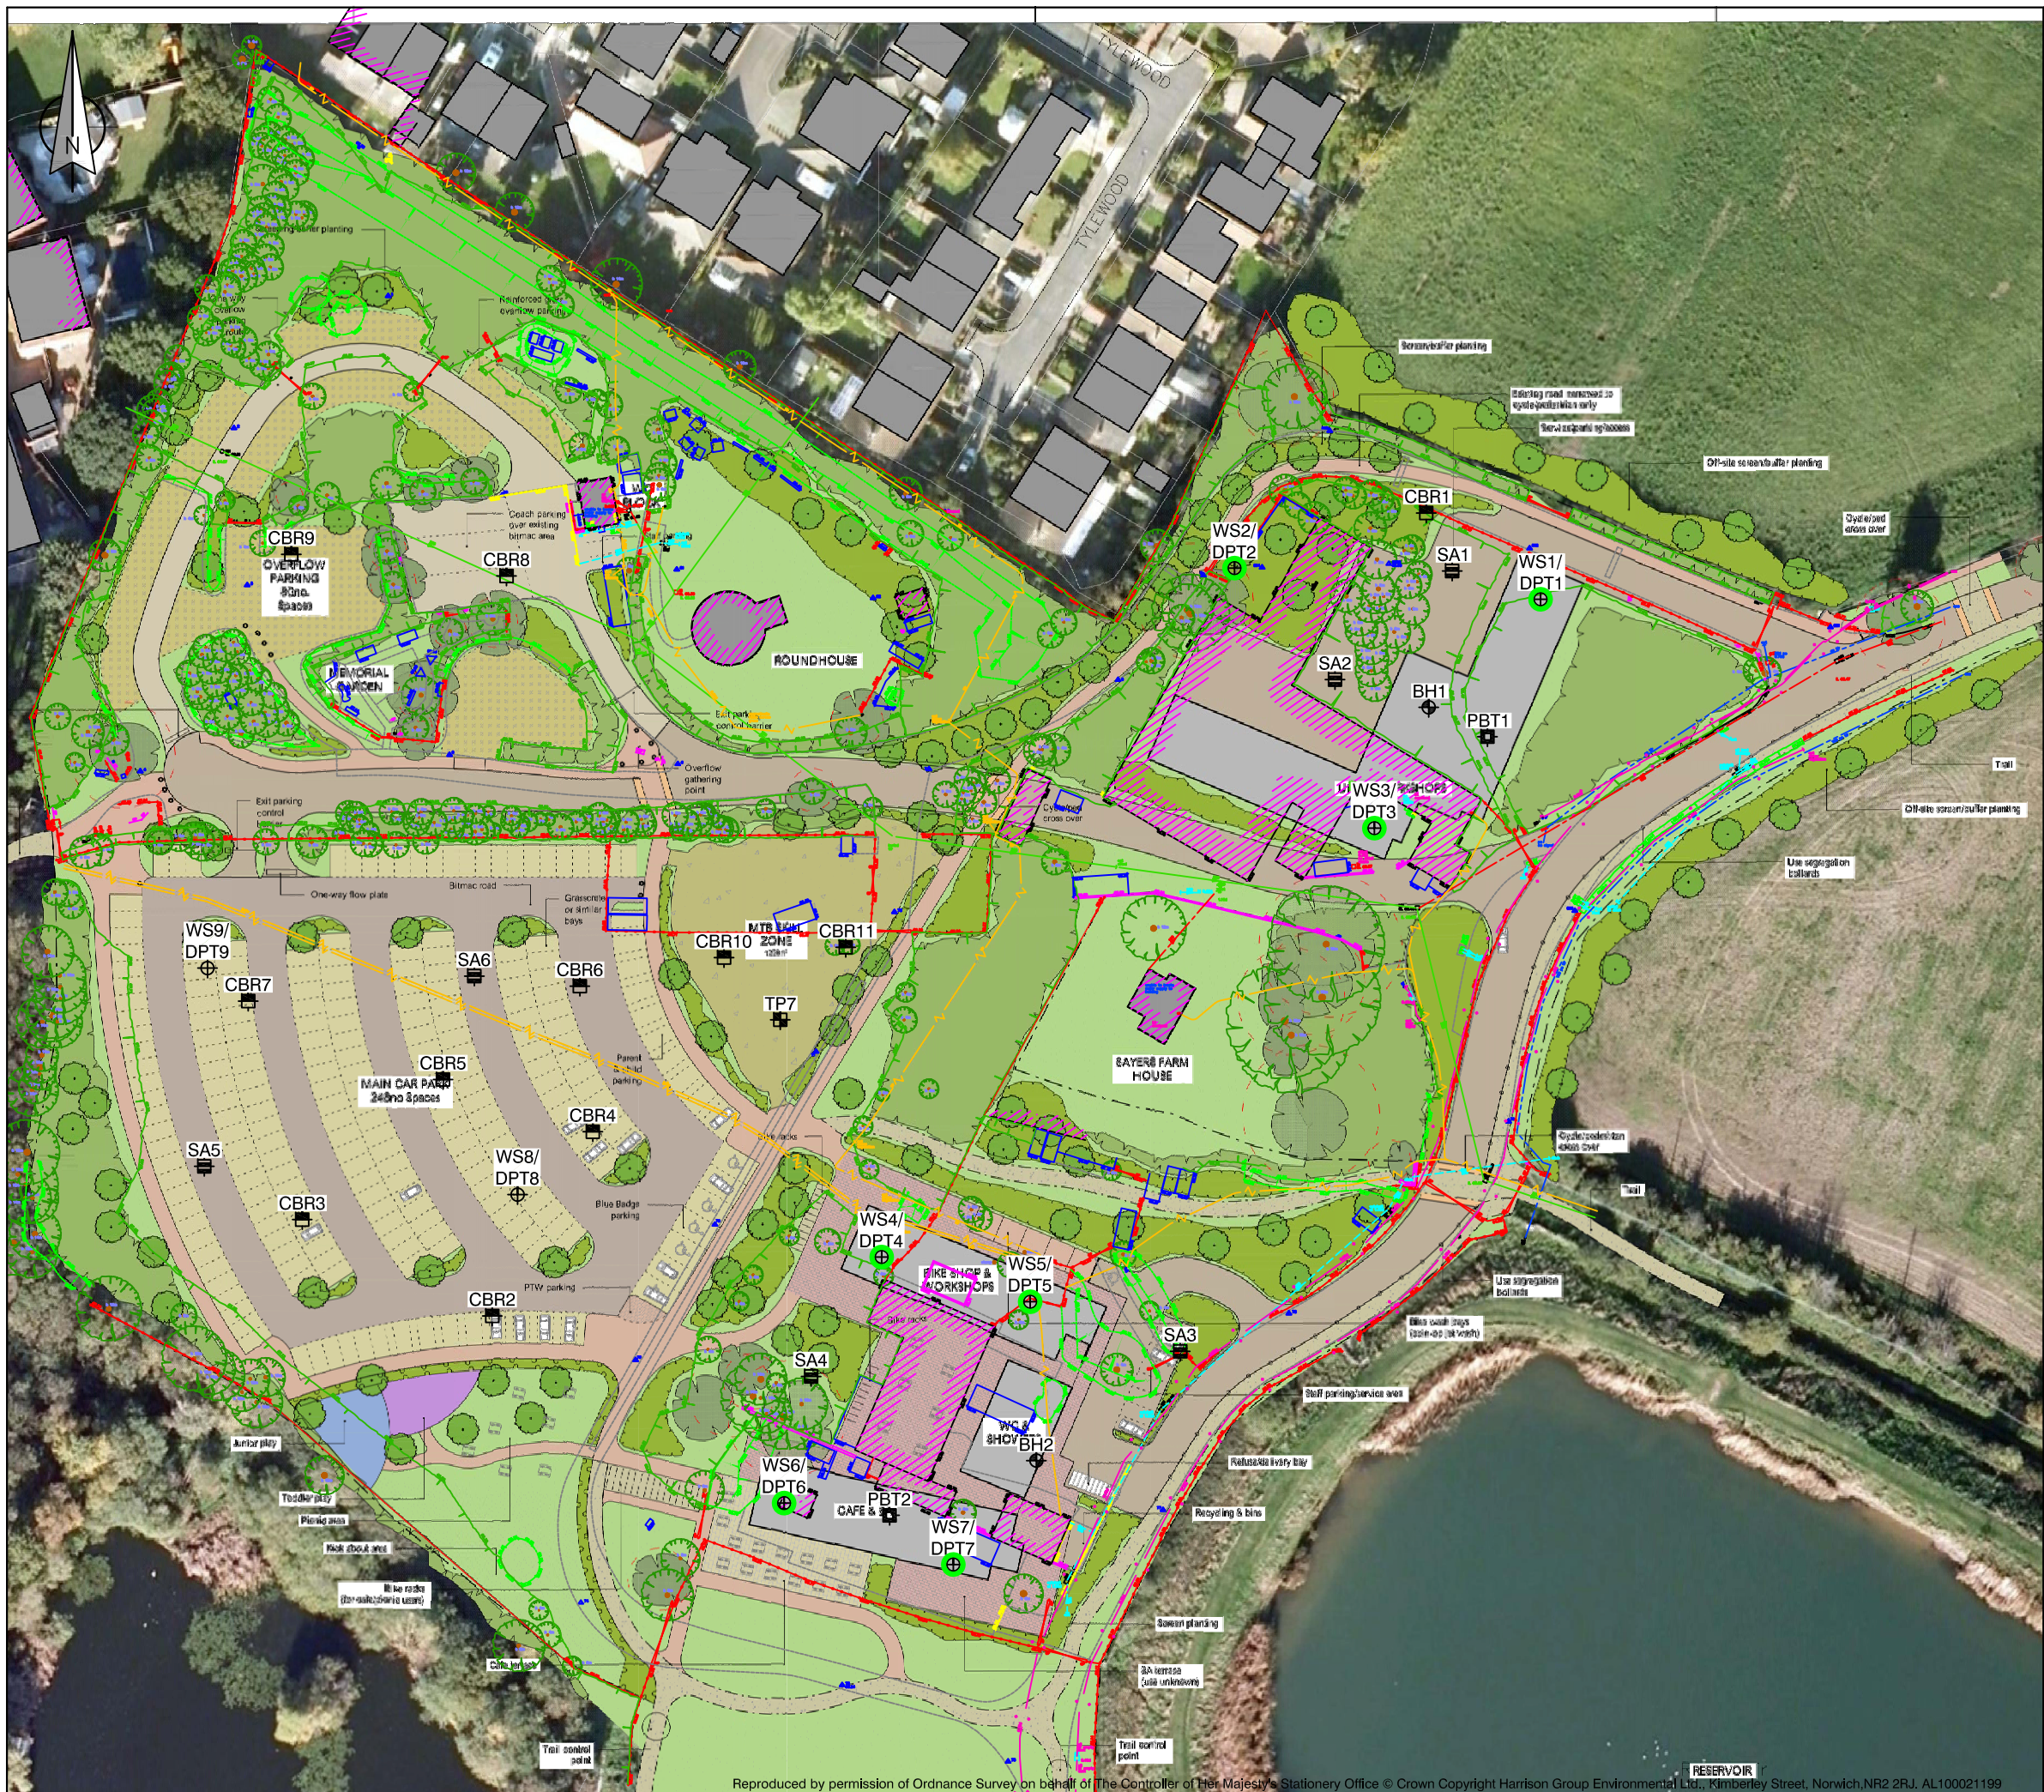
Client :	Morgan Sindall plc.
Project :	Hadleigh Farm Olympic Legacy Project
Job No :	GN16524
Date :	March 2012
Drawing Title :	Proposed Fieldwork Location Plan
Drawing No :	GN16524 - DR002
Scale :	1 : 1000 @ A3
Drawn by :	YN
Checked by :	JA
Eastings :	
Northings :

BH1	Cable Percussive Borehole
	CBR1	California Bearing Ratio Test
	SA1	Soakaway Trial Pit
	PBT1	Plate Bearing Test
	WS1/ DPT1	Window Sample Borehole/ Dynamic Penetration Test
	WS1	Gas Monitoring Installation
	TP1	Machine Excavated Trial Pit
