**ST CLERE'S HALL  
STANFORD-LE-HOPE  
ESSEX**

**ARCHAEOLOGICAL EVALUATION BY TRIAL TRENCHING  
AND DESK-BASED ASSESSMENT**

**July 2012**

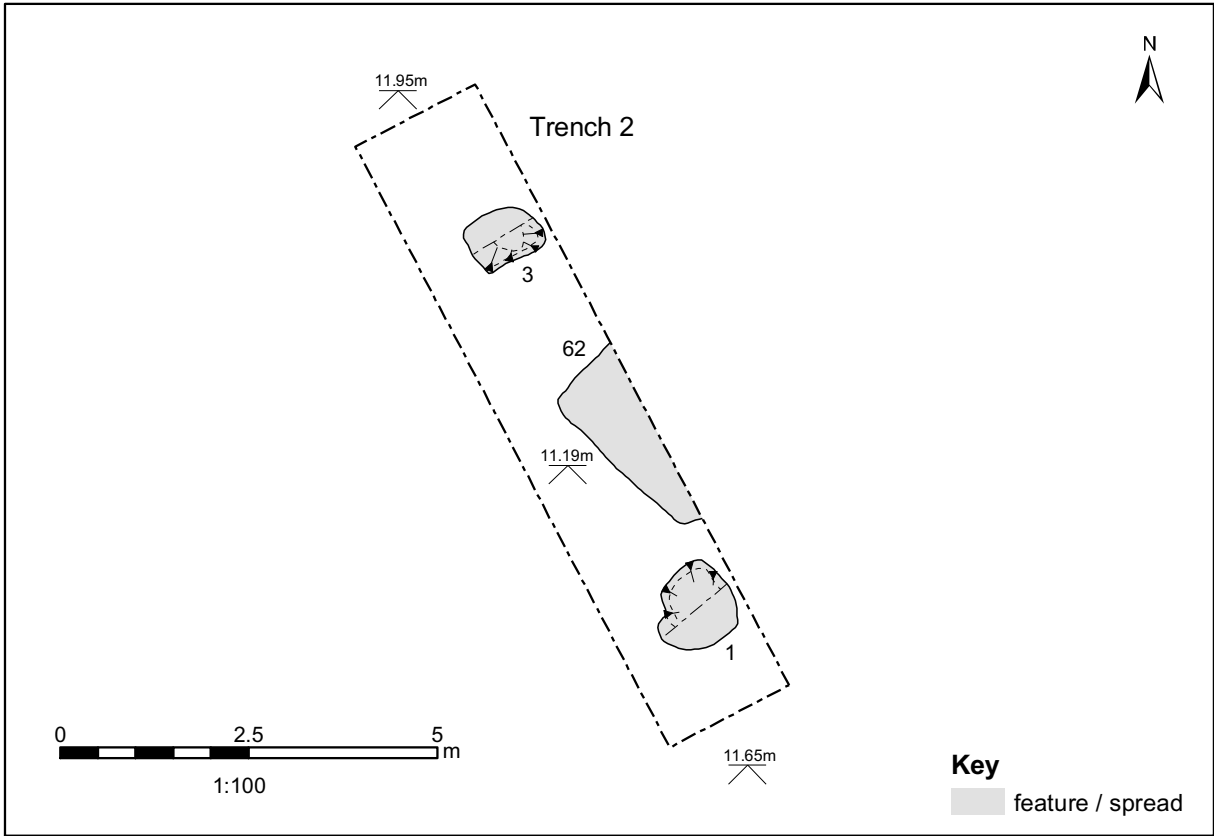
Fig.4 Trench 2

Features in trench 2 comprised part of a large, straight-sided modern pit (62), and two undatable, sub-rectangular pits (1 and 3) containing no finds.

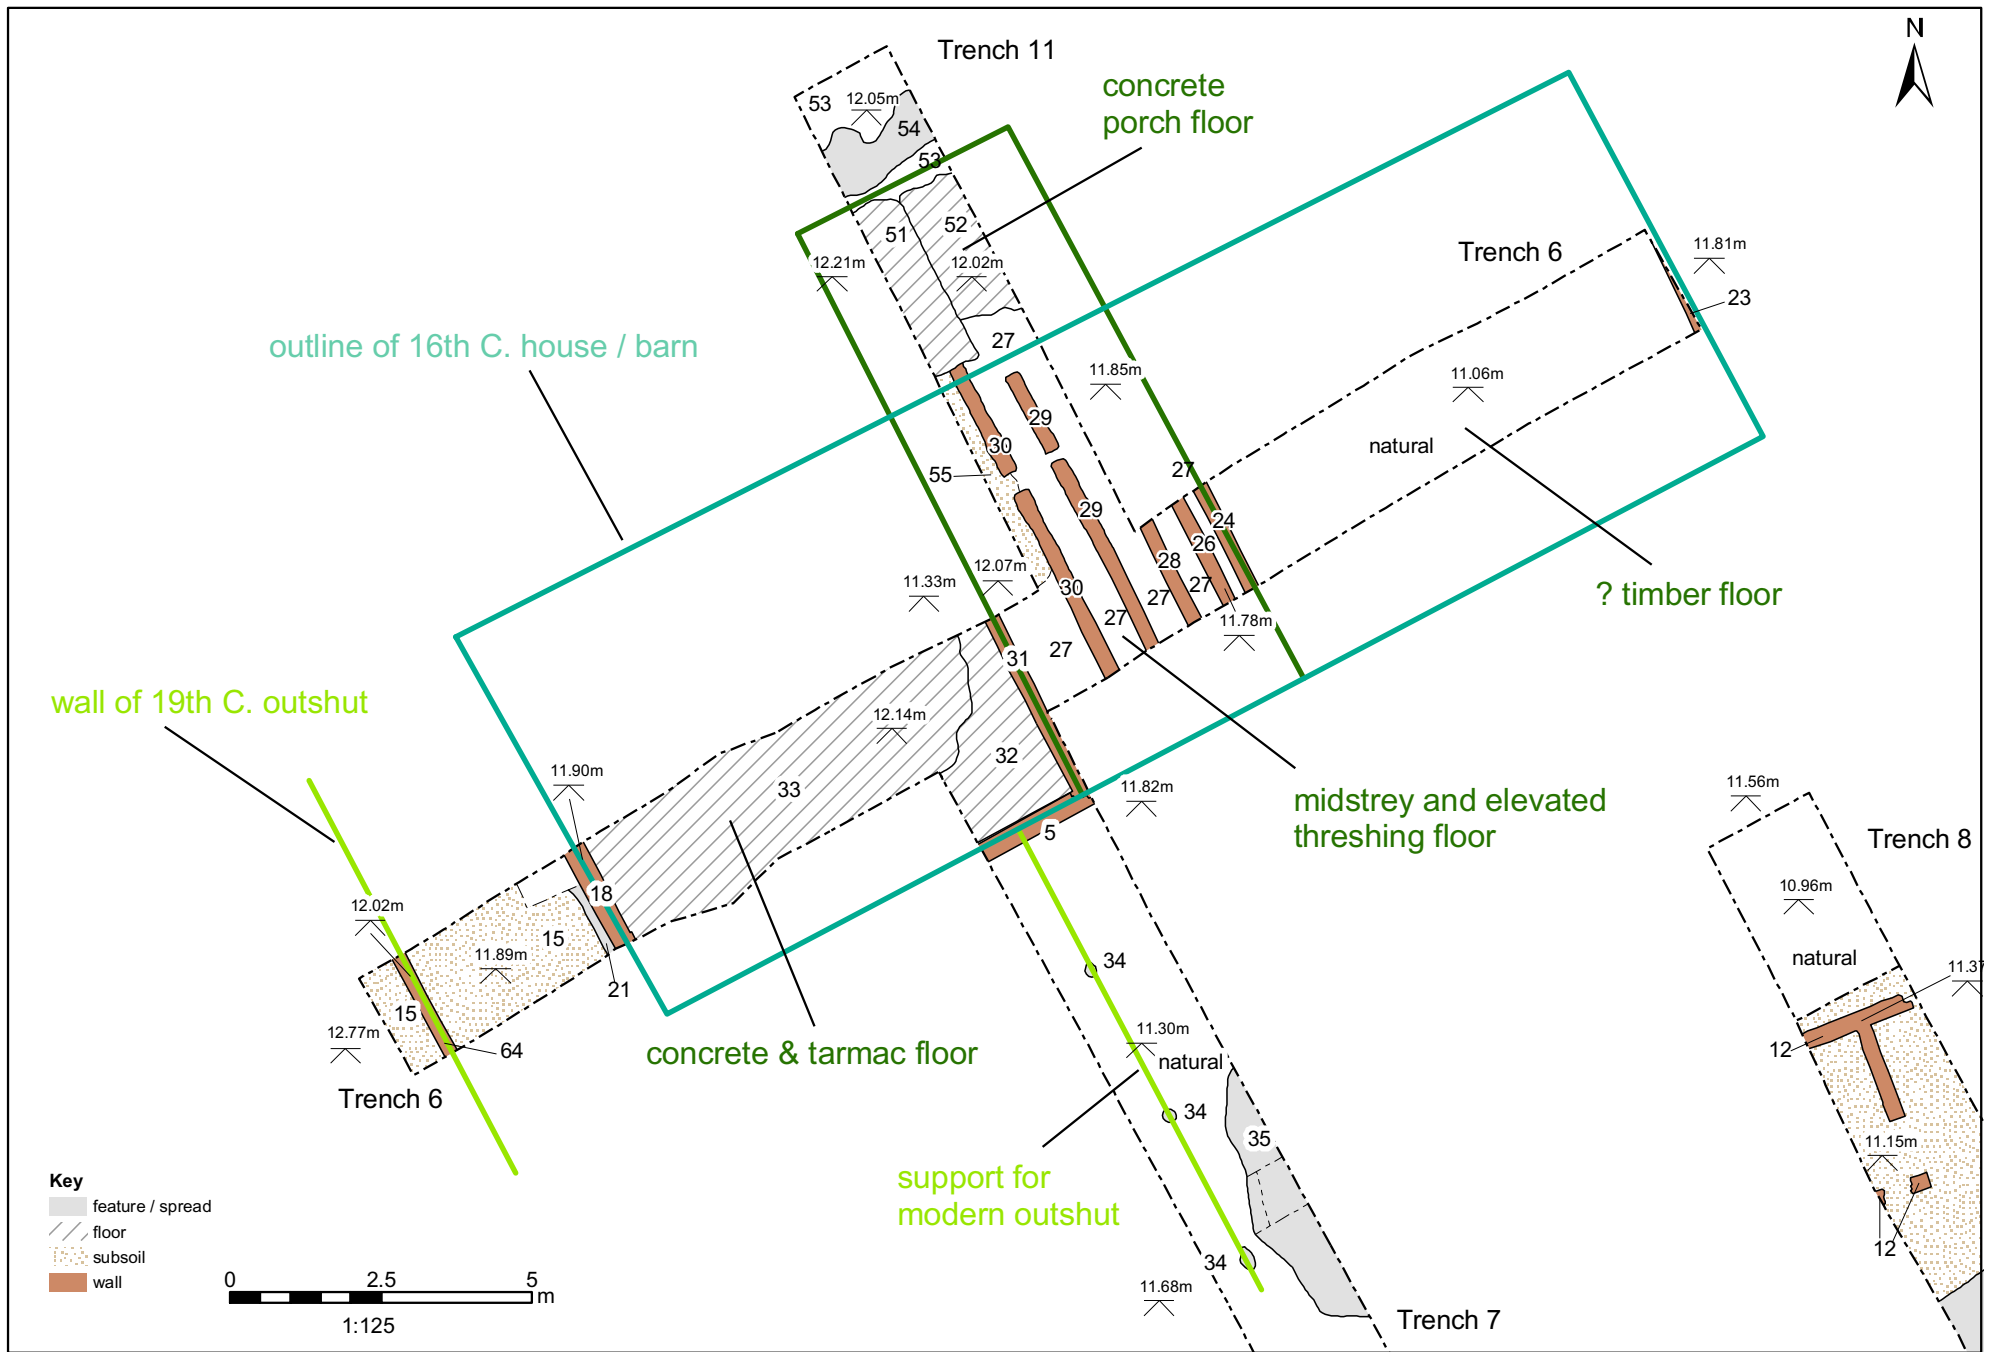
Fig. 9 Trenches 6, 7 & 11

Remains revealed by trenches 6, 7 and 11 included ten brick walls (5, 18, 23, 24, 26, 28, 29, 30, 31 and 64) and four sections of flooring (32, 33, 51 and 52). The brick walls stood up to six courses high and were made from post-16th-century dark orange frogged and / or unfrogged bricks, typically measuring 220mm x 110mm x 70mm, in a variety of regular and semi-regular bonds, cemented together with lime-based mortar. Semi-compacted chalk or degraded lime-based mortar (27) lay between walls 26 to 31, and dark brownish grey soil and brick rubble (25) between walls 24 and 26. The floors were made from tarmac (33) and concrete (32, 51 and 52). Floors 32 and 33 lay between walls 5, 18 and 31, and floors 51 and 52 overlaid deposit 27 and wall 30, indicating a fairly late phase of internal remodelling or adaptation. A possible construction cut (21) containing frequent fragments of lime-based mortar ran along the western edge of wall 18.

Other features and deposits comprised three wooden posts (34) and a spread of dark greyish brown soil (35) in trench 6, and a thin spread of compacted ash and coal (54) in trench 11. The posts were equally spaced and were made from recycled telegraph poles. Numerous fragments of dark orange unfrogged brick and roof tile lay in spread 35.

The cartographic evidence suggests that the south side of the 16<sup>th</sup>-century house / barn is represented by wall 5, the west and east ends of the building by walls 18 and 23 respectively, and internal divisions and a barn midstrey by walls 24 and 31. The north wall of the building has either not survived or has not been uncovered. If the interpretation of the cartographic and archaeological evidence is right then the building probably measured c. 7.25m wide and 20.5m long. Closely spaced walls 26, 28, 29 and 30 inside the midstrey are conjectured to be brick supports for an elevated threshing floor. The bays to either side of the midstrey are likely to have been used for storage. The floor in the east bay has not survived, but is postulated to have been elevated and to have been made of timber. The walls are all made from post-Tudor bricks and as such probably represent an underpinning of the timber

frame of the 16th-century house / barn during the 17th century or later. If wall 31 and walls 26, 28, 29 and 30 were constructed at the same time as the underpinning then it was probably carried out during or after the Victorian period as they all contain frogged bricks, which were not used until the early 19th century (Ryan 1999, 15). It is suggested that the perimeter walls were underpinned first and that the elevated threshing floor was then added later, perhaps between 1845 and 1897 when, according to the cartographic evidence, the porch was built. A similar pattern of development is seen at Little Canfield Hall, where a porch and threshing floor were added to a large medieval barn in the post-medieval period and such modifications may well be an indication of a move away from mixed farming regimes towards increasing arable cultivation.

Remains of buildings indirectly related to the house / barn comprise wall 64 in trench 6 and post-hole line 34 in trench 7, both of which are likely to be remnants of some of the outshuts which, according to the cartographic evidence, were present against three sides of the building. Wall 64 is made from frogged bricks and is probably the outshut recorded against the east end of the barn / house on the 1897 and 1922 Ordnance Survey maps. Post-line 34 is represented by recycled telegraph poles and is likely to have been in use during the 20th century.

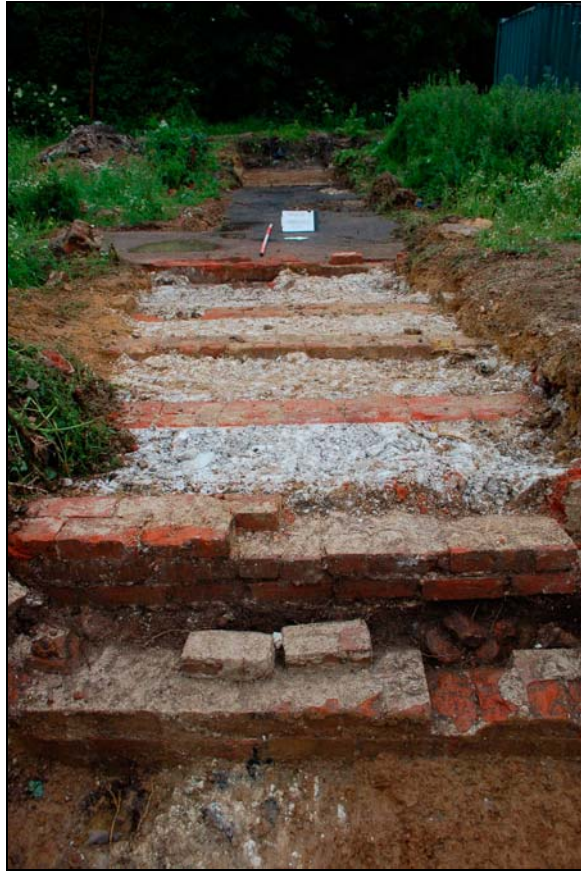
Plate 3. Trench 6, looking west

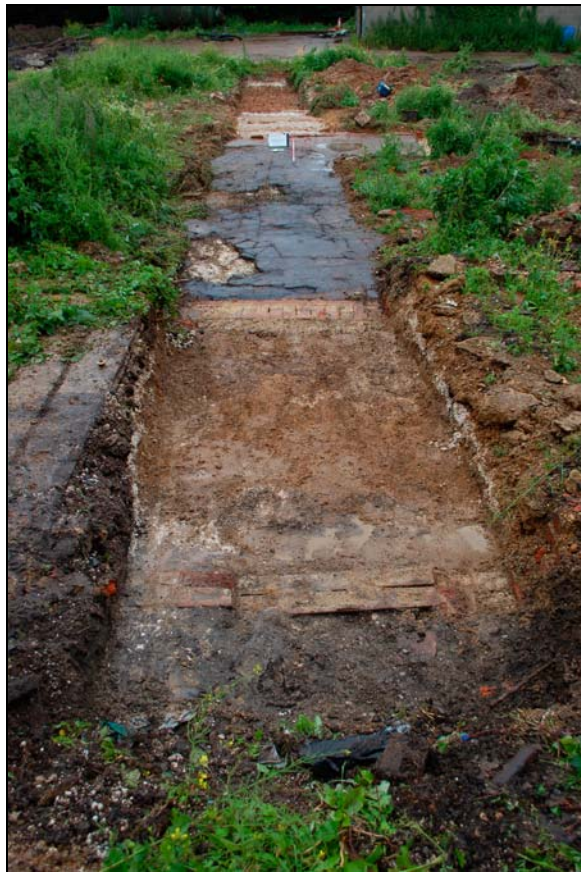
Plate 4. Trench 6, looking east

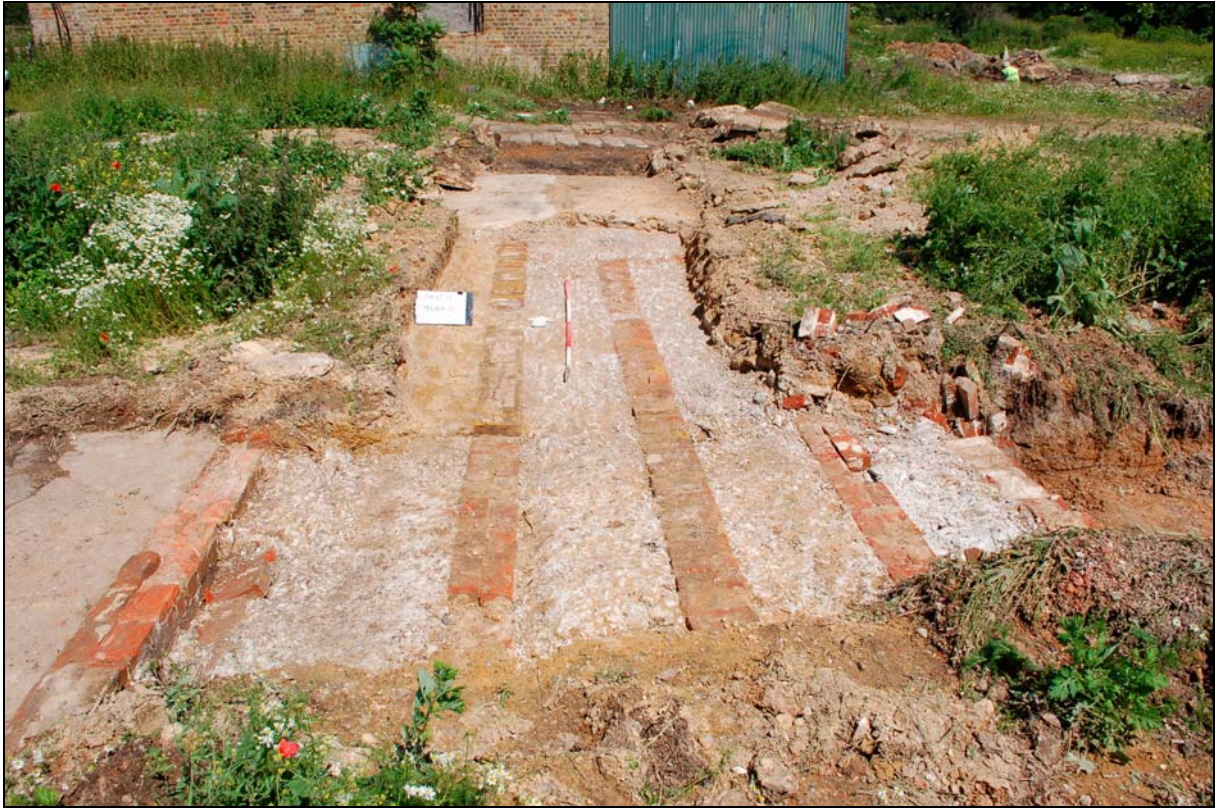
Plate 5. Trenches 6 and 11, looking north

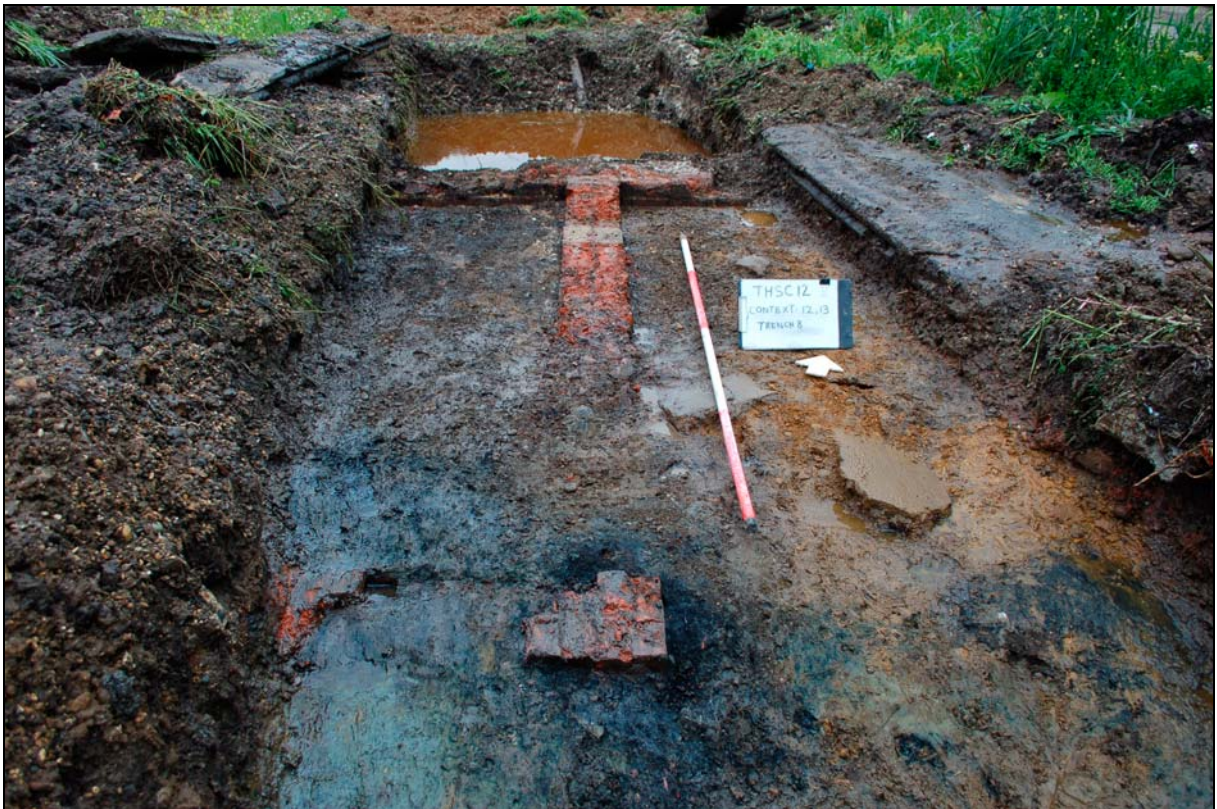
Plate 6. Trench 8, looking north

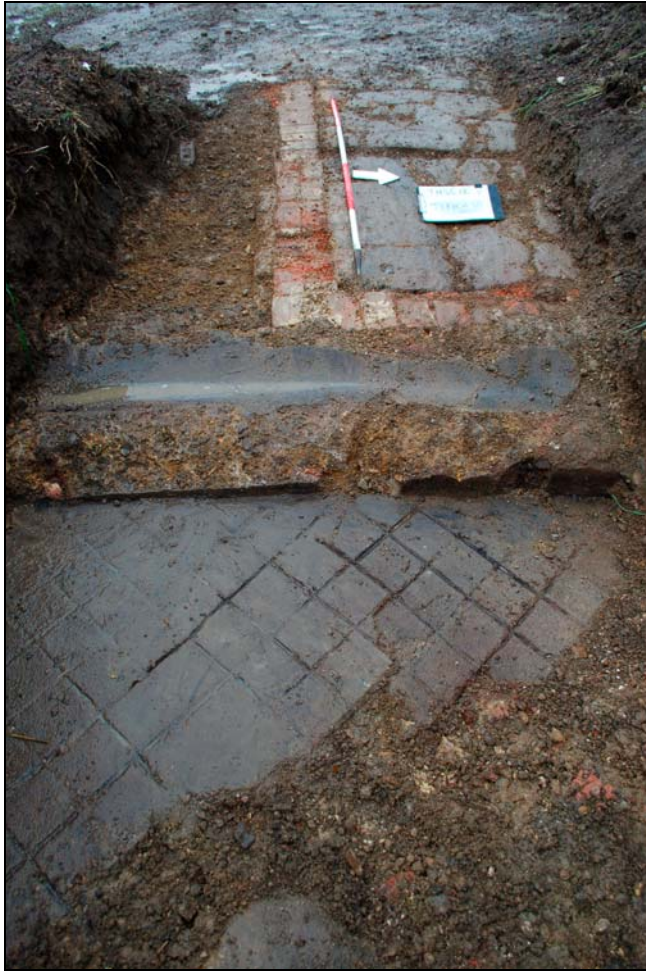
Plate 7. trench 10, looking west
