**FORMER SAICA FACTORY SITE
VILLA ROAD, HISTON
CAMBRIDGESHIRE

ARCHAEOLOGICAL EVALUATION**

Essex County Council
Field Archaeology Unit
July 2012

FAU Project No: 2402

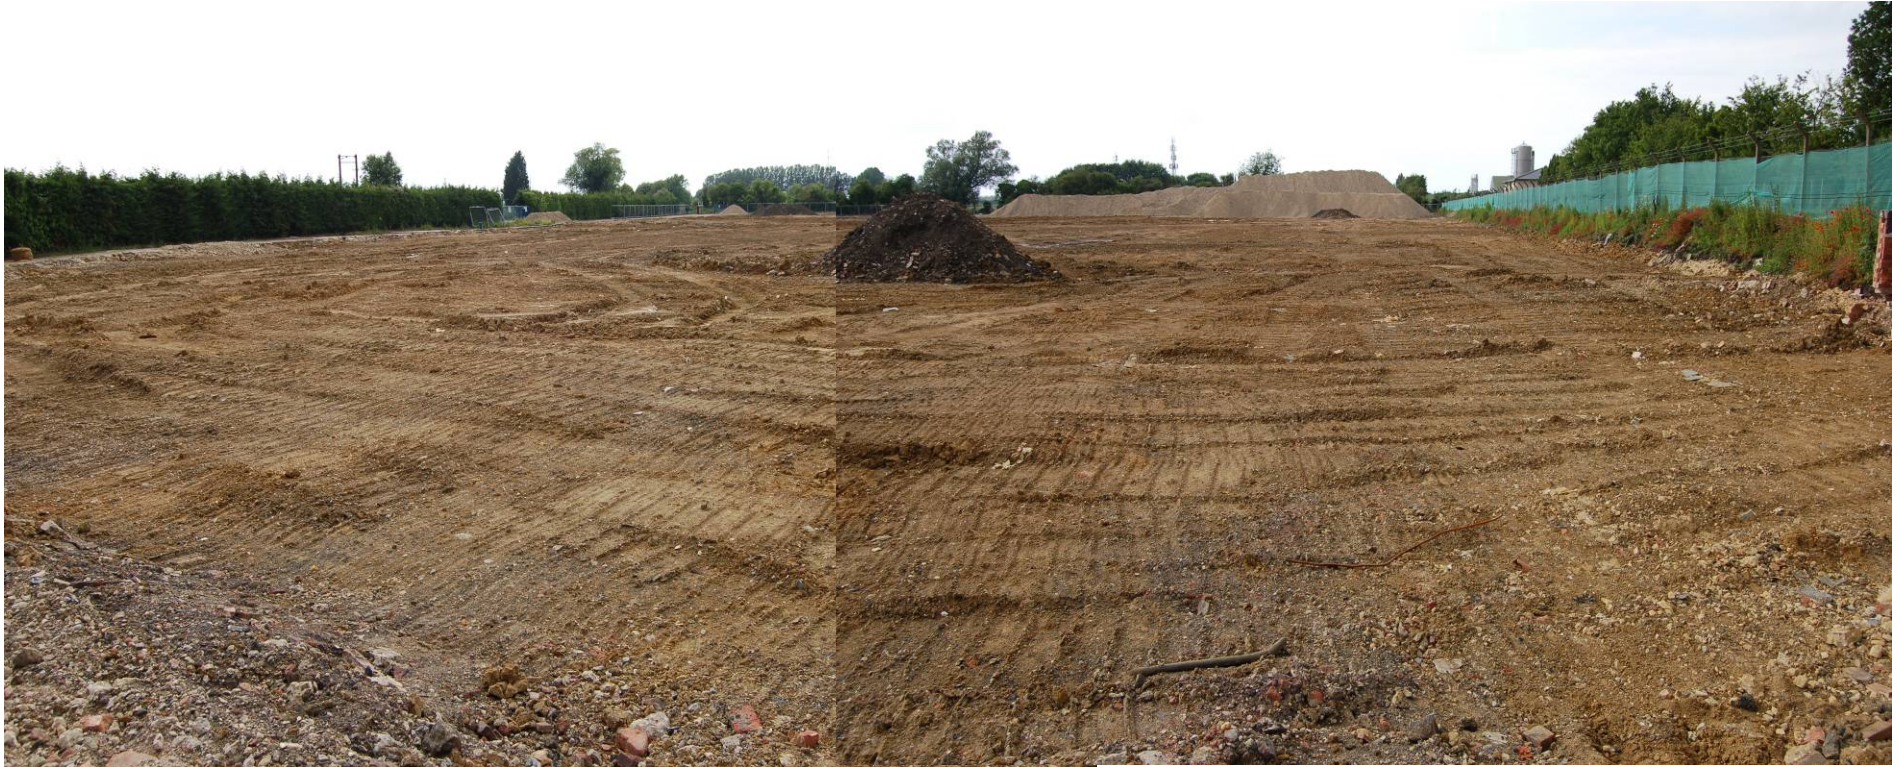
Plate 1. General view of site (composite), looking northwest

The former factory site had been demolished and all hard surfaces removed prior to the evaluation. Only fragments of tarmac surface over rubble bedding remained along the southern periphery of the site. Additionally, the building foundations had reportedly been machined-out to a depth of 1.0m and backfilled. The surface of the site was therefore stripped down to a mixture of natural and reworked deposits. Rubble spreads and areas of machine rutting and tracking indicated that the exposed surface of the cleared site was highly disturbed, though generally flat (Plate 1).

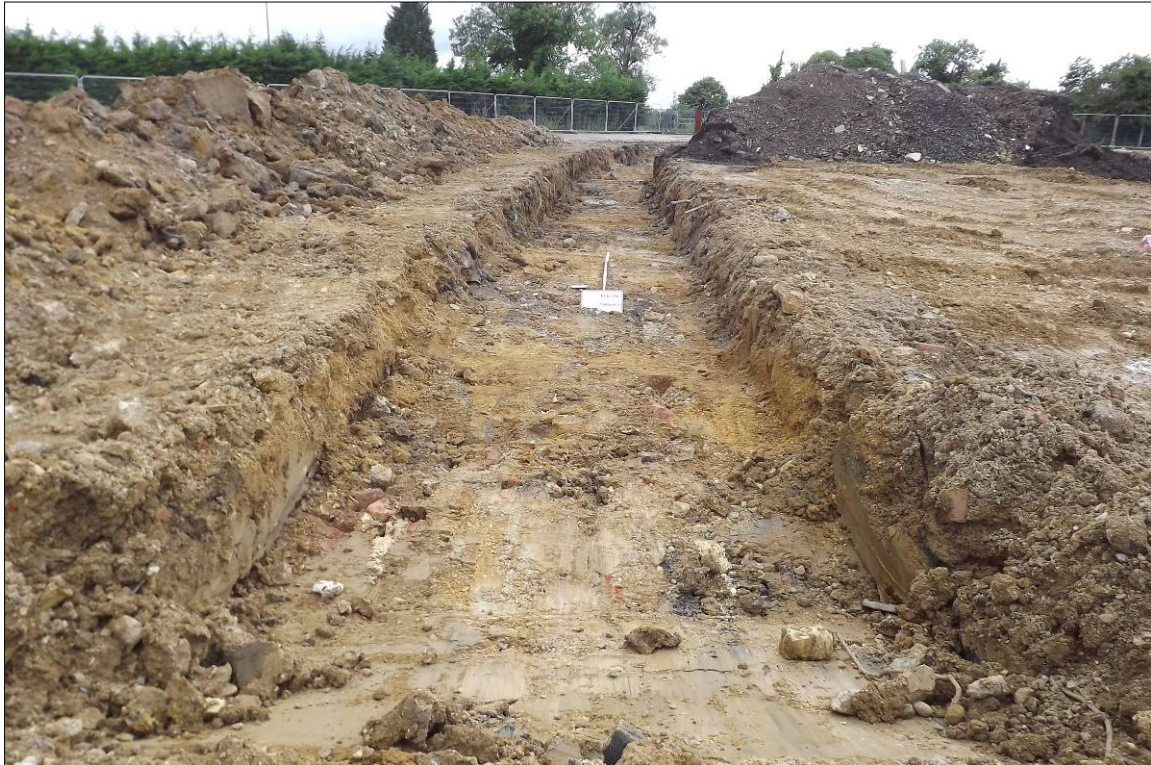
Plate 2. Trench 3, looking southwest.

The depths of the trenches ranged from 0.25m to 0.85m as the thickness of made ground overlying the natural deposits varied across the site and within the trenches. The made ground consisted of mixed soils: mid to dark greyish brown and dark orange-brown soft silty sands with frequent inclusions of modern brick fragments, pieces of concrete, tarmac and scrap metal. The mid orangey yellow-brown soft silty sand with patches of greenish grey soft plastic silty clay natural deposits were severely disturbed throughout the site by modern cuts made during the construction and demolition of the factory buildings and associated structures. It is believed that the potential archaeological horizon has been disturbed in the former and completely removed in the later process. Very few modern intrusions could be matched with mapped wall lines with any great confidence. Plates 2-7 give a representative view of the trench contents across the site.

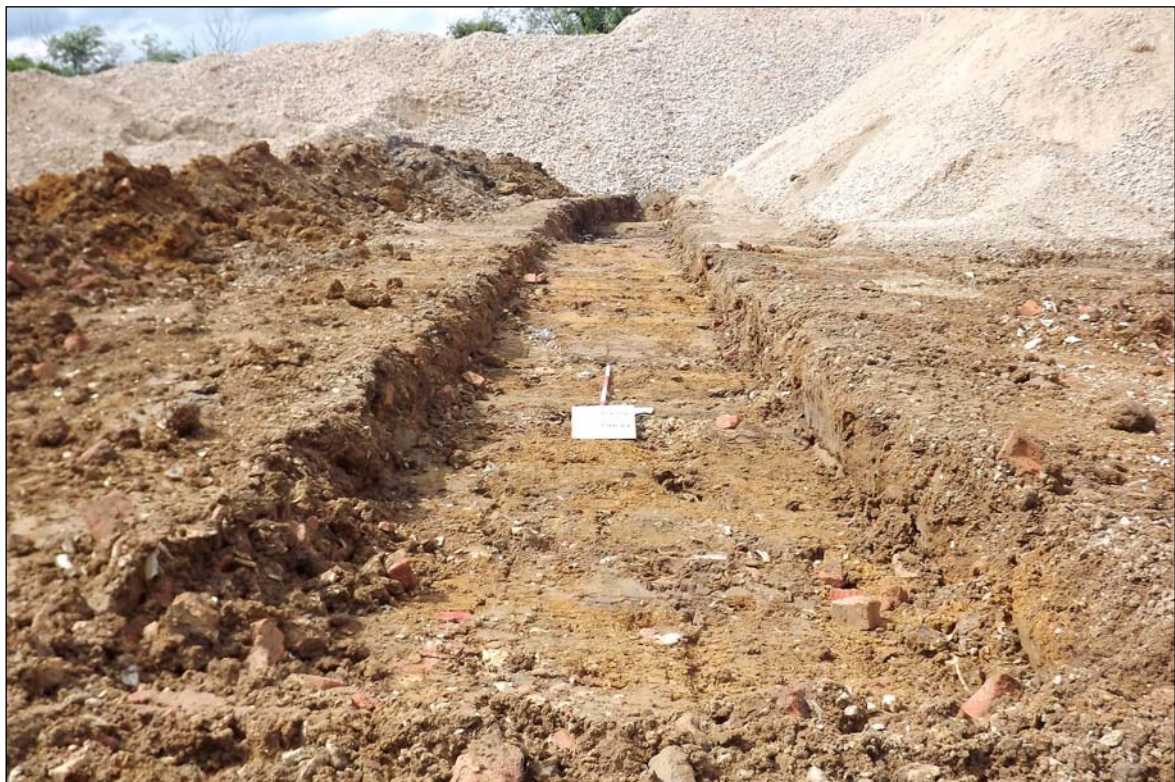
Plate 3. Trench 4, looking northwest

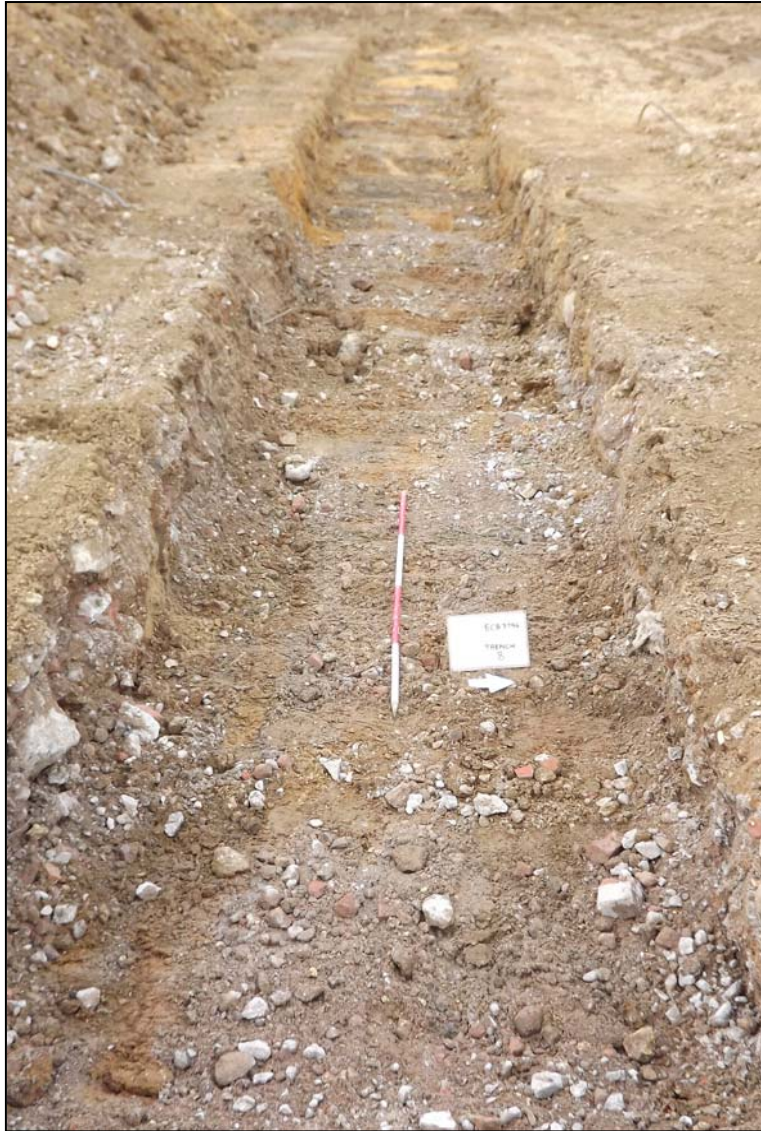
Plate 4. Trench 8, looking west

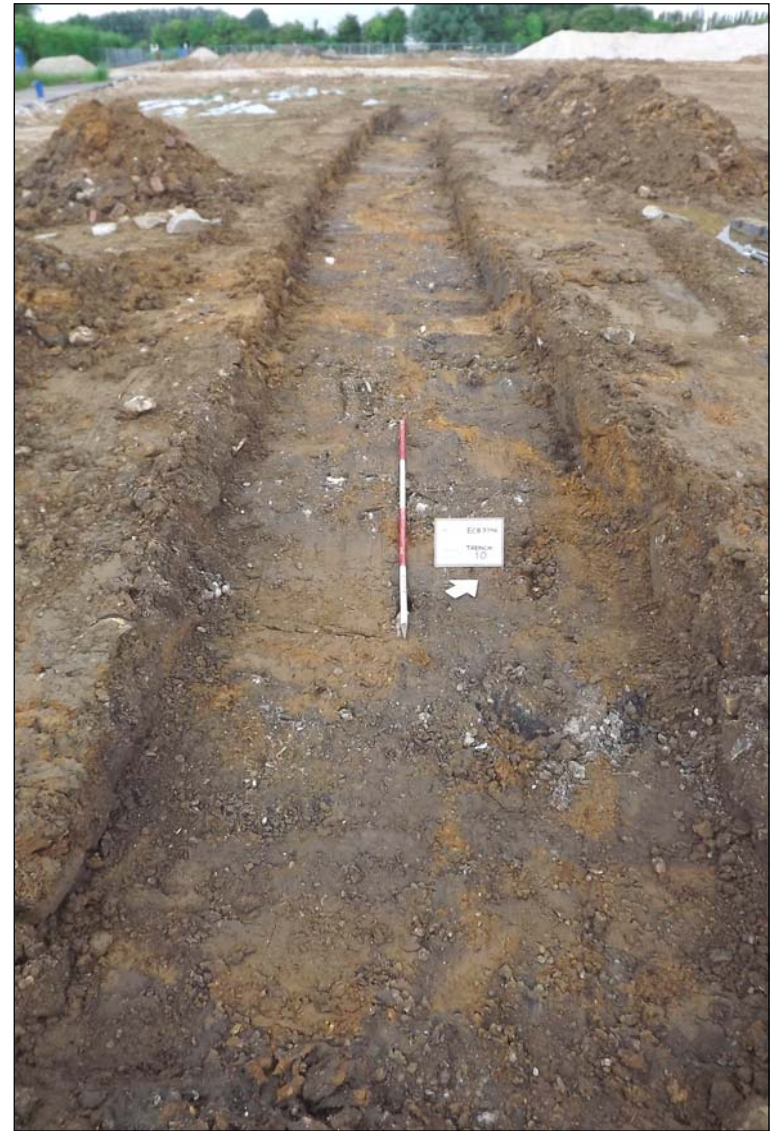
Plate 5. Trench 10, looking northwest

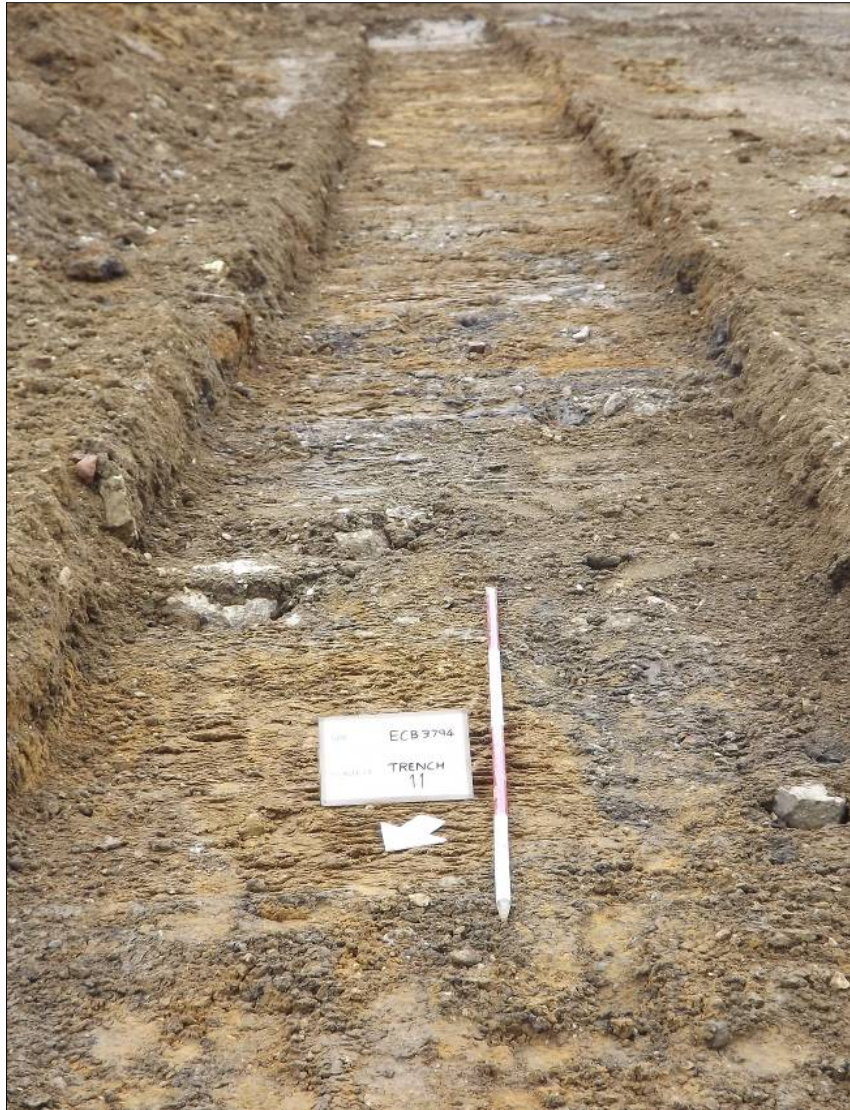
Plate 6. Trench 11, looking southeast

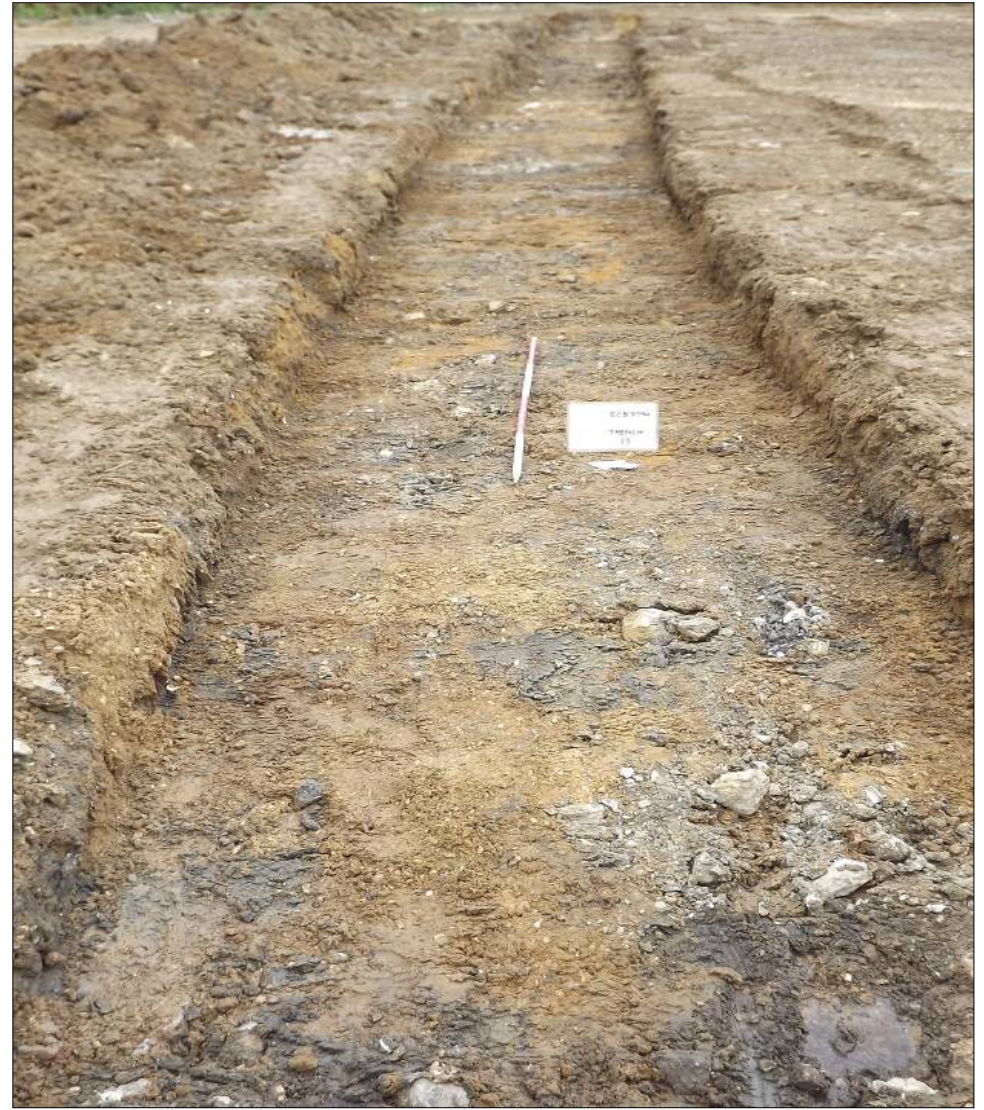
Plate 7. Trench 13, looking east.

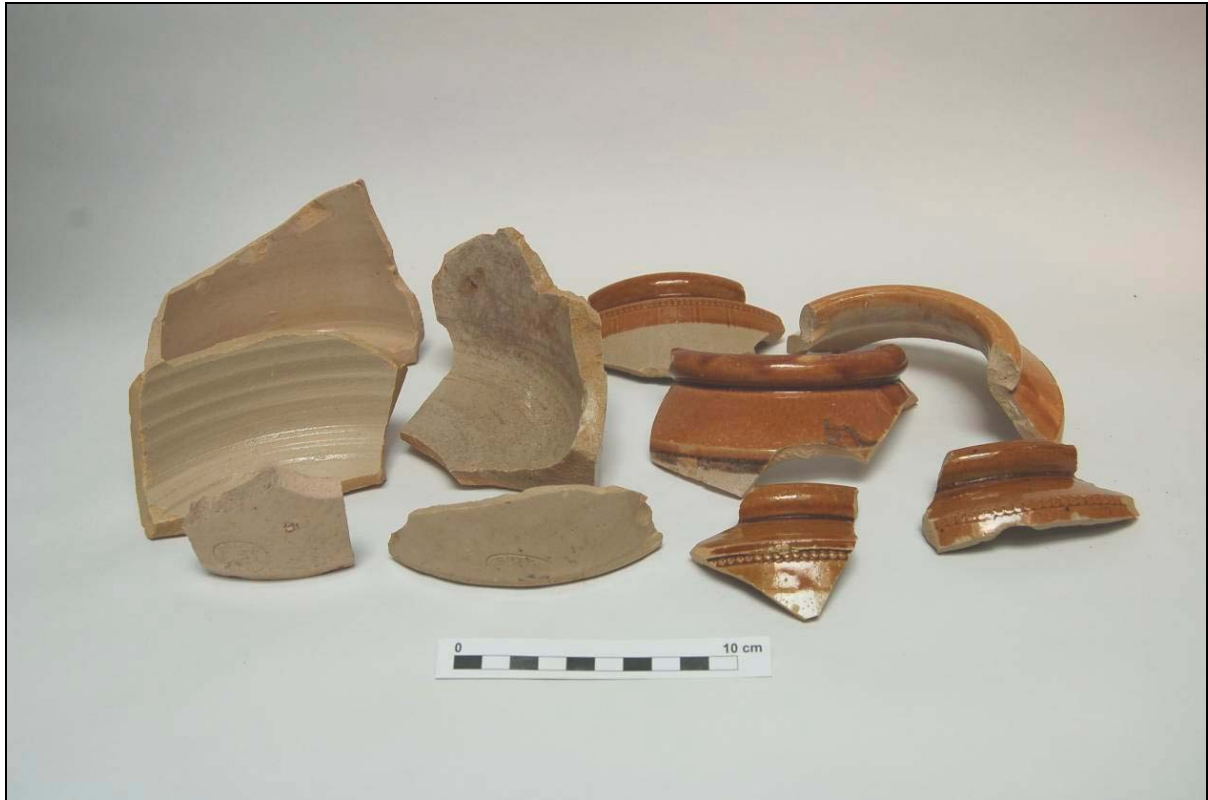
No stratified or unstratified artefacts of any significance were recovered from deposits within the twelve trenches excavated. However, a small but representative sample of the numerous stoneware vessels sherds that were observed to be spread across the cleared surface of the site was collected. This amounted to 21 sherds weighing 2840g.

These vessel sherds are almost certainly the remains of jars used for the storage of preserves and jams during the latter part of the 19th century. The assemblage includes substantial base, body, shoulder and rim sherds of vessels of varying size and wall thickness, though all appear to be of fairly simple shouldered jar form (Plate 8). All have typically glazed cream coloured bodies and brown tops, often with a simple beaded decoration at the shoulder. Impressed stamps on some retrieved sherds identify the two manufacturers Price, Sons & Co and George Skey & Co.

The collected base sherds are predominantly from vessels of 14-15cm diameter. Two are of vessels of 22cm diameter. A 'Skey 8 Tamworth' jar with beaded shoulder decoration sold on e-bay was listed as being 23.5cm high and 14cm diameter.

Plate 8. Selected stoneware jar sherds collected from the site

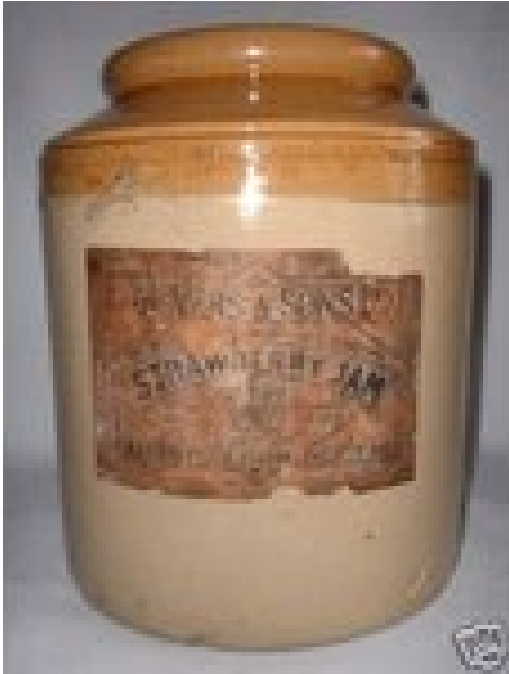
None of the retrieved sherds, or any others observed on site, bore any transfer labelling indicating use or ownership/branding. It is likely that any such information would have been on paper labels attached to the jars. A Skey stoneware jar bearing an original Chivers jam

label, in Canadian ownership, was sold on e-bay in 2007. The jar appears similar to those represented by some of the collected sherds and was apparently 19cm tall by 15cm diameter (Plate 9). Its paper label reportedly read:

Plate 9. A Skey stoneware jar bearing an original Chivers jam label

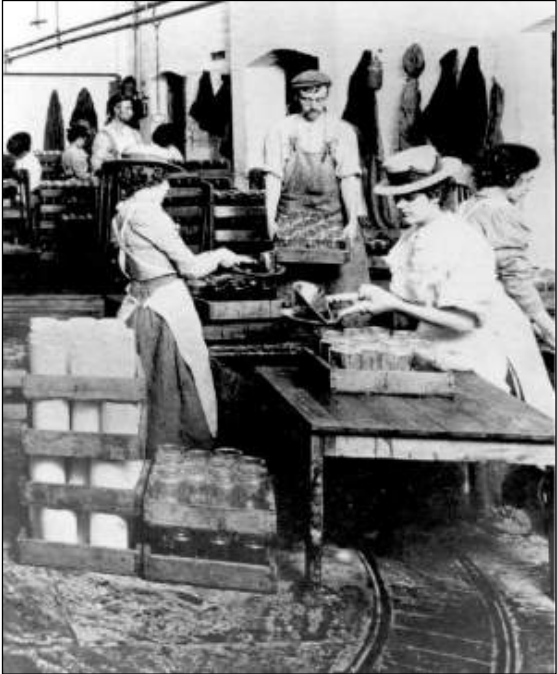
Plate 10. Stoneware and glass jars in use in the Chivers Factory, 1894

Although seemingly scattered across the site, and no doubt somewhat disturbed and displaced by site clearance works, the proliferation of stoneware jar sherds on this site is nevertheless significant. It is known that the Chivers jam factory originally used two, four and six pound jars to contain its produce. Glass jars were apparently in use by 1885 and there is a nice 1894 photograph recording the concurrent use of both stoneware and glass jars in the factory (*Histon & Impington Online* website), reproduced in this report as Plate 10. As the factory was also producing its own cans by 1895, the need for stoneware jars presumably diminished. It is conjectured that by the 1920s these stoneware jars were probably obsolete and so the Chivers' remaining stocks were conveniently disposed of by being used as hardcore during the construction of the adjacent, and associated, box factory.
