**RUNWELL HOSPITAL
RUNWELL CHASE
RUNWELL
ESSEX**

HISTORIC BUILDING RECORD

August 2012

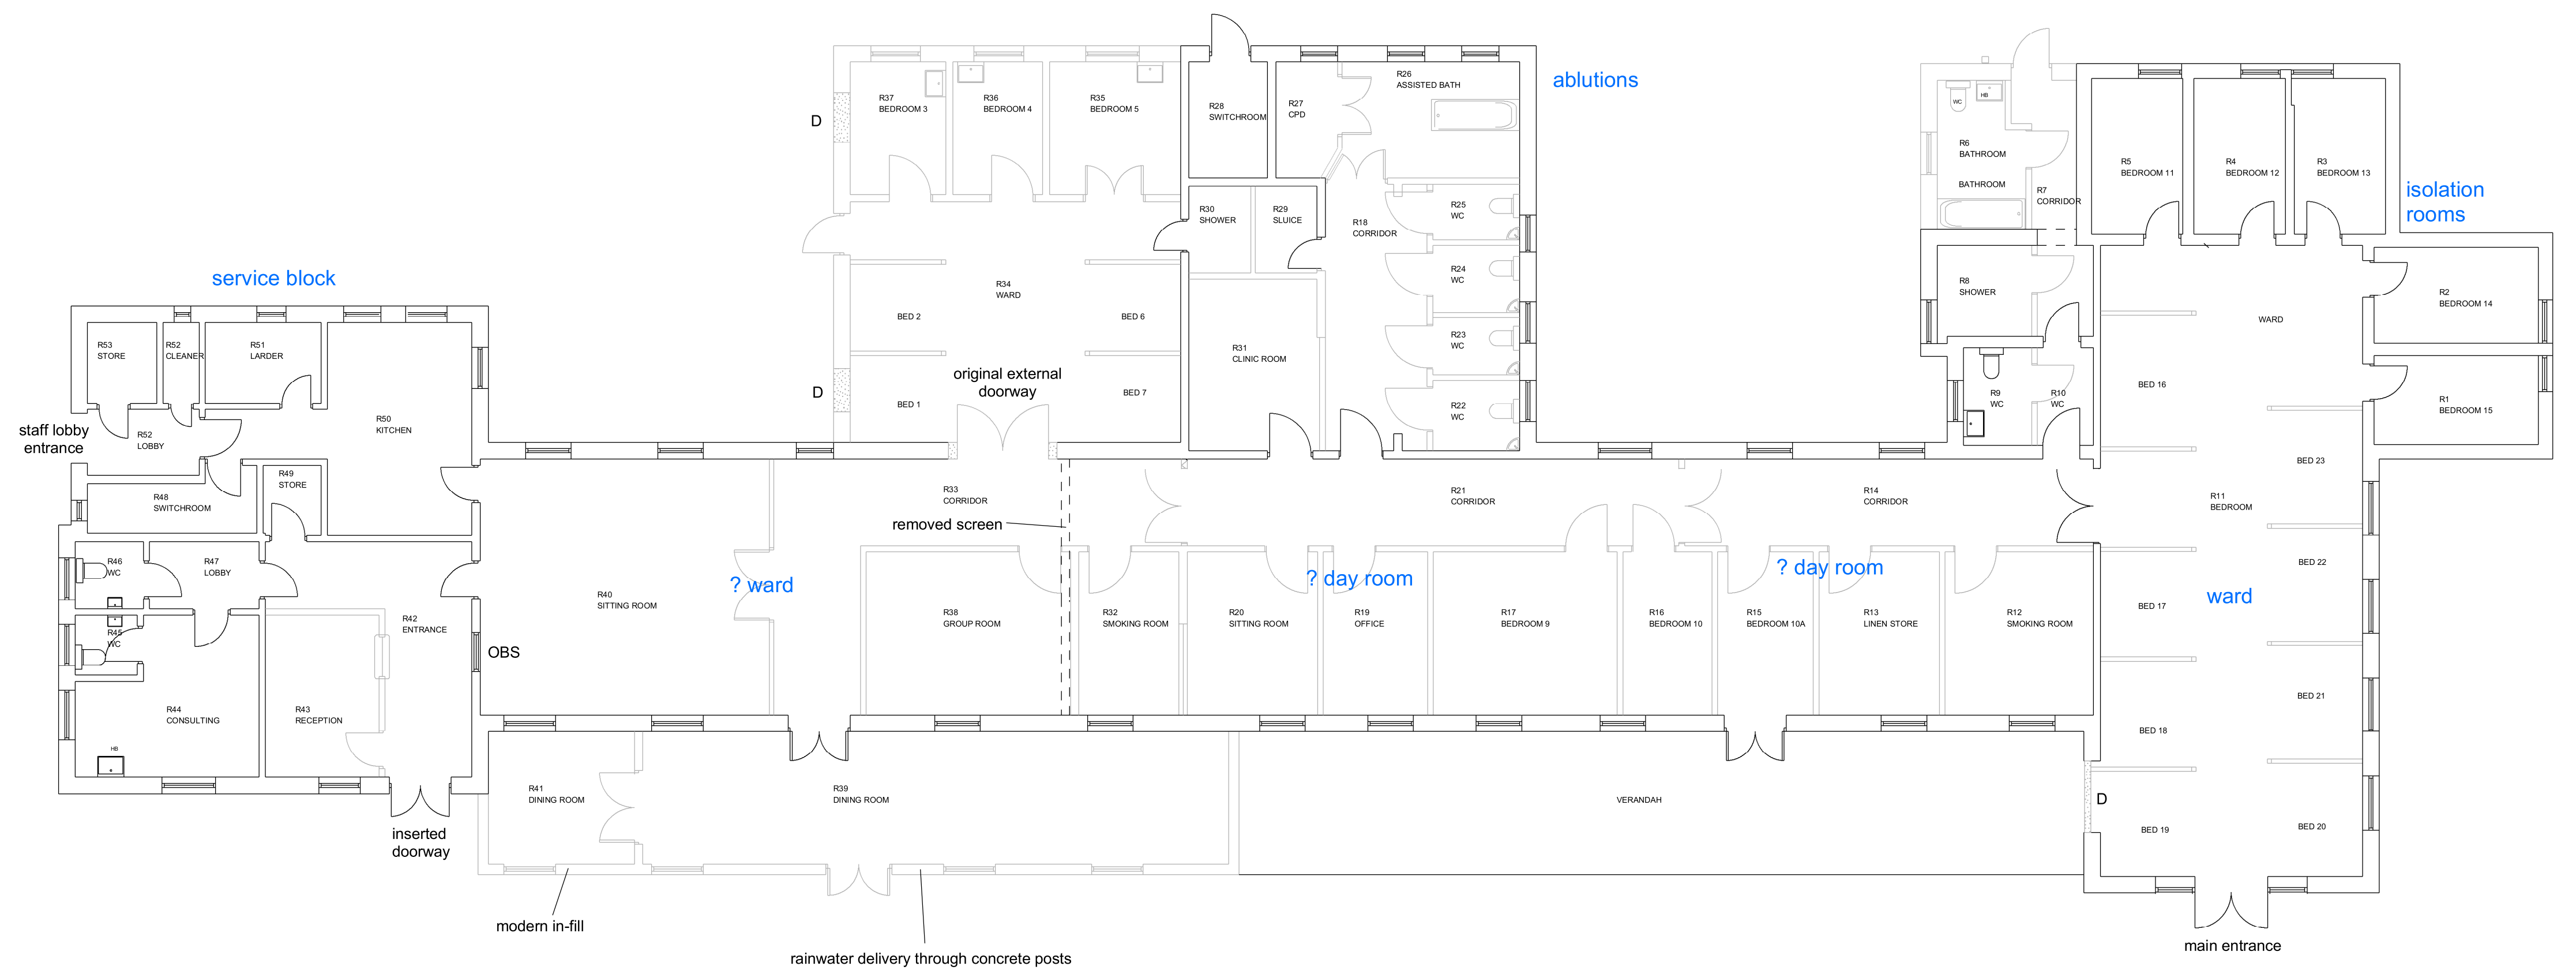
LABURNHAM WARD

Fig. 9 Infirm units Elm and Laburnum (10 & 11):

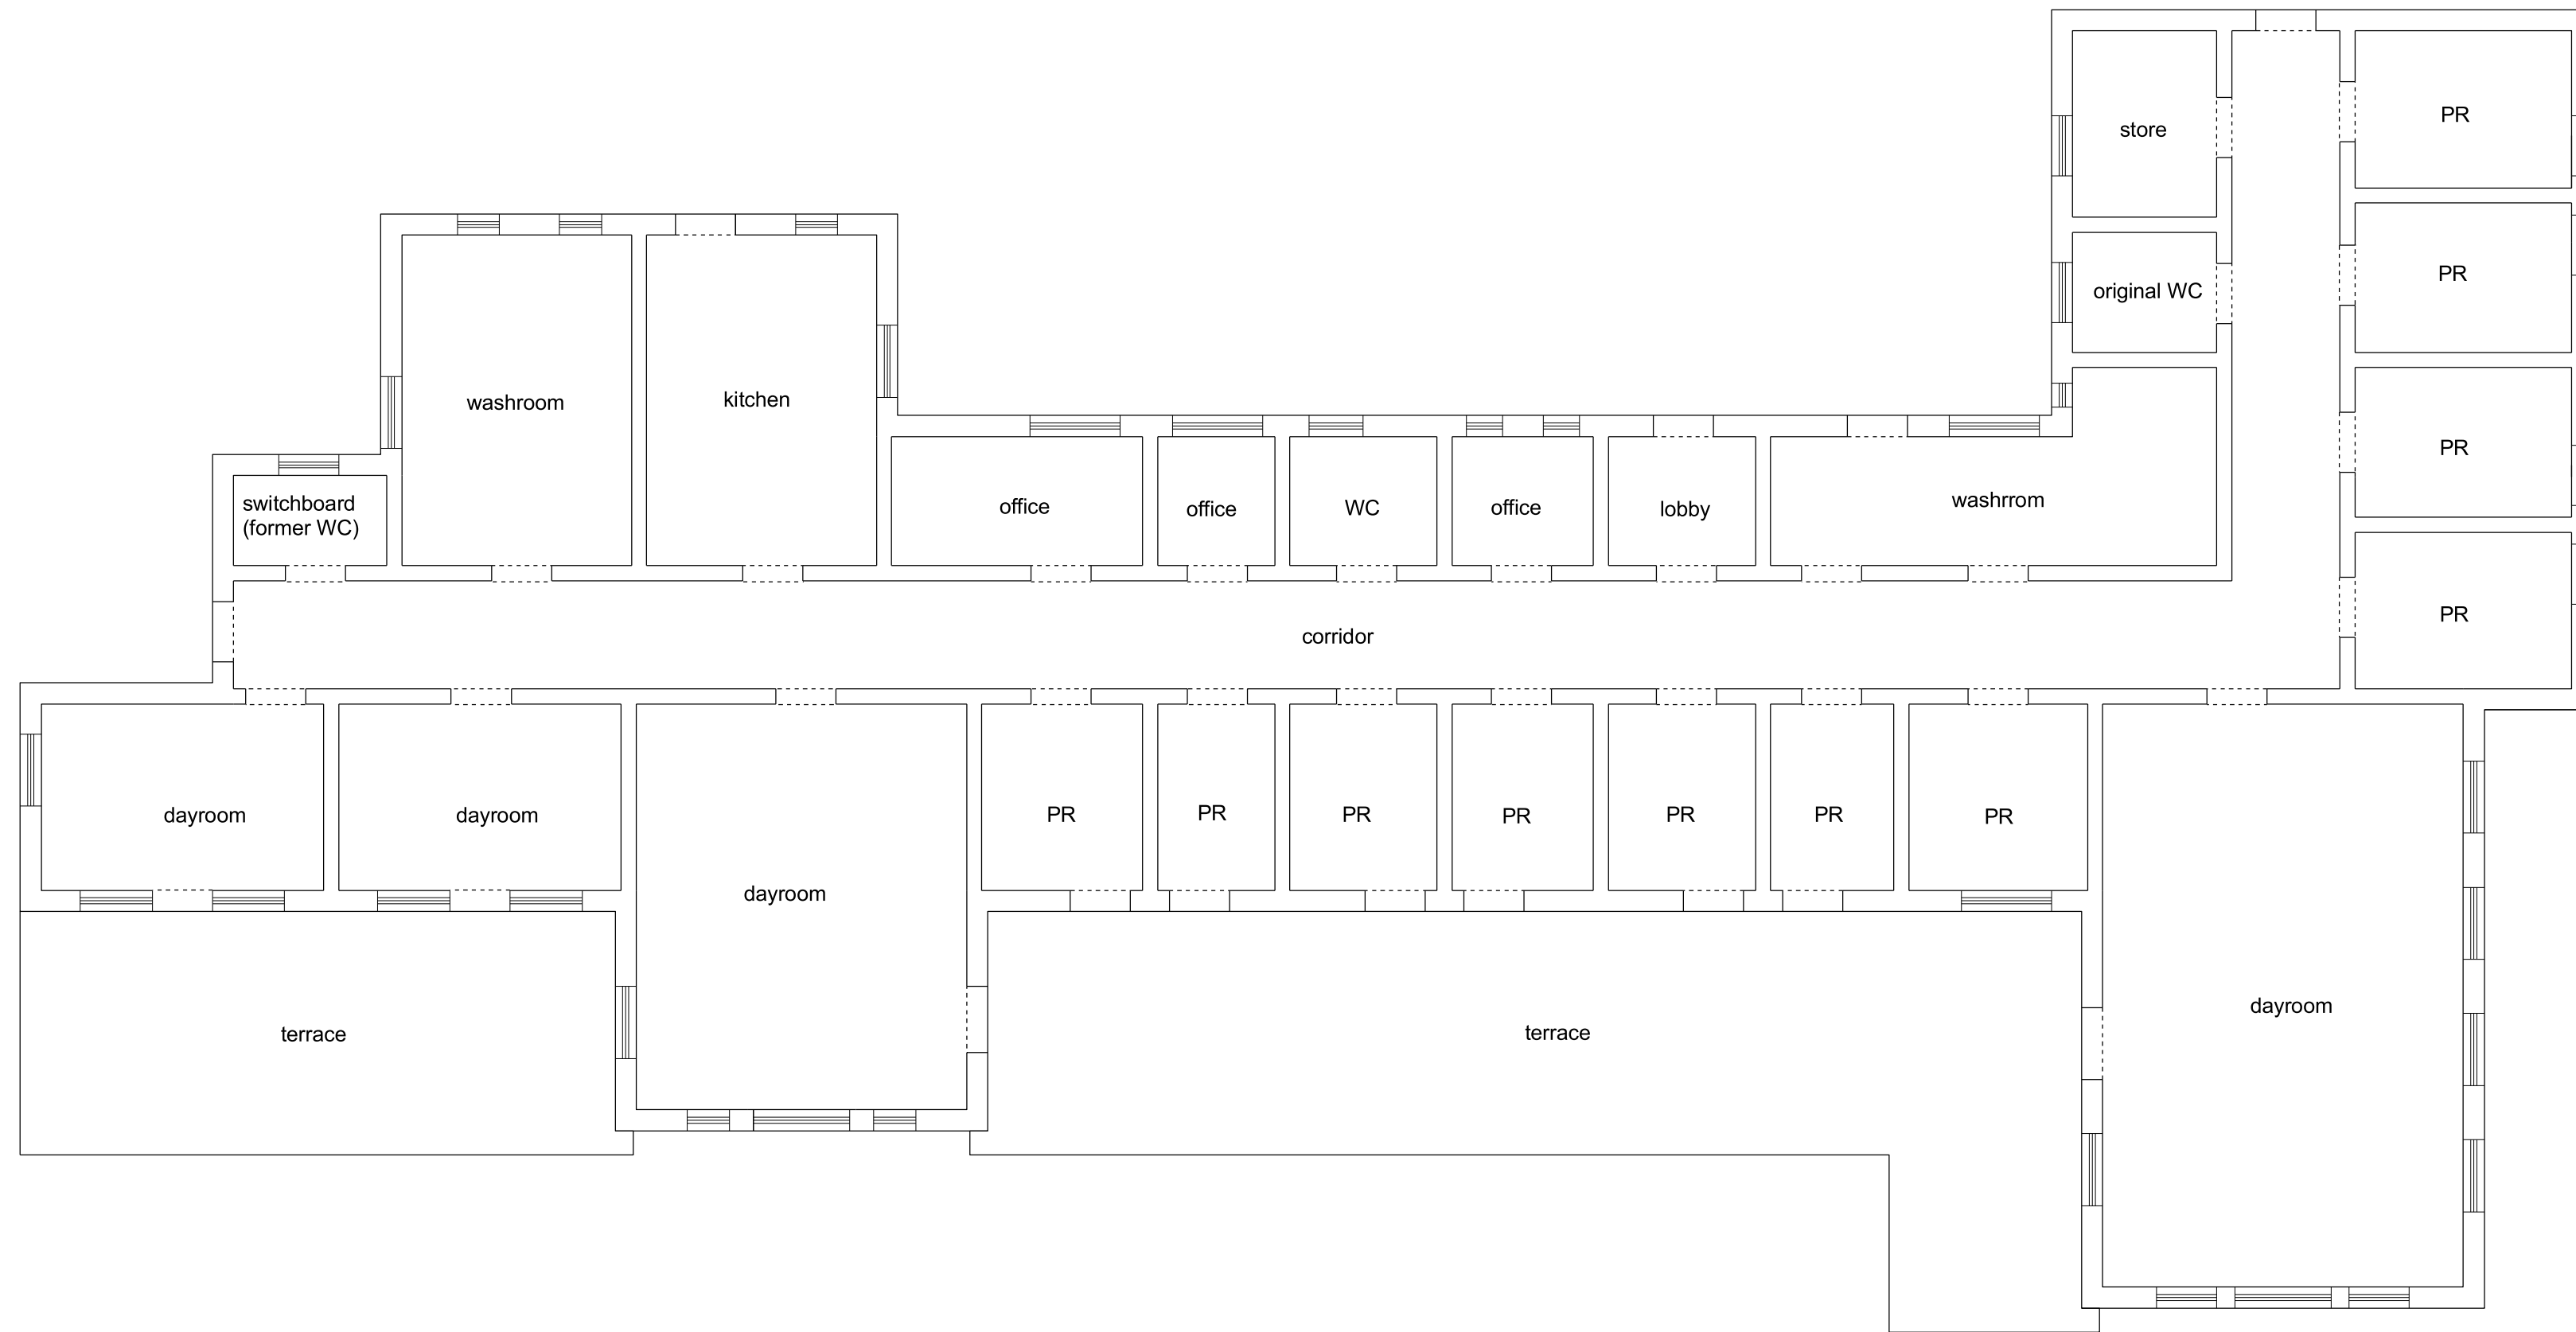
Fig.11. Leigh house

Fig. 11 Nerve patients: Leigh House (14)

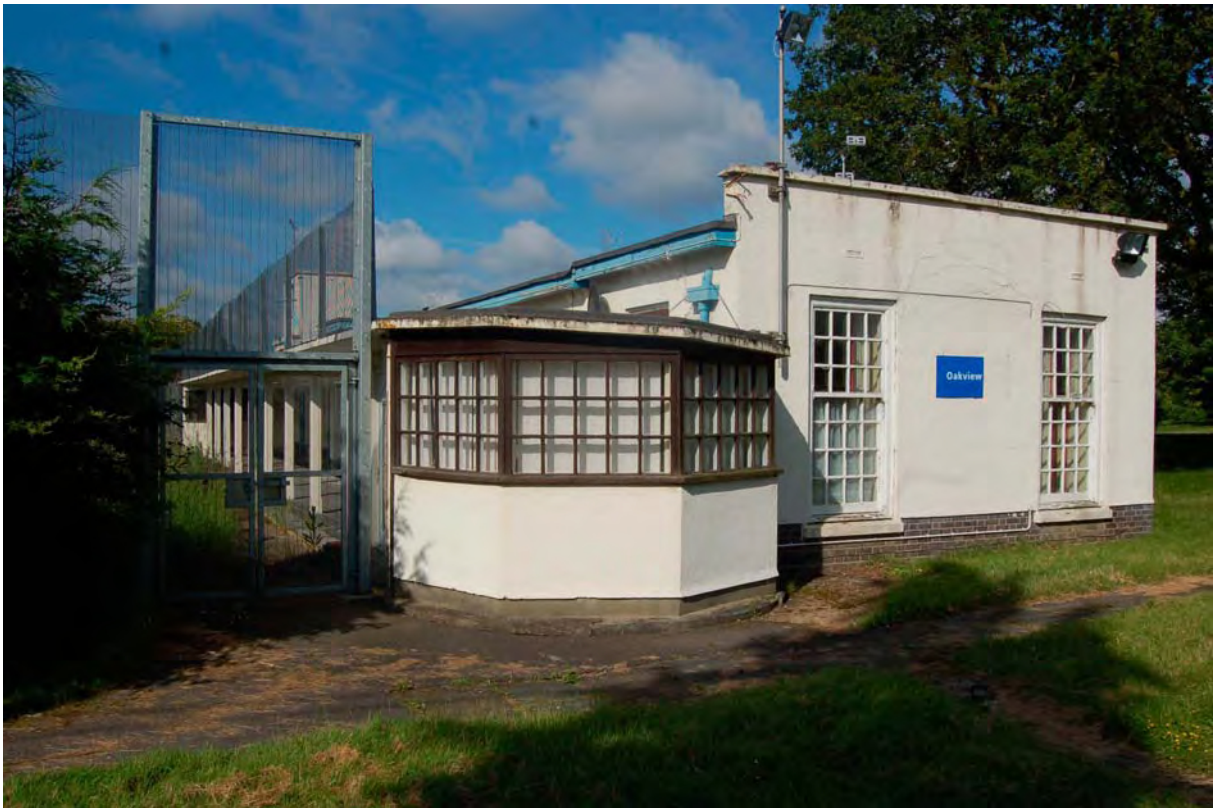
Plate 53 Sick hospital verandah (Dove)

The verandahs have the same form as those attached to the Admissions Unit (plate 53).

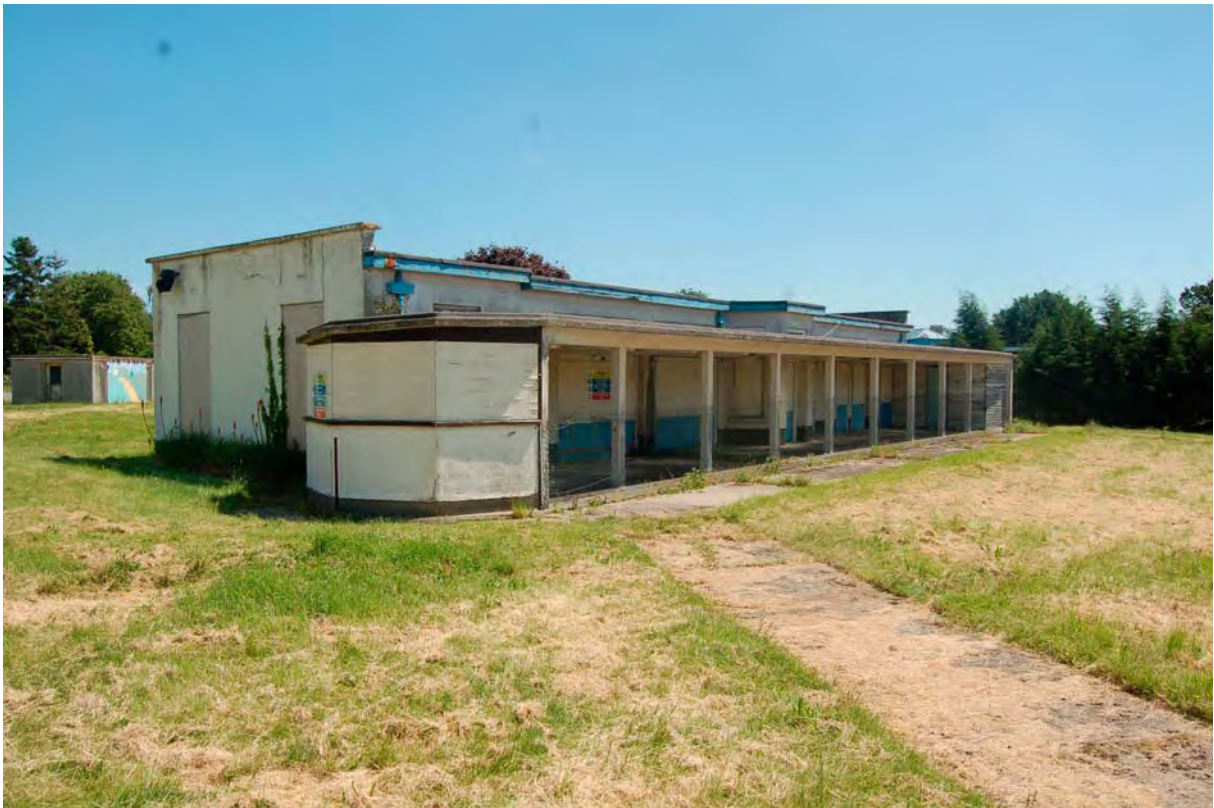
Plate 55 TB hospital verandah (Oakview)

In contrast to those in the main wards of the Admission Unit, the verandahs have multi-angled enclosed ends and square rather than tapered posts (plate 55), the latter possibly added at a later date, seeing as this is also a detail of the 1960s Strom Olsen wing.

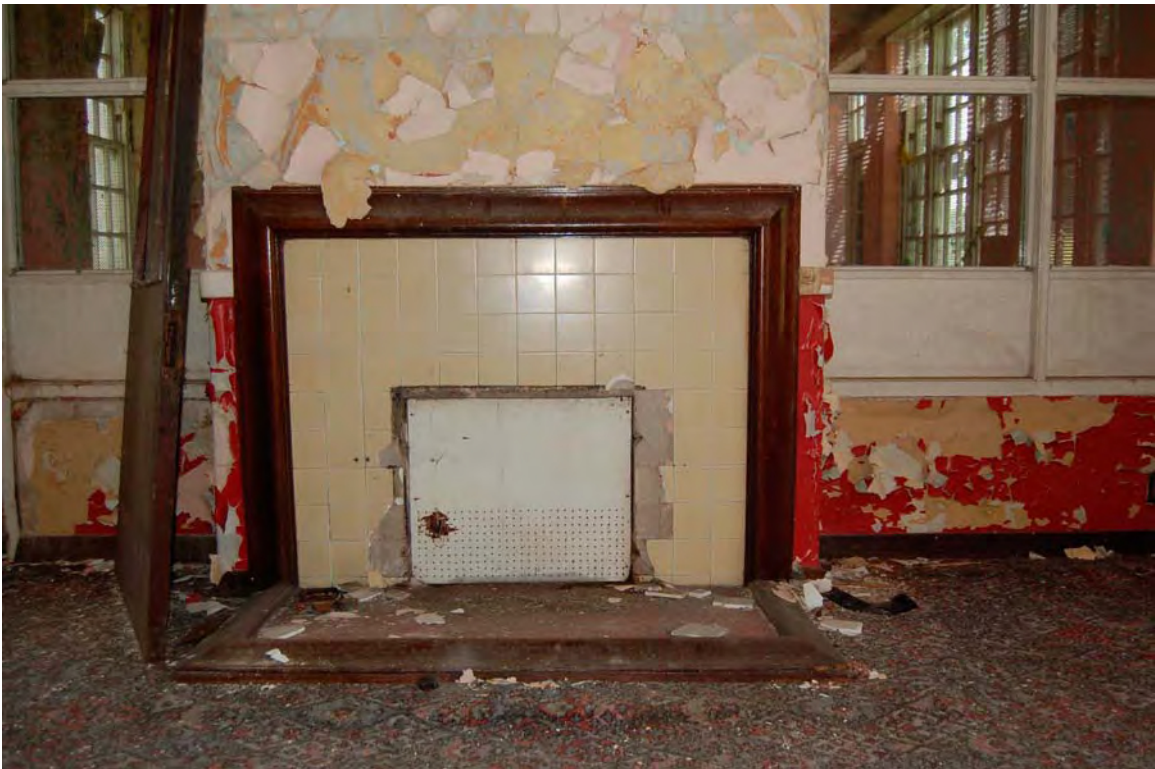
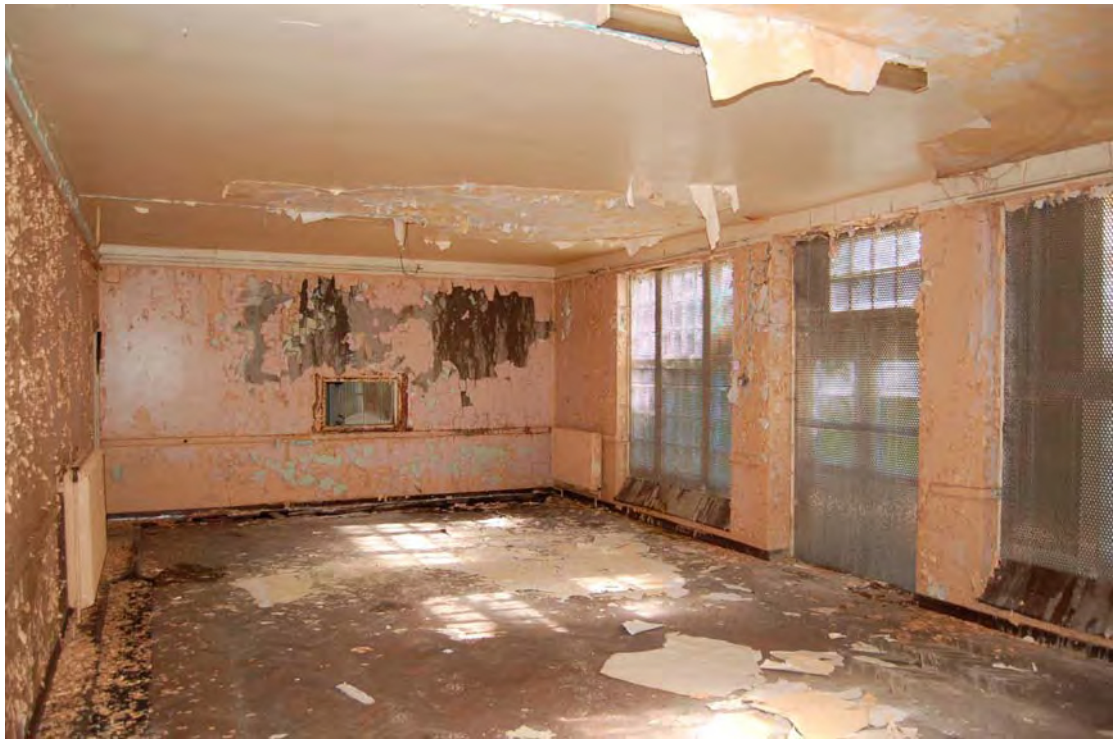
On the ground floor the main part of the building is divided into three dayrooms. These rooms are divided by semi-glazed hardboard or plywood screens and heated by back-to-back fireplaces, the best examples of which are found in Brookside ward (plates 65 & 66). The dayrooms retain original fittings in the form of parquet floors, flared skirting boards, dados and picture rails, which are also evident in the dormitories above, and are heated by large cast iron radiators. At one end is the nurse station/office, with observation window onto the adjacent dayroom (plate 67), and a lobby/store area at the other (figs. 7a & b). The surviving best nurse station interior was recorded in Sunnyside, though the only fixtures to remain are a butler's sink on the west wall and a key board over the observation window, which has been replaced in one-way glass. The projecting service blocks contain a quarry tile-floored kitchen, food store, larder and the stairs to first floor. In a departure from the normal ground floor layout, the service block at Woodside is enlarged and also originally accommodated a staff flat accessed by its own porched entrance. The flat comprises a bedroom with ensuite wc and living room (fig. 7a), though all but the toilet fittings have been cleared out. The kitchen stores have terrazzo floors and are fitted with cantilevered iron shelf brackets embedded in the walls. Slate shelves occupy the lower shelves of three-tiered larders (e.g. R2 in Sunnyside, plate 68), which is a feature of all ward kitchens across the hospital.

Plate 65 Parole Unit dayroom

Plate 66 Dayroom fireplace

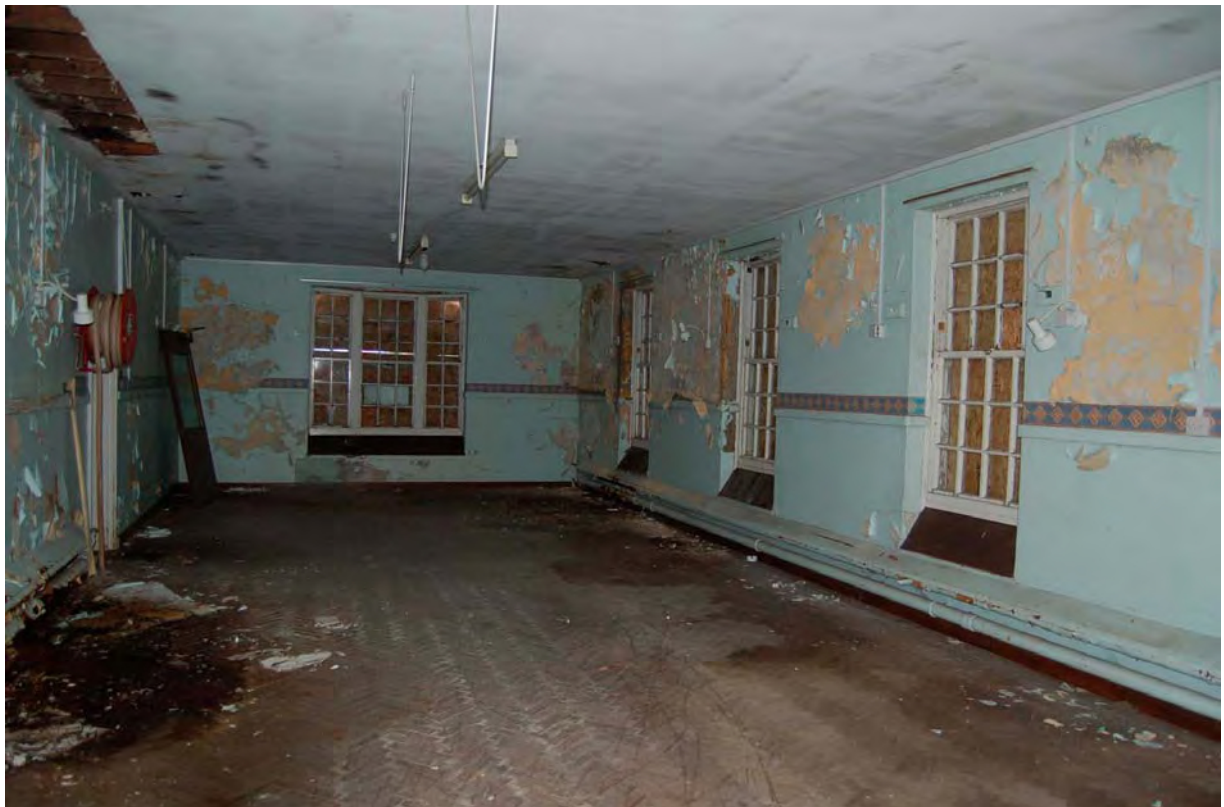
Plate 69 Cupboards in ablution block

As a general rule it is unusual to find original features in the ablutions blocks since all have been extensively modernised. However, original cloakroom cupboards appear to survive in Brookside (fig. 7c & plate 69). The pink and blue tiled floor is likely to be modern.

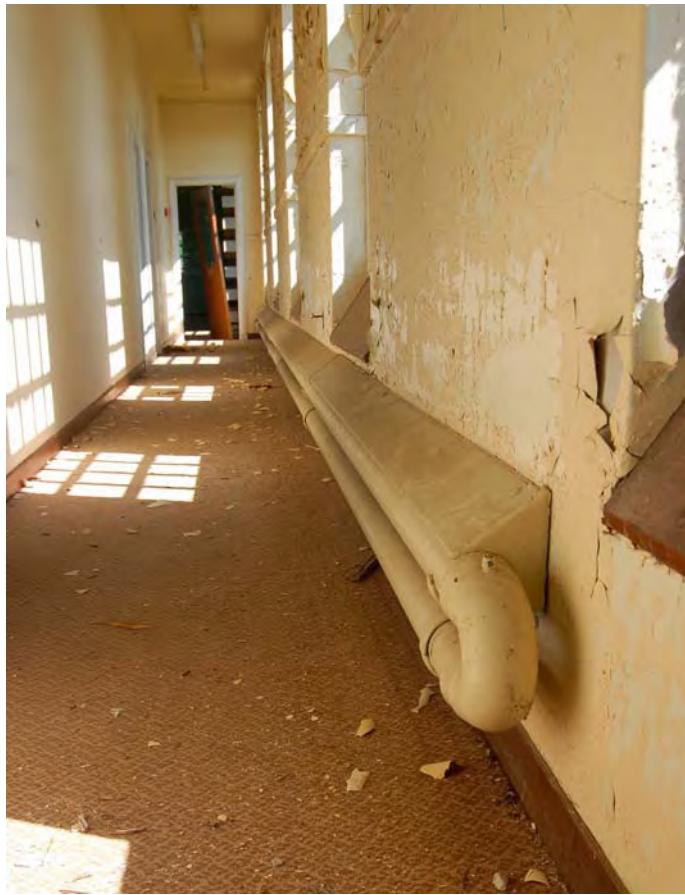
Plate 70 Dormitory

The three first floor dormitories are divided in the same way as the dayrooms below, although they now extend the full length of the main range. They are also decorated the same, apart from the lack of a picture rail (plate 70). One of the more interesting features is the shrouded hot water pipes (plates 70 & 71), an original safety measure - as is the ubiquitous splayed window sills. Room layouts of the two projecting rear blocks at this level are broadly the same as when built, though function has changed in some cases. As far as can be discerned, isolation rooms were located opposite the stairs, next to a linen store, and opposite the nurse's room; the latter identified for its lack of security features. At the far ends are washrooms and toilets (figs. 7a-c). It should be noted that all routes of access (stairs, corridors) and main rooms such as the dayroom and dormitory areas could be locked to control the movements of patients.

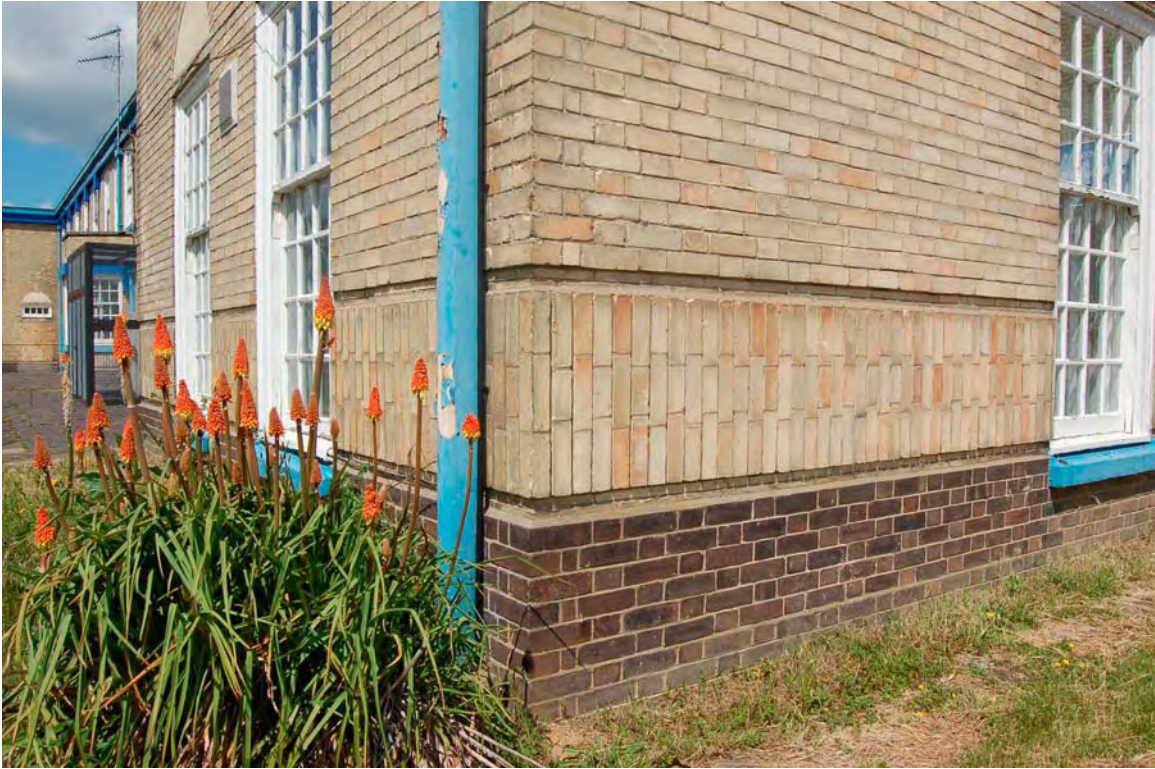
Plate 72 South elevation of Belfairs

The usual brown brick damp course extends around the building exteriors and decorative low vertical brick banding on the principle and side elevations (plate 73), and around the stair windows. Horned small-paned wooden sash windows with concrete sills (plate 72). Those on

Externally, the main elevation is on the south side, which shows a heavily-fenestrated flat-roofed façade (plate 72). The brown brick plinth and vertical brick band above, a general design feature of the original hospital buildings, is illustrated in plate 73. Modern blue steel ducting runs around the front. The only entry points on this side are on the inside of the side wings (now blocked) and via a modern doorway placed at the east end to gain access to the stairs up to Fairview ward above. The external elevations of the north side courtyard areas (plate 74) are similar but lack some of the decorative detail and those windows in the ablutions blocks are smaller, for privacy. The main entrance is now on the east side, but this may be modified from a former entrance into the same lobby (R51, fig.8) from the main corridor.

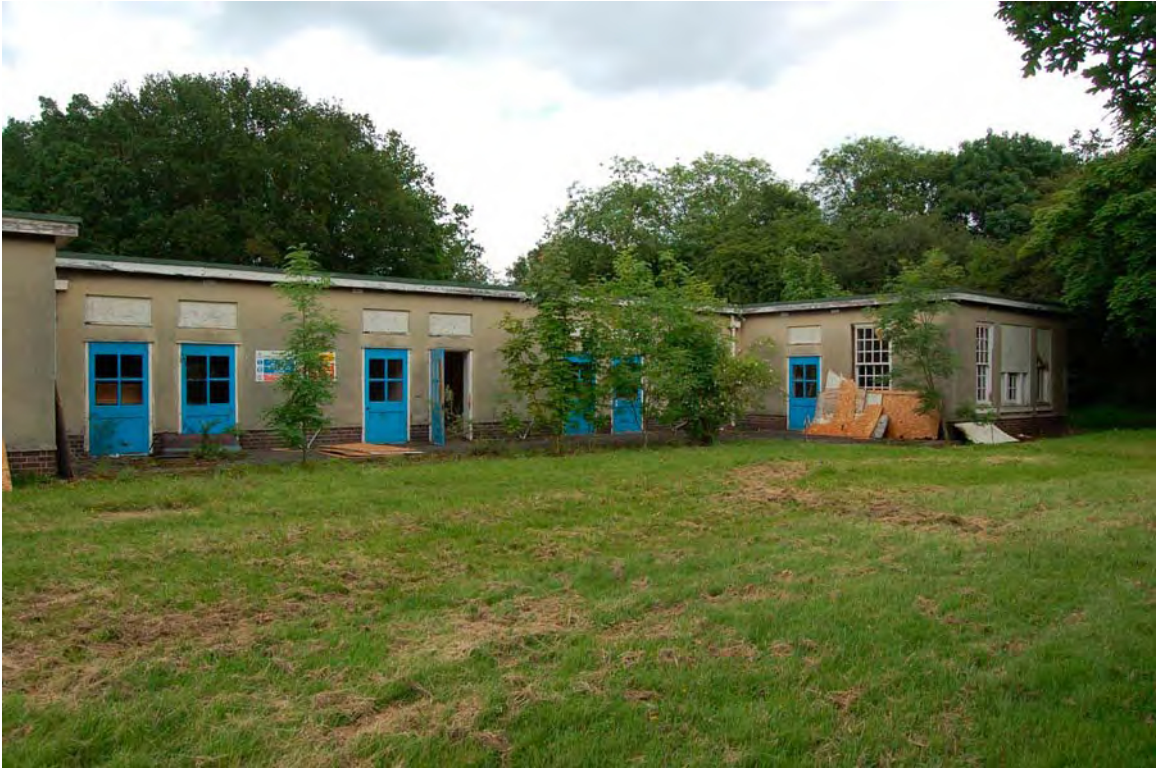
Plate 103 Leigh viewed to north-east

Externally, the main south elevation (plates 103 & 104) has two projecting dayrooms with sun terraces in between and to the west. Access onto the main terrace is via doorways on the inner walls of the dayroom blocks. Behind it are mostly wide four-pane semi-glazed doors (usually three-pane elsewhere) fronting the row of patient rooms, providing easy individual access and a fanlight (now blocked) for good air circulation. Smaller, relatively private dayrooms are located at the west end with their own terrace and doorways flanked by low, tall windows. The east elevation (dayrooms and patient’s rooms) is well fenestrated and uniform. The back of the building (north elevation) is badly overgrown and contains boarded-up windows to service areas and offices (plate 106). A doorway on the east end of the back

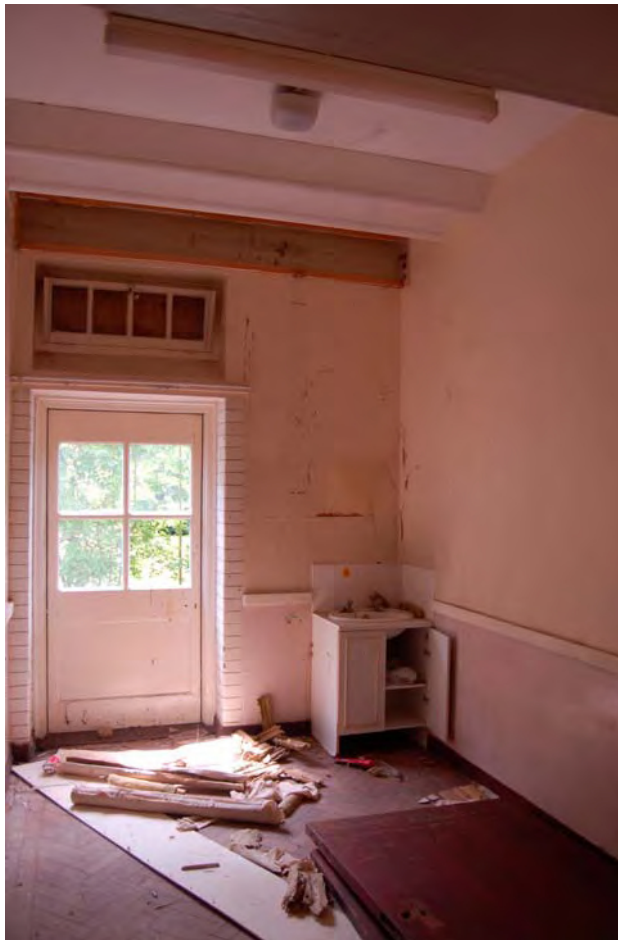
Plate 107 Isolation room

Internally, the layout is unusual for a non ward-style building in being based along an L-shaped spinal corridor that provides access to all the rooms. Those rooms on the east and south sides are all individual patient's rooms and dayrooms, while those on the opposing sides are staff offices, toilets, washrooms and a kitchen. The patient's rooms are the same as the isolation rooms seen elsewhere, fitted out to a standard pattern and design, with common fixtures and fittings (plate 107).

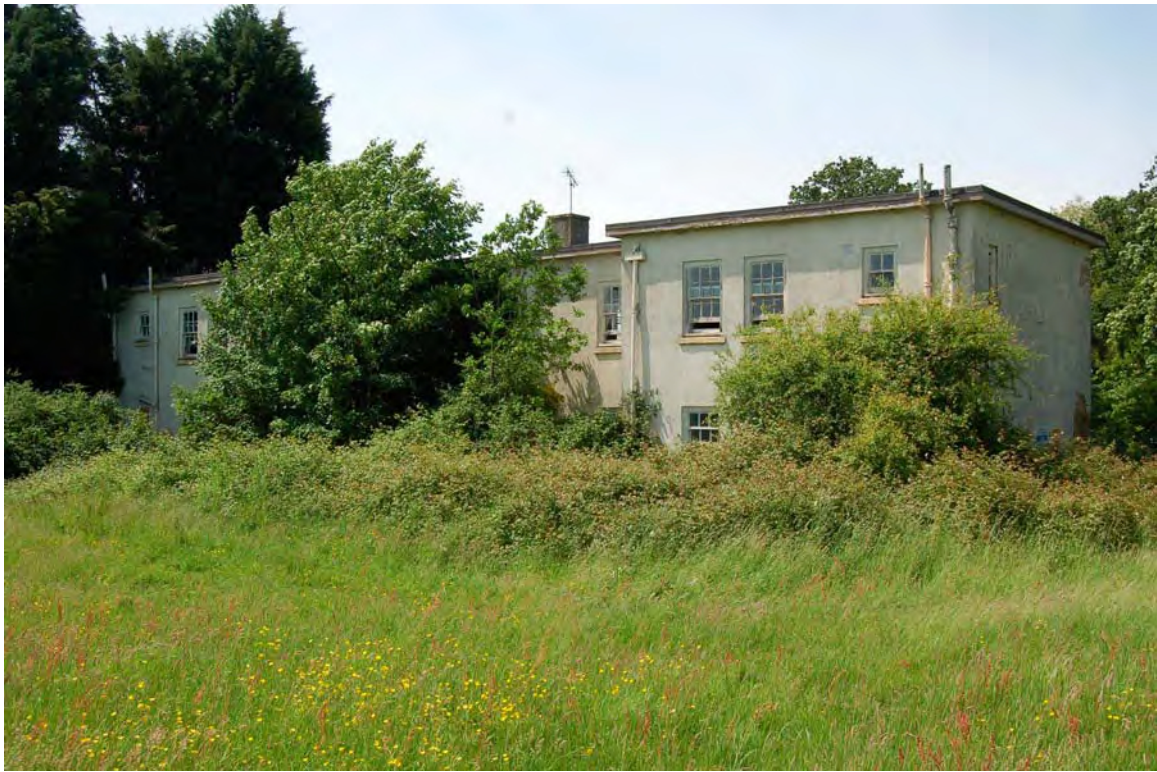
Plate 109 Oakfield viewed to south-west

Externally, the appearance of each is similar to the parole units on the north side of the site, although Oakview (plate 109) has a rendered exterior. Large parts are obscured by trees and other vegetation. Both buildings were boarded-up during the survey. Hillview has suffered internally through roof failure and some first floor areas could not be entered. On the ground floor, double doorways lead out from the fronts of the two central dayrooms onto the terrace, topped by arched heads in the same fashion as the sash windows either side and in the east wing (plate 108, Hillview). Such decoration is lacking on the west wing of Hillview and north wing of Oakfield, but is apparent on the main doorways. Regular shorter sash windows light the top floor, dressed in the usual way. The side elevations display little detail apart from some sealed square windows that light the stair cupboards. The rear elevation (plate 109, Oakfield) continues the main themes of the front.

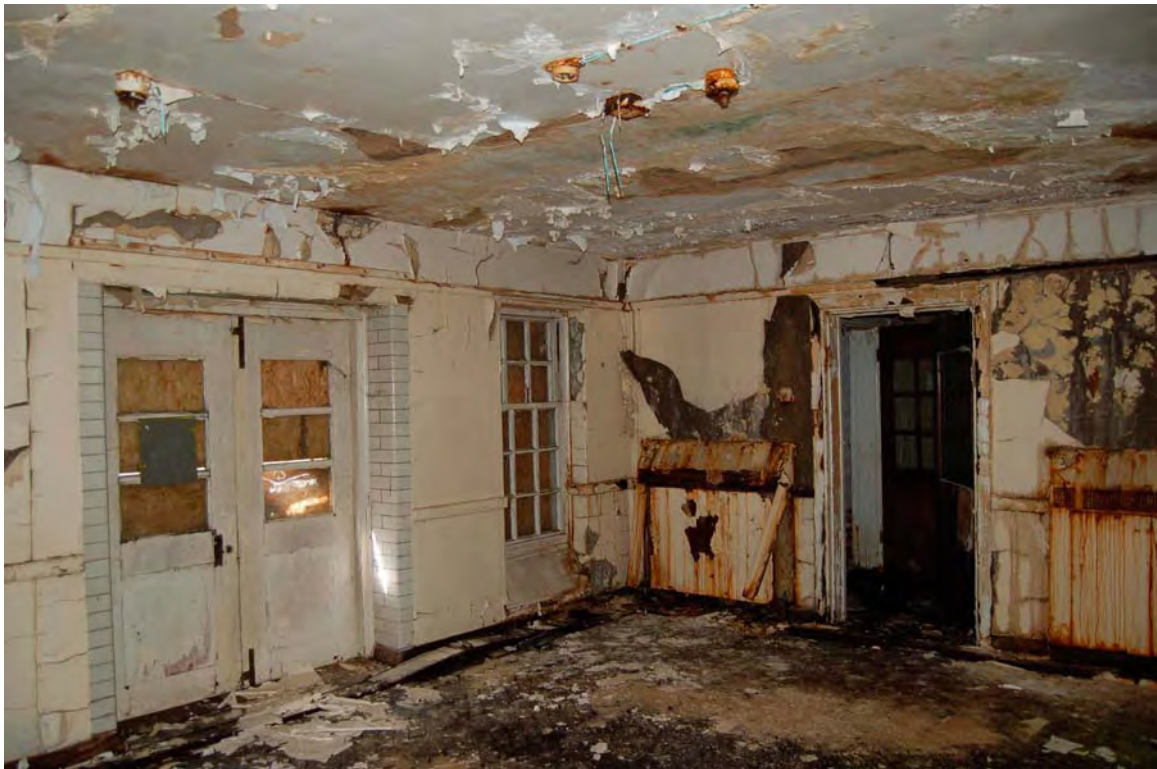
Plate 110 Hillview ward (ground floor)

Internally, the ground floor of the main part of the building comprises two wards (plate 110). Apart from the usual wall fittings, the bullnose door jambs and original double doors are the major historic features surviving. The radiator shrouding is interesting too and different in its design to those seen in other buildings. Chimney stacks are located on the back walls, but now have no fireplaces. Either side of the wards, in the end blocks, the isolation rooms are front-facing and service rooms (bathrooms, kitchen, etc) are located at the back on the other side of a short dividing corridor. Modern isolation rooms have been added into the washroom, which were formerly two isolation rooms (fig. 12a).

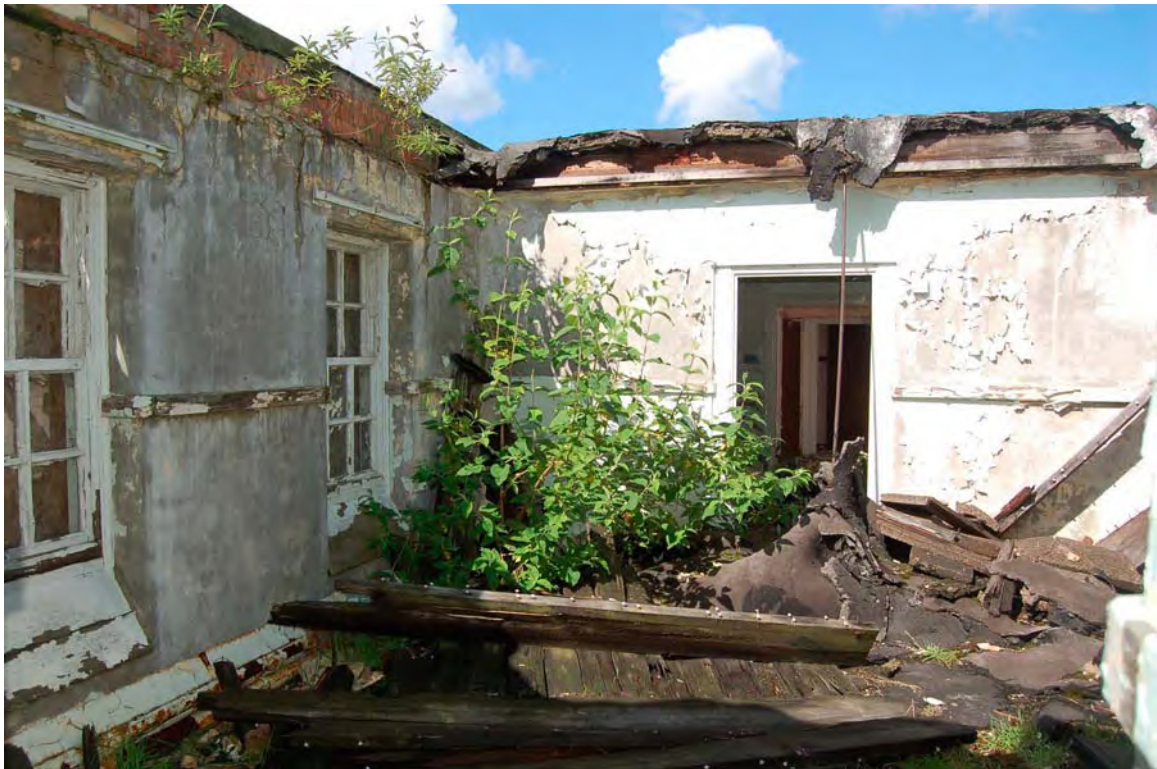
Plate 112 General roof construction (Hillview)

The ruinous nature of the Hillview roof presented a good opportunity to view the materials used in its construction during the survey. It was found that the main constituent of the roof was a thick layer of cork, overlying pine roof joists and boarding (plate 112). The cork is sealed with roofing felt and hidden from view externally by the parapet. Though not substantiated by the survey, it is assumed that this is a common construction method for roofs across the historic buildings.

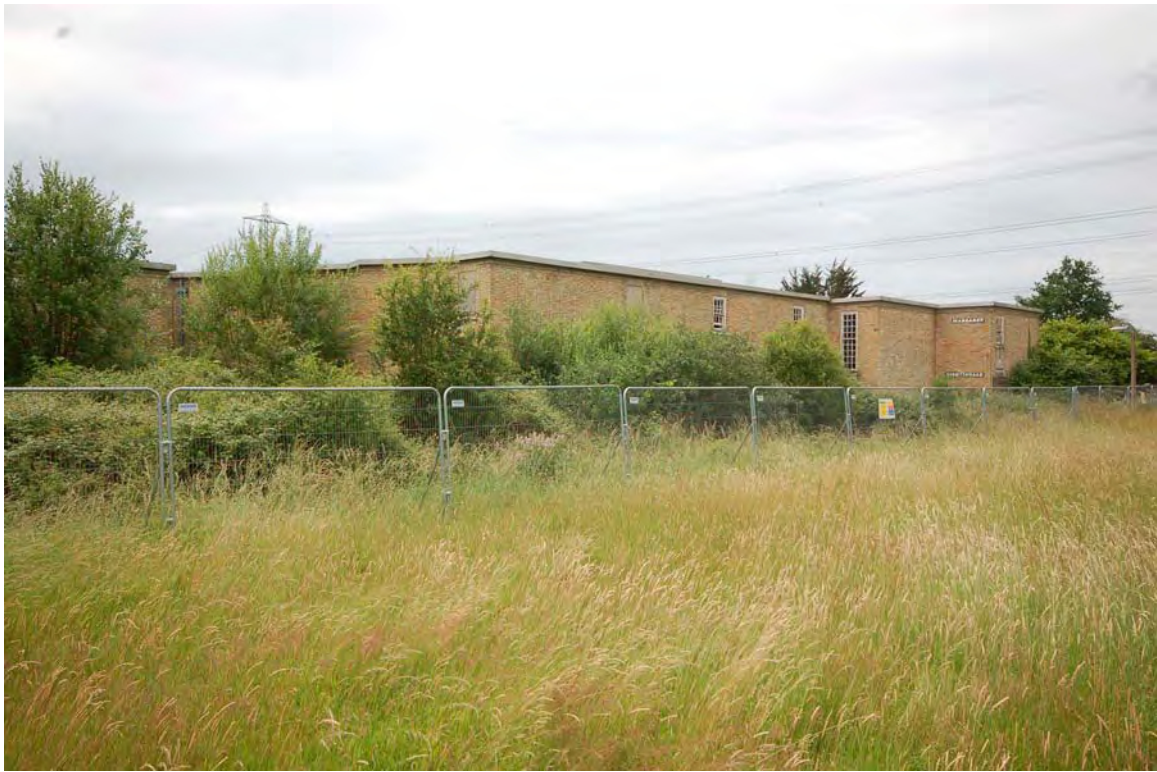
Plate 113 Boundary House (Nightingale & Margaret) viewed to south-west

Beginning at the west end, the main entrance into **Nightingale** ward is through the ablutions area on the west end and there is another towards the east allowing access into the corridor to this and Elizabeth ward (fig. 13). The main entrance has a semi-circular head over the door of door's fanlight (plate 114), which is a common feature throughout the hospital. Dressings around the main/all doors are standard (Plates 114 & 117]. Much of this elevation is dominated by the corridor wall so there are relatively few windows here (plate 113).

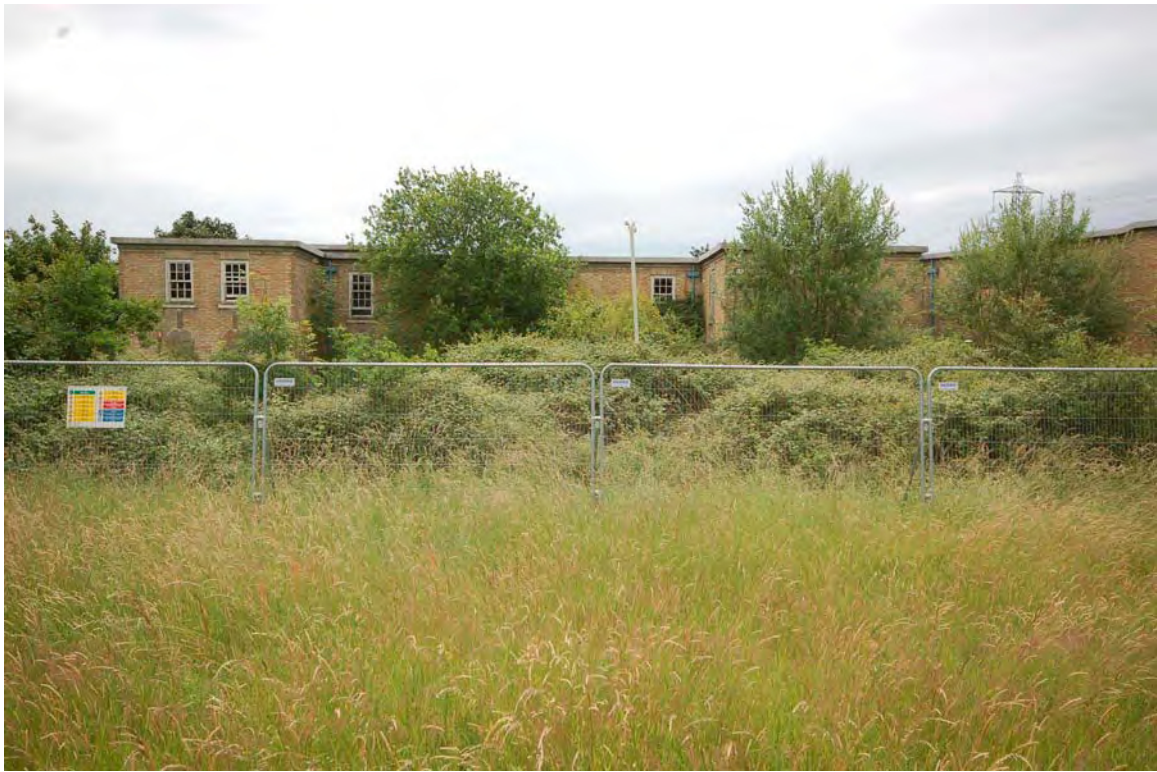
Plate 115 Boundary House (Elizabeth & Sherrington) viewed to south

A long corridor joins Elizabeth & Sherrington block to Windsor & Sandringham, part of which is taken up with the Boundaries Kitchen, a particularly ruinous modern addition (fig. 13) and of no architectural interest. Windsor & Sandringham (plate 115) has two points of access on this side, the eastern stair block and the western end of the corridor (fig. 13b). A modern lift tower has been inserted within the stair block (plate 116).

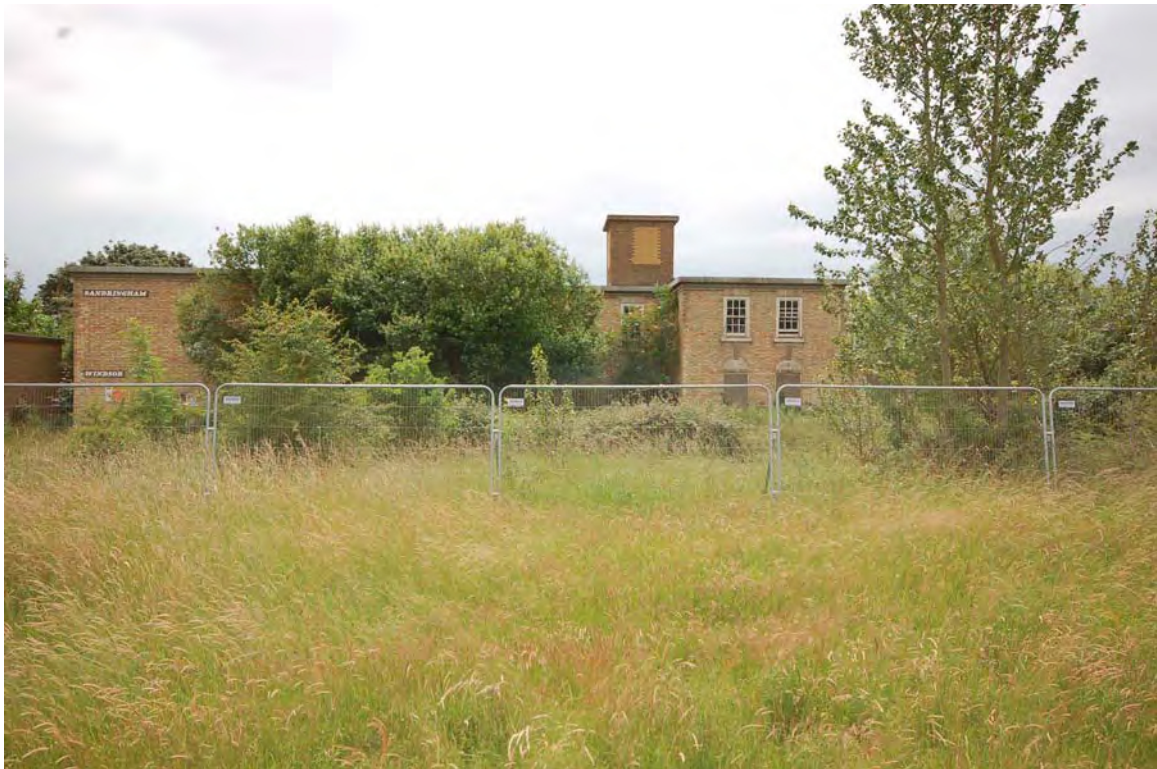
Plate 116 Boundary House (Windsor & Sandringham) viewed to south

The individual side elevations of each block were difficult to see due to lack of access. All that could be viewed of the west elevation at the time of survey is in the ablutions block and projecting dayroom of Nightingale and Margaret block (plate 116). The east elevation shows the two projecting dayrooms of Windsor & Sandringham between the bushes and trees.

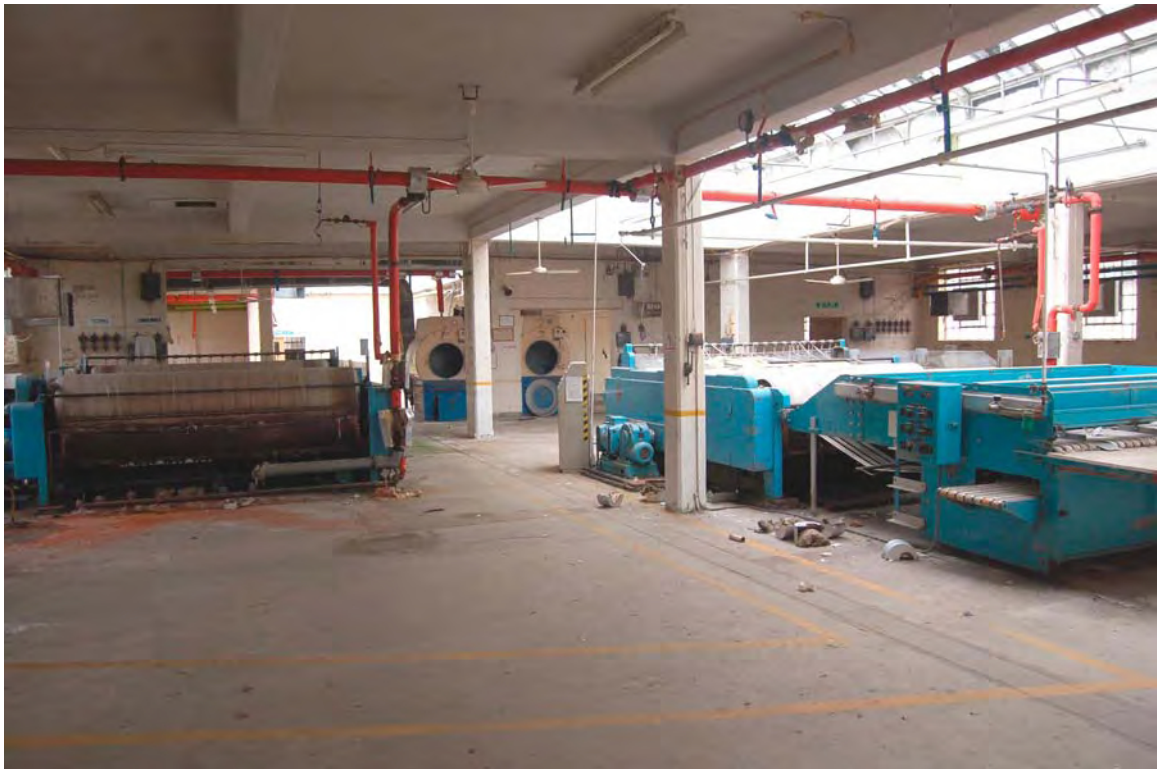
Plate 145 Laundry viewed to south-east

The laundry is a large single-storey flat-roofed building located to the north of the kitchen block and female non-parole unit. Its exteriors are plain and fenestrated with Crittalls windows, and principle doorways on the main elevation (north) are dressed in brown brick (plate 145). There is a smaller unattached laundry building just to its south and other associated buildings also to south and east. All are historic. The laundry was linked to the kitchen block and also indirectly to Boleyn and the female non-parole unit so that female patients could work here.
