**RUNWELL HOSPITAL
RUNWELL CHASE
RUNWELL
ESSEX**

HISTORIC BUILDING RECORD

August 2012

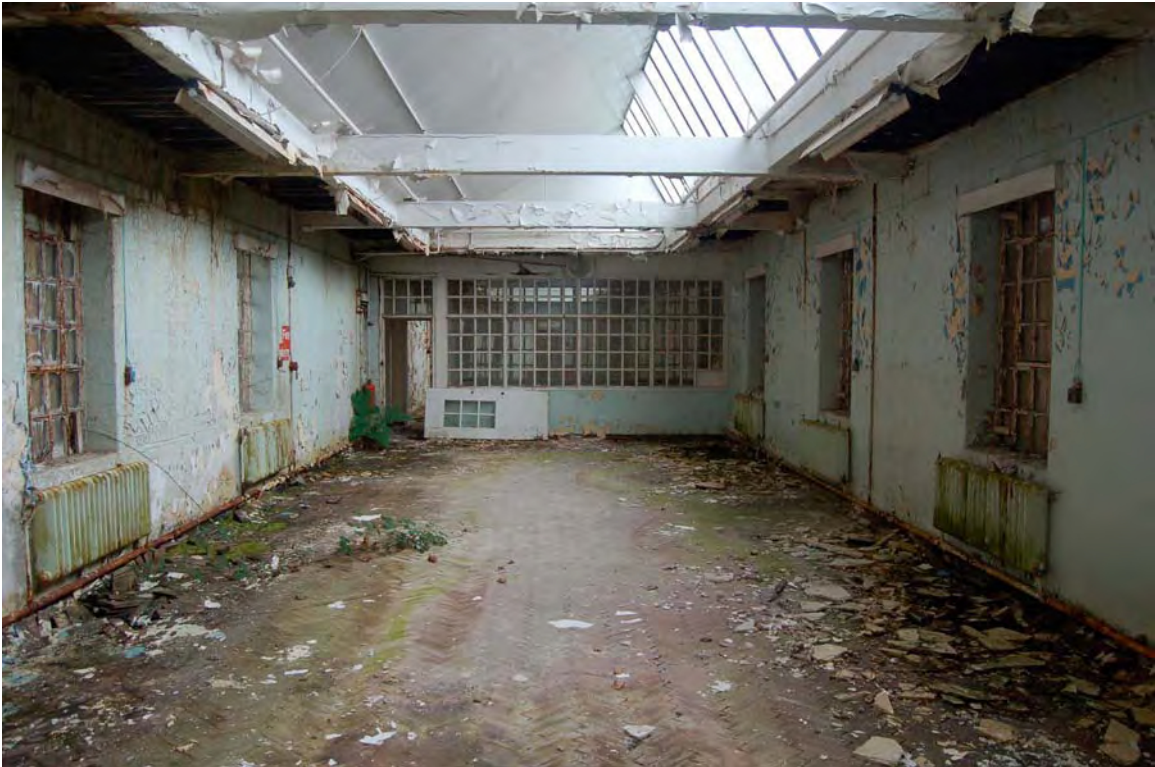
Plate 147 Sewing Room viewed to south-west

The sewing room is a long single-storey building to the east of the laundry and north of Boleyn and Harman female non-parole units. The exteriors are plain and fenestrated with boarded-up Crittalls windows (plate 147) and the doorways occupying the short elevations either end are dressed in the usual brown brick. Banks of north-lights overlie the sewing rooms below, but their neglect has caused the building to suffer badly through damp (fig. 21).

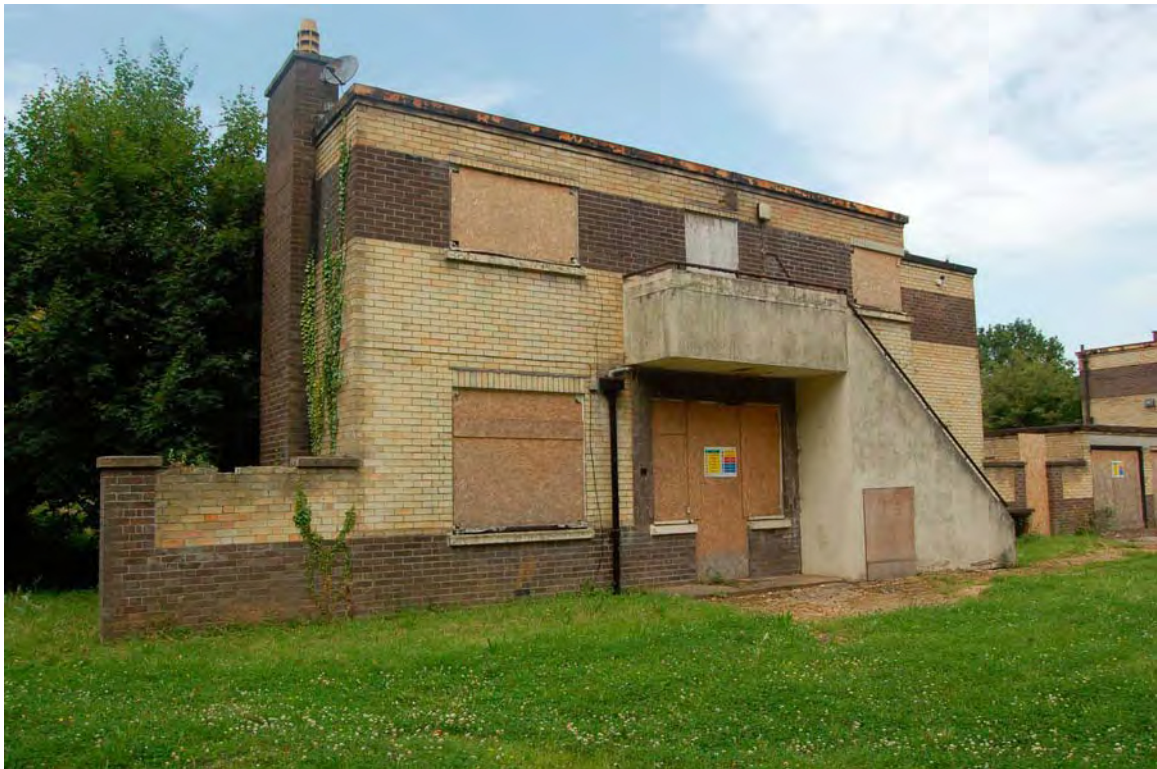
Plate 153 West elevation of Charters

Externally, the elevations display the broad themes discussed above but with some extra features deemed appropriate for the most senior member of staff, particularly the ocean-liner curve of the west-facing concrete balcony (plate 153).

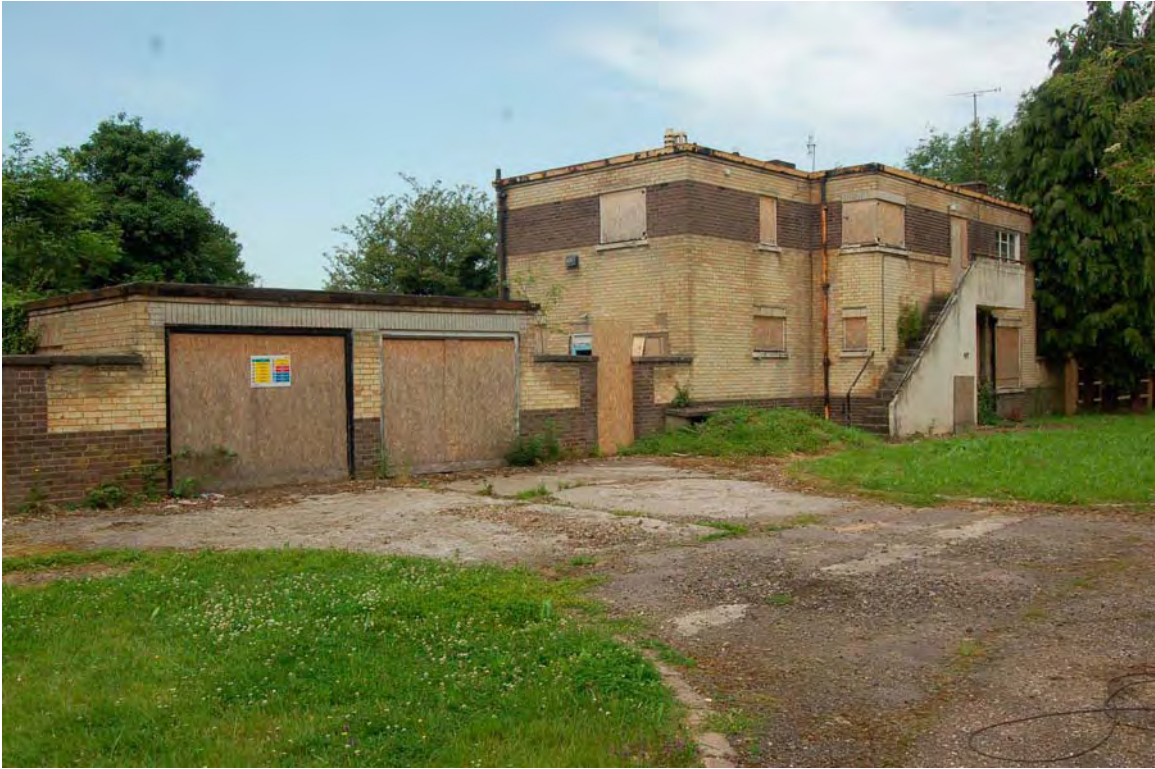
Plate 154 Penarth viewed to north-west

Penarth and Newick (plates 154 & 155) are located on the opposite side of the road to Charters and have exactly the same appearance and layout to each other, albeit as mirror

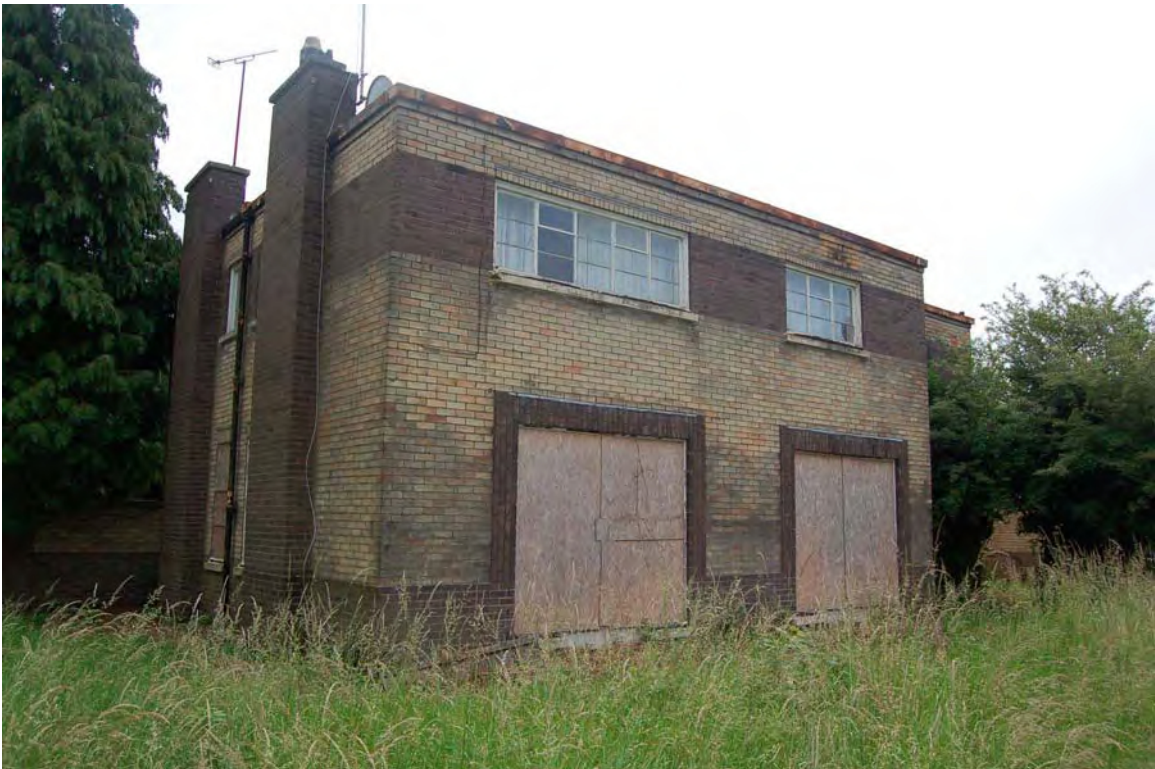
Plate 155 Newick viewed to north-west, & garages

Externally, the elevations display the broad architectural themes common to all the staff houses, apart from the fronts (east elevations) that have external concrete stairs up to the first floor, suggesting each level was split into flats for shared staff accommodation, communal living/cooking rooms on the ground floor and bedroom on the first; perhaps accommodation for trainees? French windows lead out onto the back garden from both lounge and dining room (plate 156). Despite being apparent communal accommodation, each house has only one garage. Detailing around the base of the garages and adjoining walls and gate posts is in brown brick (plate 155).

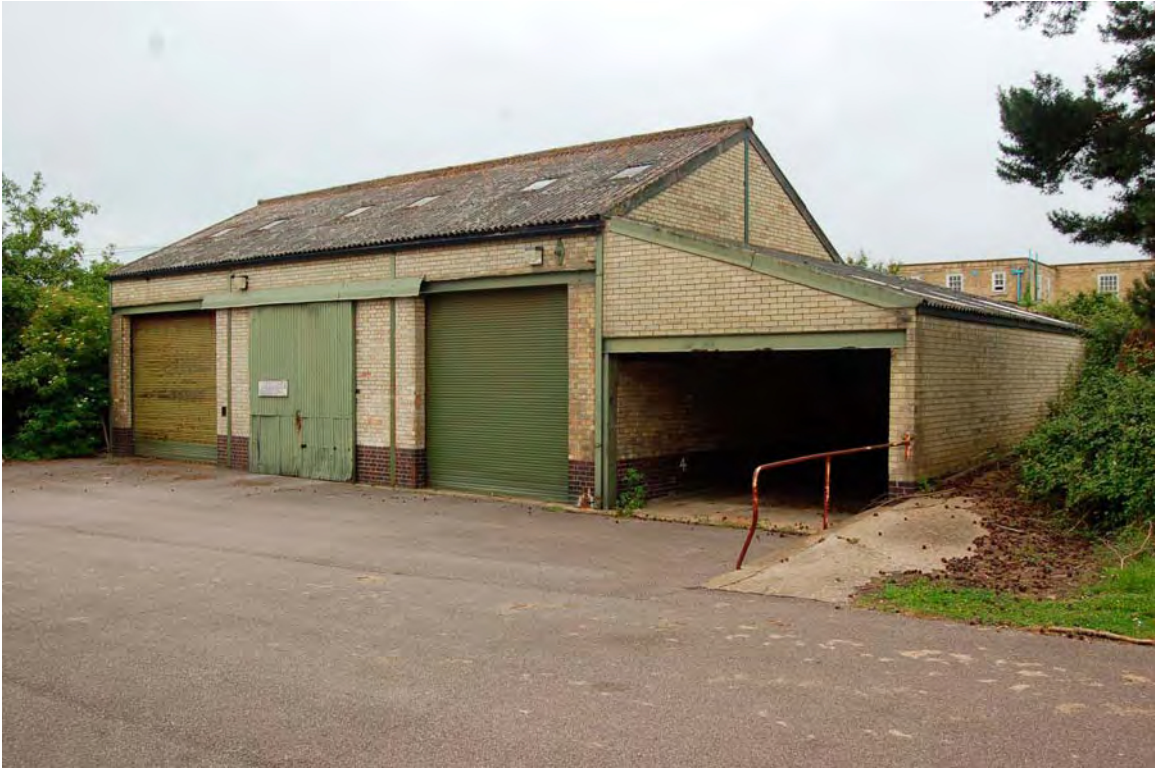
Plate 163 Porter's Garage viewed to south-east

The porter's garage stands to the west of the boiler house and is a three-bay brick building with an open lean-to to the north (plate 163). Decoration is limited to the brown banding at the base of the walls. The largest (central) vehicle bay has sliding doors and those on the side have roller shutters. There was no internal access. The roof is pitched and clad in corrugated asbestos cement panels.

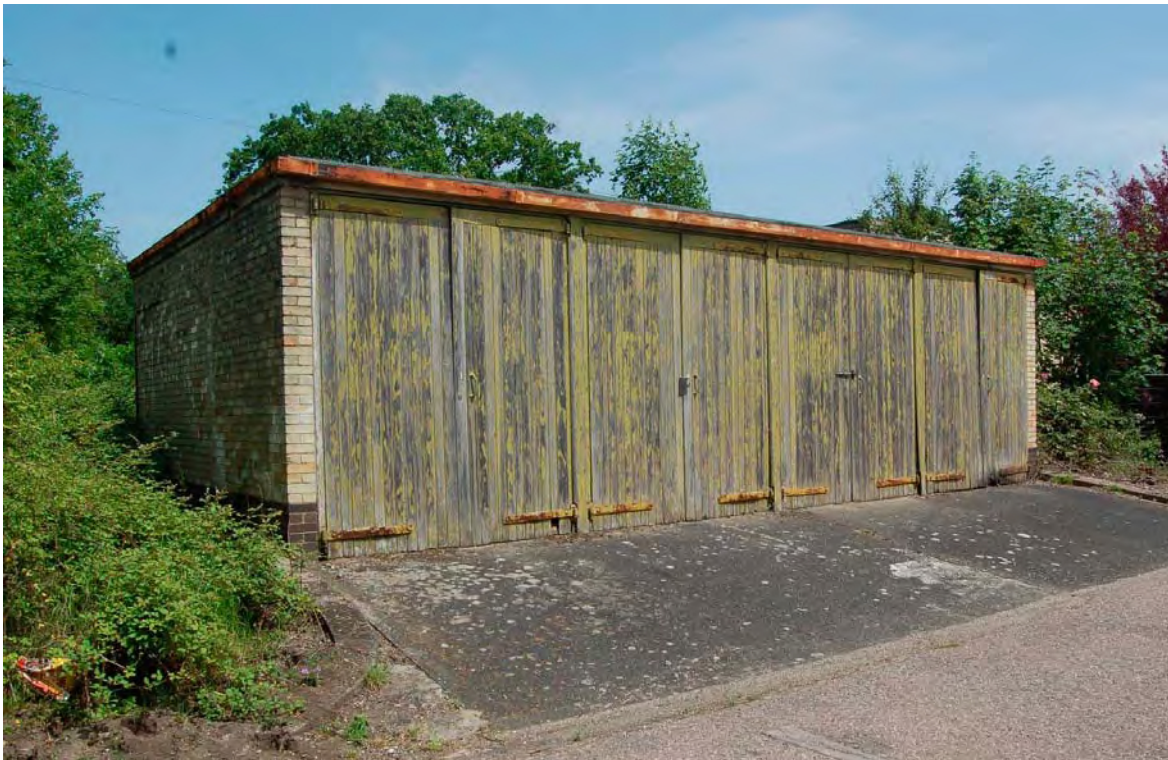
Plate 164 Garage 33 viewed to north-east

Garage 33 stands immediately east of the mortuary and to the rear of the main hospital complex. It is a brick building with a flat roof and wooden garage doors indicating four vehicle bays (plate 164). Decoration is limited to the brown banding at the base of the walls. On the east side is the only original fire point to remain (plate 165). The garage was probably for the groundsman's use, probably containing mowers, ?electric vehicles , etc. Internal access was not available but plans are available in the archive. [

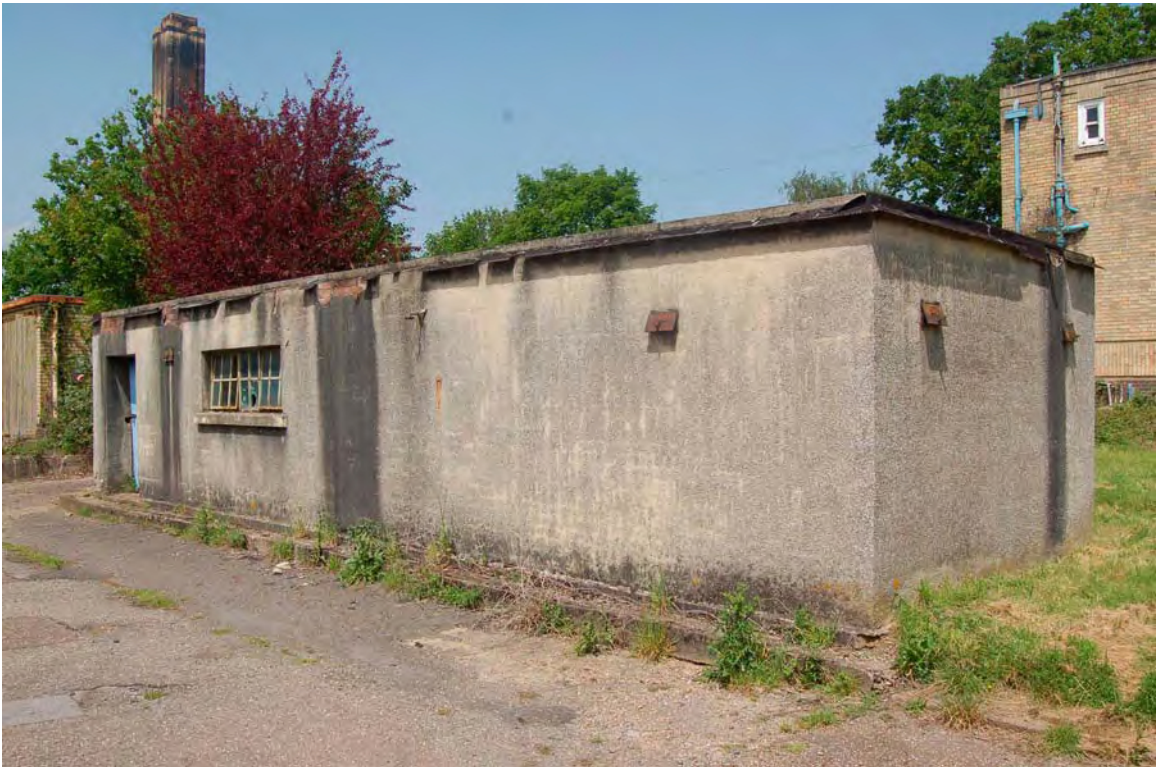
Plate 166 Air-raid shelter

Plans describe this building as the air raid shelter, but this was impossible to confirm in the survey as access was not achieved. It is located just east of garage 33 and latterly it has been used as a store. It has rendered brick walls and flat roof. The south elevation features the entrance and a set of metal windows (plate 166). Small metal vents are located around

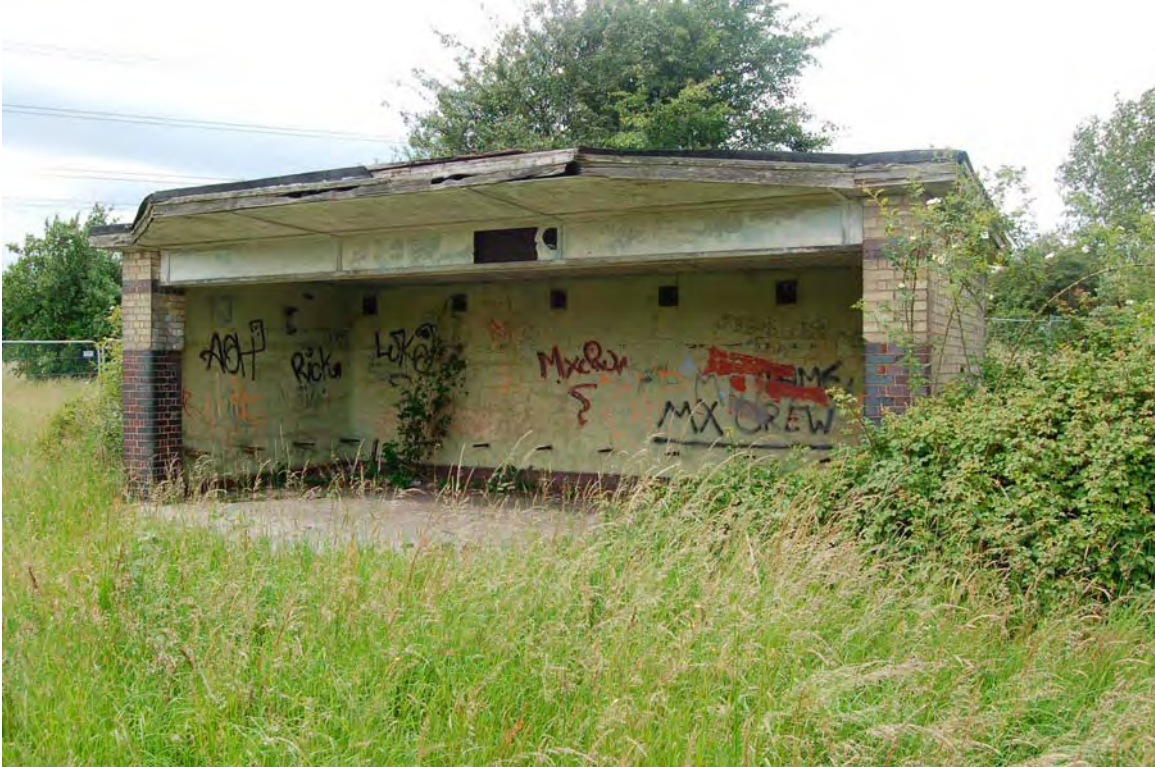
Plate 167 Sun house

A brick-built sun house survives on the south side of the Margaret and Nightingale ward block, facing the south-east (fig. 1). The shelter is open-fronted with a projecting flat roof over a small terrace (plate 167). Bullnose brown brick jambs are either side of the opening and further brick banding runs from the base of the wooden lintel. Inside the walls are plastered and finish at the base with a short brown brick damp course. Cantilevered iron brackets are fitted to the inner walls to carry wooden seating, now removed (plate 167).

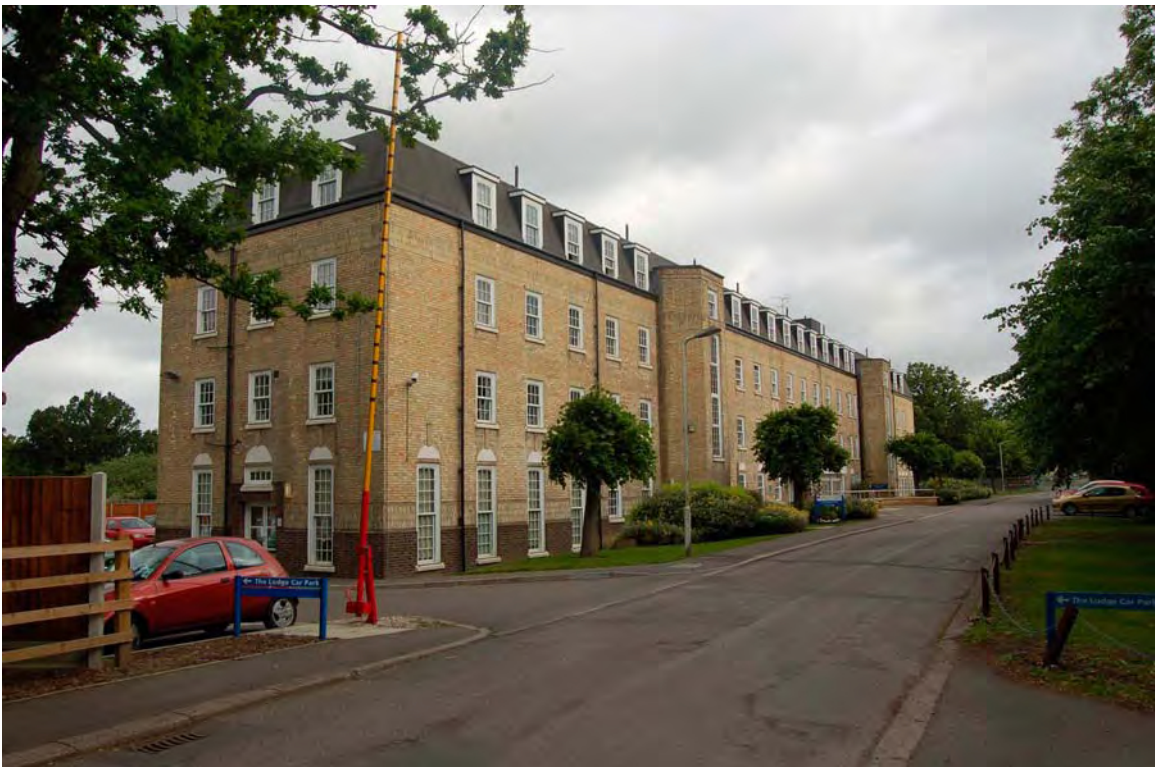
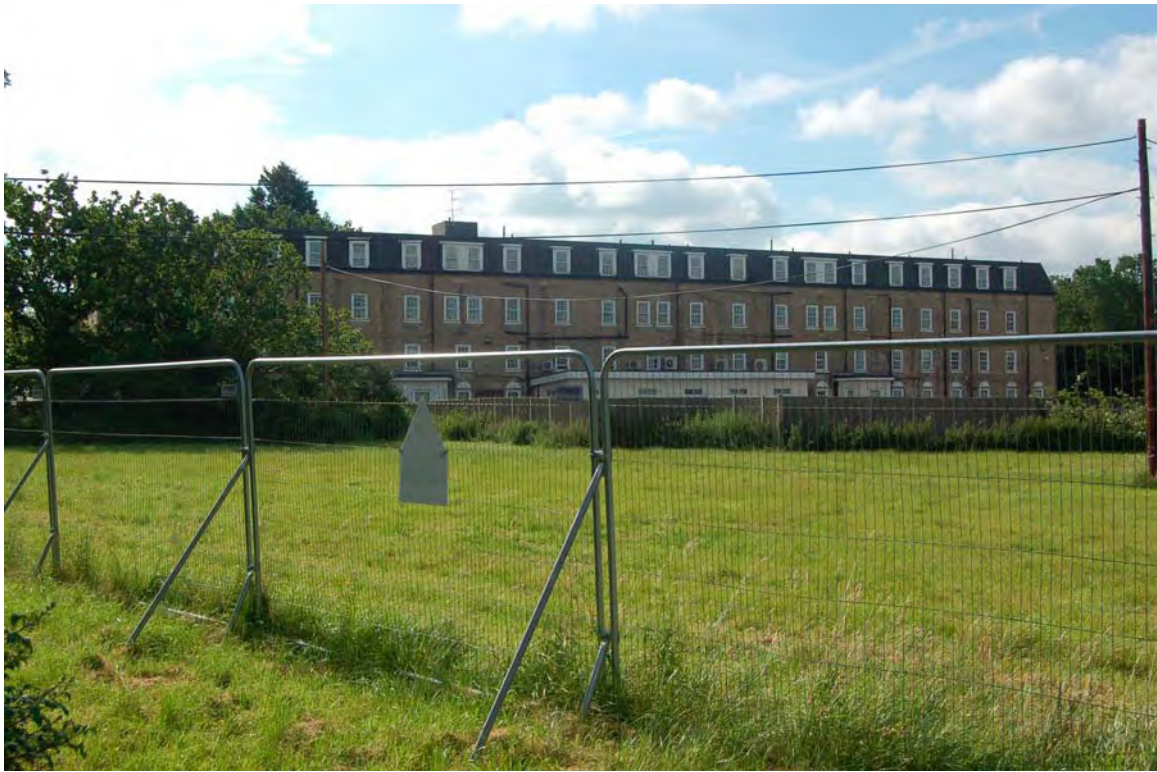
The former nurses home is the only hospital building still in use, now as the headquarters of the South Essex Partnership University NHS Foundation Trust (SEPT), and is outside the development area. Externally, at least, this substantial building retains its distinctive historic form with its four floors, Dutch roof and east-facing stair towers (plates 168 and 169). It also features many of the common architectural themes evident on the other historic hospital buildings. Being the only actively maintained building of the complex, it is in good external condition, though is likely to have been extensively altered inside.

Plate 168 Nurse's home viewed to north

Plate 169 Nurse's home viewed to south-east

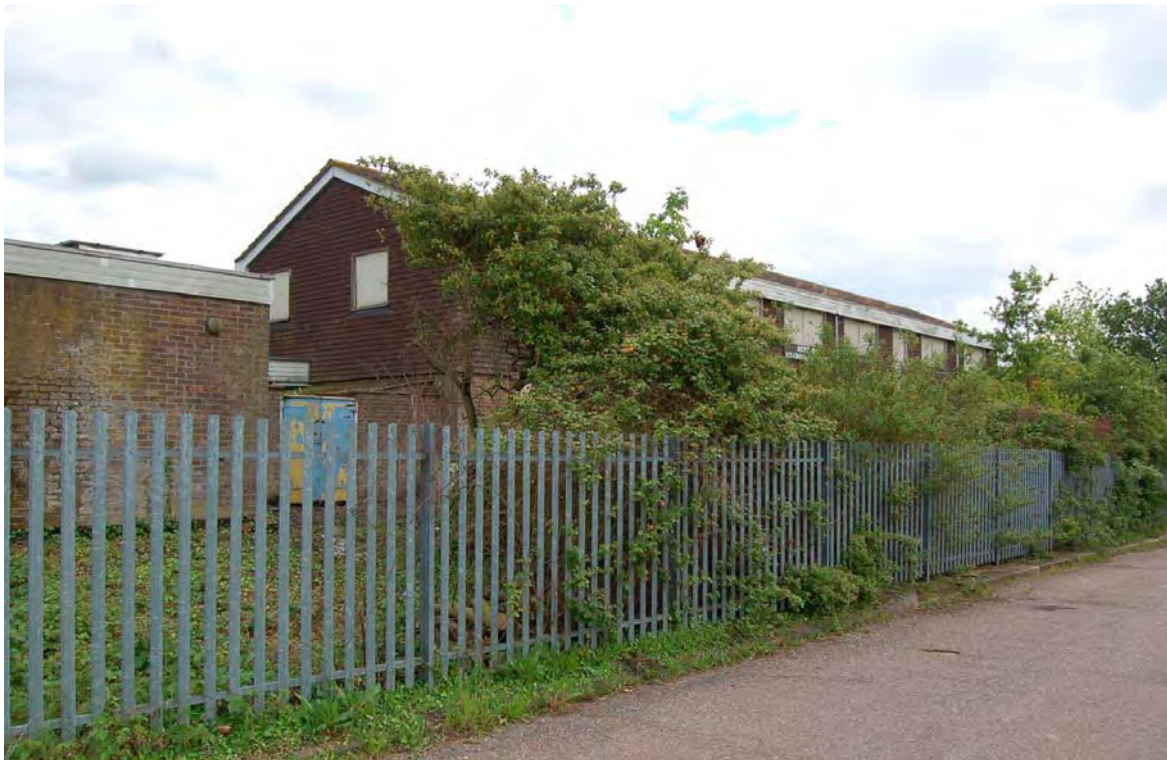
Plate 170 Modern Occupational Therapy/Neuropathology unit viewed to south

The **Neuropathology/Occupational Therapy building** is brick-built with a vaguely T-shaped layout and dates to the 1960s. It is located to the northwest of the Admissions Unit. The western range is two storeys high, the top part of which is tile-hung (plate 170), with a pitched tile roof. At the back (east) is a long flat-roofed range (plate 171). In the overall layout of the hospital complex, it is the counterpoint of the former Ashingdon ward - another modern insertion that has since been demolished.

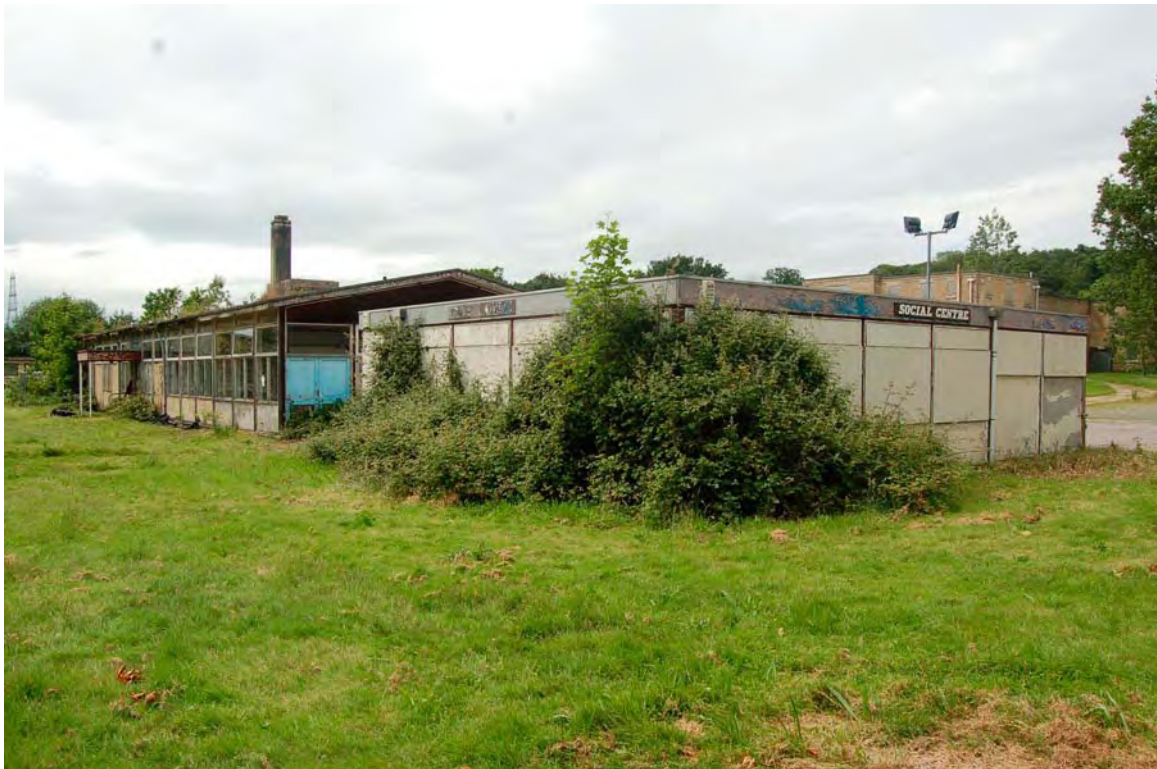
Plate 172 Canteen & Social Centre viewed to north-west

The patient **social centre & canteen** are prefabricated flat-roofed buildings located north of Harman. They were built in the 1960s are now suffering from neglect (plate 172).

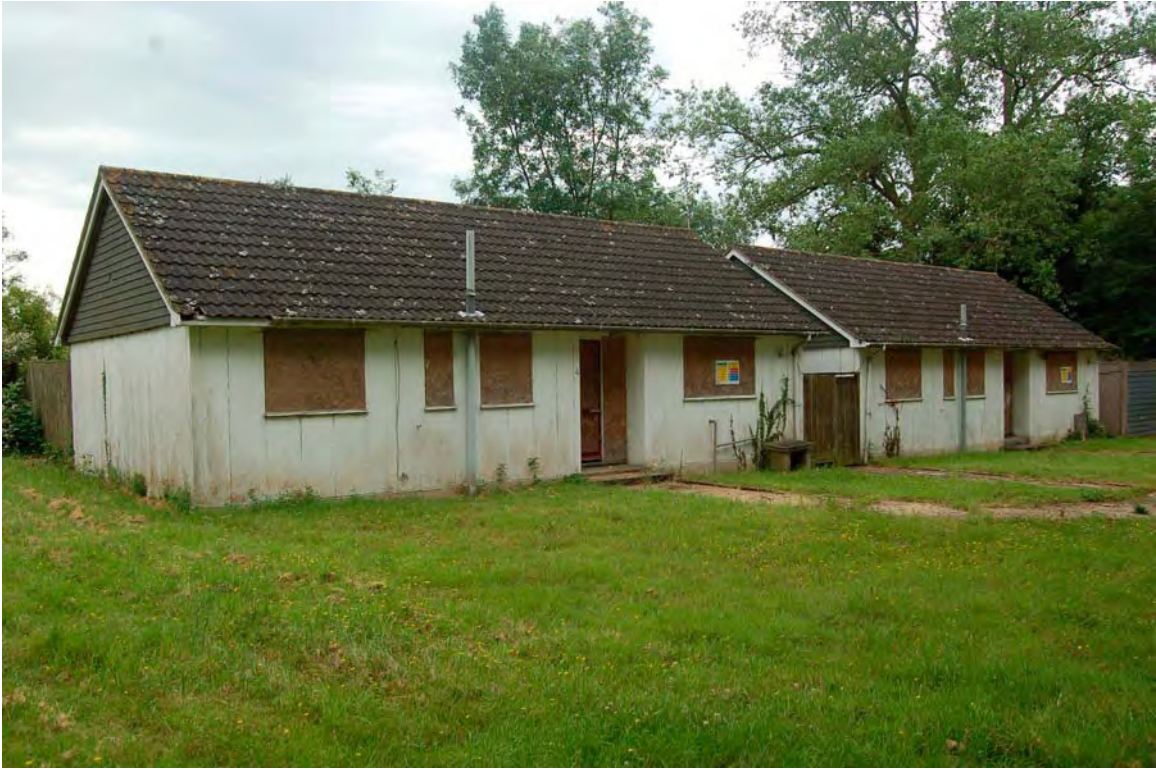
Plate 173 Bungalows 3 & 4 viewed to south-east

Additional staff accommodation in the form of **bungalows** were built in the 1960s. There are four in all, located either side of the approach road just north of Newick and Charters. They have rendered walls, tile-hung gables and pitched tile roofs (plate 173).
