THE OLD FORGE, BACK LANE

PLESHEY

**HISTORIC BUILDING RECORDING AND ARCHAEOLOGICAL
MONITORING**

November 2012

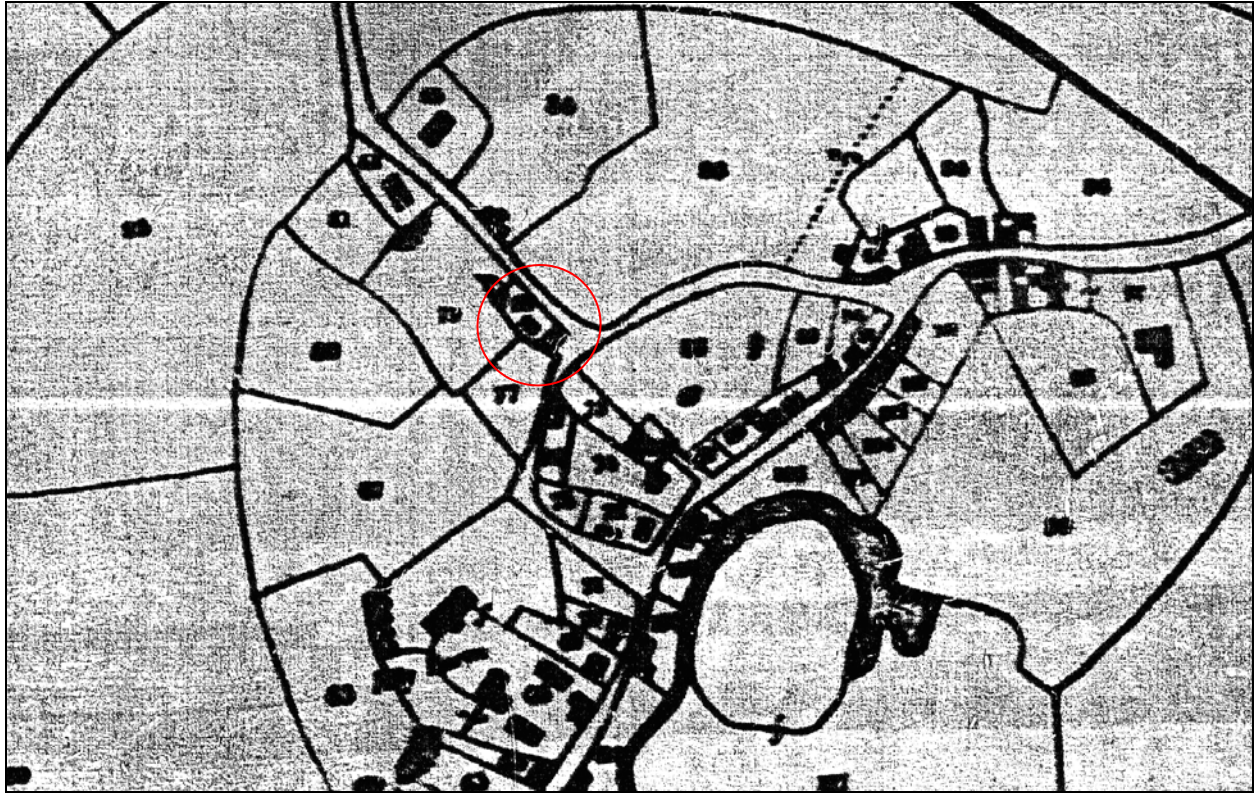
Fig.1. Location, block plan and area of archaeological monitoring

The structure was recorded using drawings (floor plans, sections and elevations) supplied by the architect, Paul Sutton. A block plan was produced to show the location of the forge within the historic townscape, the proposed extension and the area covered by the monitoring works (fig.1). A series of photographs (digital and 35mm black & white print) were taken to record the building externally and internally. Specific shots were taken of any areas of important architectural detail, fixtures or fittings. A representative selection of photographs is reproduced at the back of the report as plates 1-16. The remainder can be found in the archive.

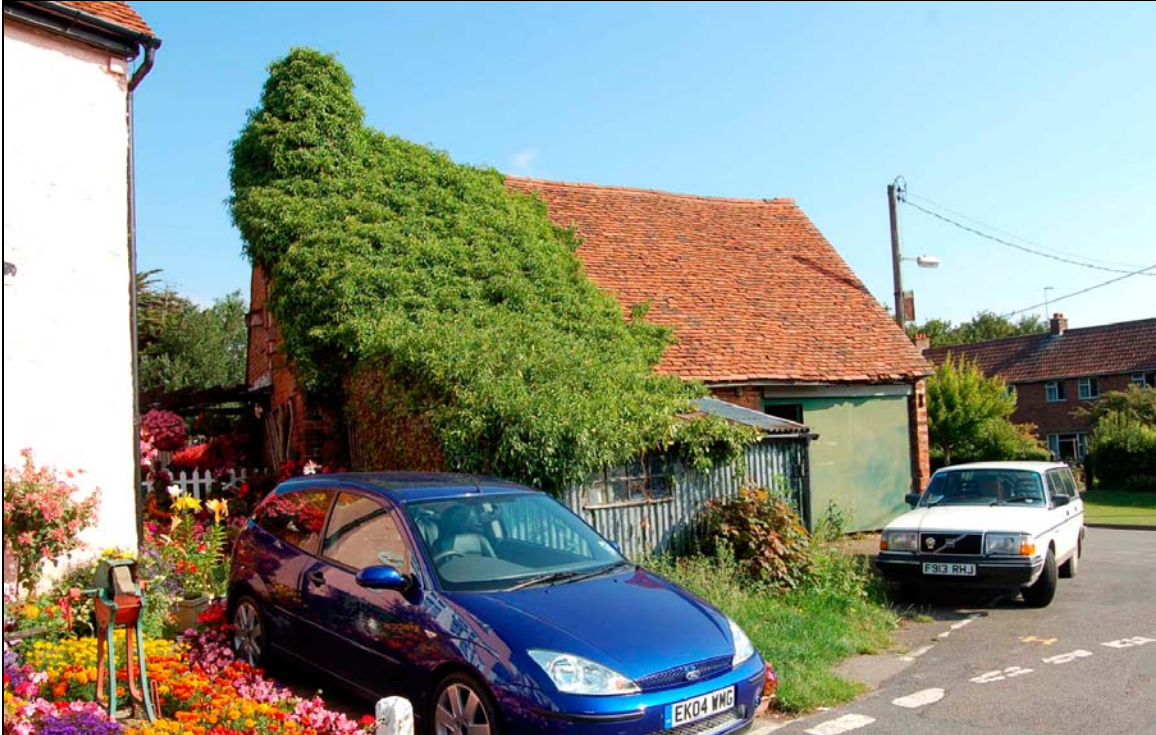
Plate 1 Forge viewed to north

The front elevation is dominated by two 20th century features- the corrugated steel office and heavy steel doors (plates 1 and 2). In the centre of the two features is a well-preserved section of original walling, containing an early wooden hatch. Original bricks are laid in Flemish bond in a lime mortar and are characteristically soft reds with frequent flint inclusions and dimensions of c.220 x 105 x 70mm. The dimensions are unusual, being quite deep and not very wide, but the high level of inclusions suggests an 18th or early 19th century brick (Ryan 1996).

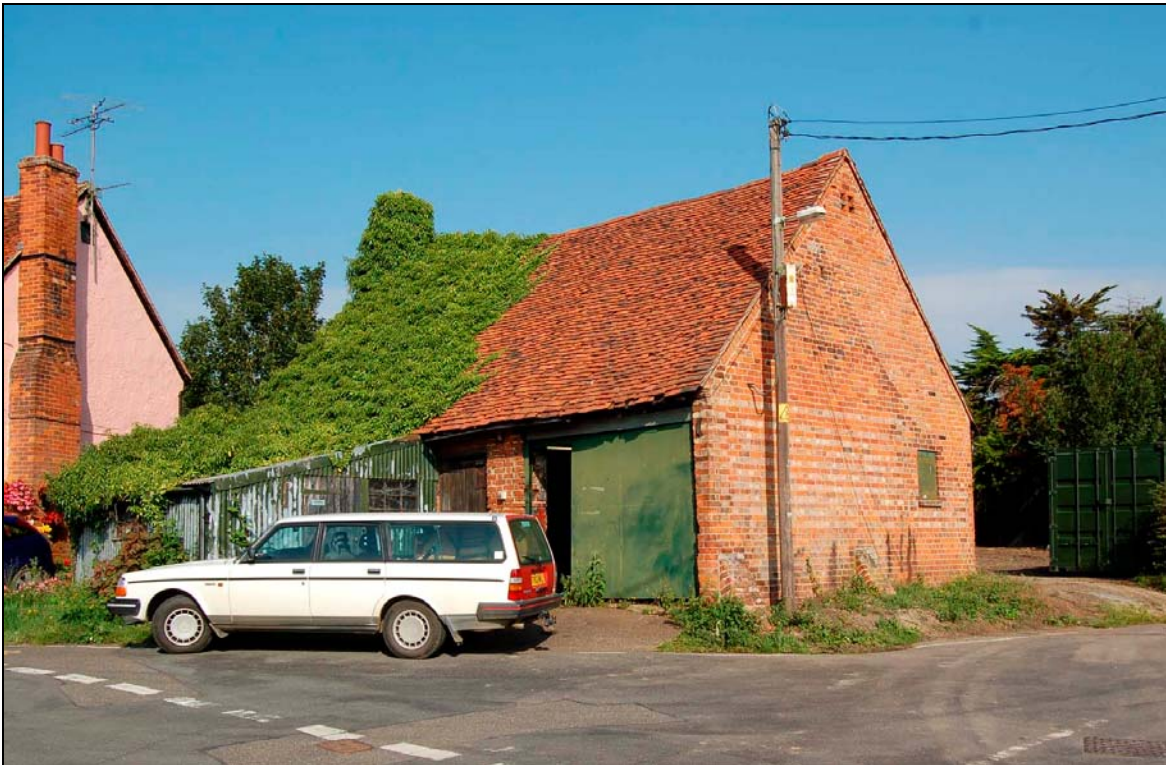
Plate 2 Forge viewed to north-west

The office/storeroom extension at the front of the forge was built in the early 20th century, pre-dating the 1928 re-build of the forge (fig. 4). Whether the current building and that shown on the historic map are the same is unclear, but the dimensions would argue that it is, though its existing corrugated steel walls and roof are probably a modern replacement for more traditional weatherboarding. The office has its own door (ledged braced and battened with

modern T-hinges and a letterbox) on the north-east elevation along with a wooden multi-paned window and a similar, second window on the south-east elevation, again slightly obscured by ivy (plate 2).

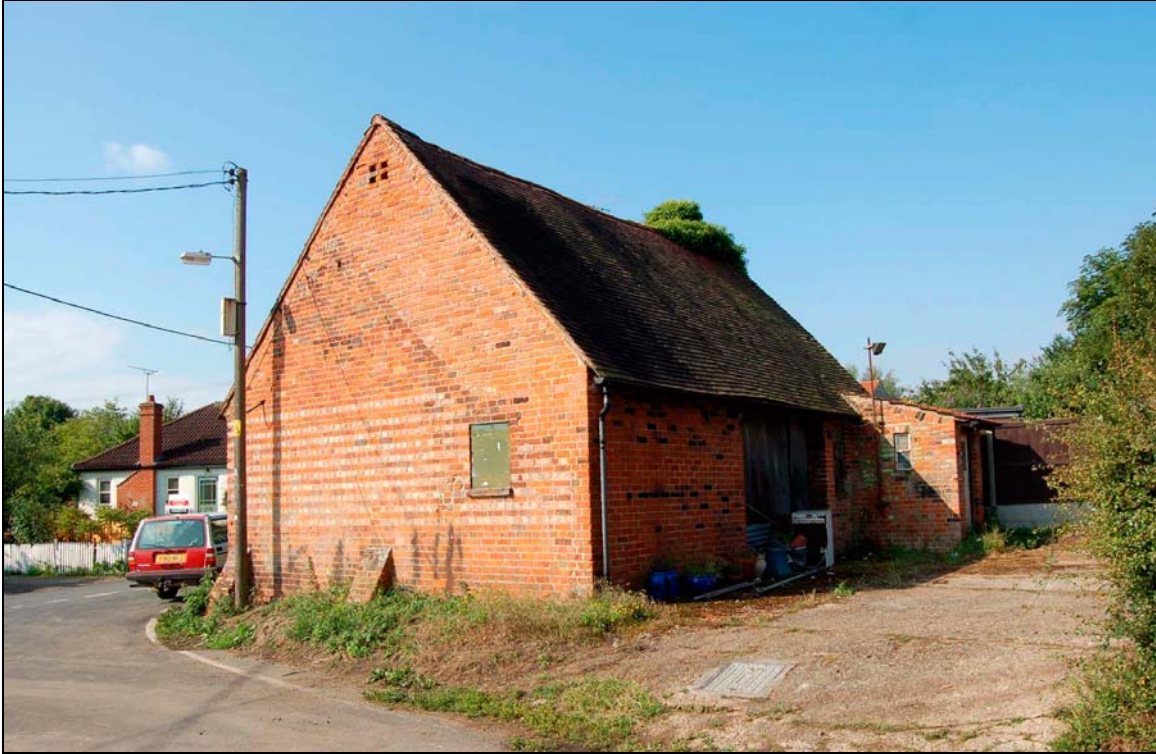
Plate 3 Forge viewed to south-west

The extent of the 1928 build is evident from the slightly darker-coloured brickwork that forms the catslide roof (plate 3). It also shows the raising of the rear wall from 1.5m to 2.4m during the 1960s phase. English-bonded brickwork forms the bulk of the construction on this side, laid in two distinct bands. The first comprises the original bottom thirteen courses in soft reds supported by low 'tumbling in' buttresses. A third buttress on the north corner was probably lost when the north-east wall was rebuilt. Above this band begins the 1928 build, where the header courses are substituted with Fletton bricks (plate 3), which were commonly used throughout much of the 20th century. From the eaves upwards the brick changes to stretcher bonded red bricks, only one brick deep. At the apex of the 1928 roof is a 'date plaque' made from hand-forged numbers (plate 4). The existing phase 4 roof is built over the 1920s roof, adding another 1m to the overall height of the building and elevating the height of the rear wall, perhaps to create a larger entrance at the back. It is characterised by stretcher-bonded red brickwork and at the top is a brick vent (plate 4).

The window close to the north corner is a 1920s feature that has been sealed-off by a steel sheet (plate 3).

The outside toilet (plate 3) is a modern structure at the back of the forge, probably post-dating the phase 4 construction phase since it is not tied-in to the main structure. The likelihood is that it was built when the blacksmith's cottage was demolished and its brickwork, a mixture of English and stretcher bond, and similar iron-framed window and c.1960s style utility door suggest it is broadly contemporary with the phase 4 modern refurbishment. It has

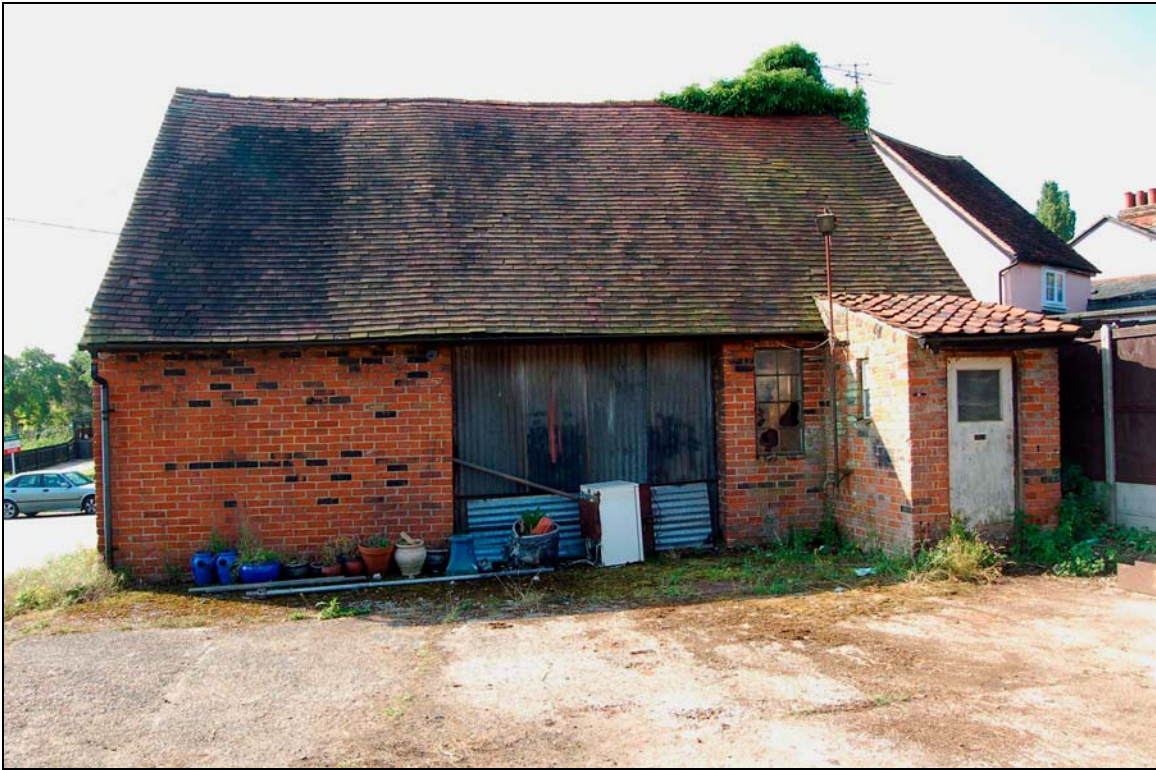
Plate 5 North-west elevation

The rear elevation (plate 5) is entirely of phase 4 construction and all the main features are modern, including the roof tiles. The central bay is occupied with three sheets of corrugated steel sheeting which signifies the doorway though there is no frame left or any other remains. To the right of this is a multi-pane metal-framed window situated beside the toilet extension.

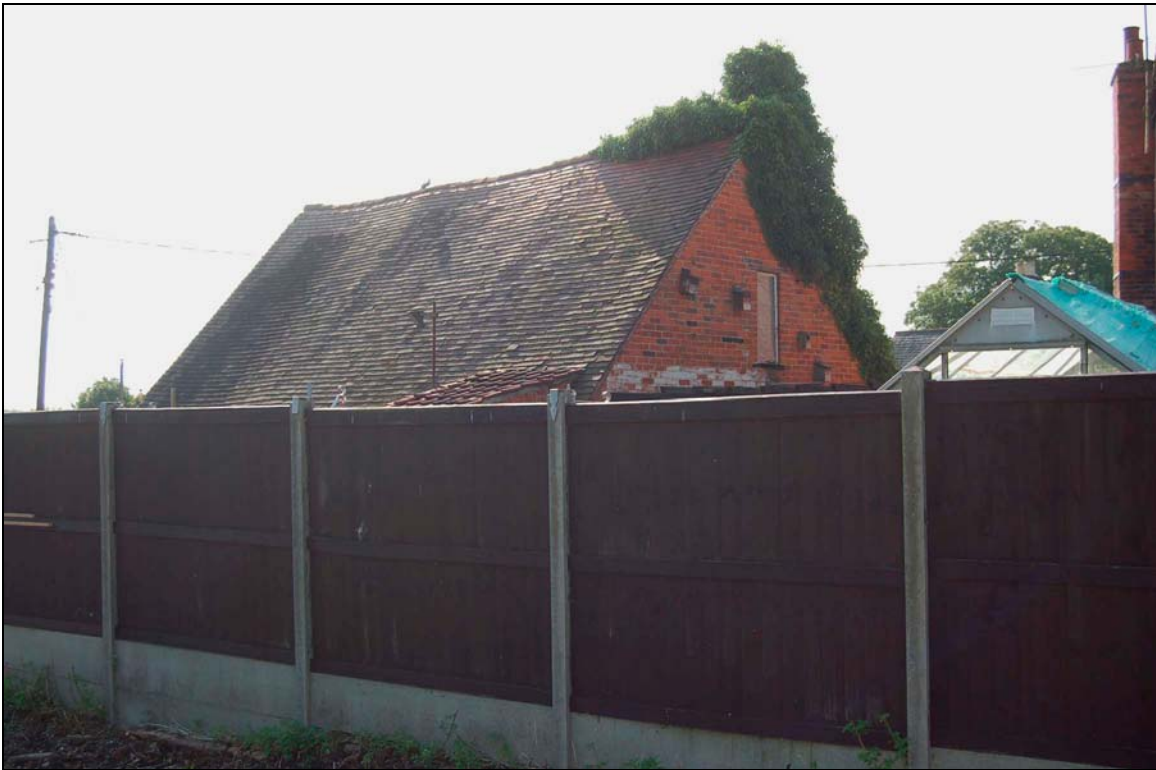
Plate 6 Forge viewed to east from behind neighbouring property

Only part of this elevation was observed since it is located in the neighbouring back garden. The gable is the same build as the opposing one, displaying the outline of a catslide roof, and there is a modern window close to the apex (plate 6).

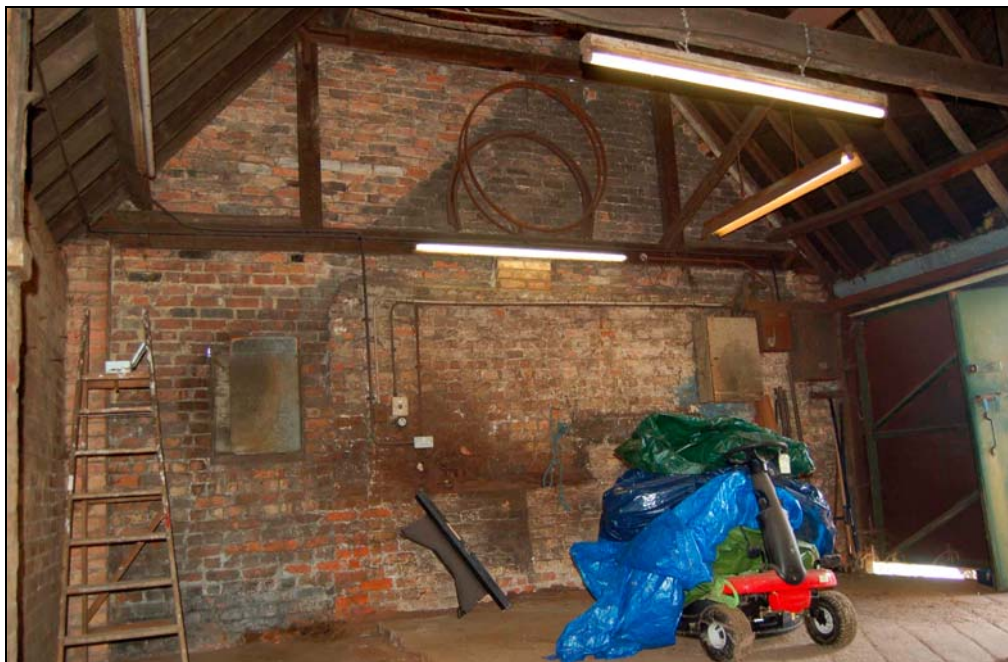
Plate 10 Outline of earlier forge on north-east wall

In the north-east bay is a raised concrete ramp leading from the steel doors. The soot-covered end wall clearly shows the outline of the 1928 forge and four old iron cart tyres have been left up in the gable, below the brick vent (plate 10).

The roof frame dates entirely to the 1960s, with purlins trenched into square queen post trusses connected by iron L-shaped brackets (plate 10). It is built from machine-sawn timbers and has been maintained and felted.

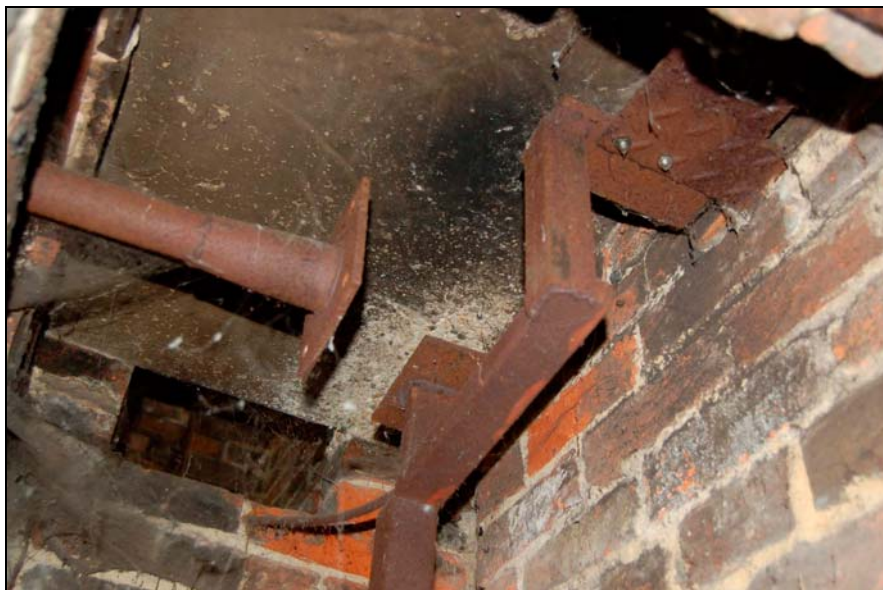
Plate 12 Cast iron tuyere and mountings

At the front, the forge has low dwarf walls to either side, and a small recess into the square brick chamber, presumably for better access around the hearth. The hearth is raised and surrounded by a thin cement bed with an iron back-plate and steel smoke visor over the top, which also encouraged up-draught. Either side are apertures in the brick work, the largest of which, on the north face, is likely to have carried the bellows or, latterly, the blower pipe from the electric motor installed in 1949 (see section 2.3). The other aperture may have held a damper to regulate airflow. Underneath the hearth are modern cast iron mountings and an iron tuyere that connected to the blower pipe and (plate 12). A square plate above the aperture has been removed.

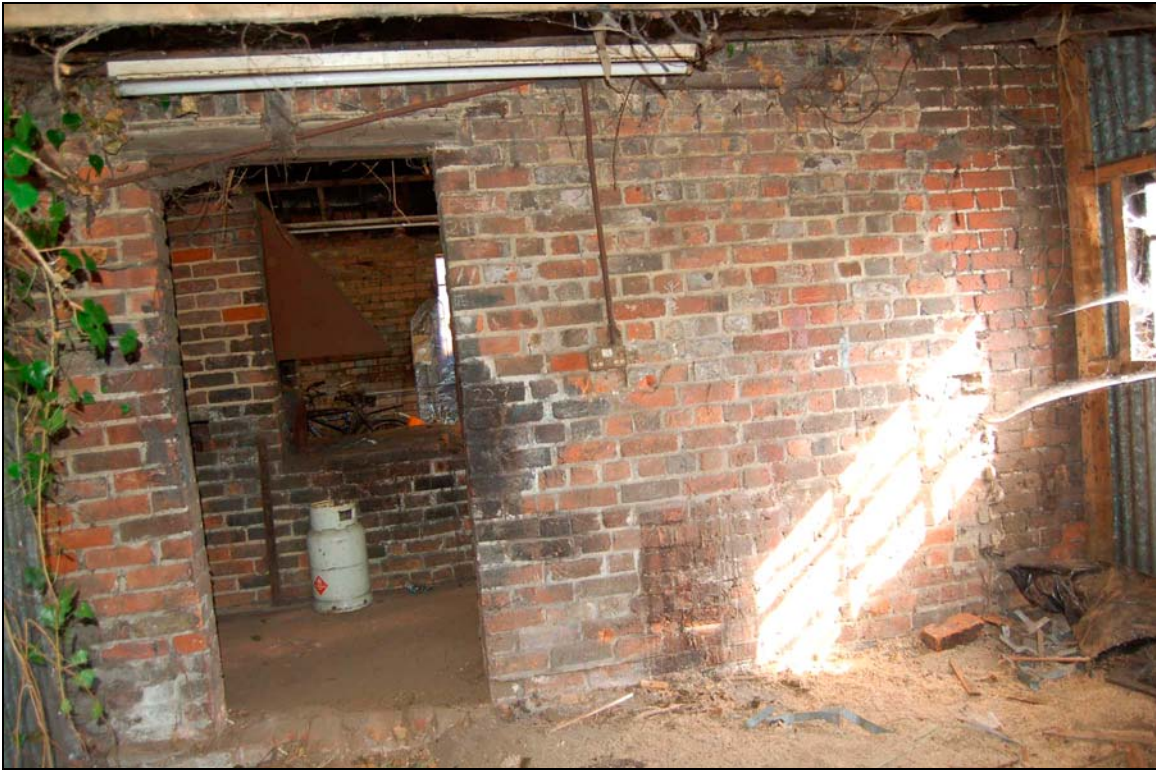
Plate 13 Blocked walling around doorway from office into forge

Situated inside the office is a rebuilt section of wall containing a doorway between the office and forge (fig. 6)? The join between this and the early wall is clearly seen, since the brickwork around the doorway is in English rather than Flemish bond (plate 13), more typical of the 1928 build. Whether or not there was a doorway here originally is not known, but it is interesting to see the inscribed bricks mentioned in section 2.3 above the rebuilt brick lintel (plate 14). Perhaps the bricks were re-sited here during the rebuild. Inside is a partitioned office, washing area and storage space (plate 15).

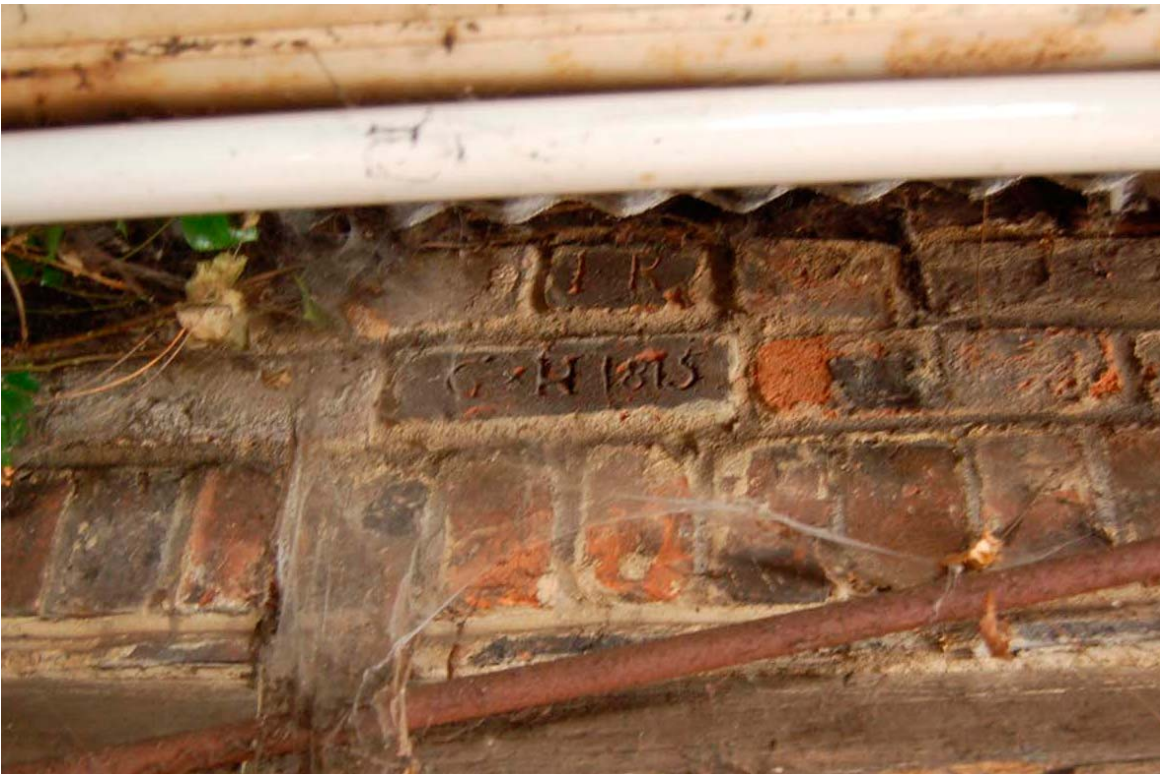
Plate 14 'I P' and G H (George Hasler) initials over the doorway, dated 1815

The forge is believed to have been constructed in 1815, since this date is inscribed on the brickwork above the former front doorway, along with the initials 'I R' and 'G x H', the latter being George Hasler, who founded the forge (Arthur Warren pers. comm.). A building close-by to the rear of the forge appears on the Pleshey tithe map of 1848 and was perhaps the blacksmith's cottage (fig. 2), which is no longer standing. The accompanying tithe award describes the plot as a tenement owned by James Dowsett and occupied simply by 'Hasler, widow'; probably the widow of George.

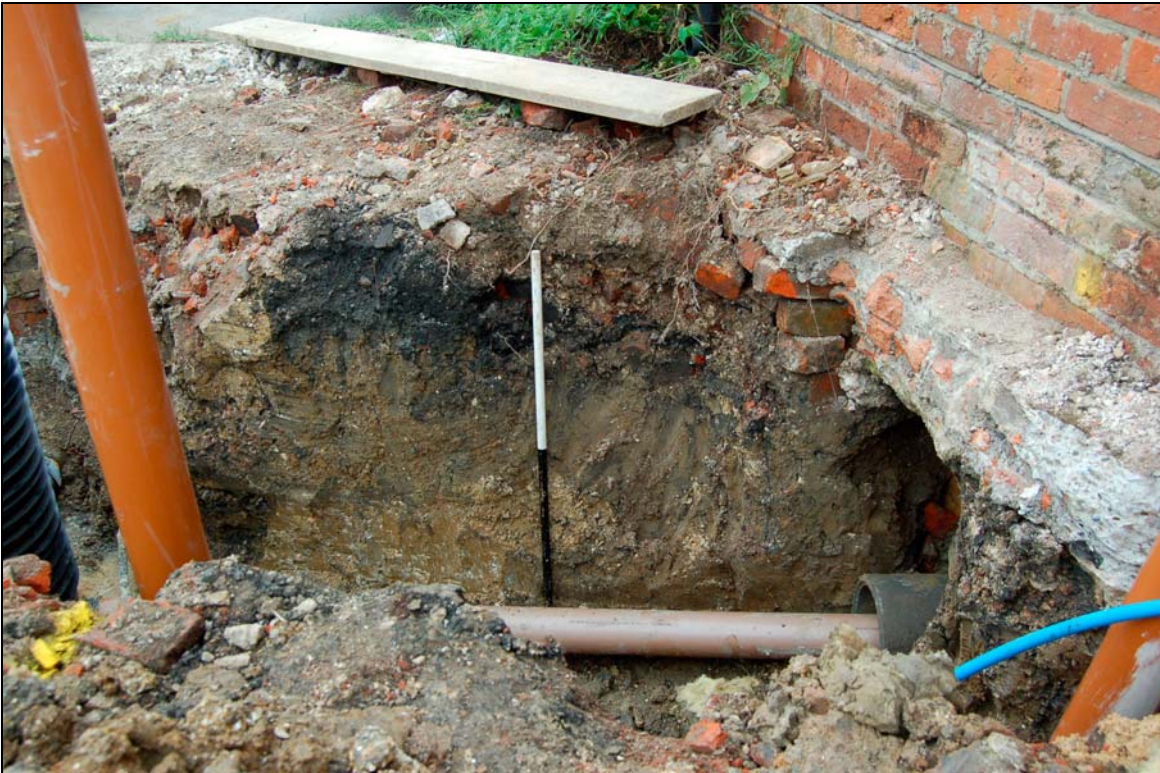
Plate 16 Typical section through pipe trench, viewed to east

A waste water pipe trench was cut from the north corner of the forge into the existing system that runs parallel to the back wall of the forge, within the area of the extension (fig. 6). The pipe trench was up to 1m wide and 1.2m deep, revealing a 0.3m depth of cindery topsoil overlying a 0.46m thick layer of undisturbed brown chalky clay subsoil and natural chalky boulder clay beginning 0.76m below ground level (plate 16). No archaeological deposits or features were observed and no finds were collected.
