**ARCHAEOLOGICAL MONITORING OF A
NEW SEPTIC TANK OUTFLOW PIPE TRENCH
AT TILBURY FORT
ESSEX**

**Essex County Council
Field Archaeology Unit**

December 2012

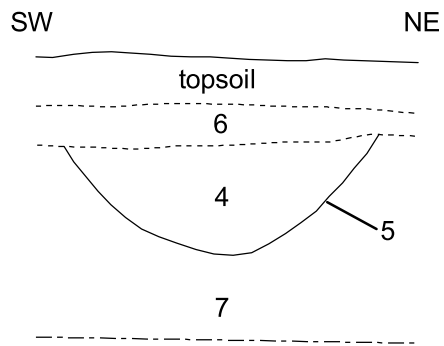
Fig.3. Section 1

The shallow topsoil continued behind the Artillery Store, where it was laid over ashy layer 6 and context 9, which may be earlier, redeposited topsoil. Underneath the ashy layer was pit 5, a small rubbish pit, 0.8m wide and 0.3m deep that contained several whole bottles of late 19th century date, contemporary with the building (fig. 3 section 1 & plate 3). Most of the unstratified finds collected during the monitoring works were collected from the area of pit 5 and some probably originated from it. The pit was cut into context 7, a dumped layer of clay mottled with grey soil from tree roots, containing moderate quantities of brick rubble and mortar fragments, which continued beyond the base of the trench.

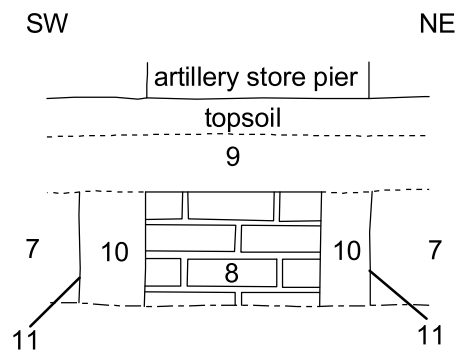
Fig.4. Section 2

Further to the east, a central foundation pier for the Artillery Store was exposed on the north face of the pipe trench. The pier (context 8) comprised four courses of yellow stock bricks identical to those used in the Artillery Store that extended beyond the base of the trench and was overlain by context 9 (fig. 4 section 2 & plate 4). The pier stood within a straight-sided 0.8m-wide construction cut (context 11), which was backfilled with similar material (10) to layer 9 above, both of which appear derived from the former topsoil. The construction cut was dug into context 7, the dumped clay layer, which is one several layers of made ground extending eastwards towards the tank. Such layers are represented in section 3 (fig. 5 & plate 5), comprising layers of redeposited subsoil (context 13) and redeposited chalky

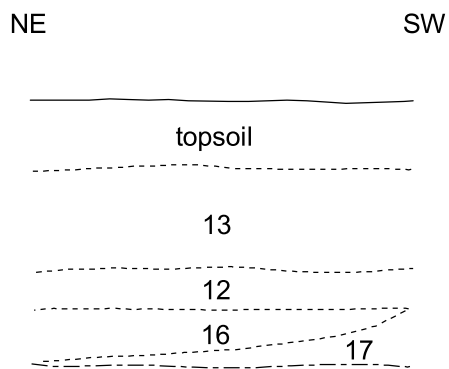
Fig.5. Section 3

boulder clays and rubble (contexts 12, 16 and 17) indicating 19th century made ground around the base of the Inner Bank.

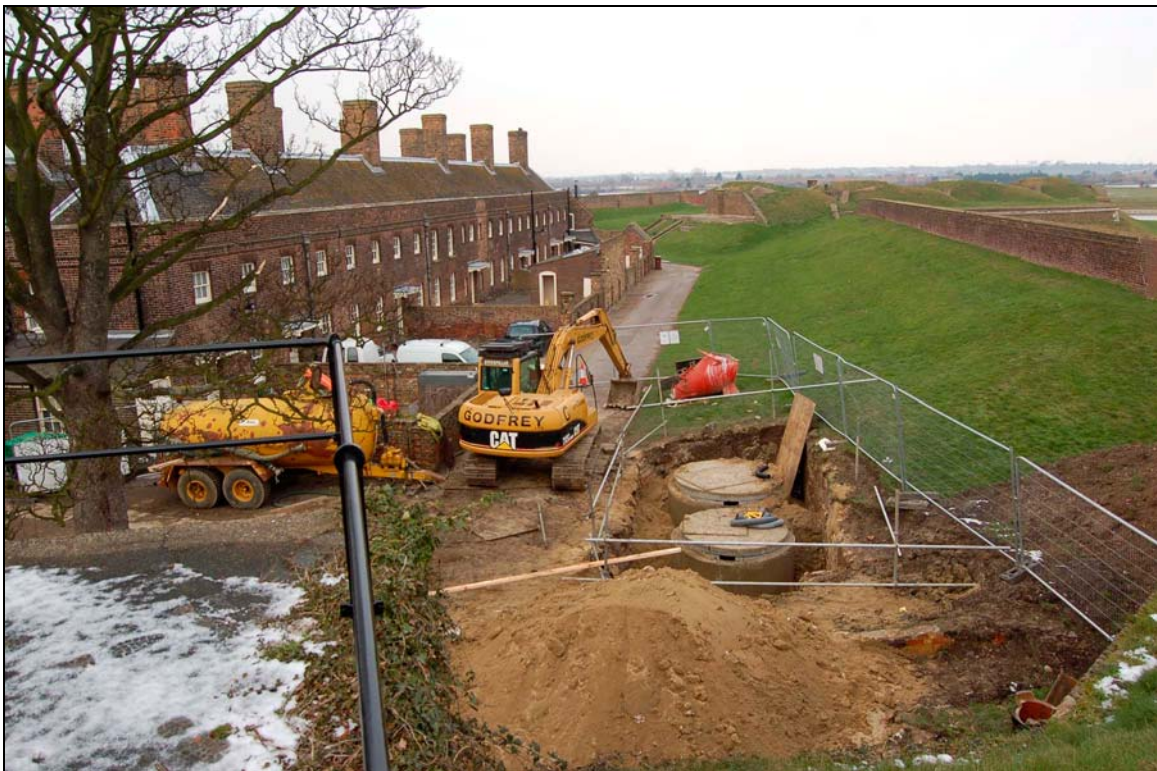
Plate 6 Excavated area for new tank viewed to north

The new tank (plate 6) was designed to fit into the cut for the old tank footprint, which was subject to previous archaeological work, and was therefore not included in the monitoring requirements.
