**FARM BUILDINGS AT STROOD HALL
TAKELEY ROAD
LITTLE CANFIELD
ESSEX**

HISTORIC BUILDING RECORD

April 2013

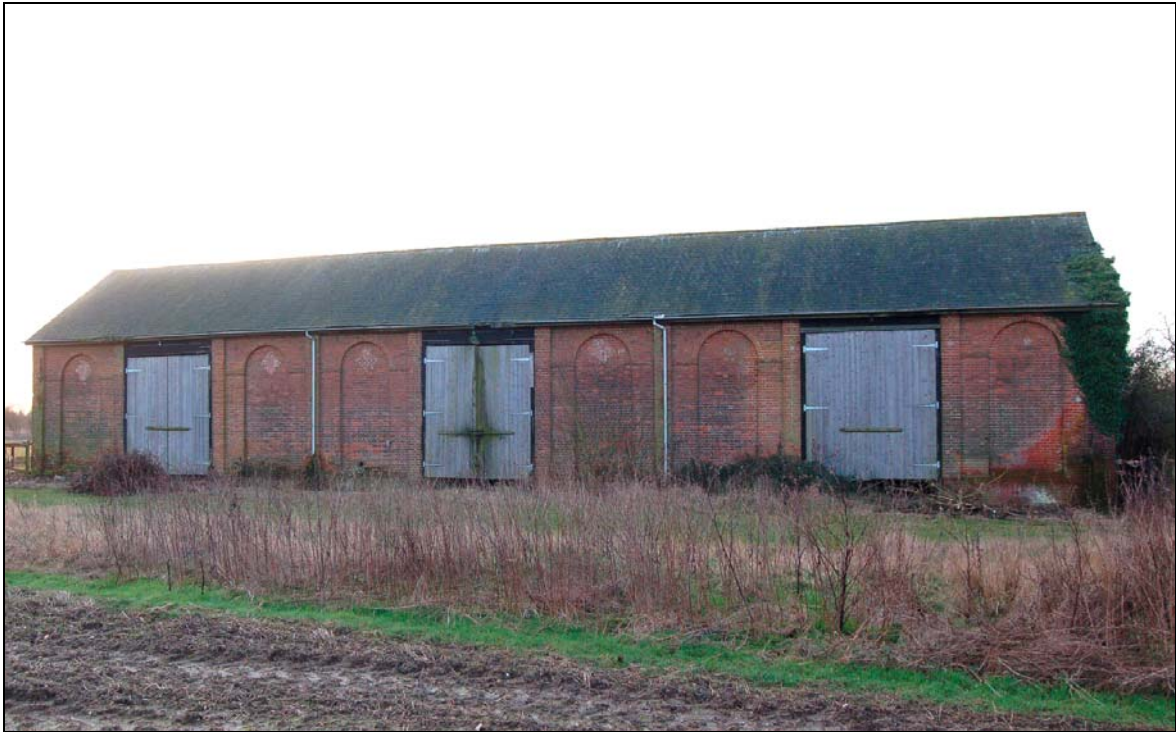
Plate 1 North elevation of barn

The north wall (plate 1) contains three evenly-spaced large cart doors set at regular intervals on the second, fifth and eighth bays. All the doors on this side are of modern ledged braced and boarded type (a traditional form) held on steel T-hinges. The brick panels between the piers contain tall recessed semi-circular arches picked out in brick headers. Original air vents

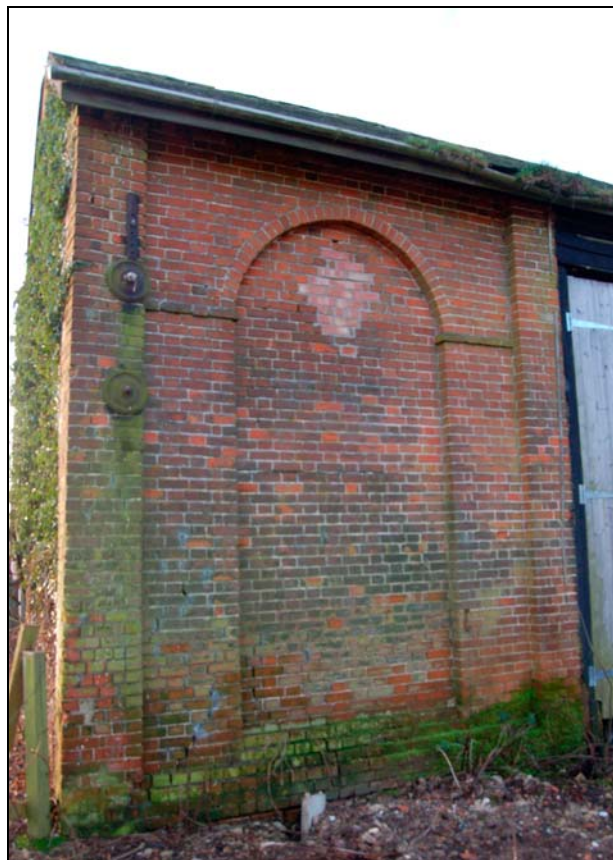
Plate 2 Pier and panel detail at east end of elevation

within the head of each have been blocked with brick, but their outlines suggest a diamond-shaped design (plate 2).

Tie rod plates are evident at the east end of the elevation in an attempt to control the twisting of the north-east corner (fig. 5, plate 2). Some iron door hooks survive to the former doors.

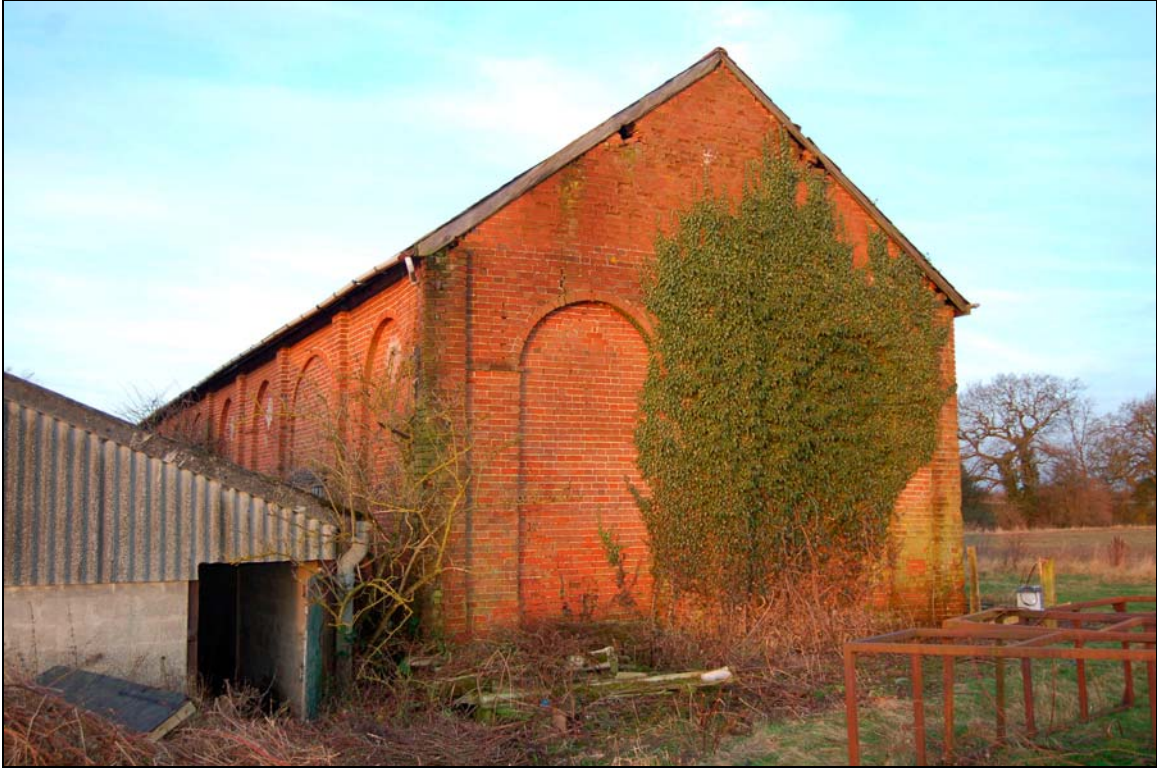
Plate 3 East elevation of barn (with modern cow shed)

The east and west gables continue the pier and panel pattern of the main elevation. In the east gable ivy covers the second of the two arches and the brickwork has suffered to the north-east corner and the gable itself (plate 3). Ivy obscures a good deal of the west elevation and the presence of small timber stables here also affected the view prior to their removal (plate 4).

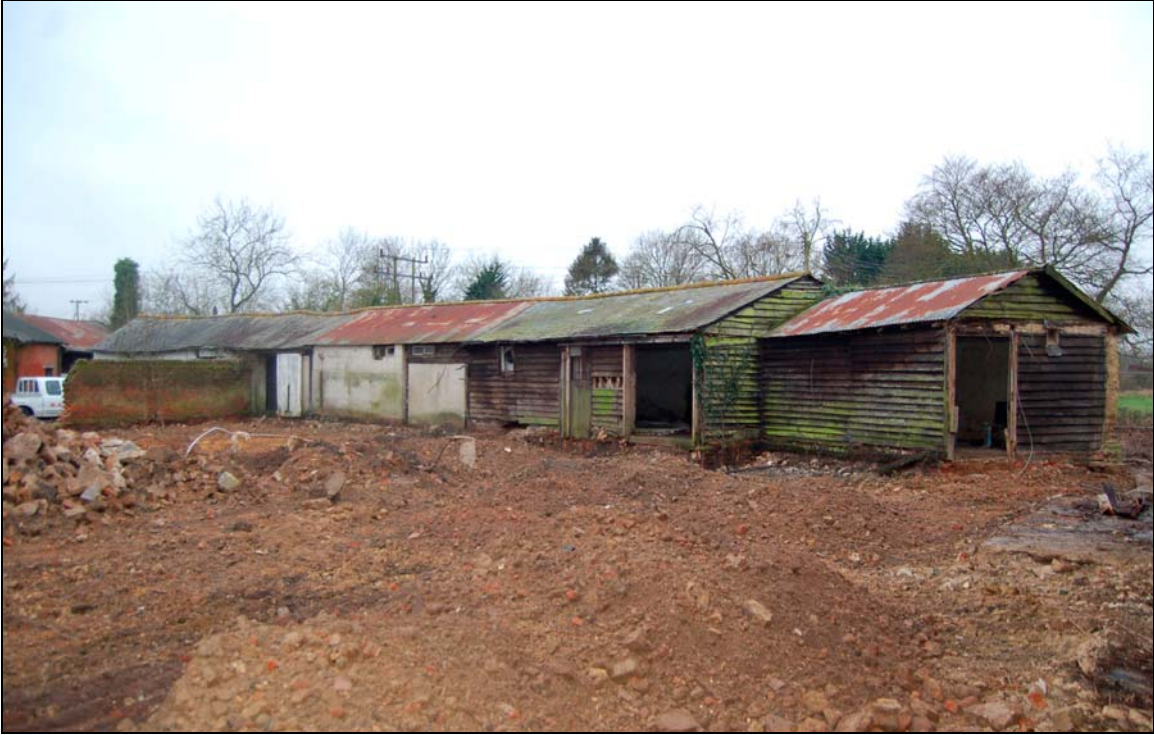
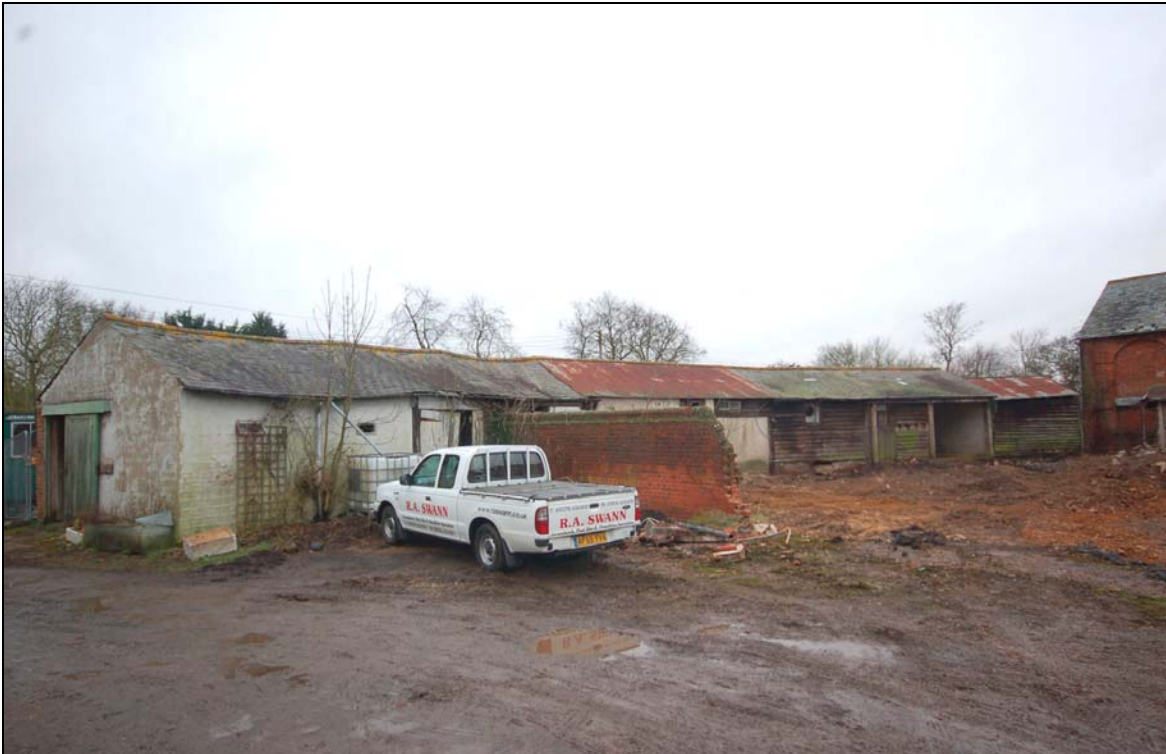
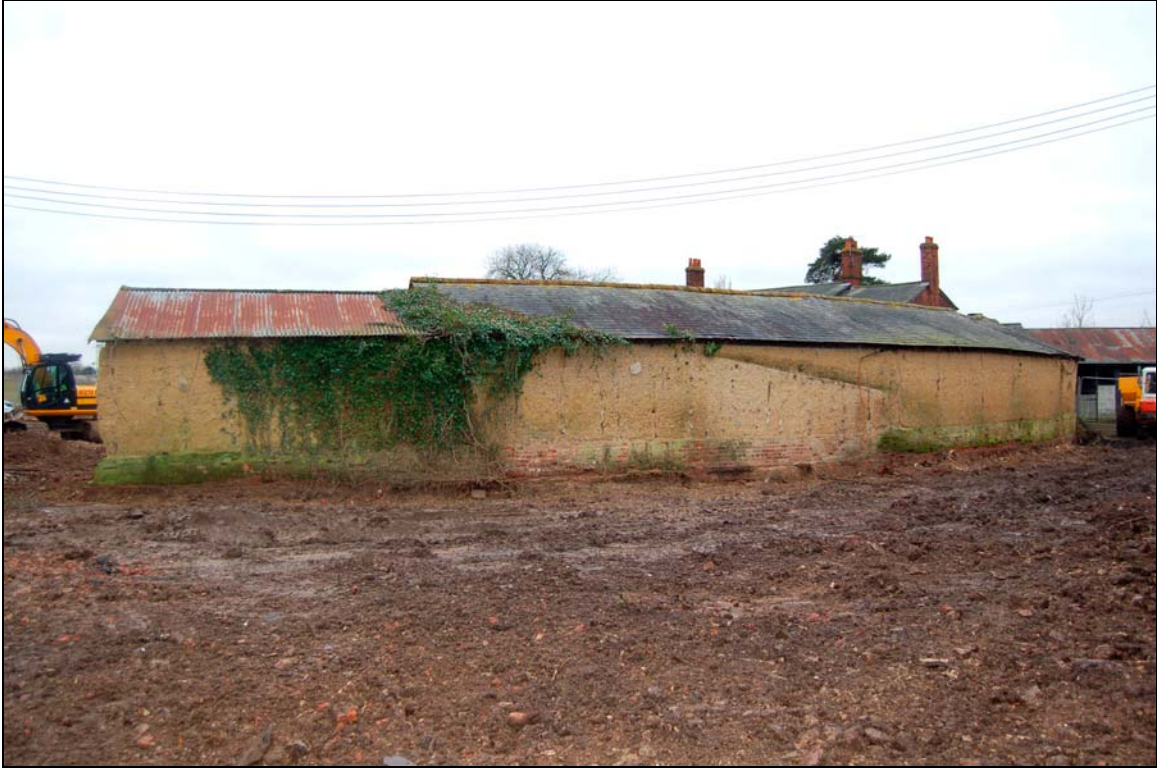
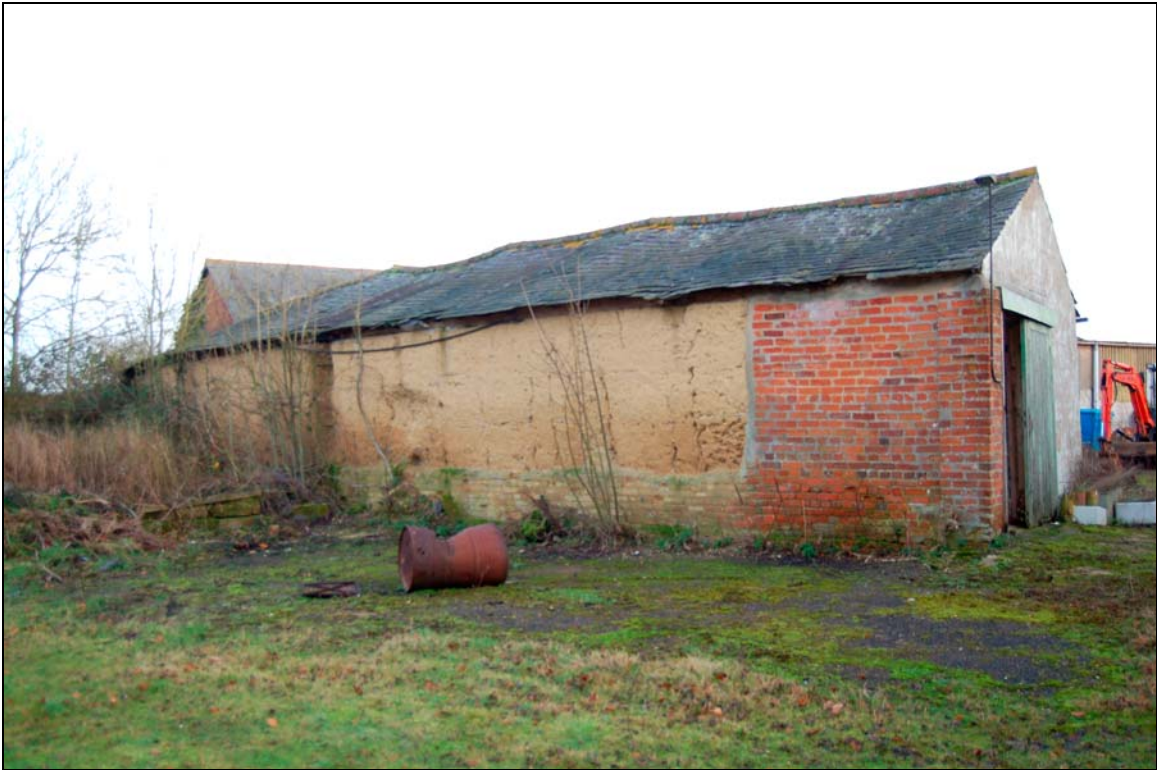
The timber outbuildings represent former loose boxes, feed stores, open-sided cow sheds, etc associated with the early 19th century farm that were viewed after the modern cowsheds and stables were removed (fig. 1). Almost the full length of the outbuilding range on the west side of the yard (plates 13-16) survives but only one part of the east side remains, the latter in a dilapidated state (plates 17 & 18). All buildings are timber-framed and weather-boarded on the yard-facing sides and cob-built on a brick plinth at the back. Roof trusses are in the same form as those in the barn and the majority of roofs are slated, but some parts have been replaced with modern corrugated iron sheeting.
