THE MARCONI SITE, NEW STREET

CHELMSFORD

LEVEL 3 HISTORIC BUILDING RECORD

Essex County Council
Field Archaeology Unit

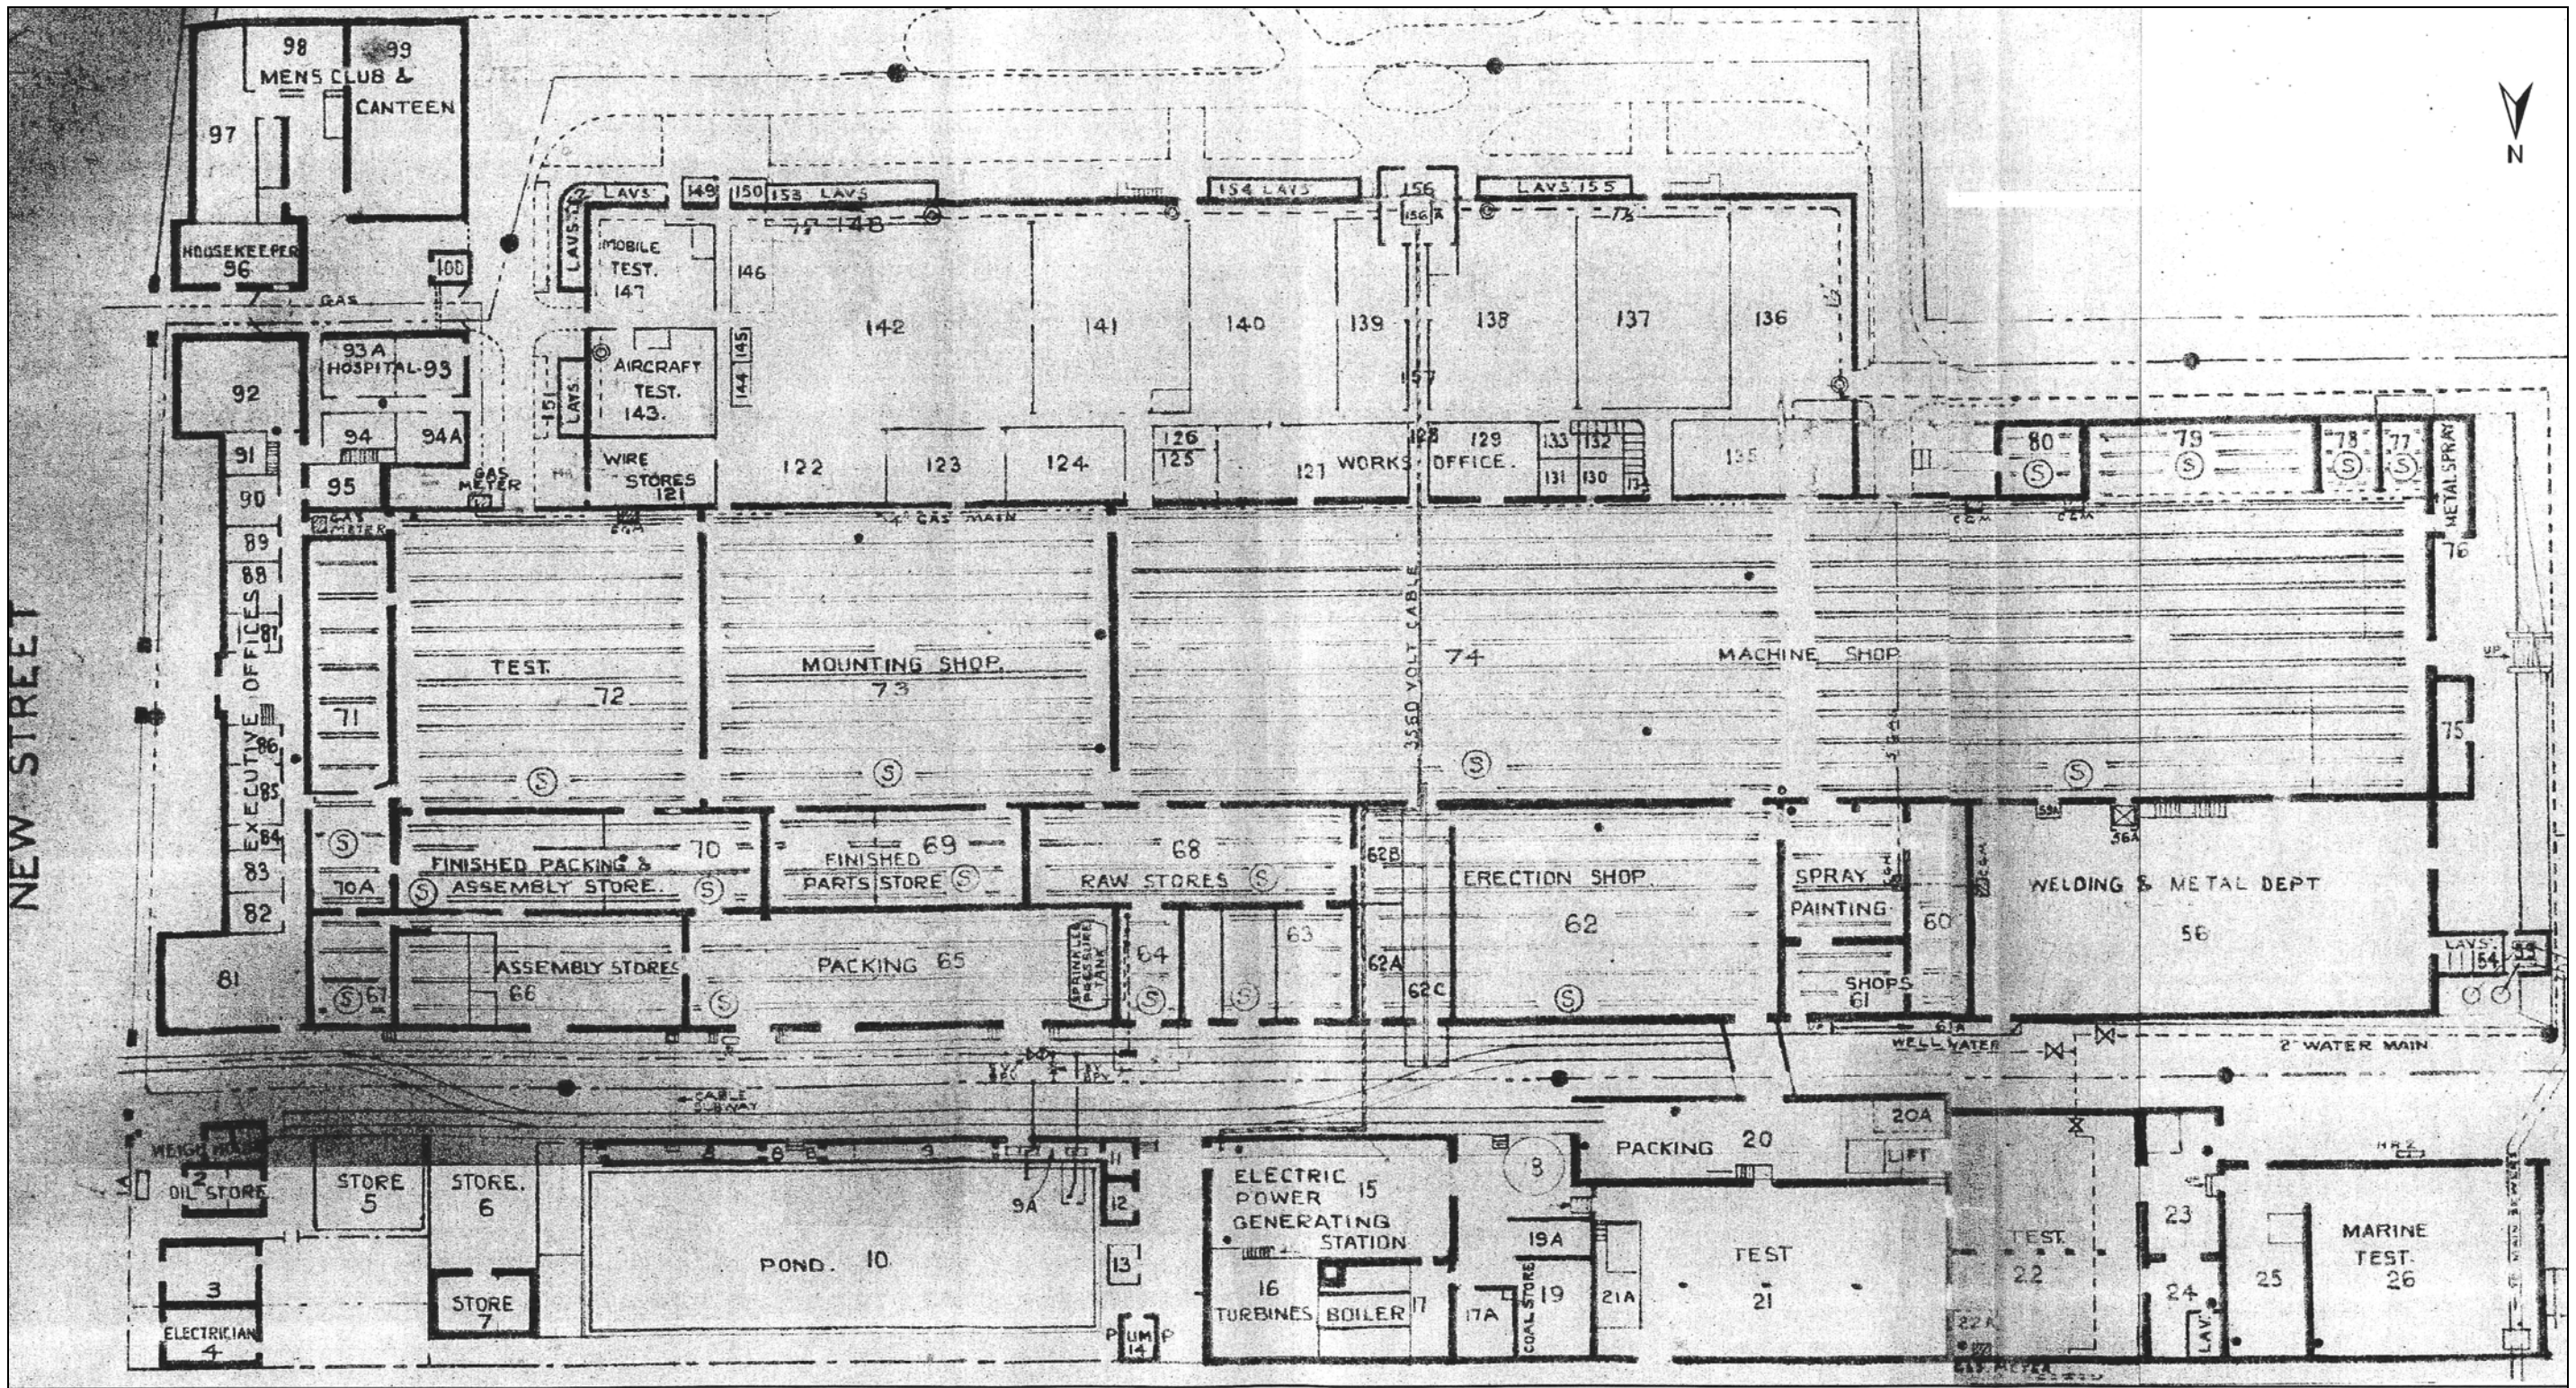
Fig. 4 1937 site plan – ground floor

Rooms 27 and 29 were the original test room but were divided by corridor 28, probably in the 1930s (fig. 4). Room 27 survives better than 29 but the earlier doors have been replaced with two 1930s/40s style semi-glazed forms, the most interesting of which has two horizontal panes divided by a thin band of glazing in the centre (plate 15). This type was seen adjoining room 27 and is also present in all factory areas. The walls of corridor 28 are made of hardboard and the factory-end fire doors have similar horizontal glass panes and square margins on the outer edge (plate 16). Square roof lights remain in the flat roof of the former test room, three tilting multi-glazed windows on each side (just visible in plate 15).

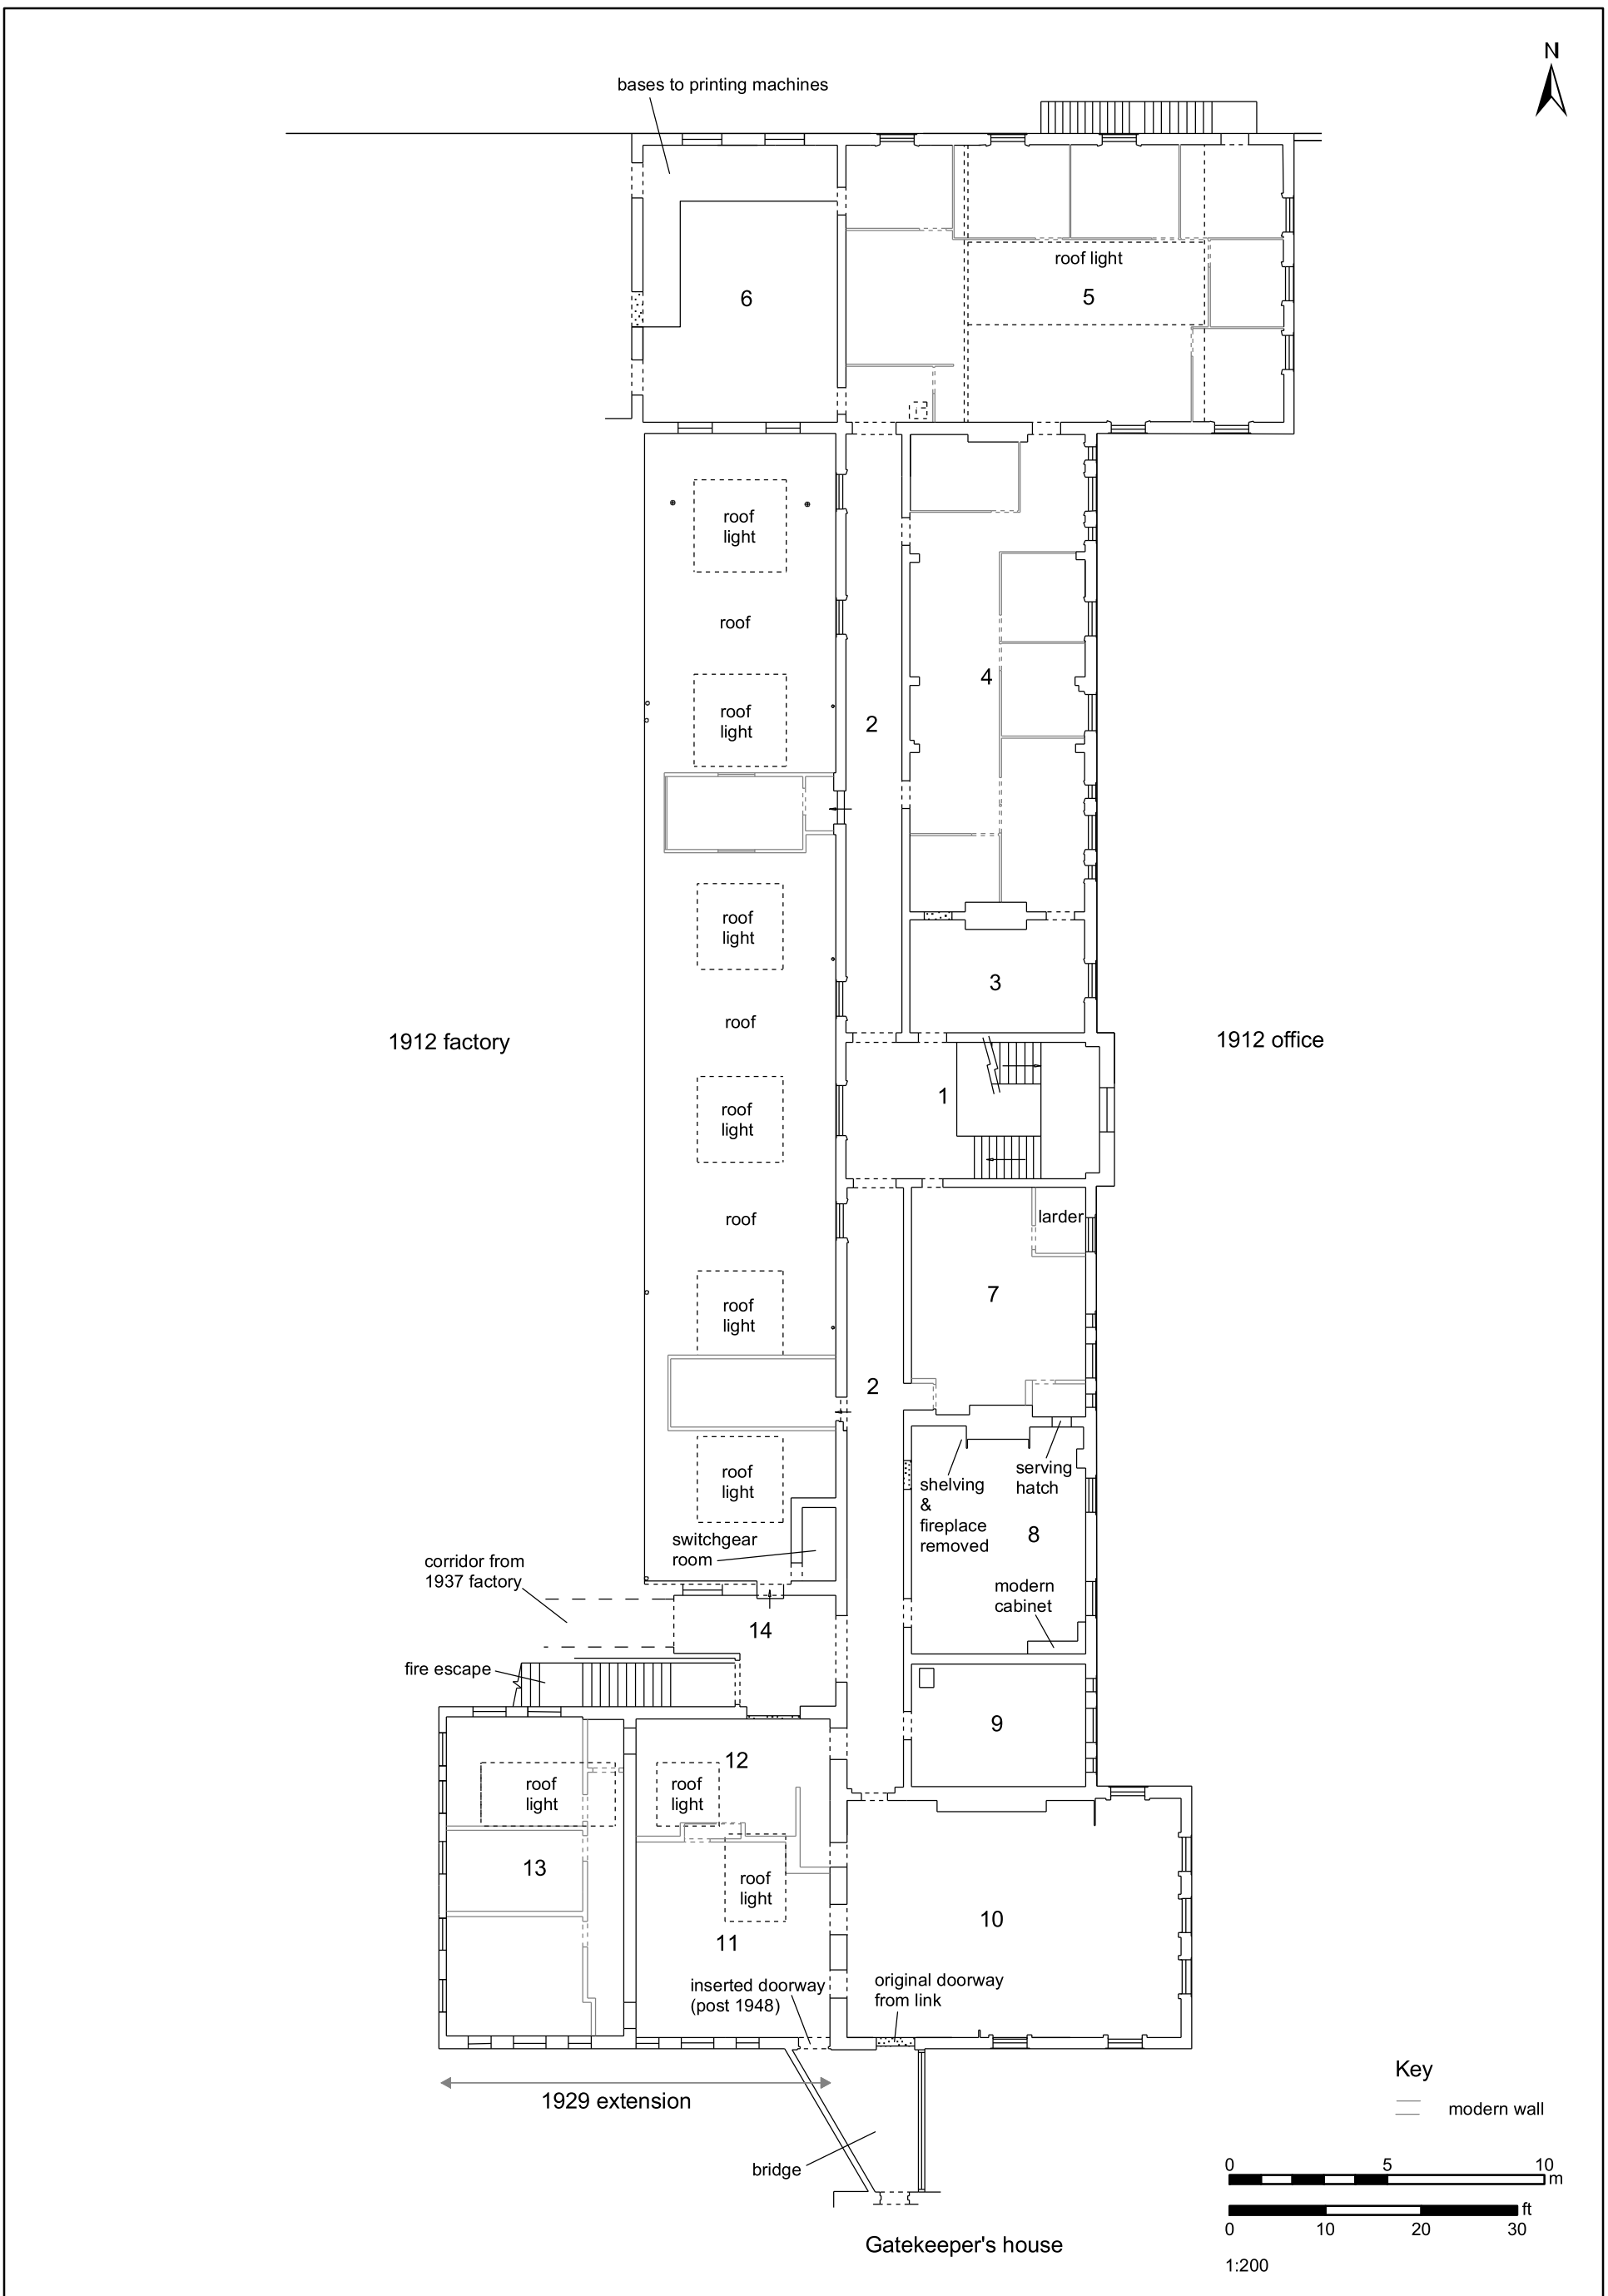
Fig.6b. 1912 offices and 1920s extension - first floor plan

The same dark-stained semi-glazed fire doors as seen downstairs lead to corridor 2 either side of the landing and single doorways enter into rooms 3 and 7 either side (fig. 6b). Corridor décor is the same as the corridor below. The only difference on this level is that the skirting boards are painted black rather than stained and the doorways, where they remain, contain heavy eight-pane doors within wide architraves, though many are either later three-panelled or semi-glazed doors.

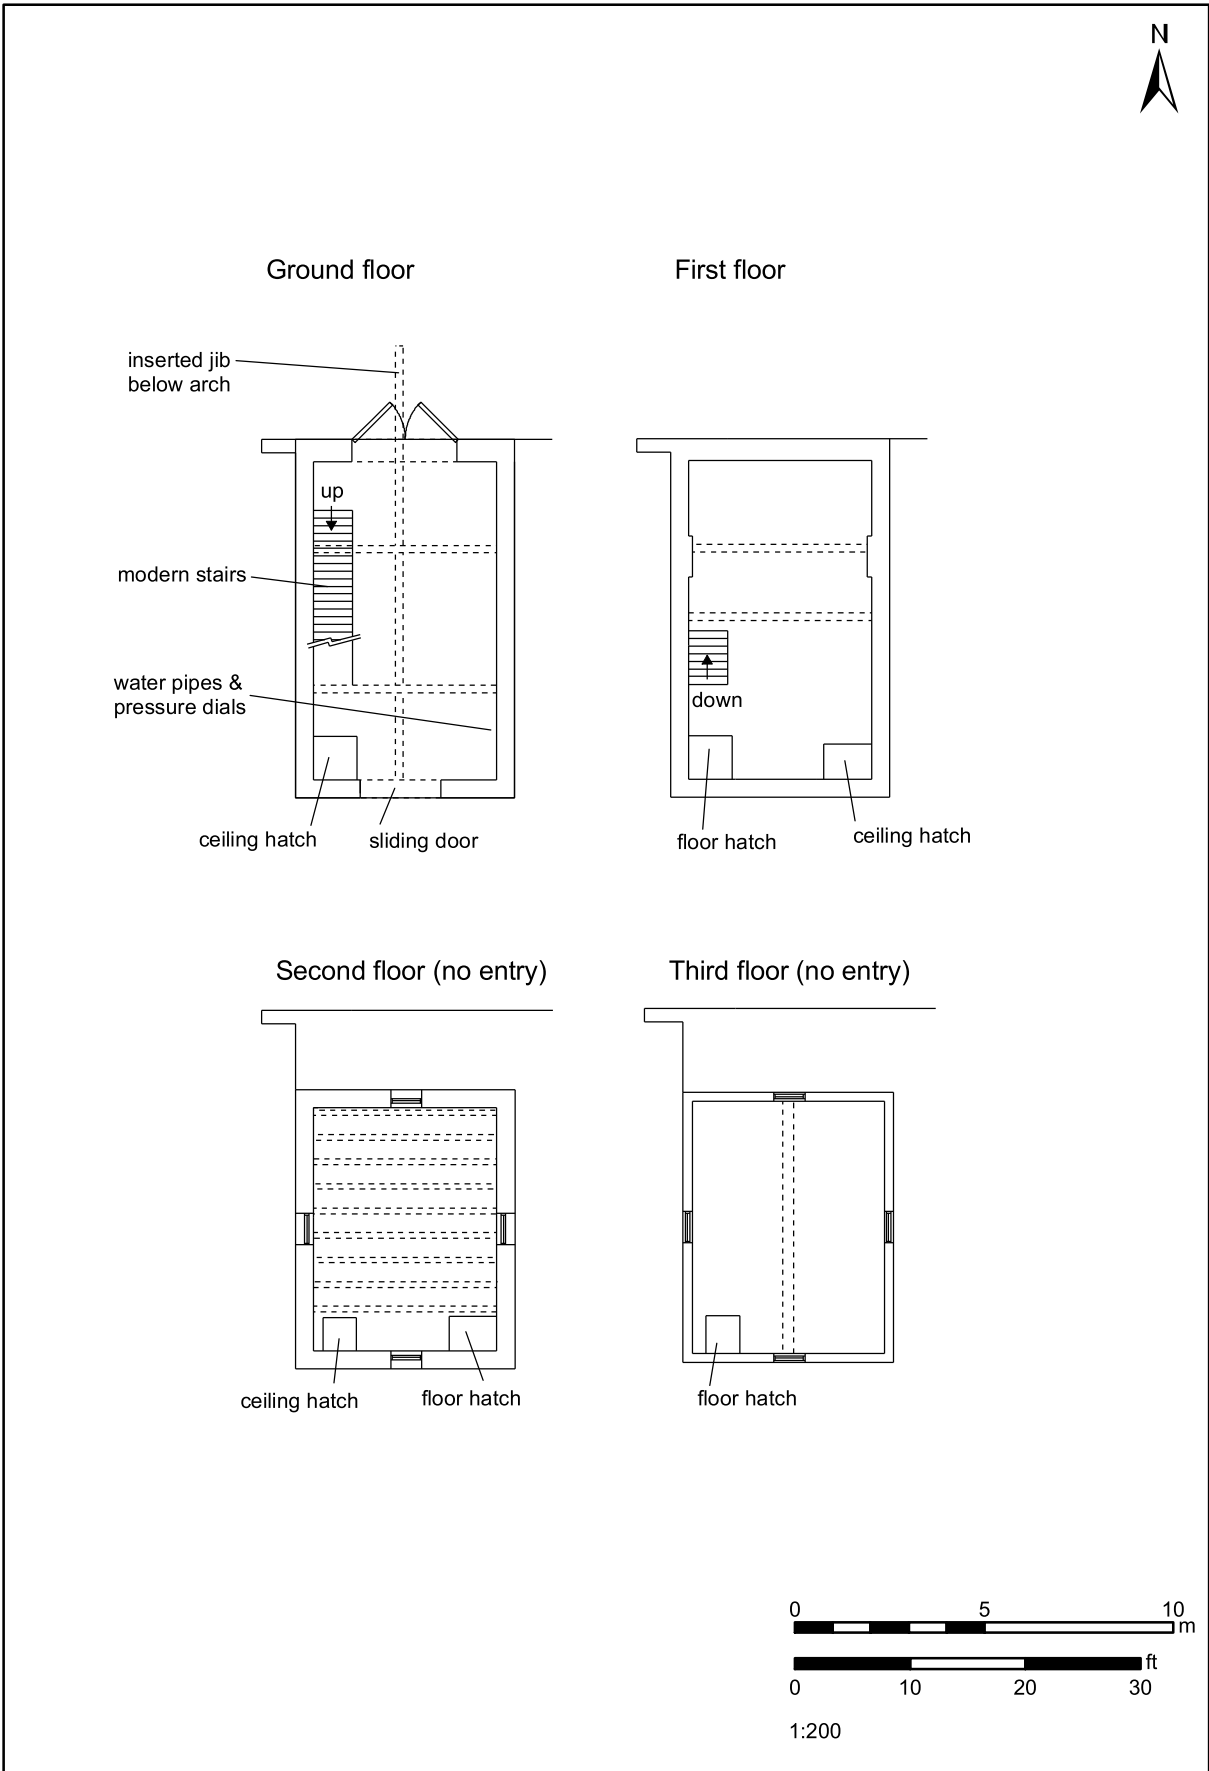
Fig.9. Water tower plans

The **water tower** (11) was accessed for survey on the ground and first floors only, since the upper two floors were infested by pigeons and unsafe. Floor plans of all levels are included in the report as figure 10.

The ground floor contains pipework and gauges within a railed enclosure along the east wall and an inserted staircase to the west (plate 53), that replaced an earlier steel ladder up to the ceiling hatch (fig. 9). A sliding door leads through into the factory raw stores (fig. 3) to enable raw materials to be brought in from the railway siding by a hoist attached to a steel (RSJ) jib. Ladders lead through ceiling hatches between the floors (fig. 10). The first floor working area is defined by pine-boarded panelling and has a concrete ceiling. No other historic features remain apart from the metal ladder to the second floor

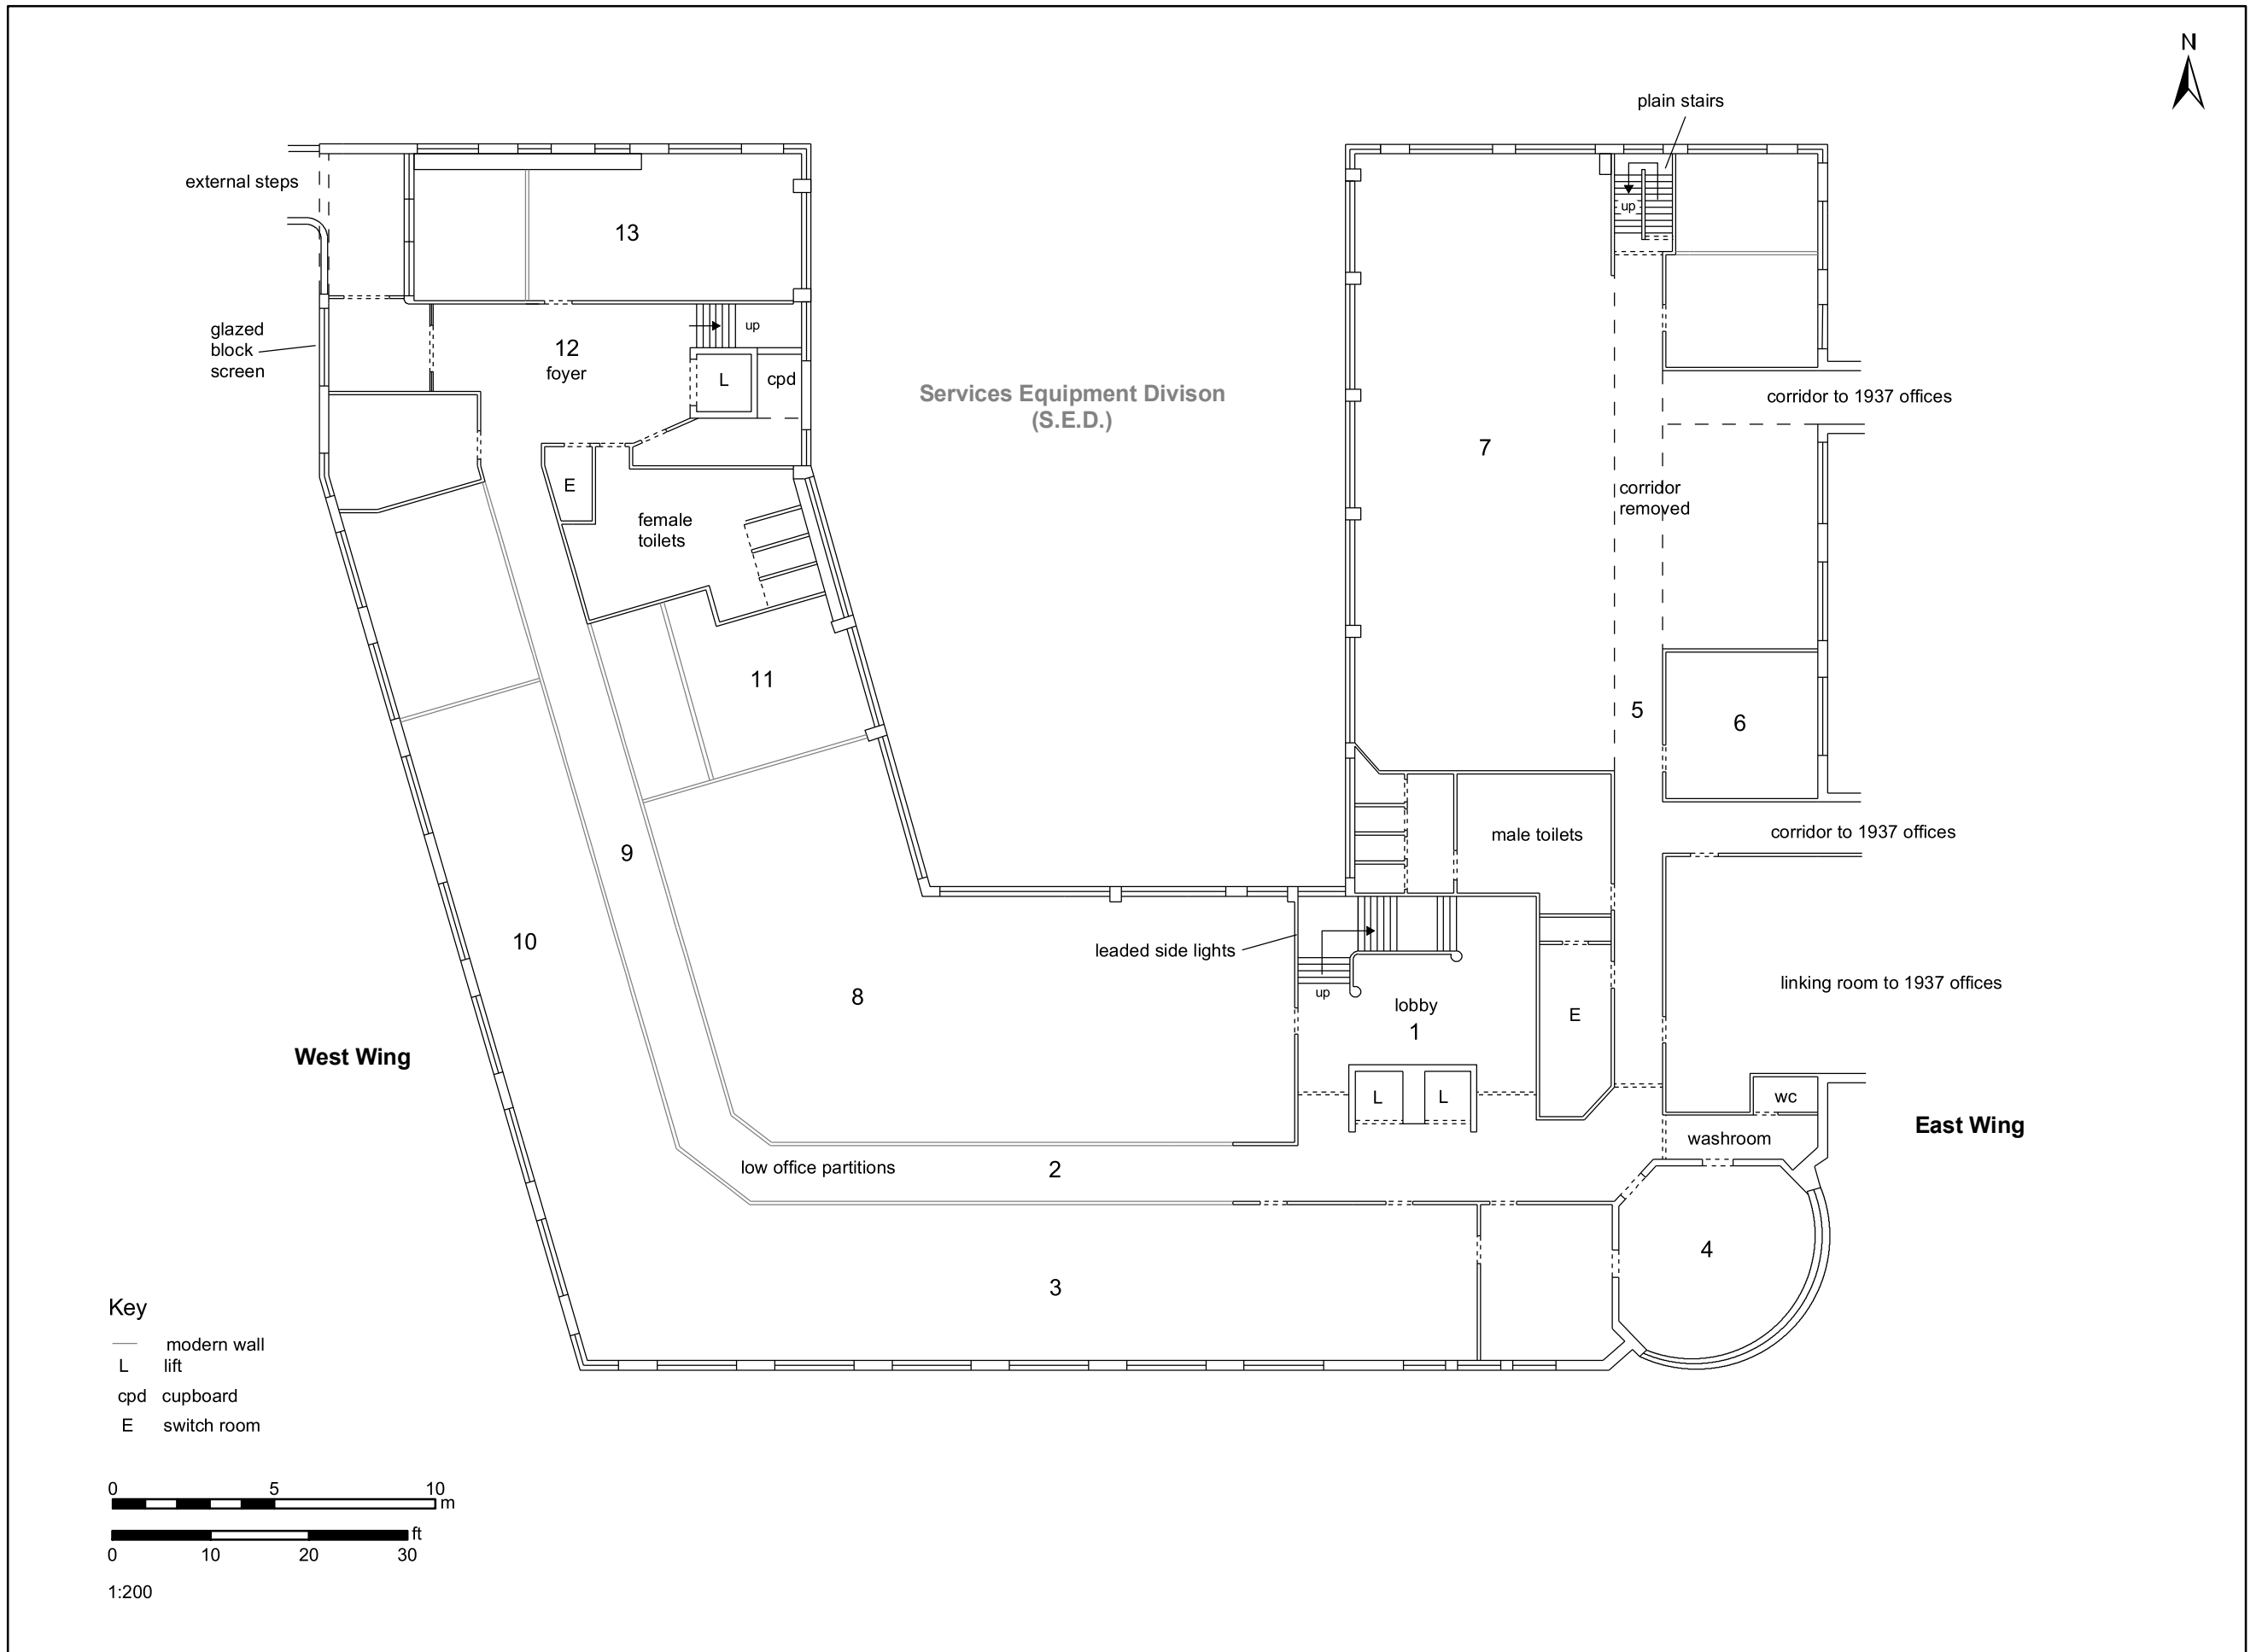
Fig.12b. Marconi House - first floor plan

room layouts (fig. 12b, first floor) and more complete historic layouts (fig. 12c, fourth floor). Plans of the second and third floors are not included because their form is so similar to the existing fourth floor, though original plans of these levels may be found in Burgess (2006).

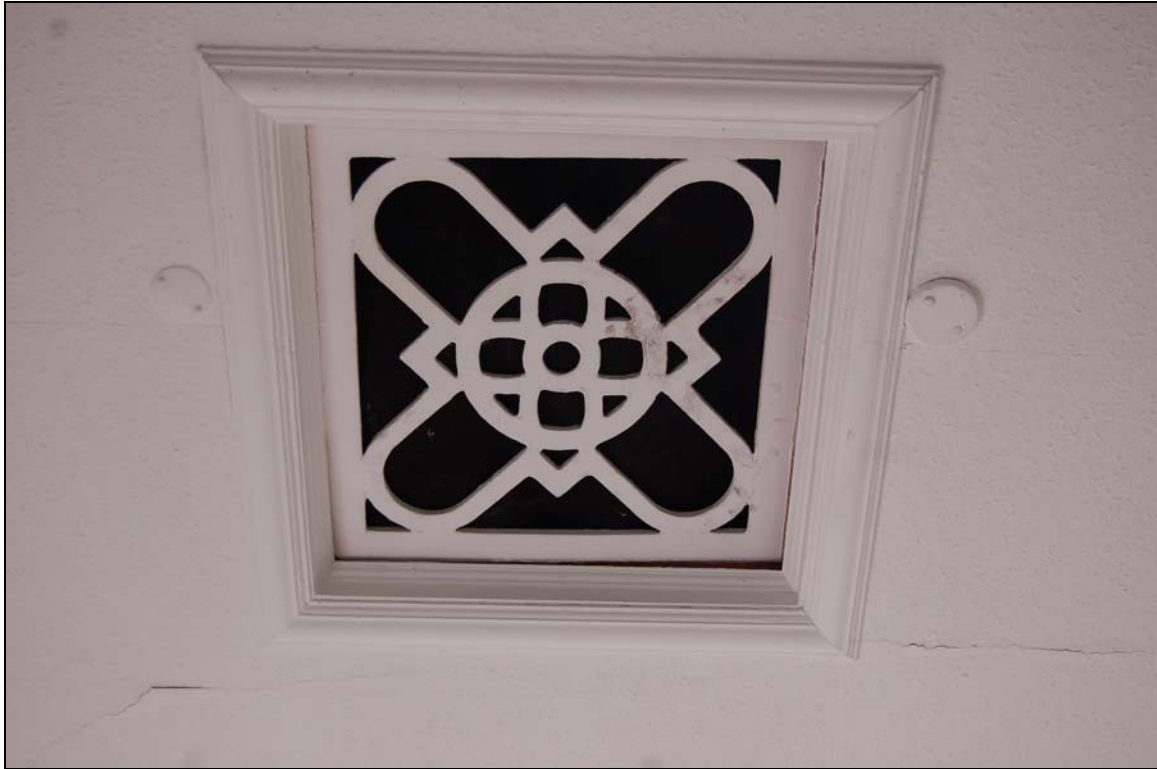
Plate 21 Ventilation grill observed in room 3 on first floor of 1912 offices
