BALANCING POND 2 & FORMER NURSERY SITE PRIORS GREEN TAKELEY ESSEX

ARCHAEOLOGICAL WATCHING BRIEF ON GEOTECHNICAL SITE INVESTIGATION TEST PITS

Document Ref.	1585rep
Report Issue Date	March 2006
Circulation	RPS Planning
	Countryside Properties
	ECC Historic Environment Management
	ECC Historic Environment Record

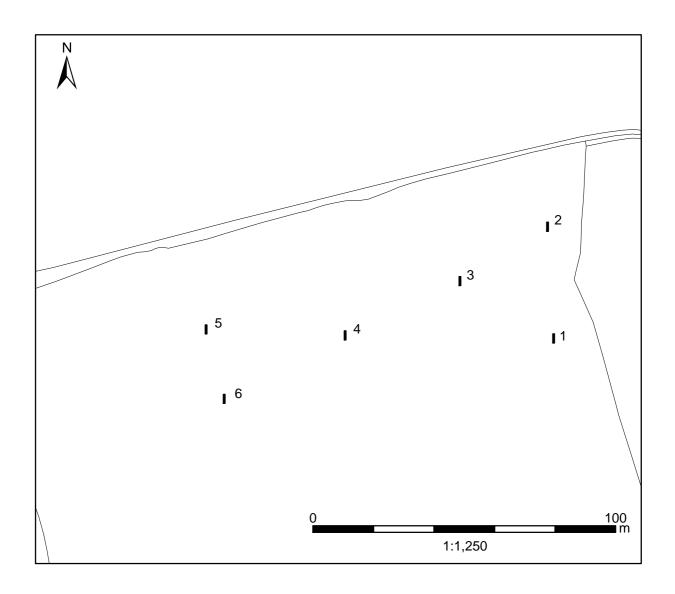
Fig.2. Location of geotechnical pits at the balancing pond site

Located at the south eastern end of the balancing pond this test pit was excavated to a depth of c.3m. Three distinct layers were recorded; from the top down these were 0.3m of topsoil, 0.3m of mid brown clay subsoil and 2.5 m of light brown chalky till with large flint nodules towards the bottom. No archaeological features were identified.

To the north of TP1, TP2 was approximately 4m deep. Five layers were identified in the section; 0.25m of topsoil, 0.26m of mid brown clay subsoil, 2 m of light brown chalky till, 1.4m of dark grey black silty clay (probably the fill of a palaeochannel) and 0.5m of white and light brown sand. No other archaeologically significant features were identified. The only cut feature visible was a modern land drain filled with ballast.

TP3 was located in the approximate centre of the balancing ponds, to the west of TPs 1 and 2. It was approximately 3m deep and cut through four layers; 0.31m of topsoil, 0.17m of mid brown clay subsoil, 2.3 m of light brown chalky till and 0.5m of the probable palaeochannel. No archaeological features were identified in this test pit.

To the west of TP3, TP4 was again located in the approximate centre of the balancing ponds. It was approximately 4m deep and contained four distinct layers; 0.23m of topsoil, 0.14m of mid brown clay subsoil, 2.1 m of light brown chalky till and 1.7m of a dark grey-black clay fill of a palaeochannel. No archaeological features were identified in either section.

Situated at the north eastern corner of the balancing pond, TP5 was excavated to a depth of 4m. Four distinct soil layers were identified, 0.22m of topsoil; 0.43m of mid brown clay subsoil, 2.3 m of light brown chalky till and 1.1m of palaeochannel. No archaeological features were identified in the section.

Located in the southwest corner of the balancing ponds, TP6 was excavated to a depth of c.3m. Three soil layers were seen in the section, 0.23m of topsoil, 0.36m of mid brown clay subsoil and 2.5 m of light brown chalky till. No archaeological features were identified.

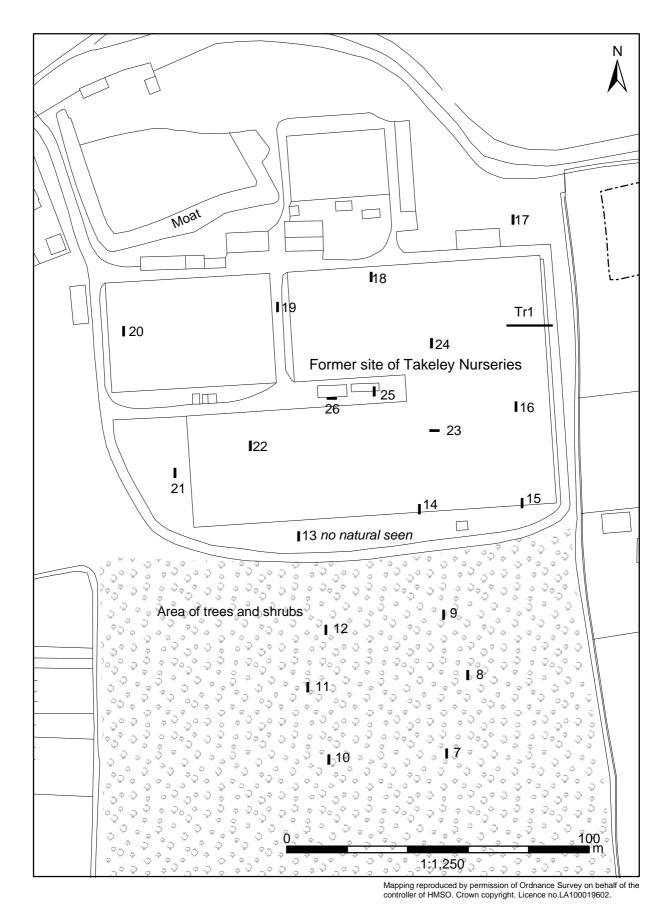
Fig.3. Location of geotechnical pits at the nursery site

Located to the south of the former green houses, TP8 was excavated to a depth of 3m. Three separate layers were recorded, 0.1m of topsoil, 0.5m of mid brown clay subsoil and 2.5m of light brown chalky till. No archaeological features were identified in this test pit.

To the north of TP8 lay TP9 which was also 3m deep. Again as with TP8 three layers were identified, 0.2m of topsoil, 0.15m of mid brown clay subsoil and 2.7 m of light brown chalky till. No archaeological features were seen in the section.

Situated to the west of TP7, this test pit was excavated to a depth of approximately 3m. Three distinct layers of soil were recorded, 0.2m of topsoil, 0.2m of mid brown clay subsoil and 2.7 m of light brown chalky till. A single archaeological feature was seen cutting through the brown subsoil layer. The feature was only partially seen in the test pit but extended 1.73m from the southern baulk. It was 0.73m deep and was filled by a dark brown silty clay. No finds were recovered from the fill of the feature and it is difficult to assign a form to it, it did however appear in both sections of the test pit which suggests that it may be a ditch.

TP11 lay to the north of TP10. It was 4m deep and the section showed three distinct layers; 0.15m of topsoil, 0.2m of mid brown clay subsoil and 2.7m of light brown chalky till. One feature, a possible large ditch, was seen in the section. The ditch was approximately 1.2m deep and extended beyond the limits of the test pit. It was filled with a mid brown chalky till with pink mottles, no finds were recovered from the fill. The size and location of this feature suggests that it may be a continuation of the large east-west running ditch seen in Area 4 of Priors Green Phase 1, Stage 2 (Robertson 2006).

Lying to the north of TP11, TP12 was excavated to a depth of 3m. Three distinct soil layers were recorded in the section; 0.2m of topsoil, 0.2m of mid brown clay subsoil and 2.5m of light brown chalky till. No archaeological features were identified and no finds were collected.

TP13 was located in the southwest corner of the area formerly covered with green houses. It was excavated to a depth of 1.6m where a large obstruction prevented any further excavation. Only modern rubble was seen in the section.

Situated in the centre of the southern limits of the former greenhouses TP14 was excavated to a depth of 3m. Four soil layers were identified in the section; 0.3m of modern rubble, 0.1m of mid brown clay, 0.4m of modern rubble and 2.2 m of light brown chalky till. No archaeological features were identified.

In the southeast corner of the area of the former greenhouses TP15 was excavated to a depth of 3m. Three distinct layers were identified; 0.3m of modern rubble, 0.3m of mid brown clay subsoil and 2.5 m of light brown chalky till. No archaeological features were identified in the section.

Located along the eastern edge of the greenhouses TP16 was machine excavated to a depth of c.3m. Three separate layers were identified; 0.5m of modern rubble, 0.3m of mid brown clay subsoil and 2.3 m of light brown chalky till. A single feature was seen in both sections of the test pit. The probable ditch ran northwest to south east and was 0.7m wide and 0.6m deep. It was filled by dark brown silty clay but no finds were recovered from it.

Situated in the northeast corner of the site TP17 was approximately 3m deep. It contained three distinct layers; 0.3m of modern rubble, 0.3m of mid brown clay subsoil and 2.5 m of light brown chalky till. No archaeological features were identified in either of the sections.

Lying along the northern limits of the area of investigation TP18 was machine excavated to a depth of approximately 3m. Three distinct layers were identified in the section of the test pit; 0.5m of modern rubble, 0.2m of mid brown clay subsoil and 2.3m of light brown chalky till. A possible east – west running ditch was recorded along the northern edge of this test pit. It was in excess of 1m wide and was 0.7m deep. It was filled with dark brown silty clay from which no finds were recovered.

Situated in the centre of the northern limits of the area of investigation TP19 was excavated to a depth of 2.7m. Four soil layers were identified in the section; 0.2m of modern rubble, 0.4m of mid grey brown silty clay, 0.1m of mid brown clay subsoil and 2m of light brown chalky till. No archaeological features were identified.

Located at the north western corner of former greenhouses TP20 was excavated to a depth of 2.5m. Two distinct soil layers were identified in the section; 1m of modern rubble, and 1.5m of light brown chalky till. No archaeological features were identified.

Situated in the southwest corner of the green house area TP21 was approximately 2.5m deep. It contained two distinct layers; 0.35m of topsoil, and 2.2 m of light brown chalky till. No archaeological features were identified in either of the sections.

Located to the east of TP21, TP22 was excavated to a depth of 2.5m. Four separate layers were identified in the section; 0.4m of modern rubble, 0.1m of blue grey silty clay, 0.4m of brown clay and 1.6 m of light brown chalky till. No archaeological features were identified.

Situated to the north of TP14, TP23 was approximately 3m deep. It contained three separate layers; 0.3m of modern rubble, 0.1m of mid brown clay subsoil and 2.5 m of light brown chalky till. No archaeological features were identified in the test pit.

Located to the north of TP23, TP24 was machine excavated to a depth of 2.5m. Two distinct layers were identified in the sections; 0.3m of modern rubble and 2.2m of light brown chalky till. A single feature, a presumptive gully, was seen running east-west through the test pit and was over 0.3m wide, 0.4m deep and was filled by dark brown clay. No finds were collected from either the feature or the test pit.

Positioned over a fuel tank in the centre of the area of the former green houses, TP25 was approximately 4m deep. Only two layers were identified in the section; 0.3m of modern rubble and 3.7m of light brown chalky till with mid brown clay lenses. No archaeological features were identified in either section.

Located immediately to the east of TP25, TP26 was situated down the southern side of a fuel tank. It was machine excavated to a depth of approximately 4m and three separate layers were identified; 0.2m of modern rubble, 1.7m of dirty yellow clay which was probably redeposited and 2m of light brown chalky till. No archaeological features were identified, although the top 2m of the test pit was disturbed.
