**FARM BUILDINGS AT LITTLE THORBENS, TOOT HILL ROAD
GREENSTEAD GREEN, ONGAR, ESSEX**

HISTORIC BUILDING RECORDING

Essex County Council

May 2006

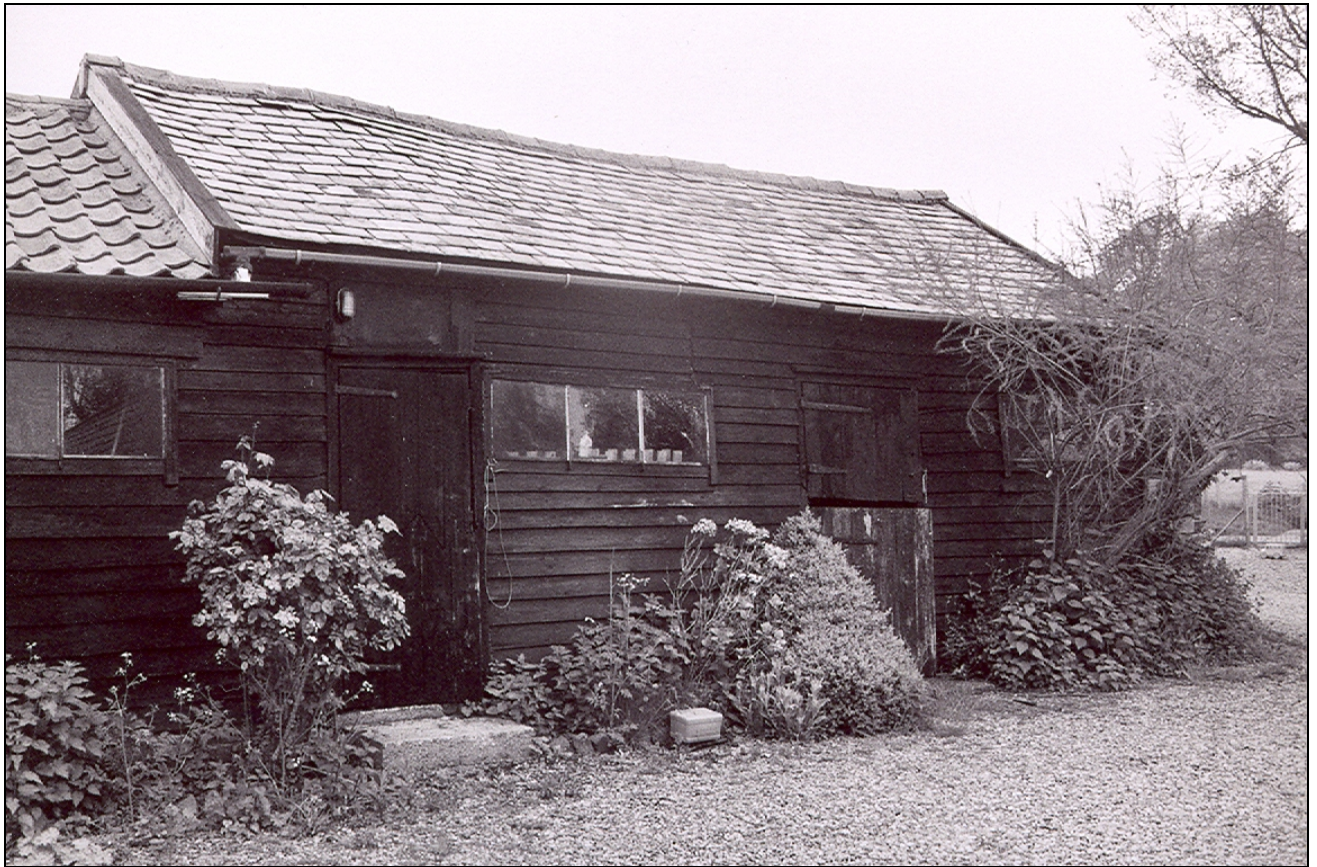
On the main, south-east, elevation (plates 1 & 4), a centrally-placed stable-type half-heck door provides entry into the main part of the structure, between two three-light windows. A second door with fixed plain fanlight over, leads into the narrow woodstore that originally was probably either a loose box or feed store. Both doorways are fastened to the frame by distinctive round-ended and spearhead strap hinges, suggesting a post-17th-century date (Alcock and Hall 1994) and are likely original fixtures. The doorway into the woodshed has a

The small area currently functioning as a woodstore (plate 4, left) displays identical construction techniques to the main part of the shelter shed. The boarded partition between the two is original and, again, the north-west side has a machine-sawn primary-braced frame. However, mortice holes on the wall plate soffit on this side show the sawn framing replaced an earlier stud wall on this side. The interior (plate 9) is limewashed and there are vague possible Baltic timber marks (*ll*) on the south-west wall plate (fig. 6, plate 10).

Plate 4 Former Shelter Shed 1 viewed from south

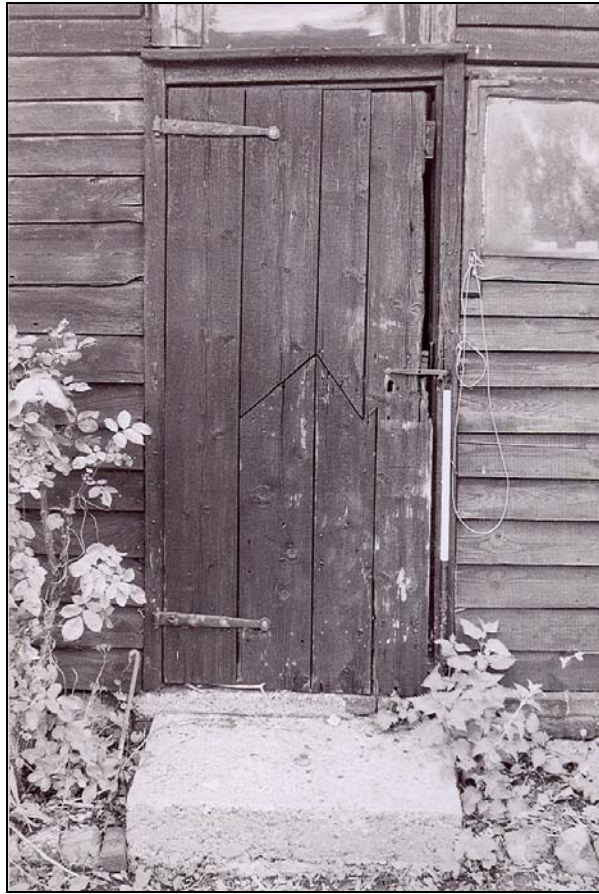
distinctive zigzag timber construction (plate 5) that appears to be contemporary rather than a later graft.

Plate 5 Door into woodshed, Shed 1

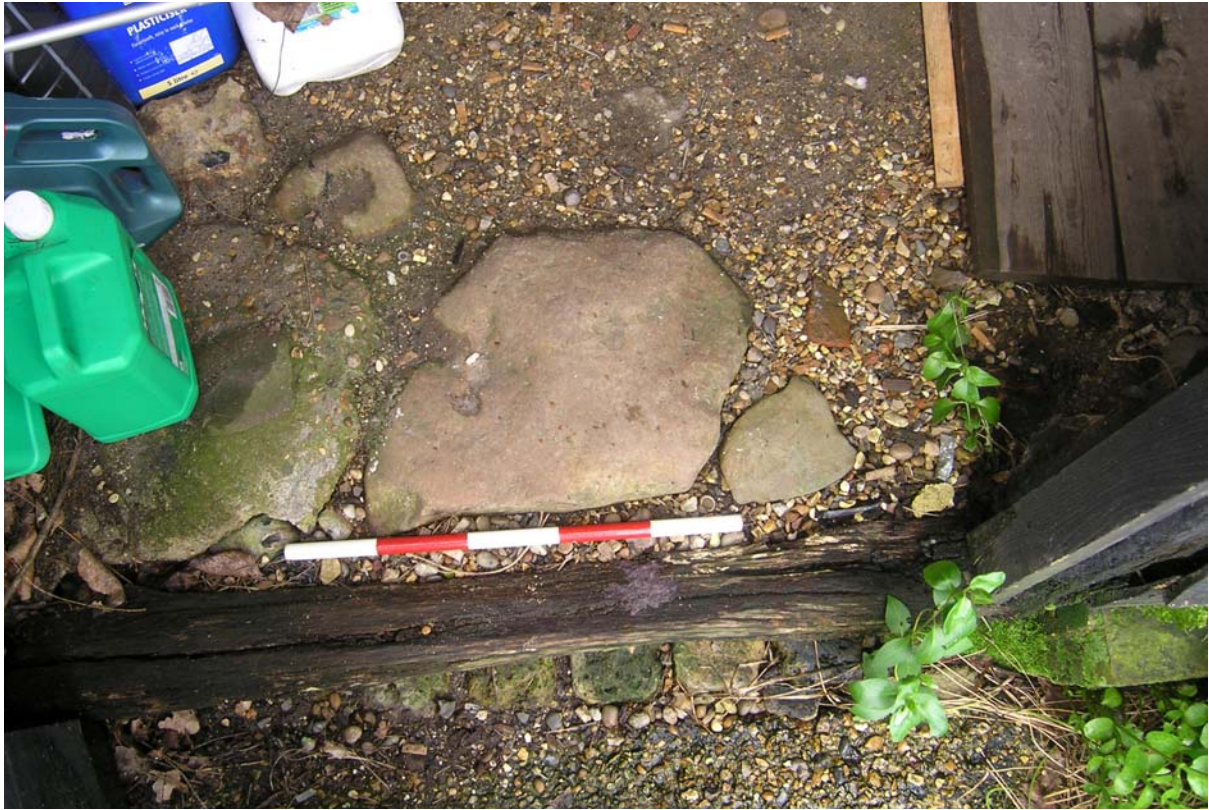
Inside are two unequally-sized bays, plus the partitioned store on the south-west end; effectively three bays. The shed was originally built open-sided, connecting to the store by a doorway in the southern corner that was blocked with reused timber (plate 6) in the 19th-century with the construction of the enclosed layout. The weather-boarding on the inside of the store clearly shows the former in-filled outline of the doorway. The internal earthen floor has a cobbled threshold (plate 7).

Plate 7 Stone threshold to Shed 1

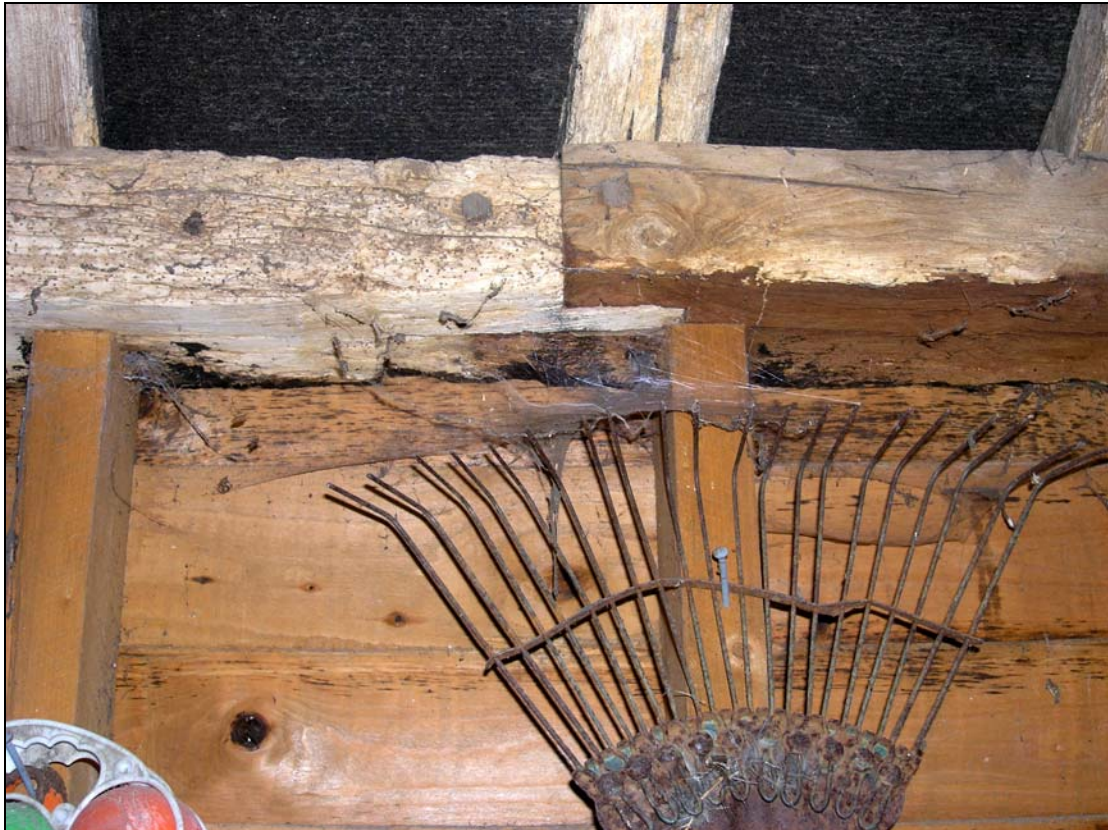
Plate 8 Edge-halved and bladed scarf jointed wall plate above in-filled wall framing in Shed 1

In the oldest structure, the wall framing is of fairly thick, primary-braced oak, with pegged trusses and edge halved and bladed scarf joints securing the wall plates. The studwork is tenoned into the plates at the top, but nailed onto the sills (which appear to be original) at the base. The clasped purlin roof is later, but probably replaced an earlier one. All things considered, this is post-medieval construction that would not be out of place in a structure built in the 18th- or perhaps early 19th-century, hence the dating of this primary phase.

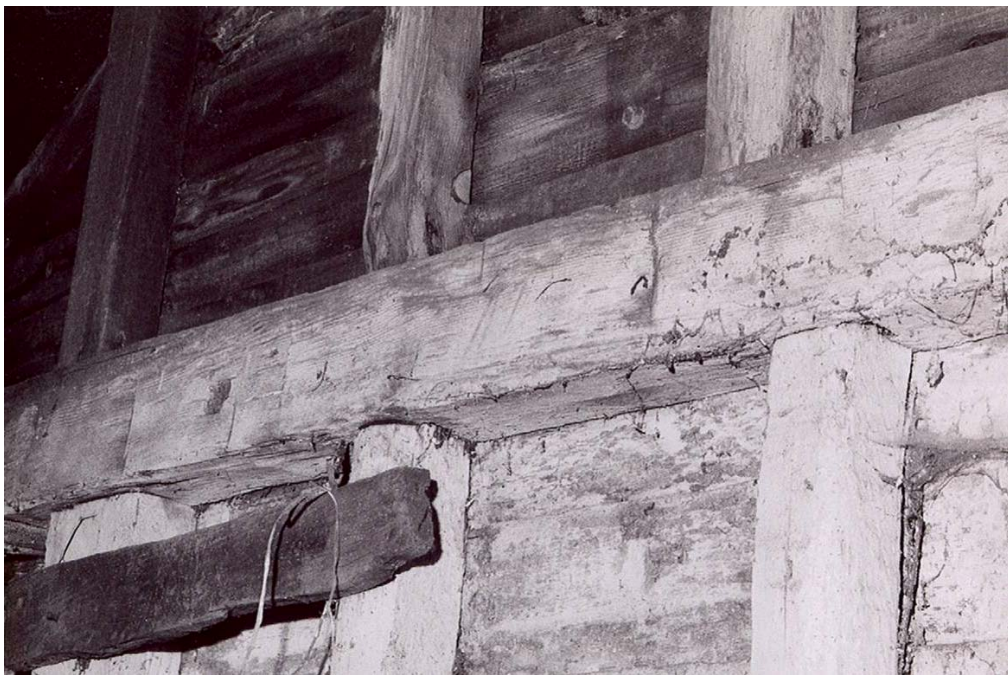
Plate 10 Possible Baltic timber mark (central //) inside woodshed

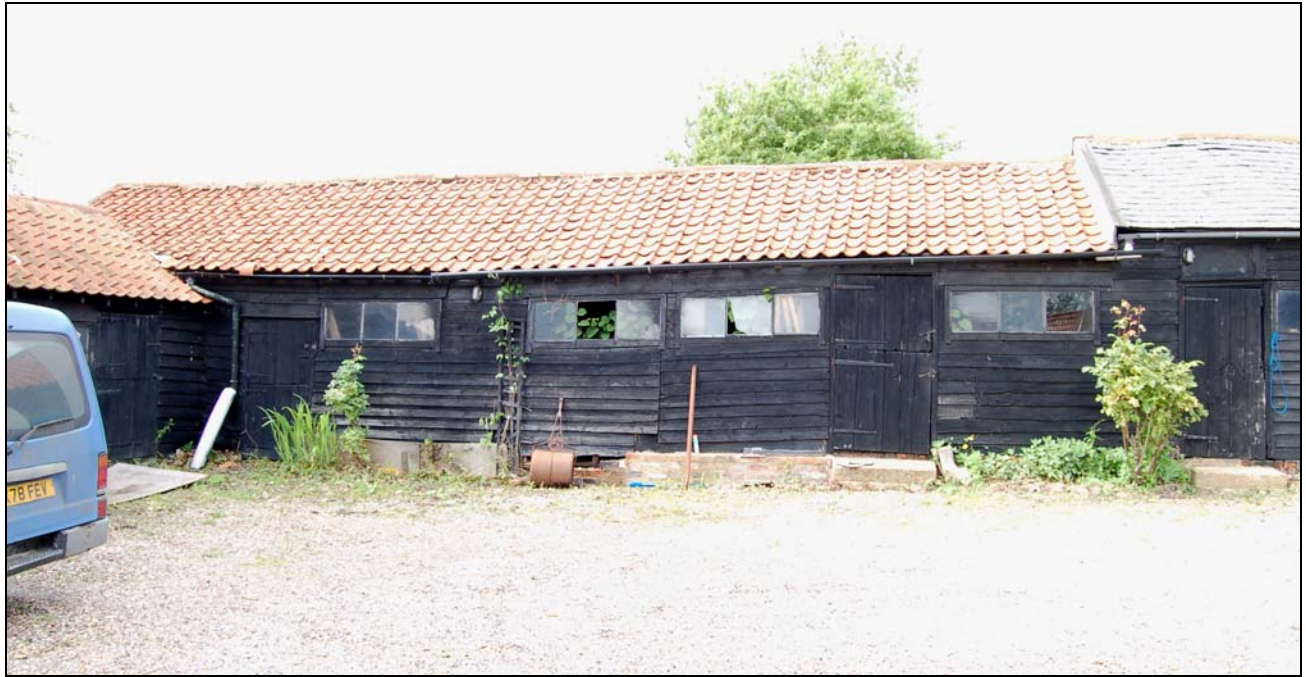
The main elevation (plates 1 & 11) fronting the yard contains two half-heck doors either end, with inserted fixed windows set between. Both doors appear contemporary with those in building 1 and the one furthest to the north-east end retains the same round-ended strap hinges. In fact, there is evidence to suggest the north-east bay contains elements of wall-framing to the pre-1840 structure, left upstanding when the rest of the building was constructed. A scar in the weatherboarding on the first bay (plate 11) is consistent with original framing on the inside, as if this side of the bay was retained. Indeed, the ground sill here appears to be original (9 x 19cm) and has been cut off where bays 1 and 2 join. The following sill is narrower and appears to be replaced.

Plate 11 Front elevation of Cowhouse 2, showing wall scar between bays 1 and 2

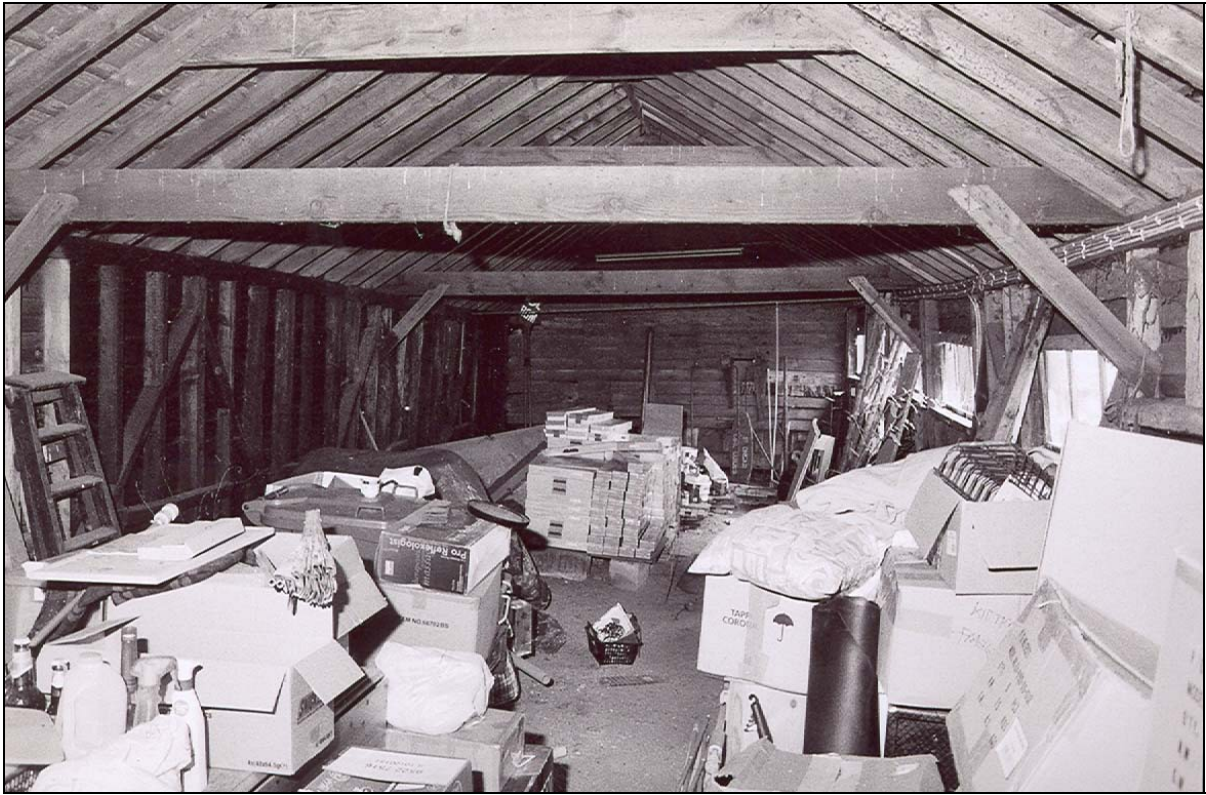
A new wall plate and sill have been added to the rear (north-west) wall joined by basic lapped scarf joints and carrying a mixture of new and reused timbers in a dark stain (plate 13). Most of the south-east side retains possibly original wall plates, though the sills appear

Plate 13 Interior of Cowhouse 2 viewed from south-west

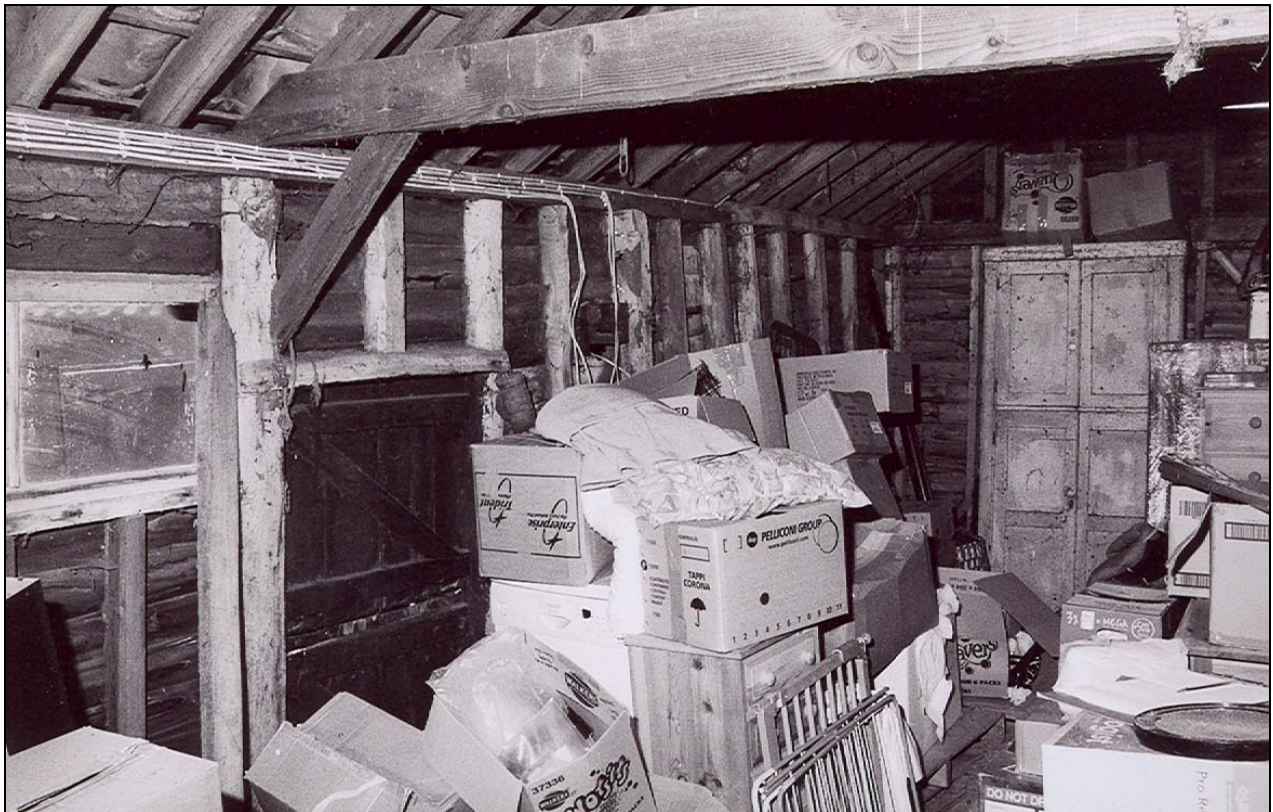
to be replaced on bays 2 and 3 (plate 14). Certainly, the door into bay 2 is in the right position (plate 00) and surrounded by genuine limewashed studwork. Proper inspection in this area was hindered slightly by the amount of stored items kept here.

Plate 14 Original wall framing around doorway into third bay of Cowhouse 2

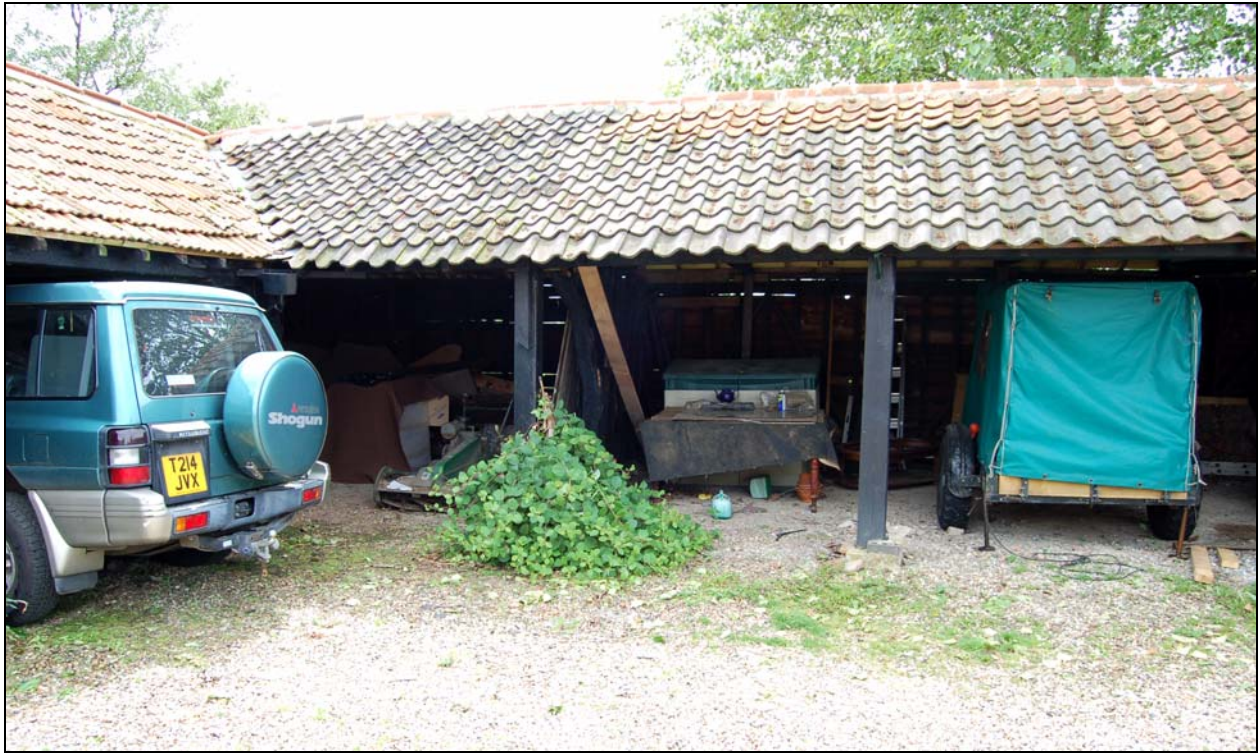
The main component of the south-west range is Shelter Shed 4 (plate 17), situated between Loose Box 3 and Shelter Shed 5; essentially the same, but with slightly differing construction and alterations. Shelter sheds were open to the yard, giving cattle room to roam. Historic mapping (fig. 5, 1896) shows that this end of the yard was enclosed and it is possible that areas were zoned off to different animals. The plan form is linear and its proportions similar (9 x 29m) to the other two, although this is slightly misleading as there is no real partition between sheds 4 and 5.

Plate 17 Close-up photograph of Shelter Shed 4

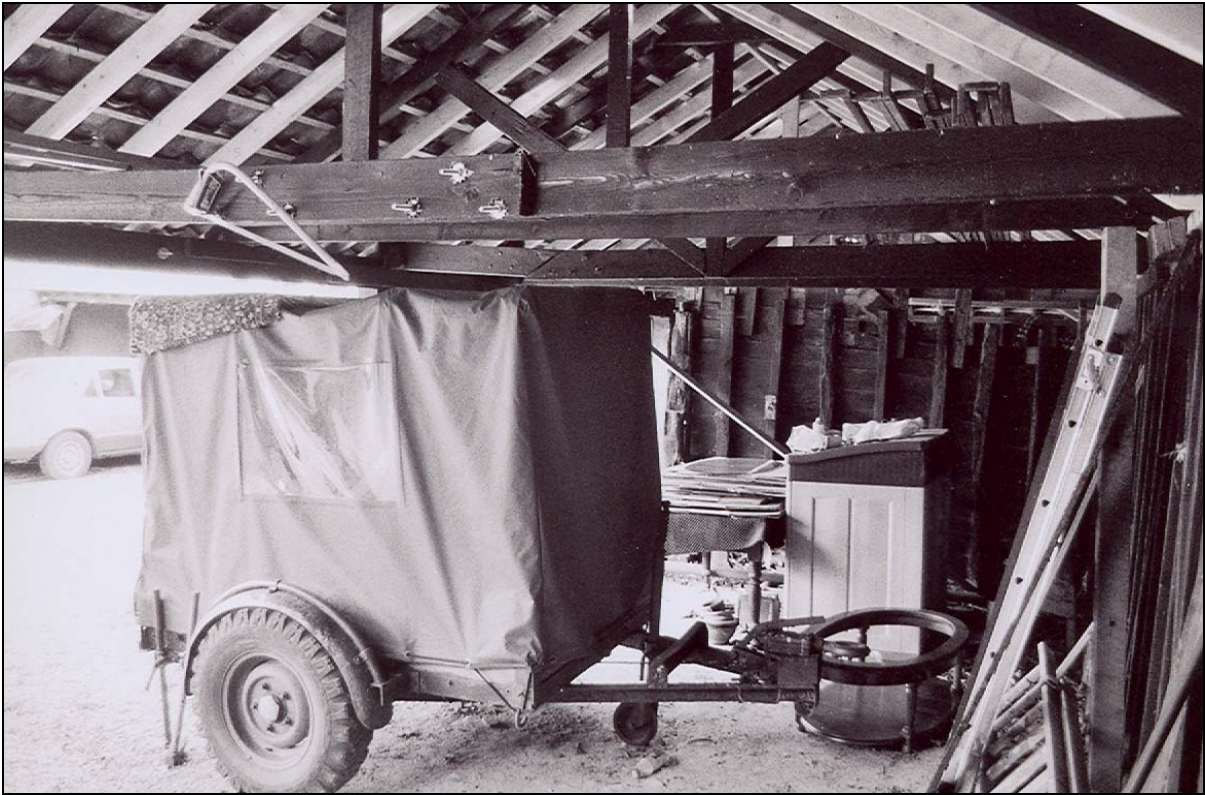
usually between 0.91-1.07m (Peters 2003). A partition built from sawn and reused timbers defines the feeding area in the larger bay from the other three bays, which are linked by an open doorway (fig. 6, plate 19).

King post strut roof trusses (fig. 8, section D, plate 19) define the bays and also appear in-between as modern insertions, to support a heavier roof load. The latter are not shown in fig. 6. The roof has been replaced in plain clay tiles on new rafters. Some of the accompanying plank tie beams have been repaired in the modern period with new timbers splay-scarfed on and secured with stainless steel bolts. The valley and hip rafters have been replaced where buildings 4 and 5 join (Tattershall 2006). The rear wall consists exclusively of sawn primary-braced softwood.

Plate 19 King post trusses and internal north-west side of timber partition to Shelter Shed 4

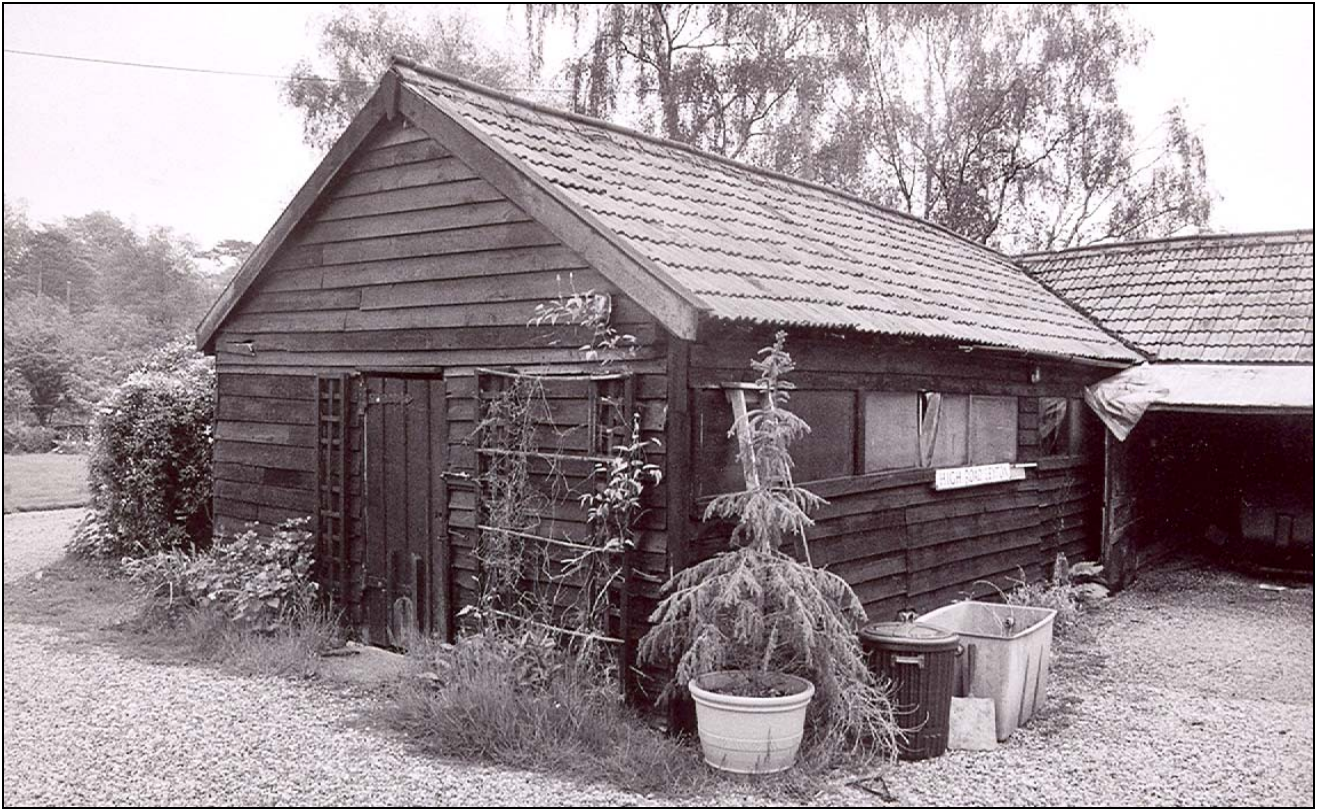
small chained opening at the base of the doorway on the north-west elevation is a later insertion for cat entry and vermin control (plate 21). The roof structure and pitch (fig. 8, section F) appear to be original and are the same as Shelter Shed 5.

Plate 21 Former Shelter Shed 6, viewed from west

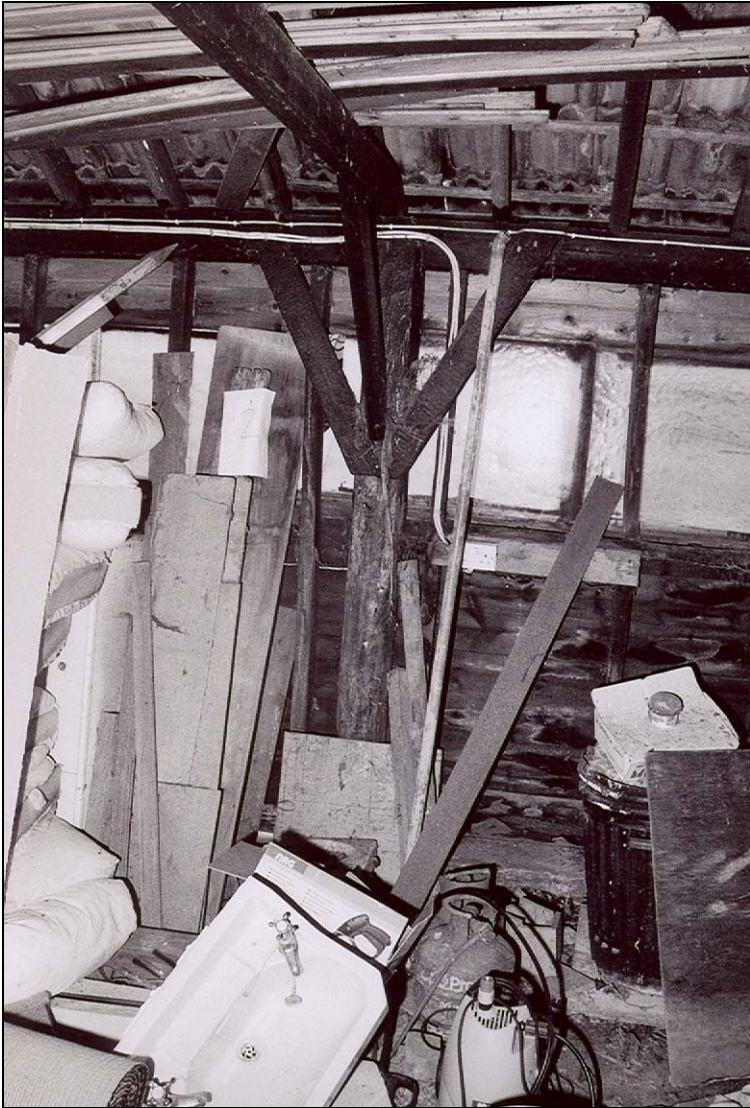
Plate 23 Braced bay post inside Shelter Shed 6

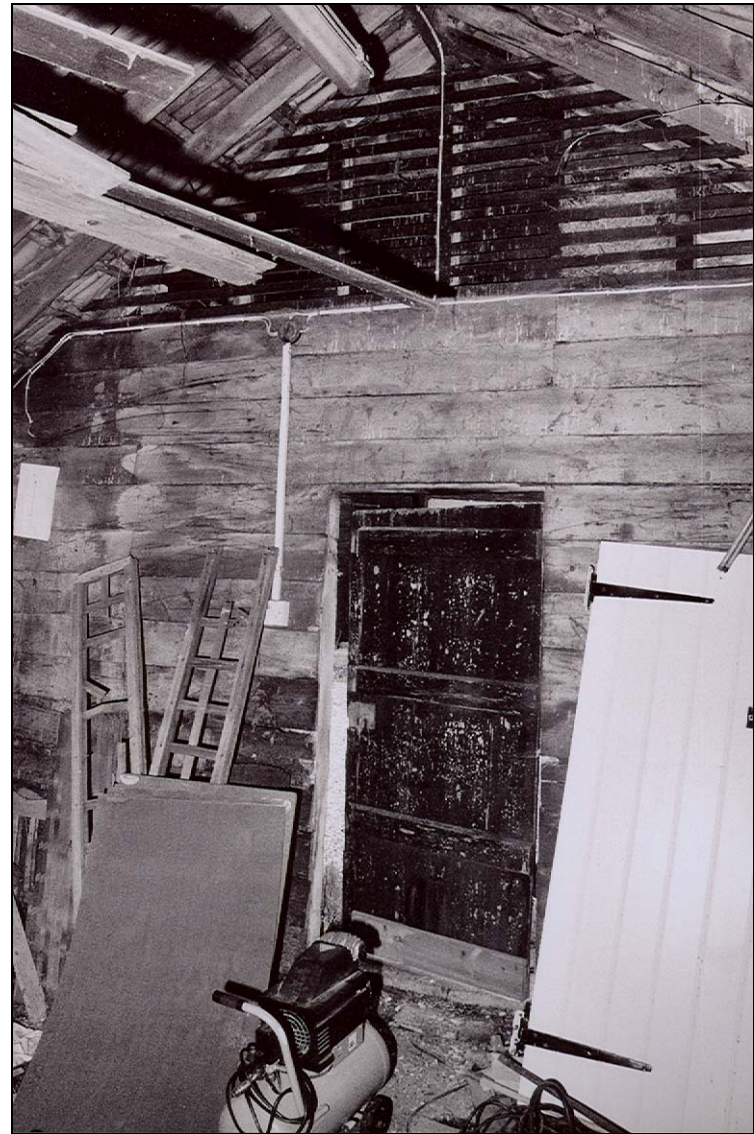
Plate 24 Ventilated gable inside north-west gable of Shelter Shed 6
